QUTB SHAHI
HERITAGE PARK

ANNUAL REPORT 2023-2024

Conservation & Landscape Restoration

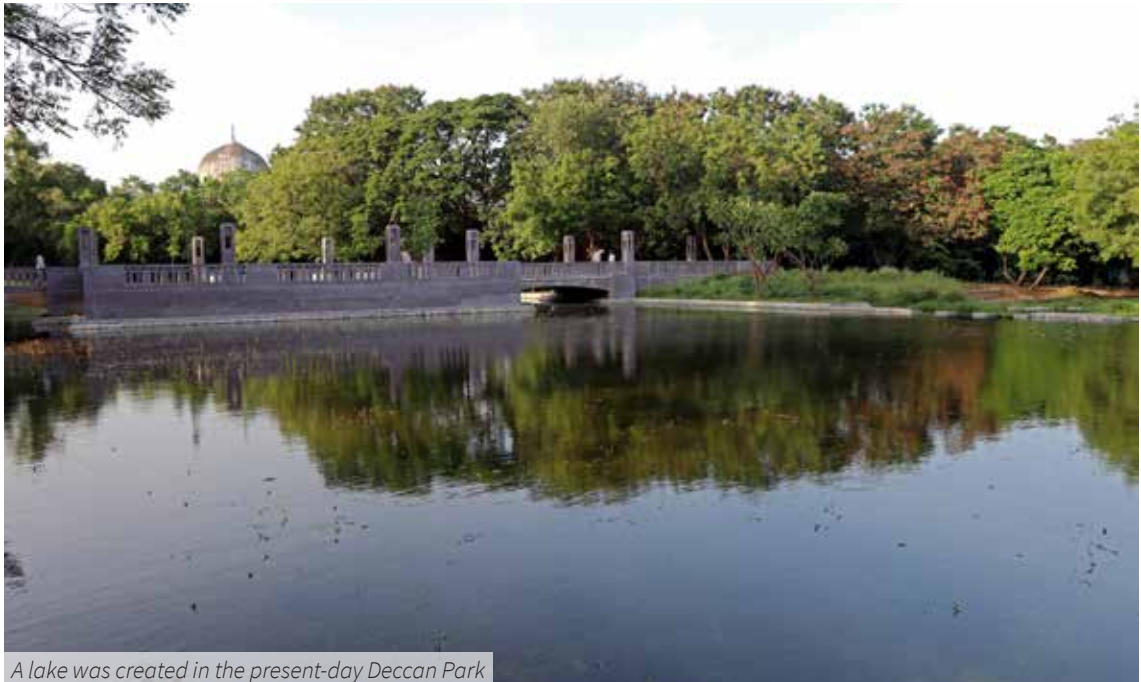
A lake was created in the present-day Deccan Park

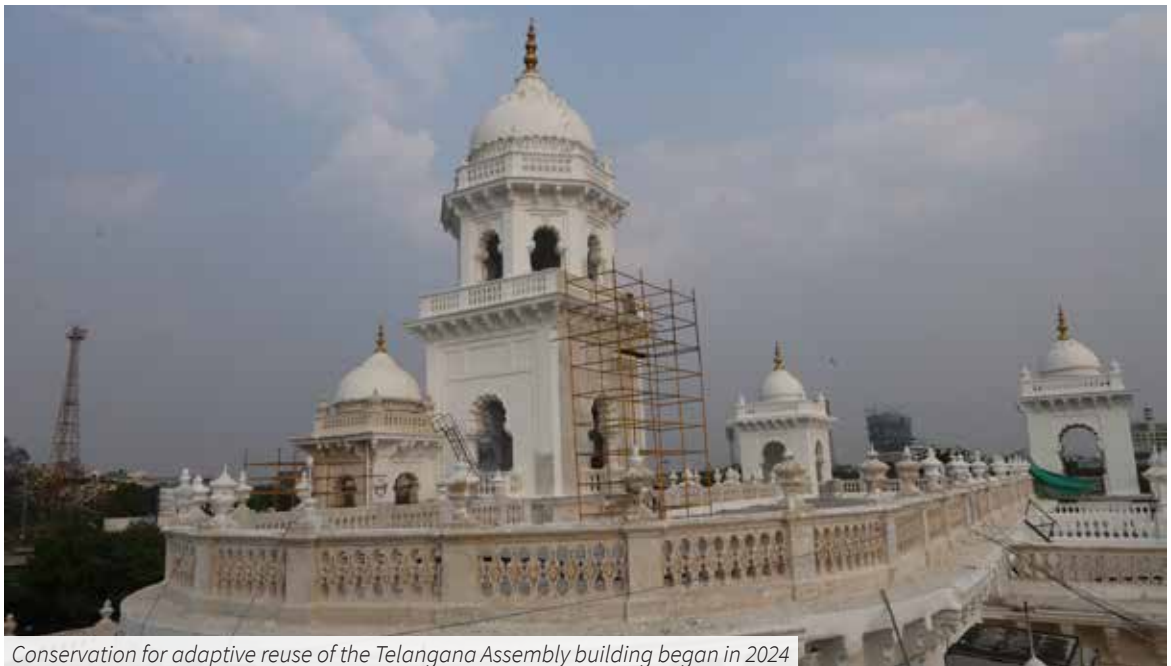
Conservation for adaptive reuse of the Telangana Assembly building began in 2024

A major undertaking commenced in 2024 was the conservation for adaptive reuse of the Telangana Assembly building built in AD 1905 by the Nizam government. This commenced with AKTC being asked to review a Rs 90 Crore estimate for repair works – which included replacement of the Jack Arch vaults with a RCC slab. Conservation works now being undertaken by AKTC at less than 15% of that cost have revealed several significant elements though not all are allowed to be restored on account of the proposed intensive reuse of the building.

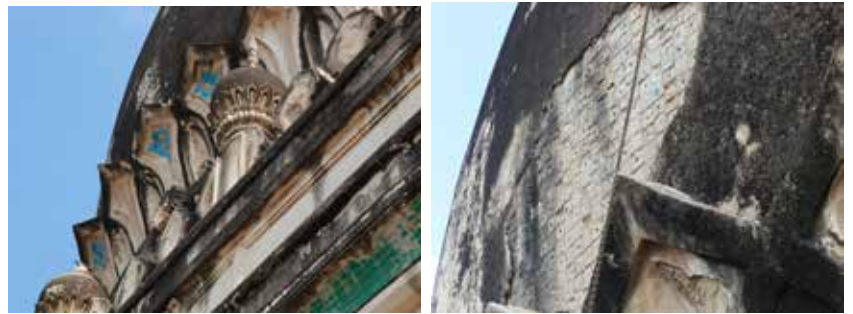
Even before conservation, evidence of 16th century tiles was visible under the cement covering the mausoleum

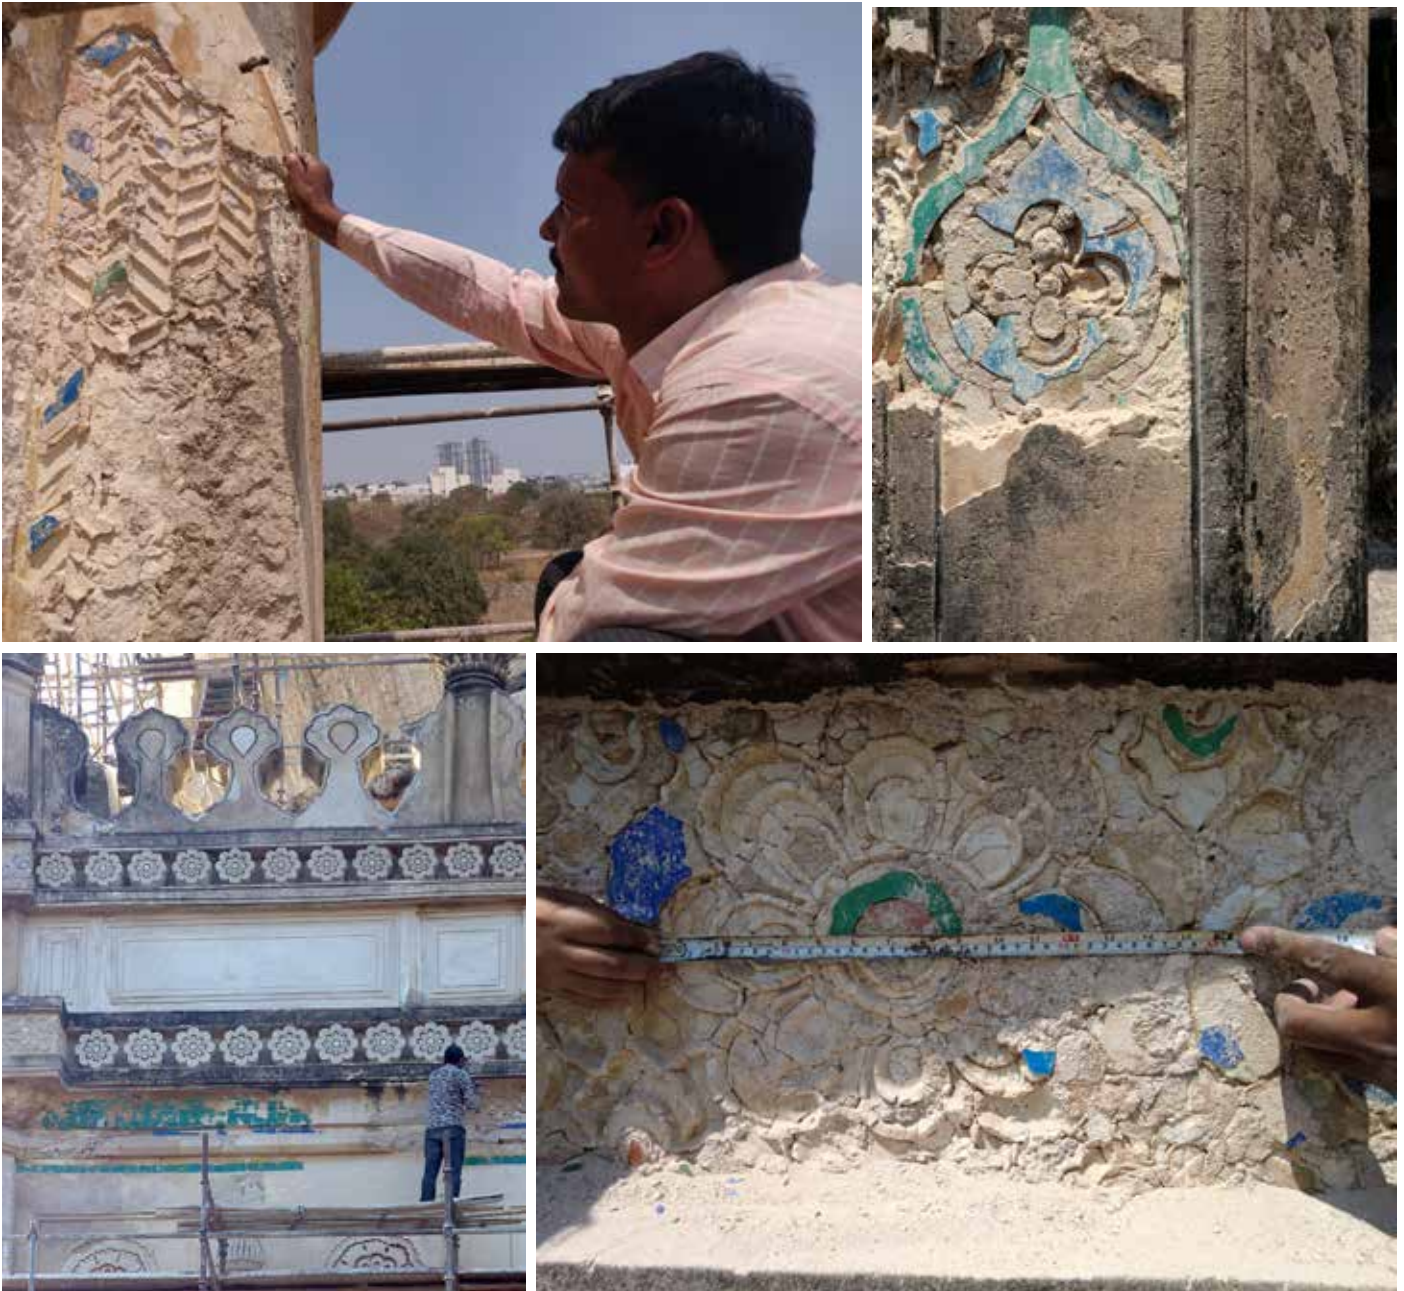
Careful removal of 20th century cement plaster revealed that the façades were adorned with multi-coloured glazed tiles in blue, yellow, white, turquoise, orange, and green, arranged in intricate geometric and floral patterns.

Remnants of original glazed tiles and tile patterns revealed on various portions of the mausoleum, including the facade and corner columns

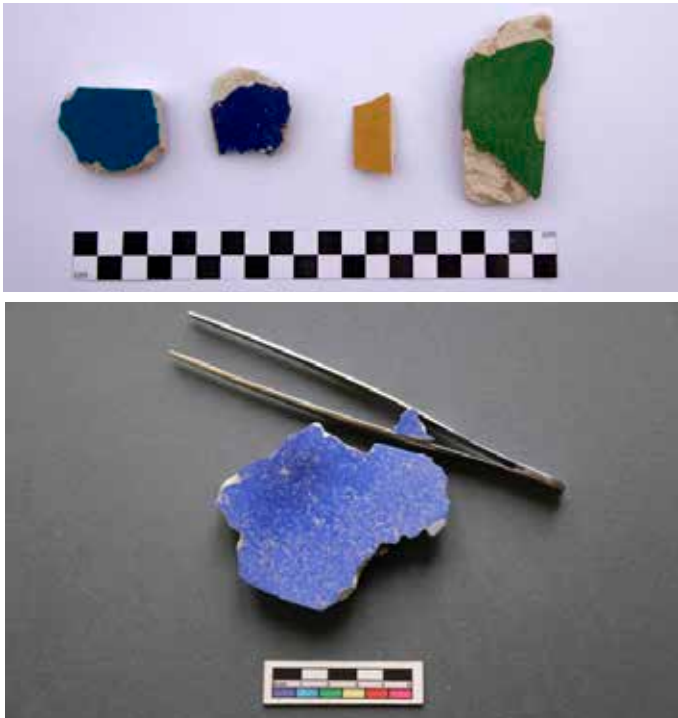
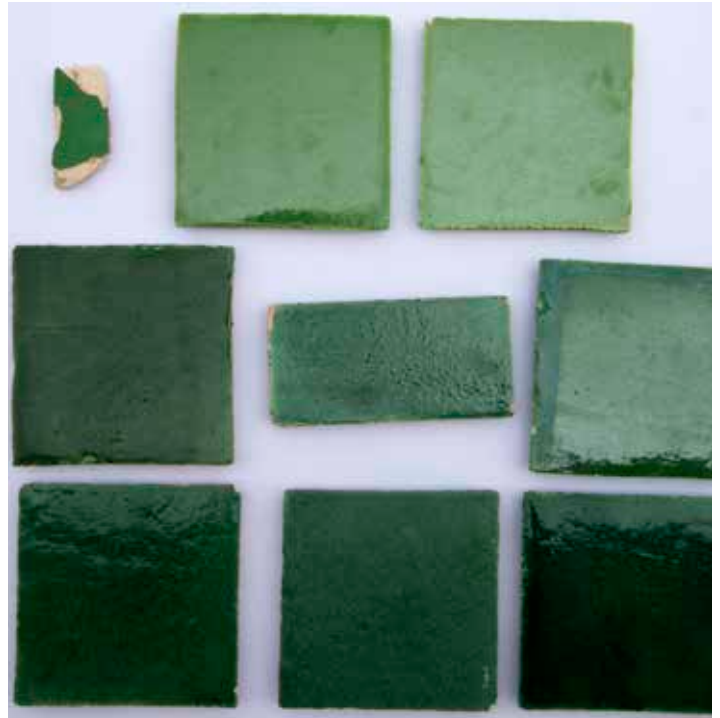
- Non-invasive tests were carried out using an Optical microscope to detect the colour space of the tile (CIE L*a*b) and X-ray fluorescence (XRF) spectrometry to determine the chemical composition of the tiles. Invasive tests were carried out by examining the cross-section of the tile under an optical microscope to determine the thickness of the glaze, its bonding agent, and the tile base. Scanning electron microscopy (SEM - EDS) - Energy Dispersive X-ray Spectroscopy helped determine the inner particle bond, the firing temperature of the kilns and the process for making the tiles.
- The tests indicated that the tiles were primarily made from crushed quartz (90 - 95%) with a glaze layer composed of lead-alkali glass or feldspathic sand. Coloration came from various metallic oxides like copper, cobalt, and iron.

Tile samples were tested and replicated to match the original in composition and colour

- Based on scientific material testing of the original tiles, tile manufacturing was undertaken using traditional ingredients to match the colours and composition of the original tiles. Thousands of samples in the six different colours were manufactured at various temperatures and environmental settings. The compositions, environmental conditions, and temperatures were finalized based on the selected sample.

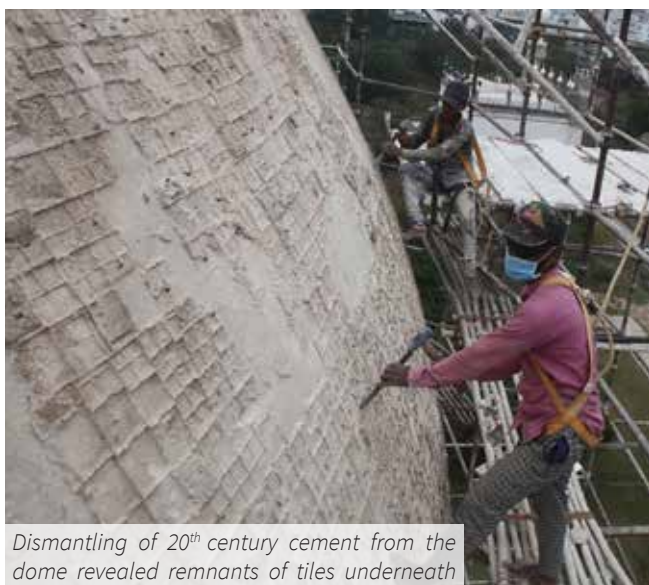
Dismantling of 20th century cement from the dome revealed remnants of tiles underneath

- Loose plaster and tile layers were carefully dismantled under meticulous supervision and dome surface was consolidated by filling gaps and holes in the original dome masonry. The surface was then roughened to improve adhesion.

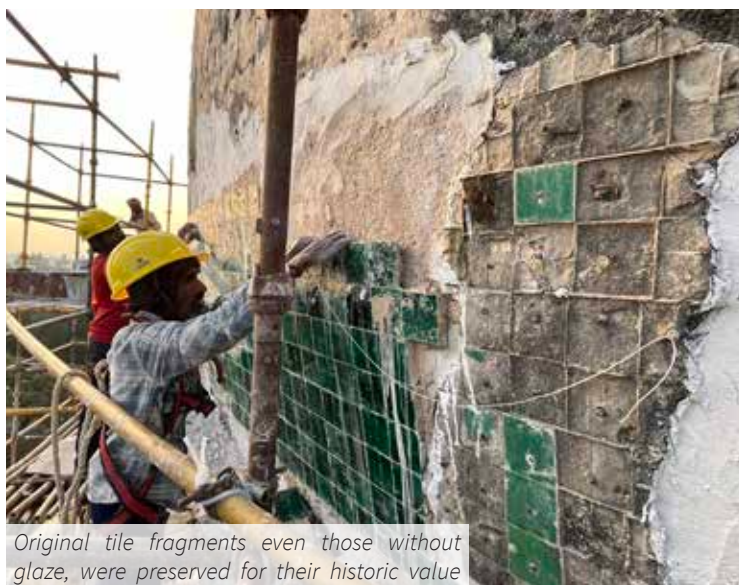
Original tile fragments even those without glaze, were preserved for their historic value

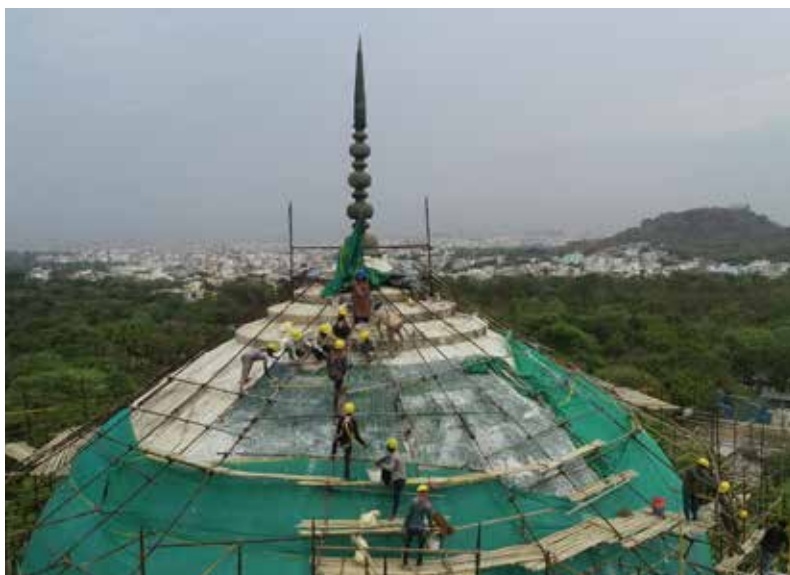
- Calculations confirmed that the dome was originally covered with approximately 80,000 tiles of size 110 x 110 mm; about 8,000 tiles survived, including both glazed tiles and the tile with lost glaze. Most surviving tiles were found on the South-East and North-West sides of the dome.

Skilled craftspeople installed over 80,000 tiles, covering 850 square meters of the dome surface

- The restoration of glazed tiles at the dome was carried out between January and May 2024. Following the completion of the work, the tiles and lime mortar were given sufficient time to set and cure properly.

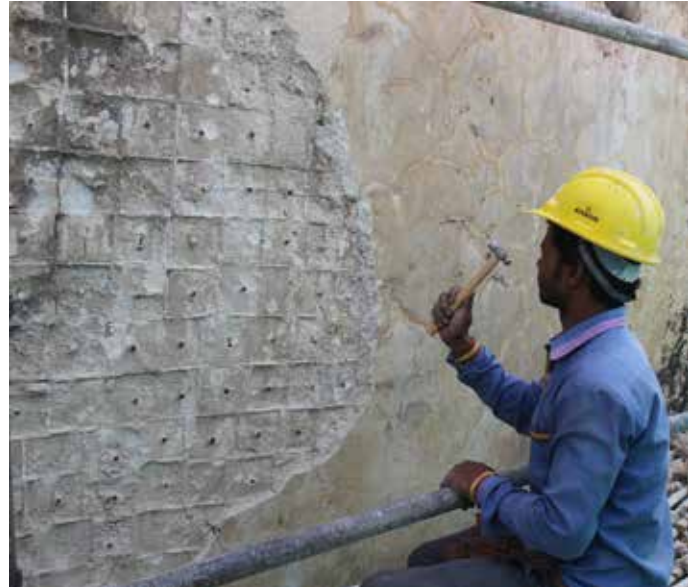
20th century cement layers were carefully removed, revealing original tiles held in place with iron nails. Iron nails were historically used to secure tiles along the dome's curve

- Historically, 2.5-inch iron nails were used to hold the tiles in place on the dome, from the spring point to the centre. These nails helped secure the tiles in place while maintaining the curvature of dome. But rust from these nails caused cracks and glaze loss on the original tiles.
- To address this, stainless-steel screws were considered as replacements for iron nails for improved durability and to prevent rusting in the future. These screws were used to replicate the historical system of tile installation ensuring the tiles remain securely in place on the curved dome surface.
- After the tiles were set properly and cured around in November – December 2024, 70,000 stainless-steel screws were installed carefully to hold the tiles on the dome surface as a precaution for better bonding.

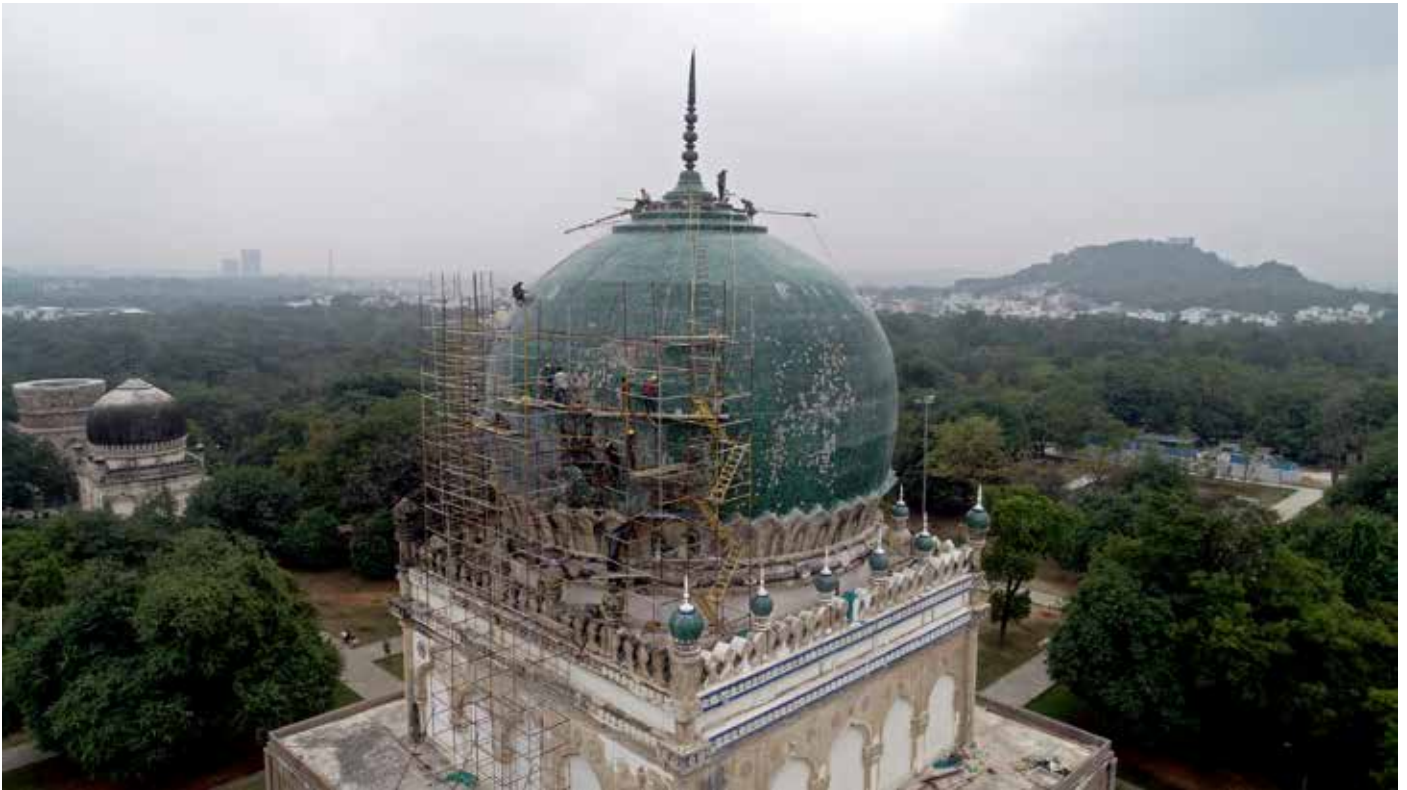
Gaps in mortar joints were filled with lime mortar and slurry to prevent seepage and strengthen tile bonding after heavy rains in 2024. Following tile restoration and screw installation, the dome was thoroughly cleaned to remove lime marks

- During the investigation following the heavy rainfall in September 2024, gaps in the mortar joints were observed at some locations. To address this, these gaps were filled with traditional lime mortar and lime slurry to improve bonding, prevent water from getting behind the tile layer, and reduce the risk of water seepage and tile detachment.
- After the restoration of tiles in the third quarter, the lime mortar was allowed sufficient time to set and cure properly. Stainless-steel screws were then installed to secure the tiles. After the installation was complete, the entire dome surface was thoroughly cleaned to remove any residual lime mortar marks, ensuring a smooth and polished finish that enhanced the green-glazed tiled dome.

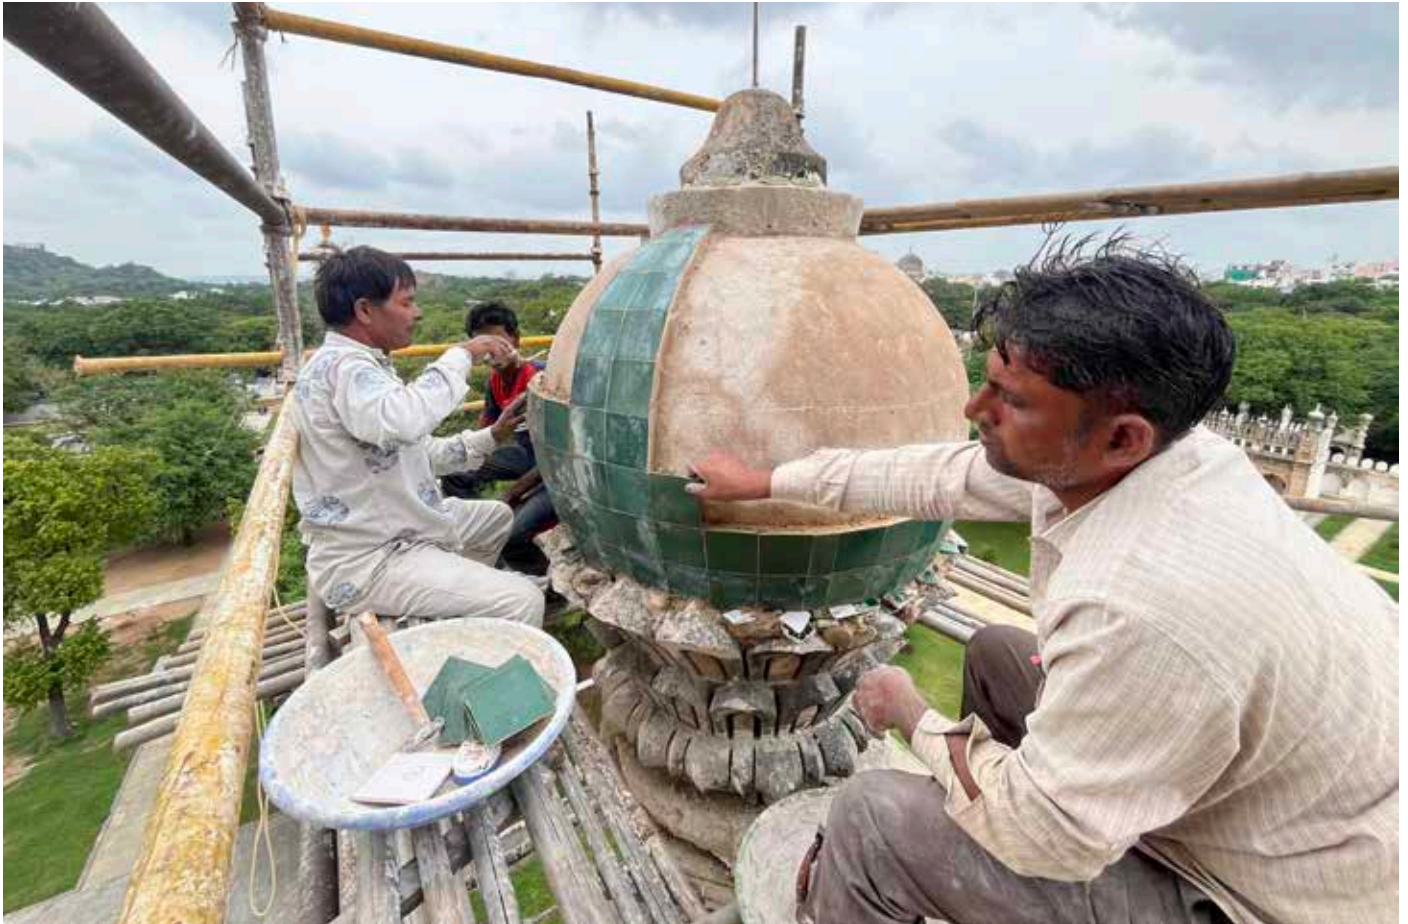
Tiles were installed by master craftspeople after consolidating the minaret bulbs with traditional lime mortar

- The damaged and loose base plaster was carefully dismantled, and the minaret bulbs were consolidated using traditional lime mortar to create a uniform base for tile installation, ensuring it matched the original shape.

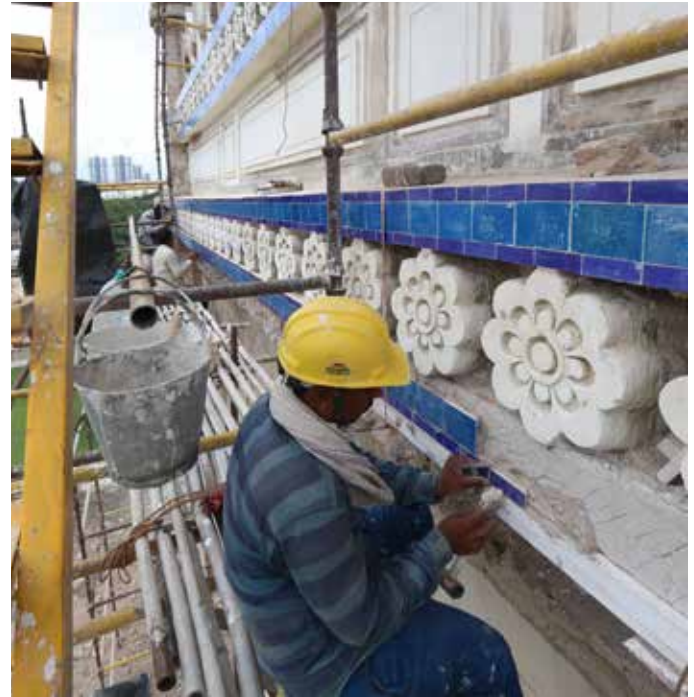
Blue and turquoise glazed tiles were reinstated on the decorative bands using traditional lime mortar, restoring the original detailing beneath the parapet battlements

- The decorative bands, each 22 meters in length 0.16 m (160 mm) in width, located above and below the floral motif bands beneath the parapet battlements on all four façades, were found to be adorned with glazed blue and turquoise tiles arranged in linear patterns.
- After carefully dismantling the 20th century cement and damaged lime plaster from these bands, they were consolidated with traditional lime mortar to create a uniform base for tile installation.
- The tile restoration was completed on western and southern façade with the installation of a total of 6360 tiles, consisting of one band of turquoise tiles sized 110 x 90 mm and two bands of blue tiles measuring 30 x 110 mm.
- Along with the tile restoration, the damaged portions of floral motifs and the bands at the same level were repaired with traditional lime plaster and finished with a layer of lime punning.

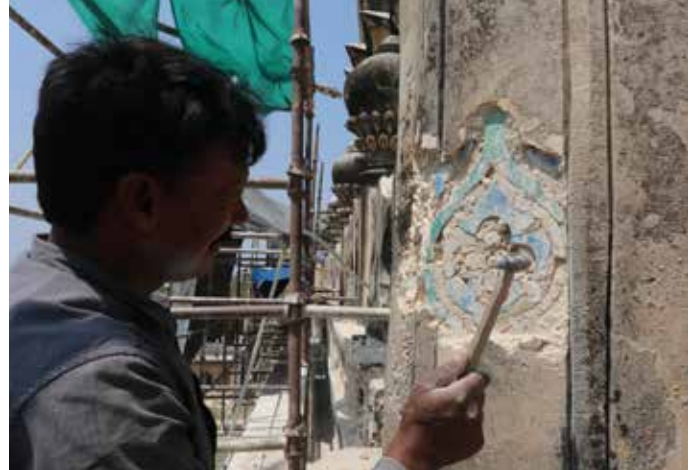
Upon removing the 20th-century cement plaster, two distinct original multi-colored tiles were discovered on the corner minarets

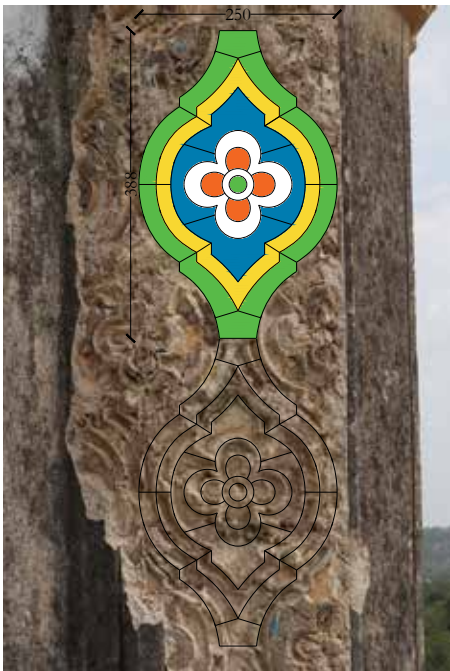
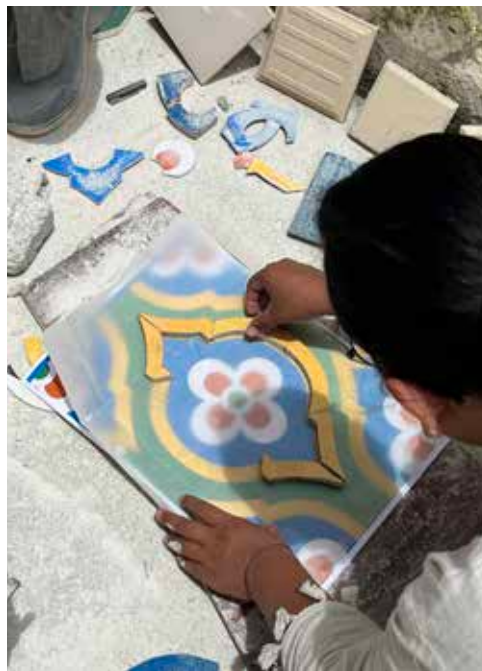
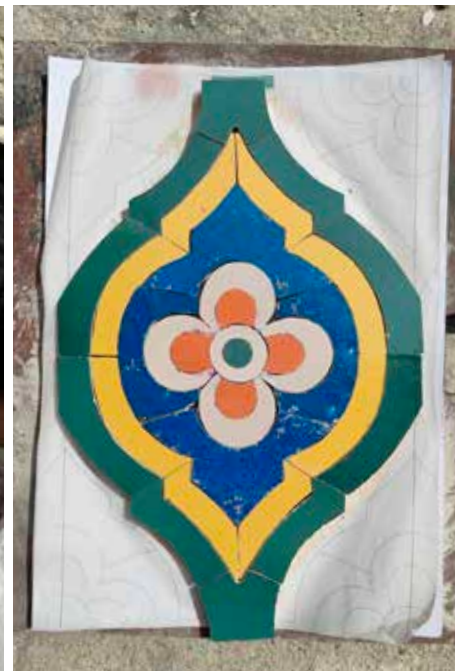
Scaled drawing of the two motifs were created using identified colors and patterns based on on-site evidence

- Based on on-site investigations and thorough documentation, master craftspeople meticulously crafted samples of two distinct floral motifs for the columns of the minaret, as well as a geometric pattern at the corner minaret , ensuring they closely match the original designs. These motifs feature a vibrant combination of blue, turquoise, yellow, orange, white, and green colours.
- To facilitate this intricate work, a formwork was created to ensure precision. Each tile was then carefully cut into different shapes and sizes to fit perfectly in place, accurately replicating the original pattern.

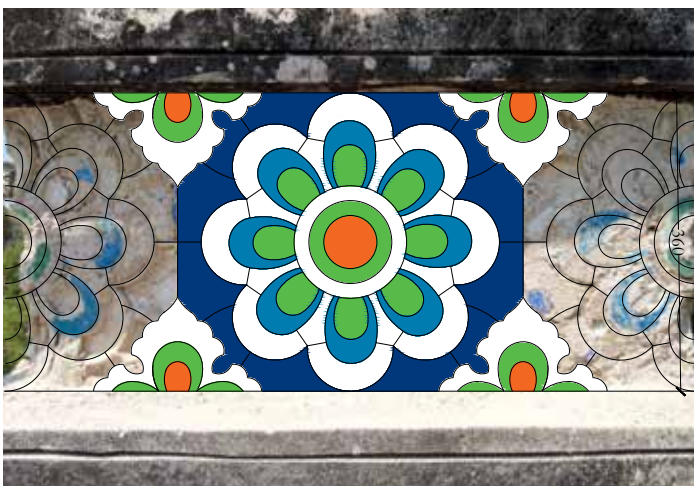
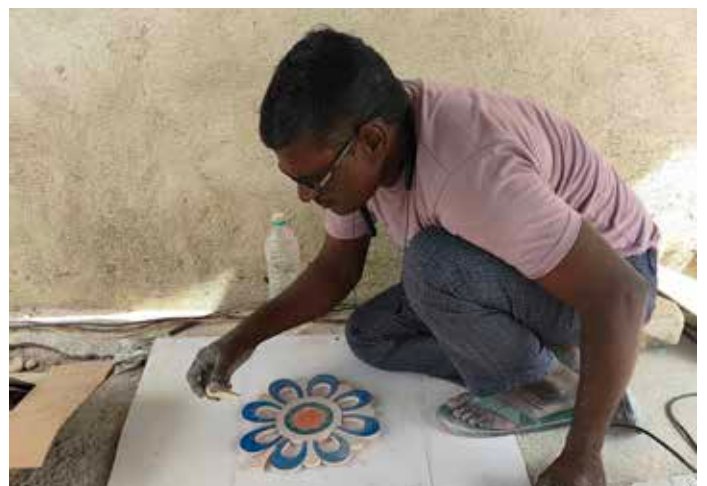
Master craftspeople carefully cut each tile to shape and size, creating samples of the motifs based on the formwork and scaled drawing, ensuring they match the original details revealed

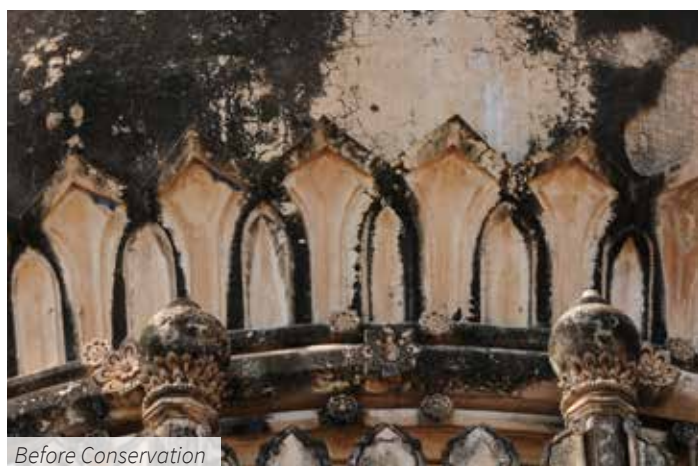
Before Conservation

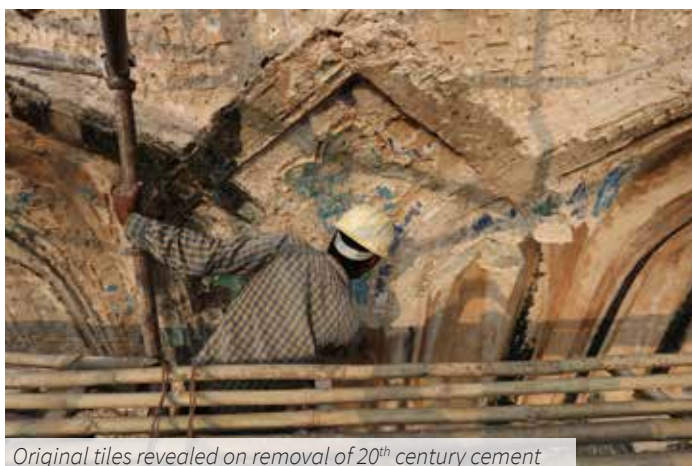
Original tiles revealed on removal of 20th century cement

- The restoration ensures retaining the original tiles, even those with weathered or lost glaze. These fragments are original and thus hold immense historical value, providing a direct connection to the Qutb Shahi period.

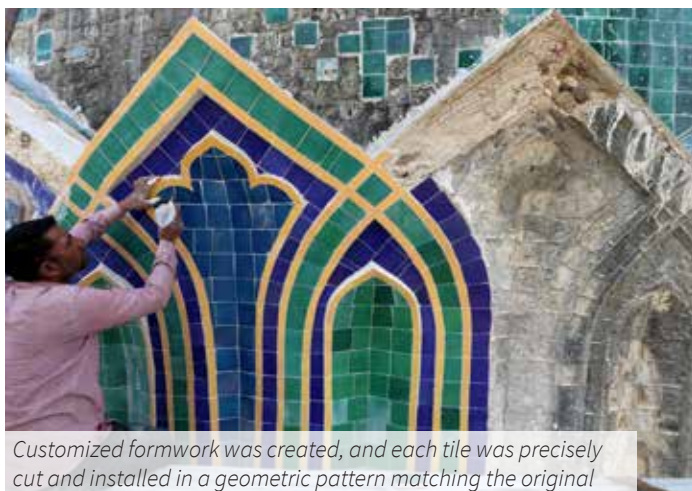
Customized formwork was created, and each tile was precisely cut and installed in a geometric pattern matching the original

- To facilitate this intricate work, a formwork was created to ensure precision. Each tile was then carefully cut into required shapes and sizes to fit perfectly, restoring the original pattern with accuracy. Restoration, based on the approved sample, is currently ongoing at the monument.

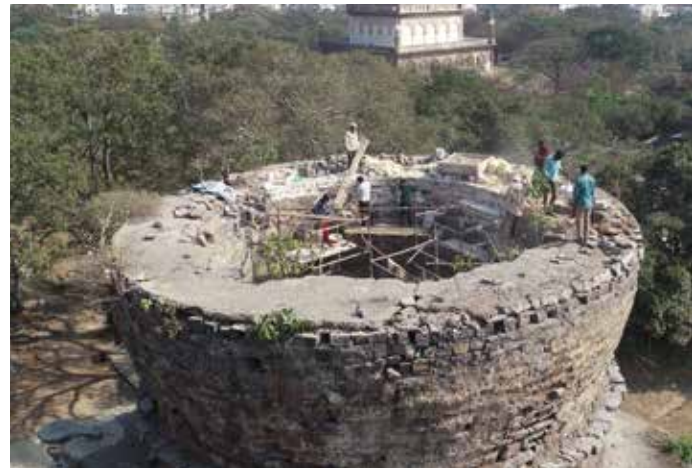
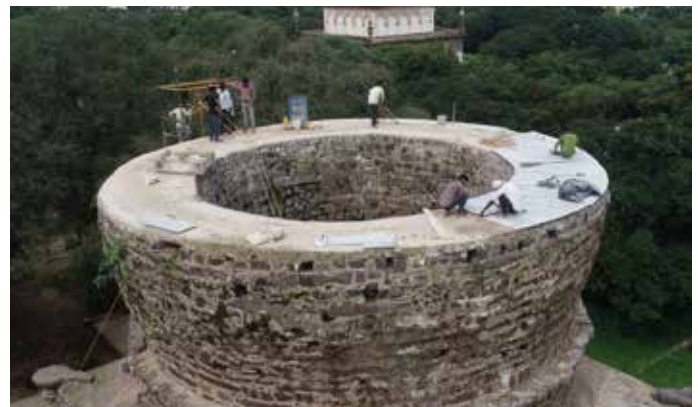
Finishing of the incomplete dome masonry with 20 mm thick granite stone slabs as coping to prevent water ingress and vegetation growth

- The damaged and loose masonry at the incomplete dome level, affected by water seepage and vegetation growth, was carefully repaired. The last two courses of damaged and missing stone masonry were rebuilt using stone masonry matching the original, by skilled stone masons, to achieve a uniform level. A layer of 150 mm thick traditional lime concrete was then re-laid, and 20 mm polished grey granite stone slabs were installed as coping to prevent water ingress and vegetation growth.

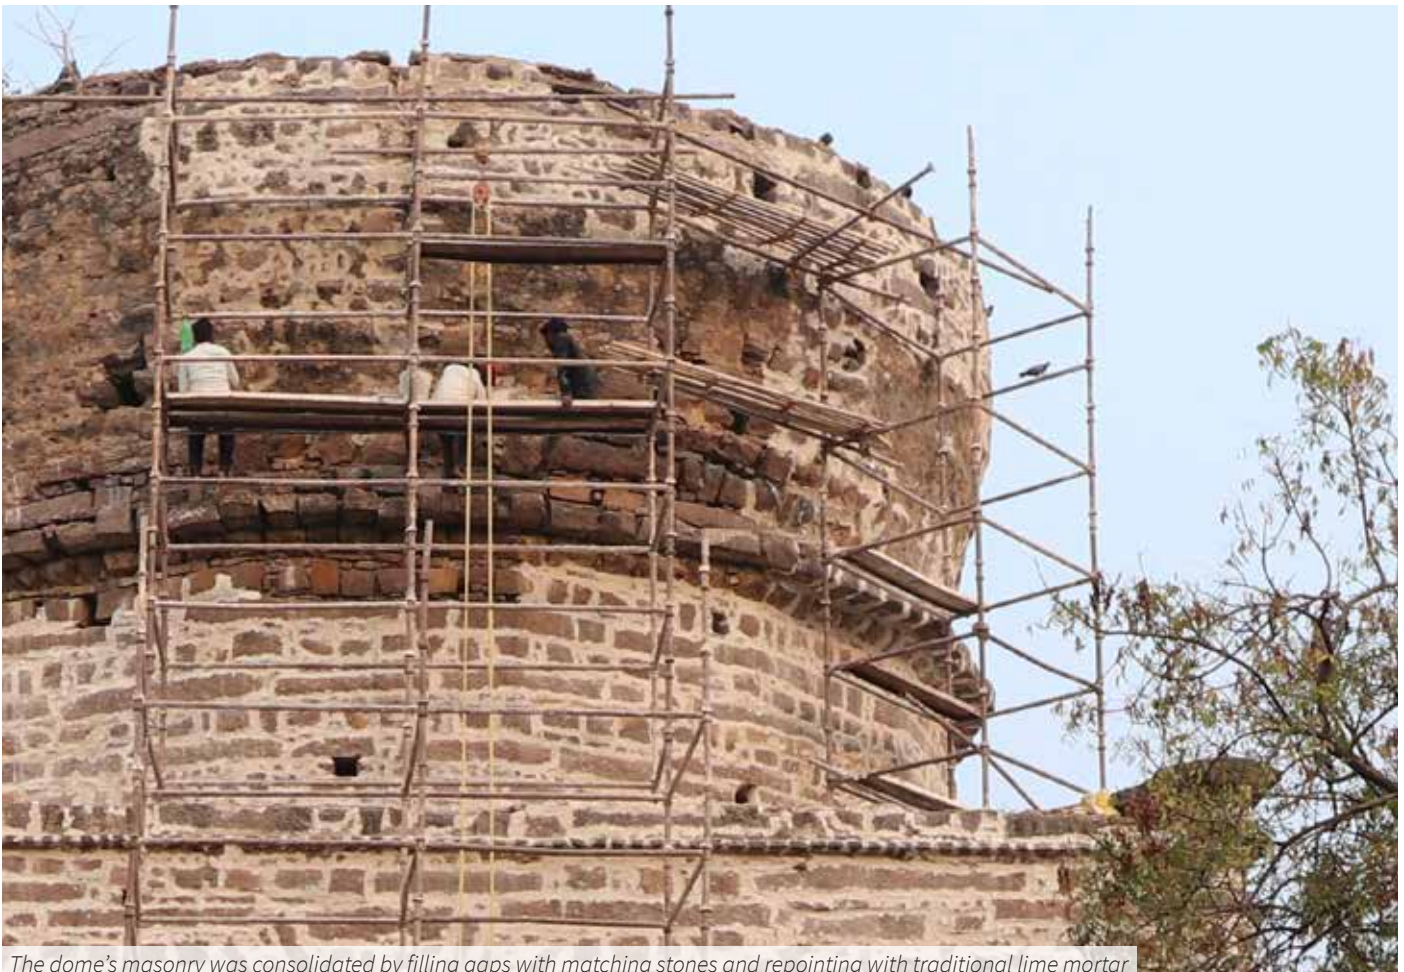
The dome's masonry was consolidated by filling gaps with matching stones and repointing with traditional lime mortar

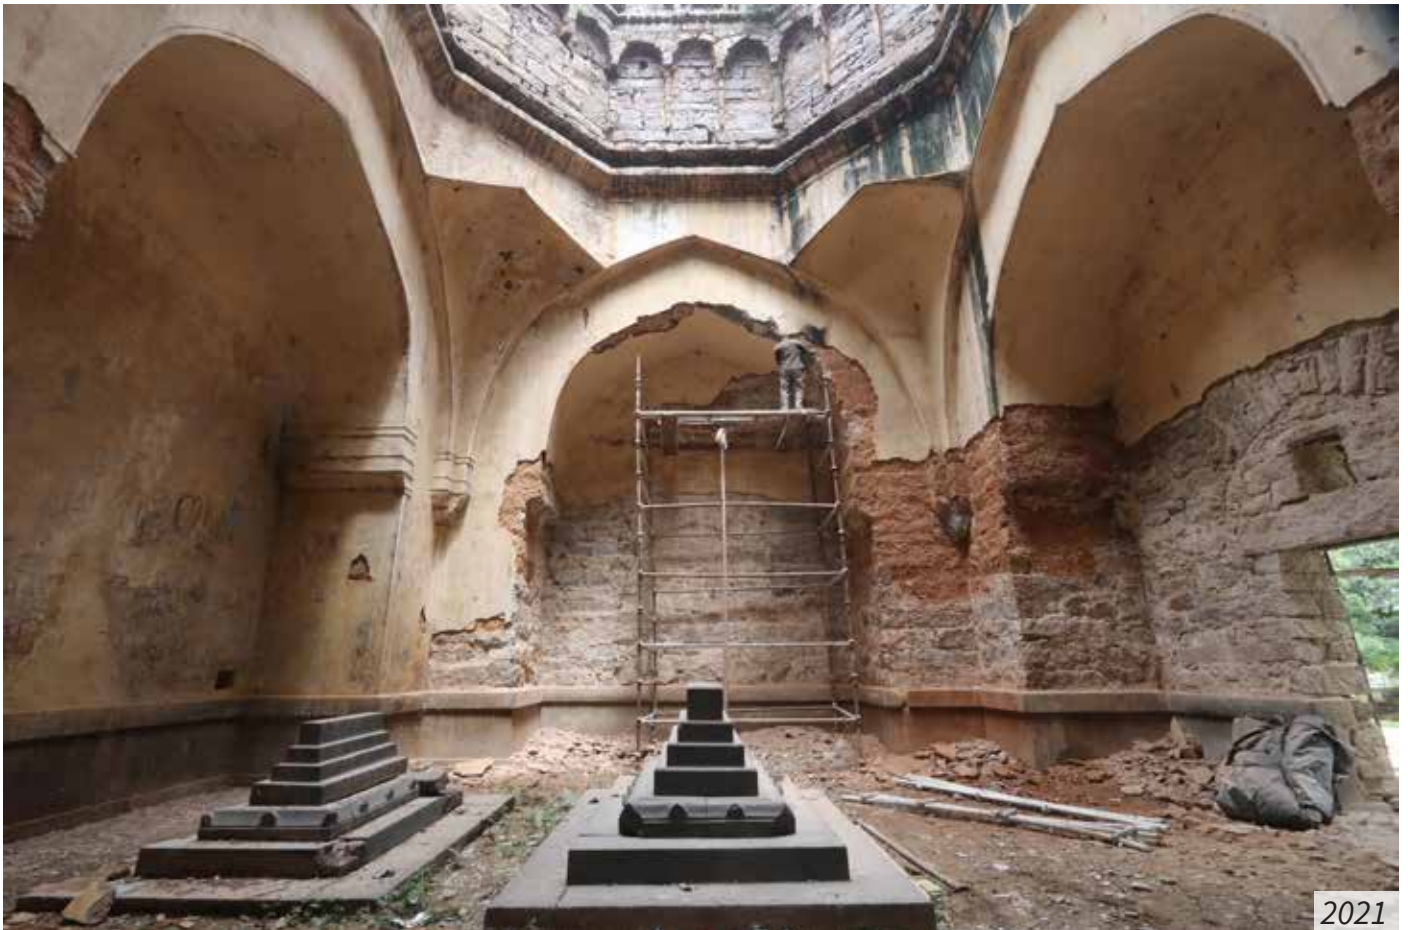
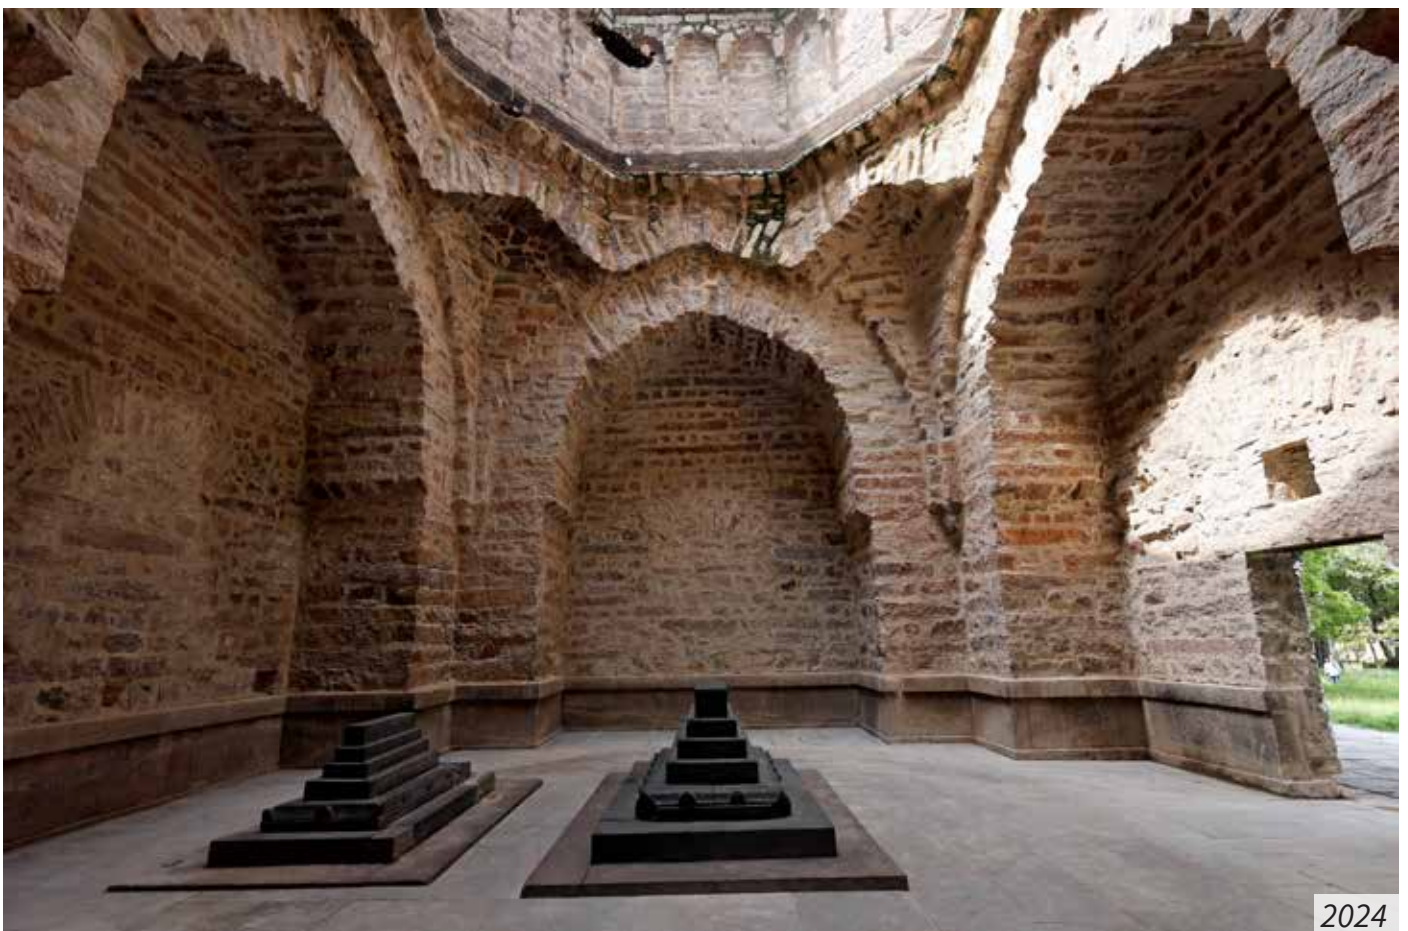
Internal walls of the mausoleum: the 20th century cement plaster was carefully dismantled to reveal and consolidate the original masonry with lime mortar. The damaged flooring was replaced with a traditional lime concrete base, finished with polished granite stone to ensure durability and proper drainage.

- 4-5 inches of 20th century cement plaster covering internal walls was carefully dismantled. The masonry walls on all four sides
- The masonry walls were consolidated by fixing missing stones and re-pointing with traditional lime mortar.

- Damaged and loose lime concrete of the flooring, affected by rainwater and dogs, was carefully dismantled. A 150 mm thick layer of traditional lime concrete was re-laid, topped with 20 mm thick polished gray granite stone, as per the approved design and appropriate slopes to drain rainwater away from the structure and prevent further seepage.

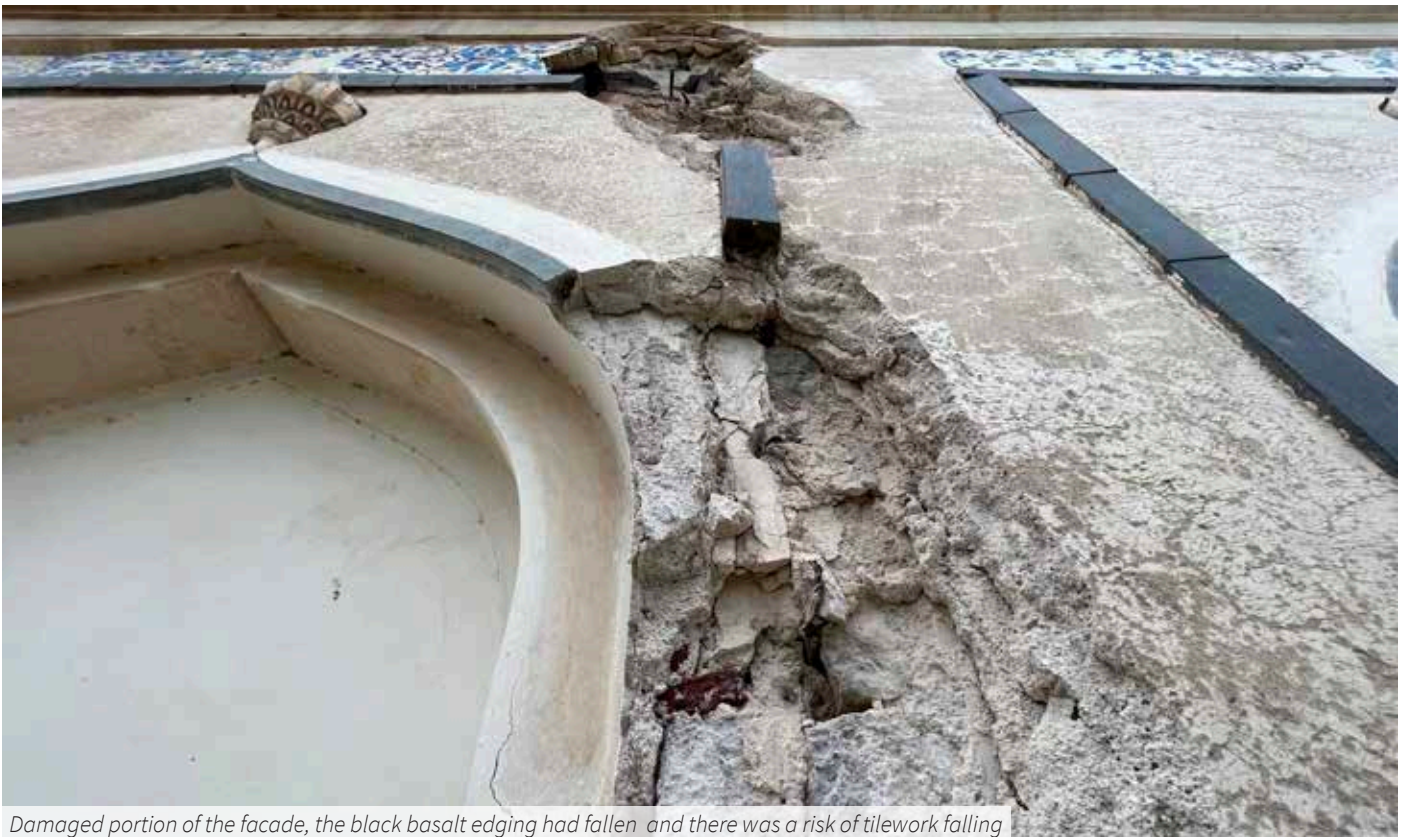
Damaged portion of the facade, the black basalt edging had fallen and there was a risk of tilework falling

The force of the impact dislodged architectural elements, most notably at the first arch bay on the eastern façade. Here, approximately 600 mm of historic tile and a 6-meter-long section of the black basalt frame collapsed, exposing the underlying stone masonry and structural layers. A detailed assessment revealed that iron nails embedded within the stonework and plaster—originally intended to anchor the tilework—had corroded over time. The rusting of these nails not only weakened the plaster but also compromised a surrounding radius of approximately 300 mm, leading to further detachment and vulnerability in adjacent areas.

Additionally, the surviving historic tilework next to the damaged section was found to be precariously seated in a bed of loose mud and lime mortar, leaving parts of it hollow and unstable. These findings pointed to a broader structural vulnerability, prompting immediate conservation action. Skilled teams were deployed to stabilize the affected zones, carefully document the extent of loss, and initiate repairs using traditional materials and techniques. This swift and sensitive intervention was essential not only to mitigate further deterioration but also to uphold the architectural integrity and heritage value of the mausoleum.

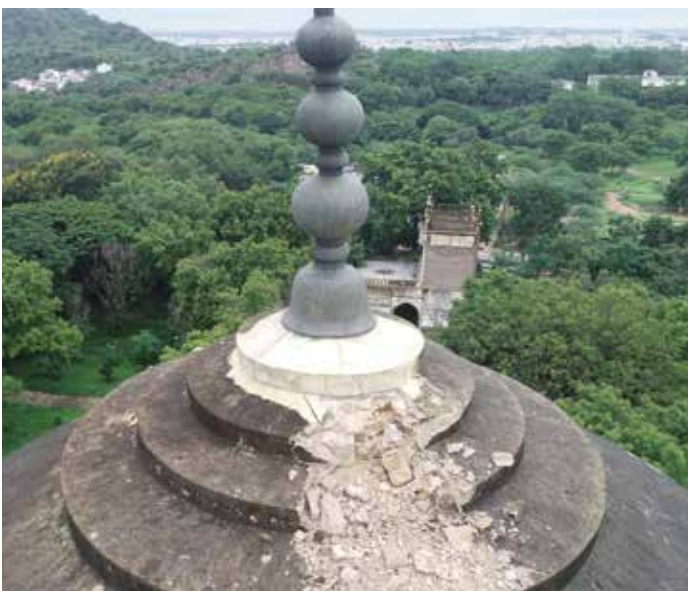
Plaster from the rings on the dome at the finial's base had come loose

- Scaffolding was installed to assess and document the damage.
- The damaged and loose lime plaster at the rings on the northwest side at the base of the finials was repaired using traditional lime plaster and finished with lime punning.

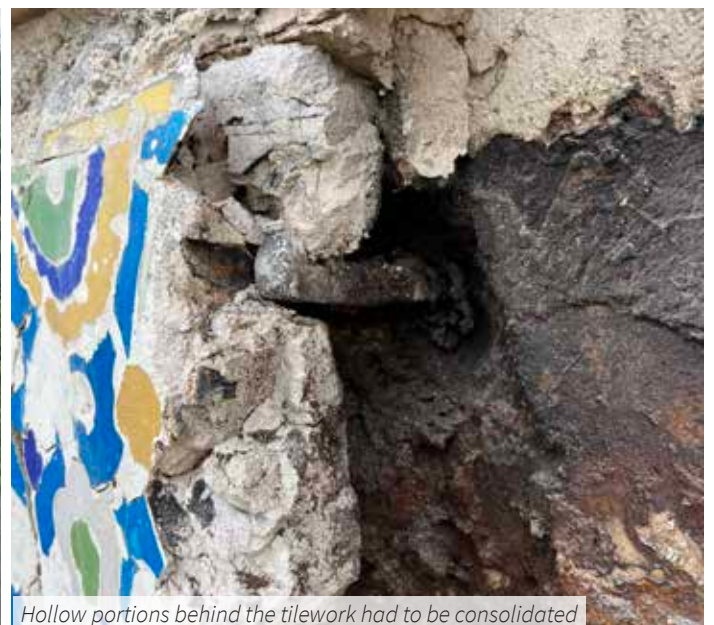
Hollow portions behind the tilework had to be consolidated

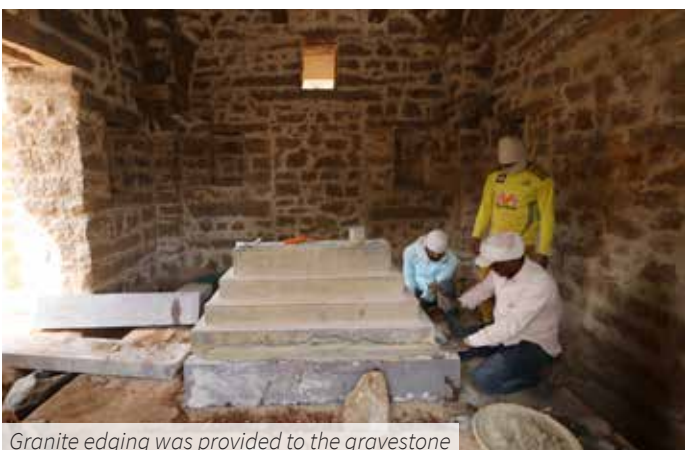
Granite edging was provided to the gravestone

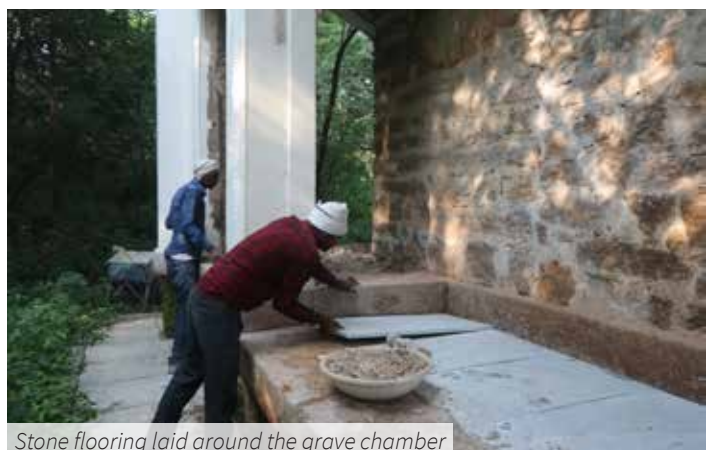
Stone flooring laid around the grave chamber

- The remaining earth was levelled to create a suitable surface for flooring.
- A 100 mm thick layer of traditional lime concrete was laid, followed by the installation of 30 mm thick granite stone flooring according to the approved design. This arrangement preserved the visibility of the dressed stone platform. It also helps to protect the monument from future vandalism.
