QUTB SHAHI
HERITAGE PARK

ANNUAL REPORT 2023-2024

Conservation & Landscape Restoration

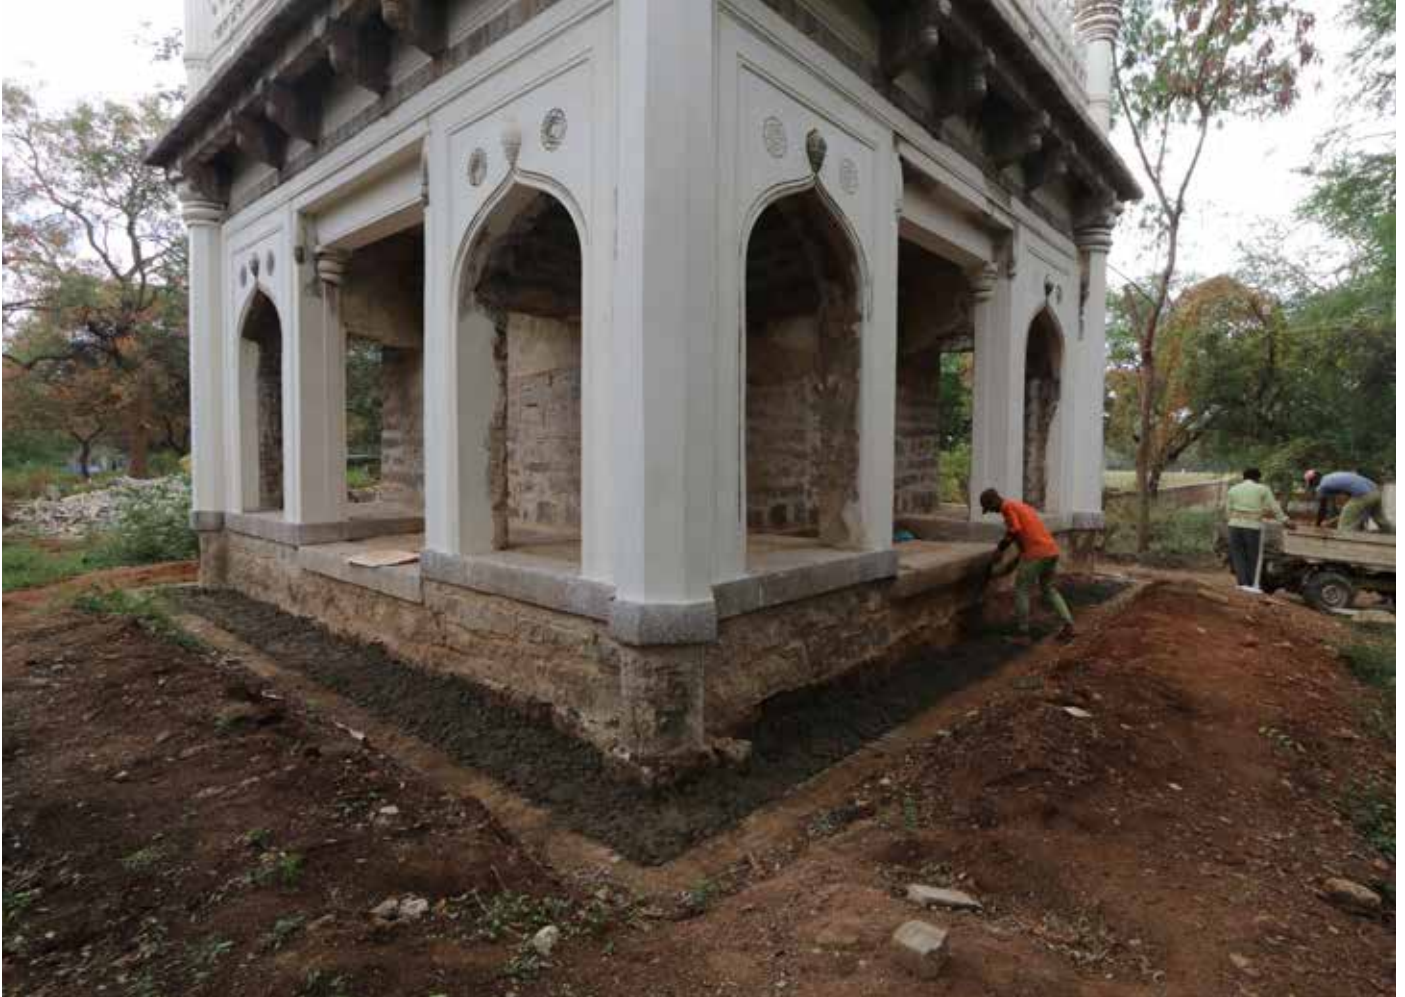
Base work for the laying of plinth protection around the monument

- After removing excess earth surrounding the monument the original plinth levels were unearthed
- With reference to the original levels , base work for plinth protection carried out , including brick masonry retaining walls .
- A 900 mm wide plinth protection layer was installed, consisting of 100 mm thick PCC topped with 100 mm thick, rough gray granite and 200 mm wide granite edging on all four sides of the monument, as per the approved details.

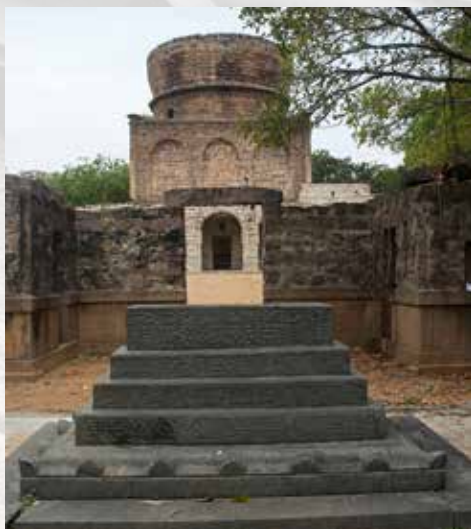
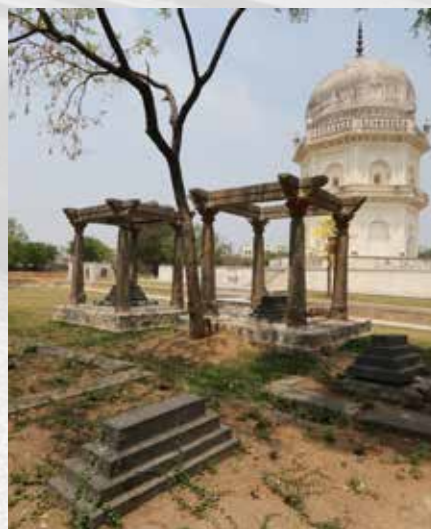
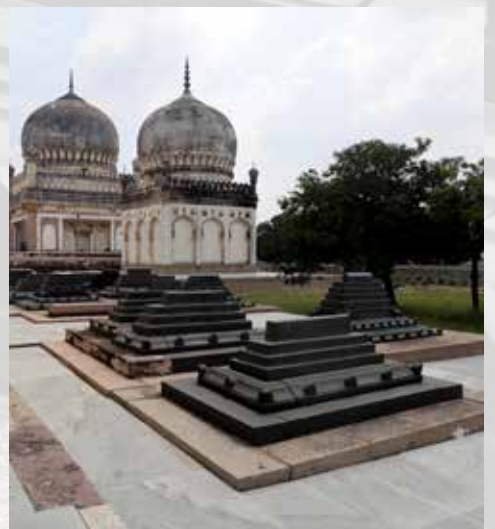
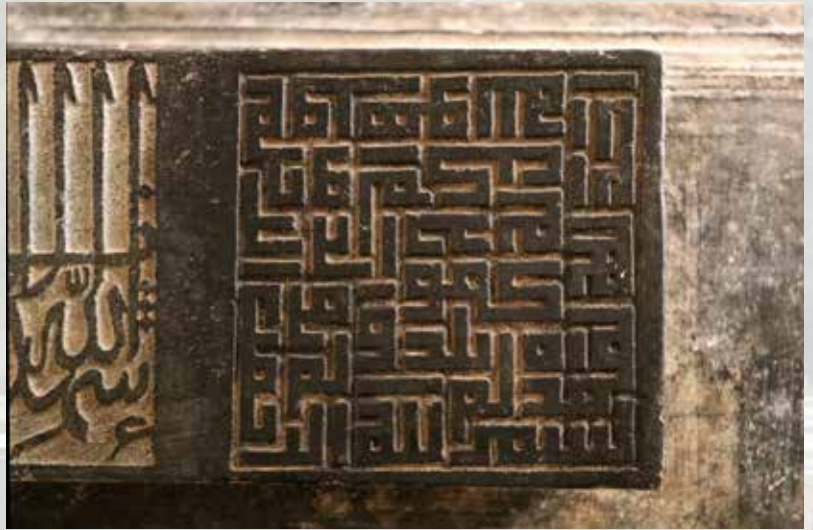
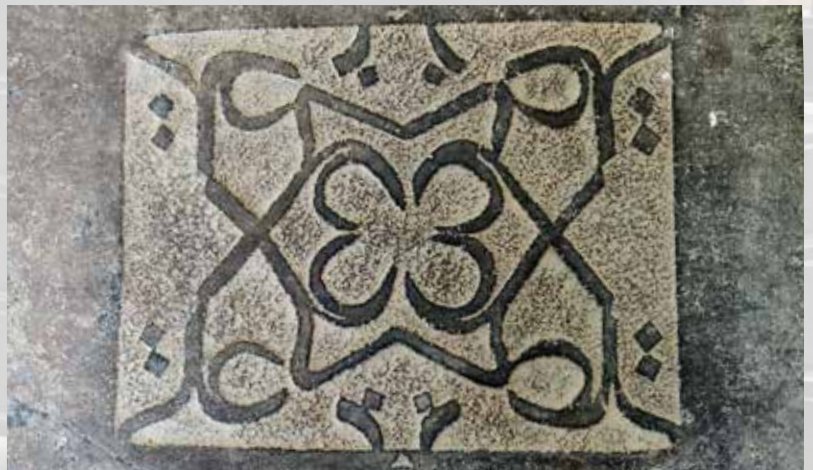
(Top) A rare instance of Kufic calligraphy in India can be seen on a square panel on the grave of Mirza Muhammad Amin; (Bottom) One of the graves at the necropolis is inscribed with the word 'Ali' eight times in Nastaliq style of calligraphy

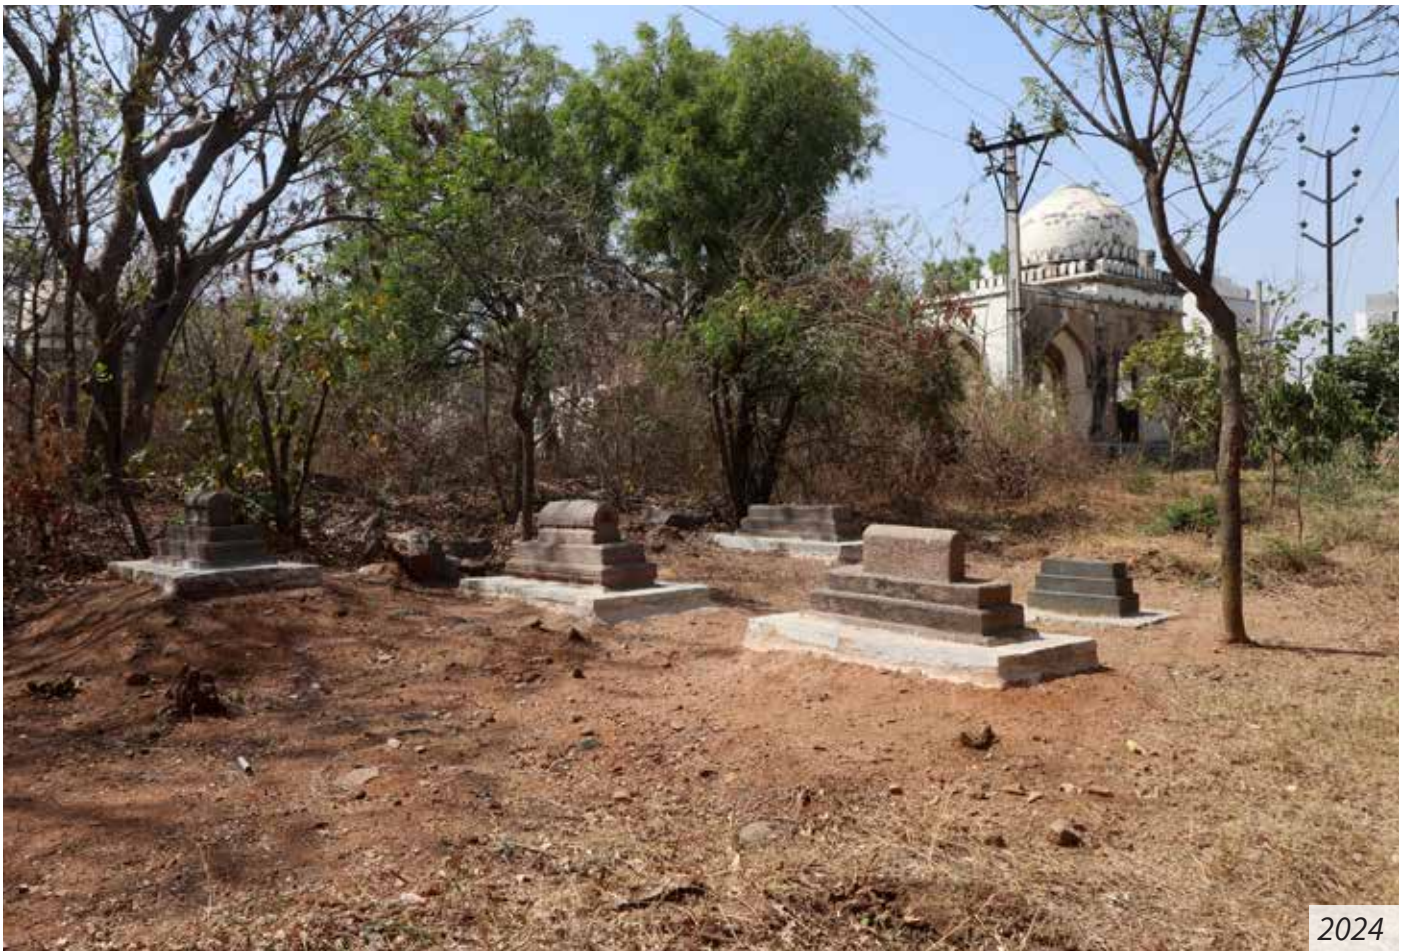
Before the conservation works, common conditions observed included excess vegetation, accumulated earth, altered original levels of the grave platforms, and missing stones from the gravestones and their platforms.

One example of a grave cluster is located northeast of Unknown Tomb 19, consisting of four granite stone gravestones and one basalt stone gravestone.

- A group of six graves is located northeast of Unknown Tomb 19, consisting of four granite stone gravestones and one basalt stone gravestone were repaired.
- Excess vegetation and earth accumulation surrounding the grave cluster were carefully removed.
- Grading and levelling of the earth were carried out, adhering to the original ground levels of the gravestones.
- Consolidation of the gravestones was completed, and plinth protection was provided with a 200 mm wide and 100 mm thick, rough gray granite stone slab around all four sides.

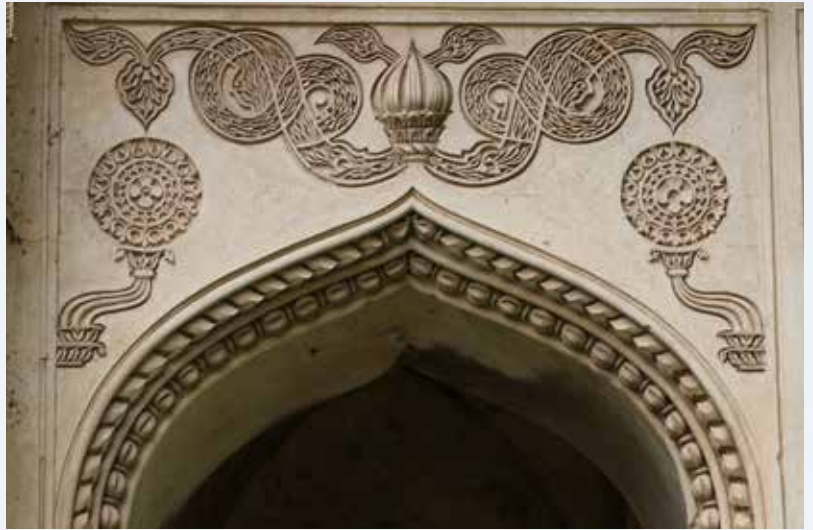
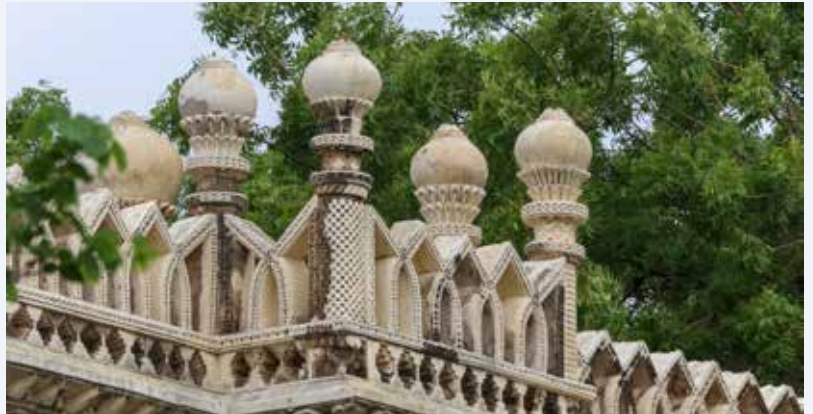
The funerary mosques feature highly intricate lime stucco details and decorative minarets

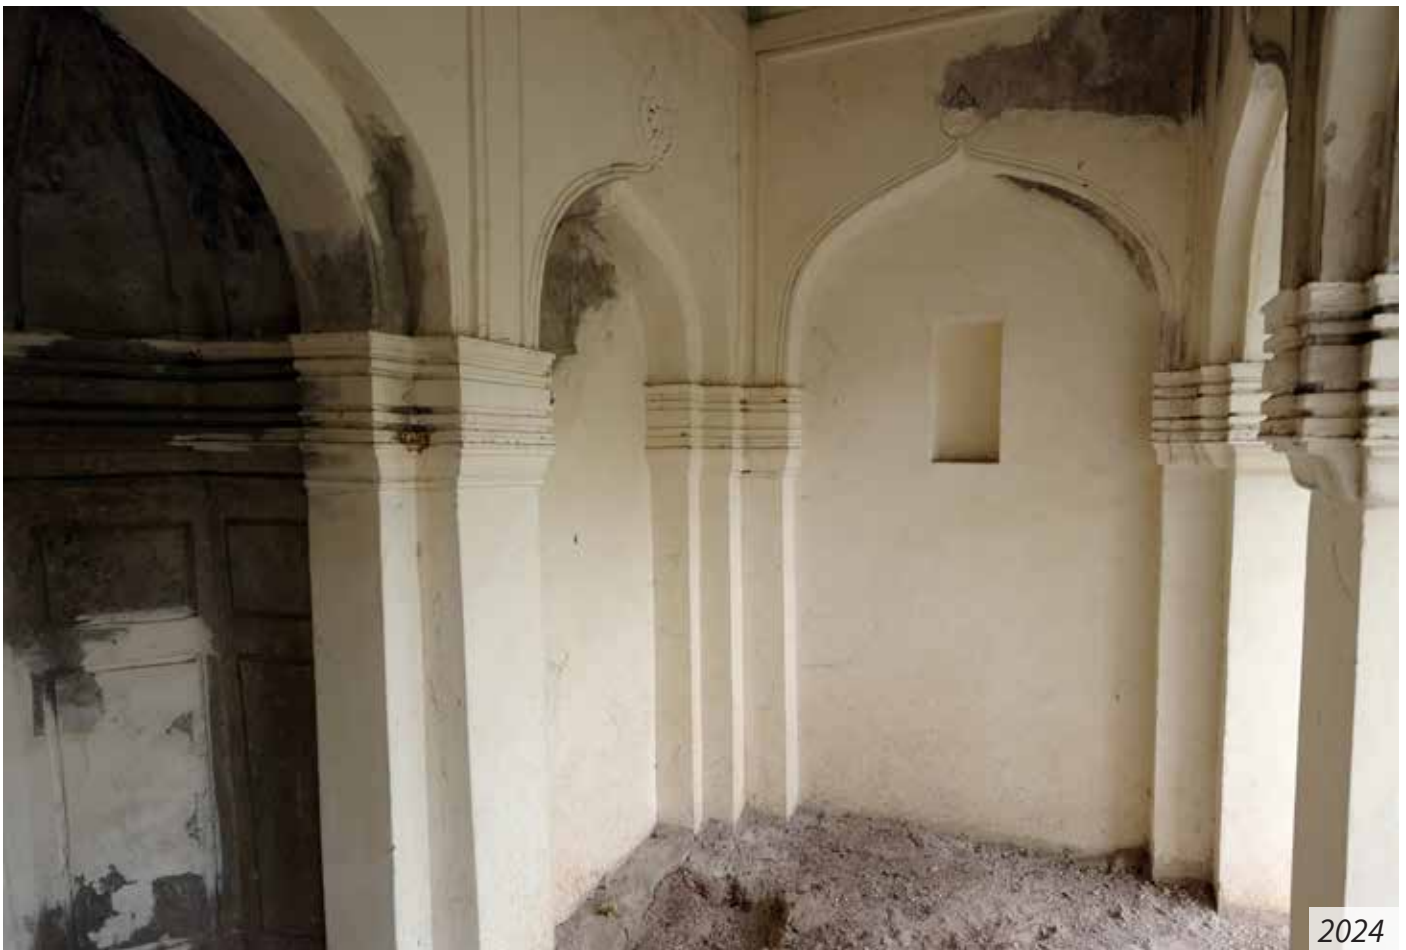
2024

The northern arched wall of the structure was in a state of disrepair with missing portion of masonry. The wall was carefully examined to assess the extent of damage and deterioration. The damaged portion was consolidated, and missing portion was reconstructed matching the historic masonry using rich lime mortar to achieve the structural integrity of the structure. Following which the lime stucco details in the internal side and the plain plaster on the external façade were reinstated as per on site evidence

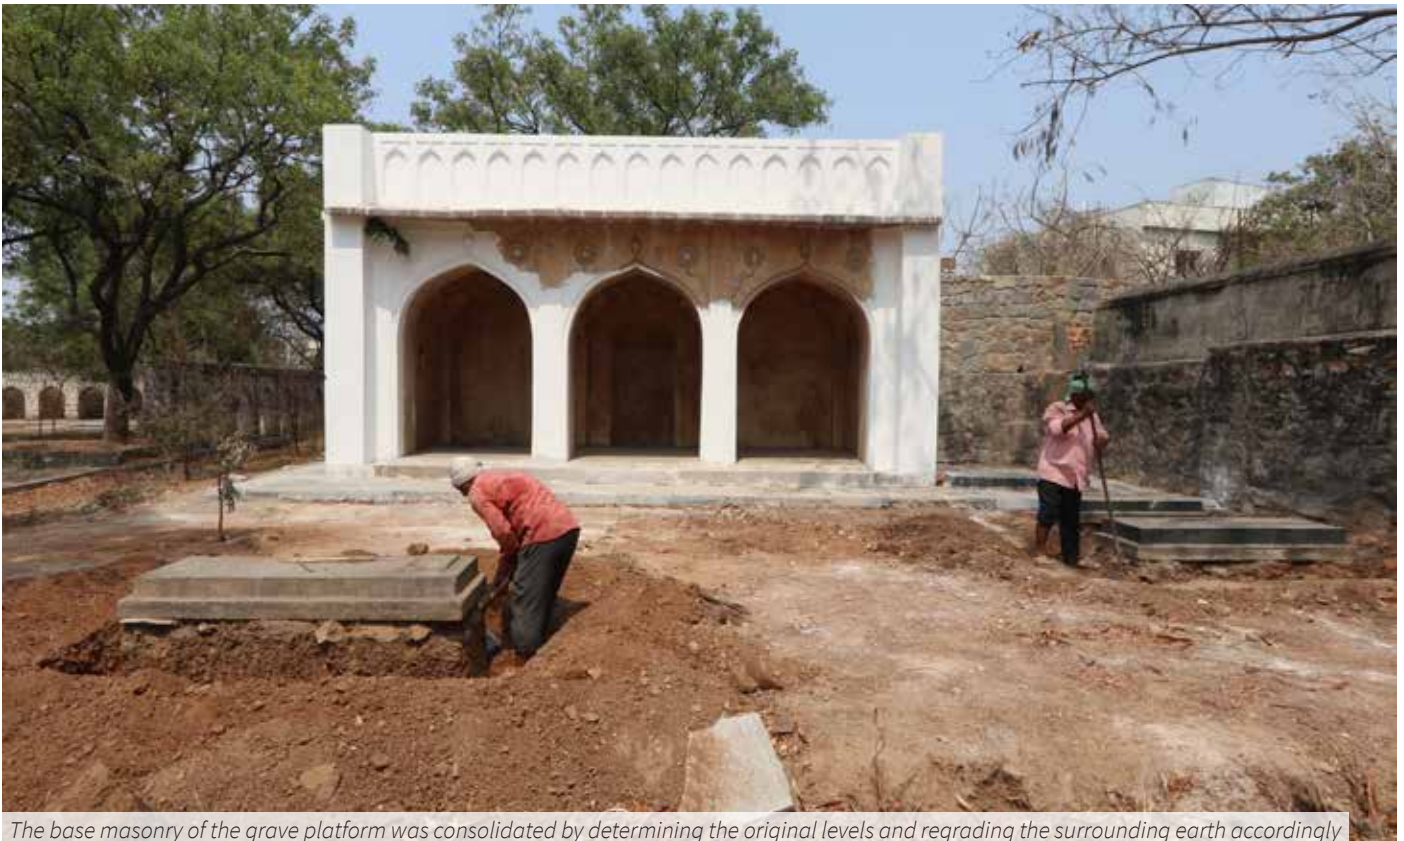
The base masonry of the grave platform was consolidated by determining the original levels and regrading the surrounding earth accordingly

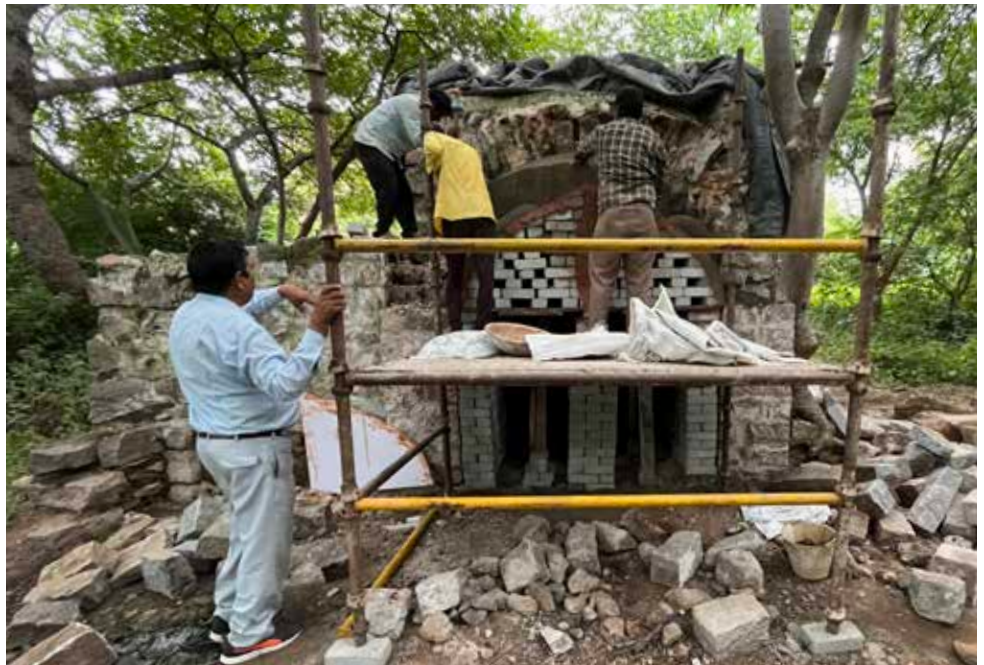
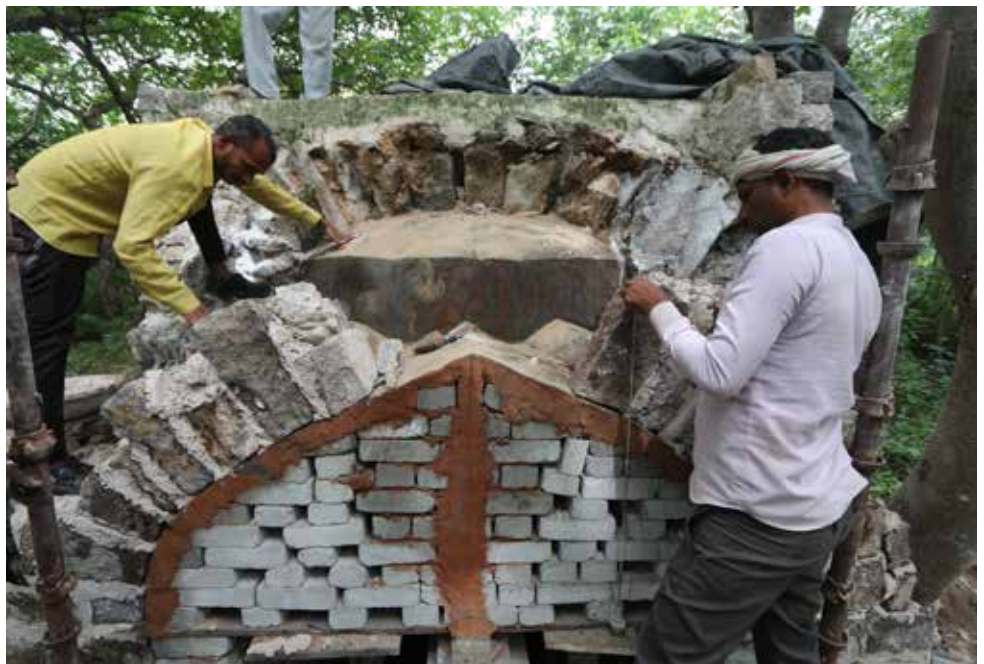
The eastern part of the dome is in a dilapidated condition. The north and south side arches are also dilapidated and have been further supported by the masonry walls on the eastern side. The internal chamber, measuring 2000 x 1730mm, consists of a central recessed three-sided mihrab with arch moulding stucco detail.

- The missing and dilapidated arch and squinches on the eastern side, which provide crucial support, were rebuilt by highly skilled masons using stone masonry to match the original design. Brick formwork was provided for the reconstruction of arch.

- After completing the arch masonry, brick formwork was set up to build the missing portion of the dome. The stone masonry dome was then reconstructed by highly skilled stone masons to replicate the original, maintaining the correct levels and courses of masonry.

Highly skilled masons reconstructed the stone masonry arch and dome of the mosque using brick formwork and traditional techniques, guided by in-situ evidence

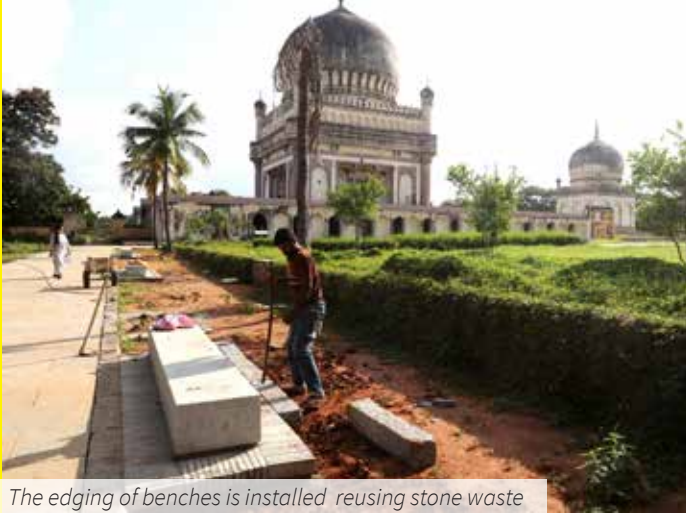
The edging of benches is installed reusing stone waste

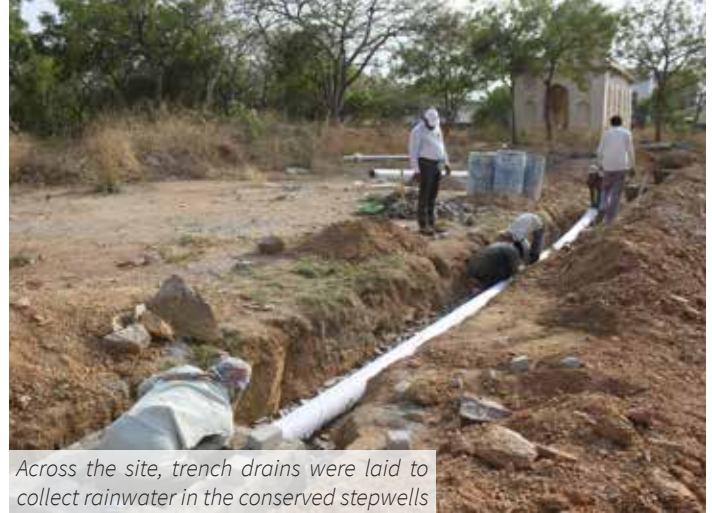
Across the site, trench drains were laid to collect rainwater in the conserved stepwells

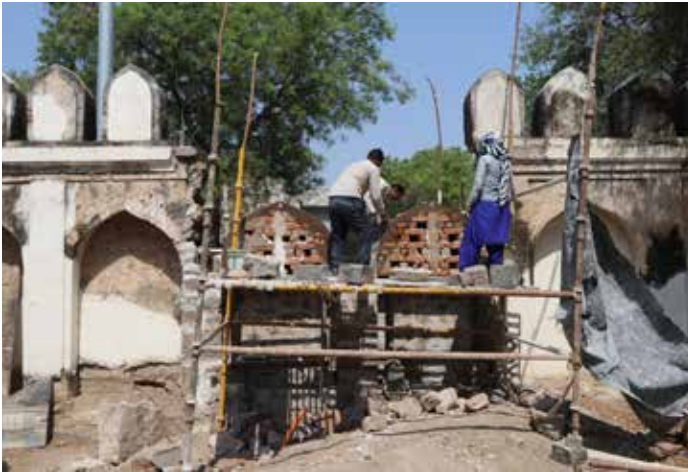
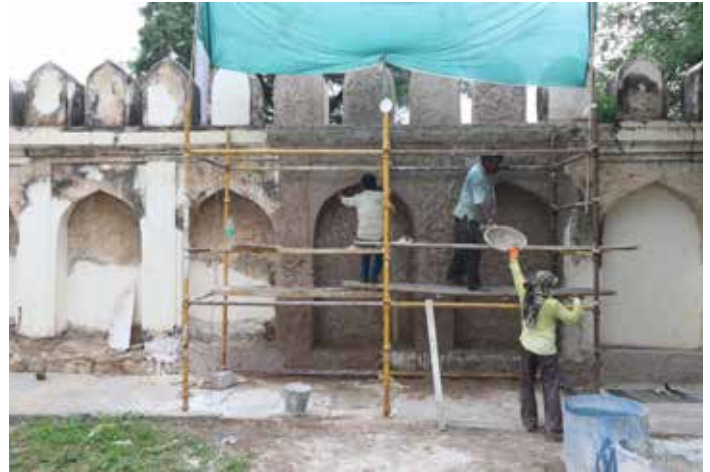
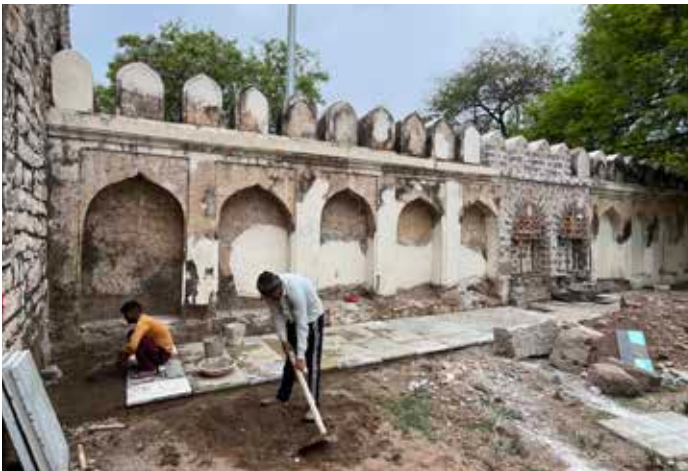
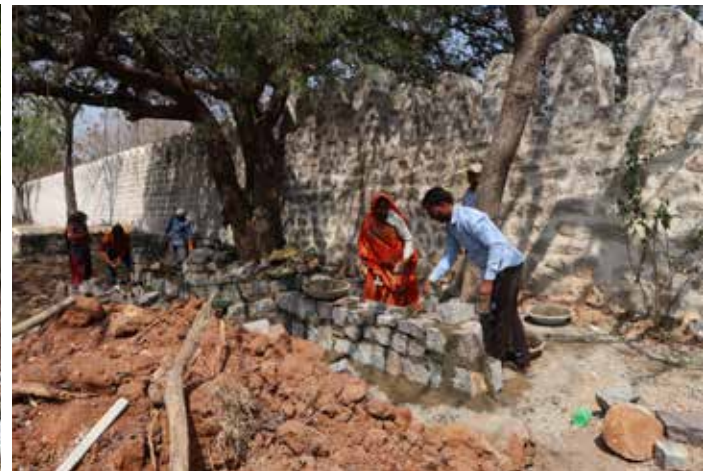
(Clockwise from left-top) Reconstruction(matching the original) of missing masonry walls and arches using formwork; Replastering the masonry walls and arches with traditional lime mortar matching the original details of the enclosure wall; Plinth protection using stone masonry walls along the northern enclosure wall; Finishing of the plinth protection with laying of 30 mm tandoor stone along a portion of the western enclosure wall

- In 2024, the reconstruction of two missing arch bays on the western enclosure wall was carried out. These had remained unrepaired due to the necessary service access required for the conservation of nearby monuments, particularly those near the Hammam Baoli.
- The restoration work involved reconstructing the masonry walls and arches to match the existing western enclosure wall.
- Formwork was created using brickwork, and the arches were constructed by skilled stone craftspeople. These were then allowed to set and cure for a month.
- After the removal of the formwork, four battlements at the top of these two arch bays were also reconstructed to match the original design.
- The arches and battlements were finished with traditional lime mortar mouldings and completed with a 1-mm thick lime punning—a lime putty prepared with natural additives.

- Following the conservation of the northern and eastern sides of the enclosure wall of Muhammad Qutb Shah's mausoleum, plinth protection was installed on the internal side of the northern enclosure wall.
- The original height and levels of the wall were identified during the conservation works by removing excess soil and overgrown vegetation, and the plinth protection was installed accordingly to match these original levels.
- The 900 mm wide plinth was designed to prevent rainwater damage and control the growth of unwanted vegetation along the wall. A 450 mm thick stone masonry retaining wall, 600 mm high, was built in a stepped manner to follow the natural slope of existing ground adjacent to the wall, covering the entire length of 232 meters of northern enclosure wall.
- Large trees along the wall were preserved and protected with a provision of stone masonry planters.

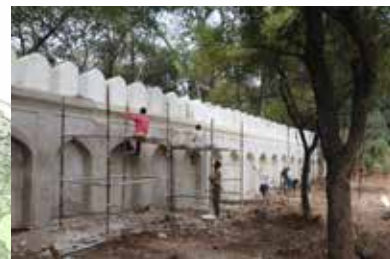
Lime repairs on the arcaded wall

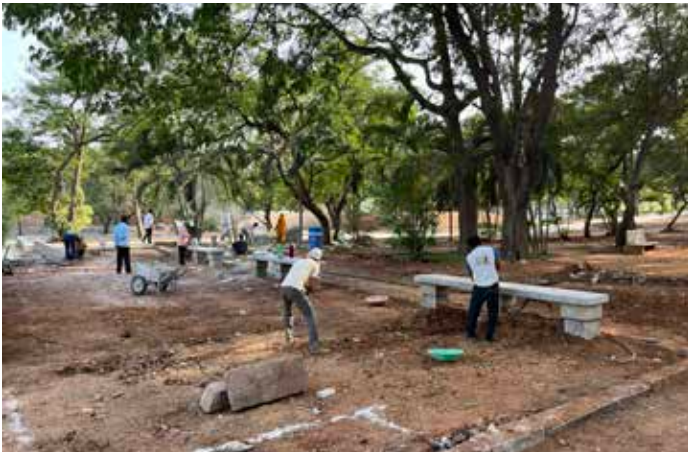
Levelling of earth at a gradual slope for laying of flooring

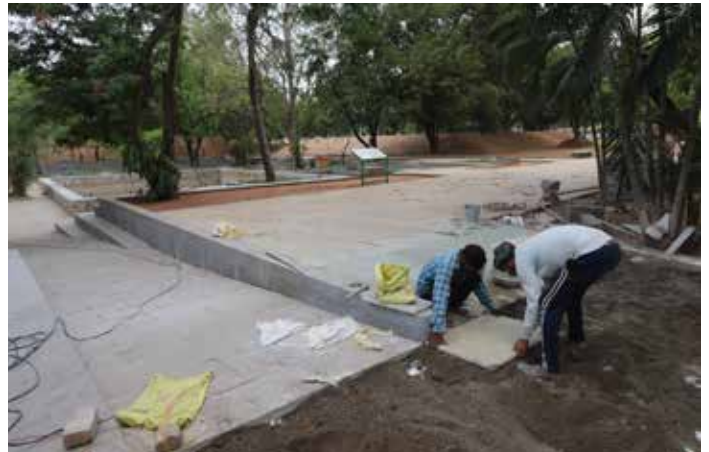
Laying tandur stones at the ramp was for universal access

The network of stone pathways laid out as part of the landscape masterplan had been majorly completed in the previous years. Few pockets left for ease of vehicular access for conservation and horticultural works inside the park have also now been laid with the standard tandur stone pathways and granite kerb stones. The Entrance Plaza and the pathways between mounds in Deccan Park, around the Site Exhibit space and the one leading to Muhammad Quli Qutb Shah's tomb from Badi Baoli have been completed.

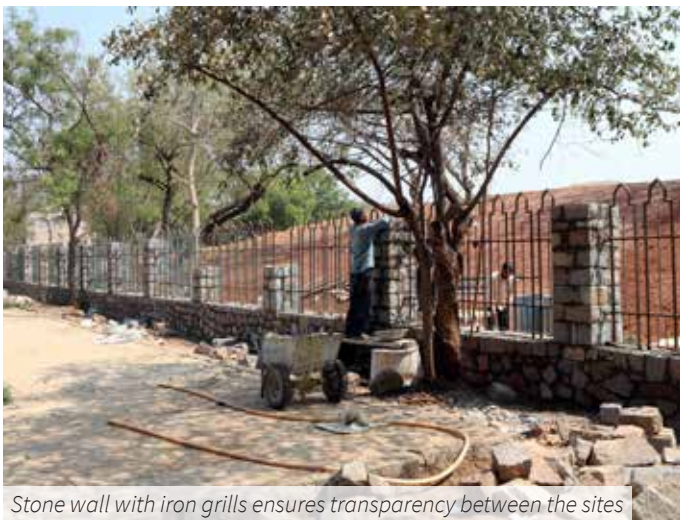
Stone wall with iron grills ensures transparency between the sites

- The 100 meter long wall was dropped by 300 mm at every 5 meter interval, maintaining an average height of 900-1000 mm from the ground level. This staggered reduction created an unhindered visual connection for visitors to both the Qutb Shahi Tombs and Deccan Park.
- To ensure transparency and visual connectivity of the two sites, stone masonry wall with iron grills was constructed demarcating the two sites.
- The alterations done were matched with the existing stone size, shape and masonry style to blend with the original 450 mm thick wall in cement.
- The earth at either side of the wall was levelled to a proper slope based on the site conditions.
- The wall now culminates in a pivoted gate installed as an access between the Tombs and Deccan Park. At this junction, a brick planter has also been created to accommodate the existing Jamun tree.

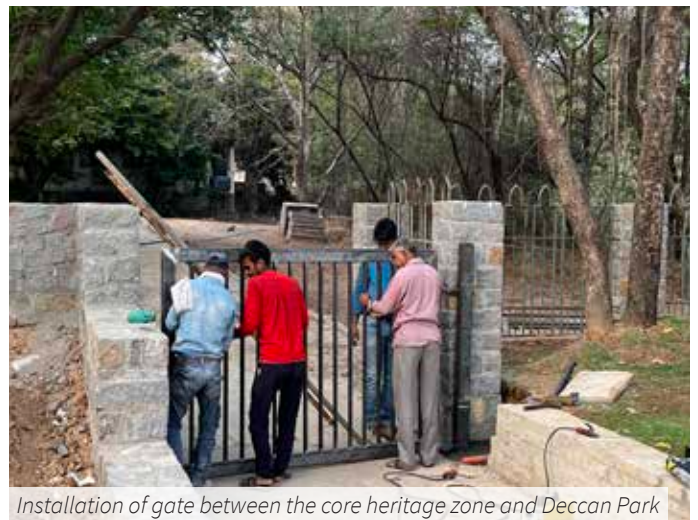
Installation of gate between the core heritage zone and Deccan Park

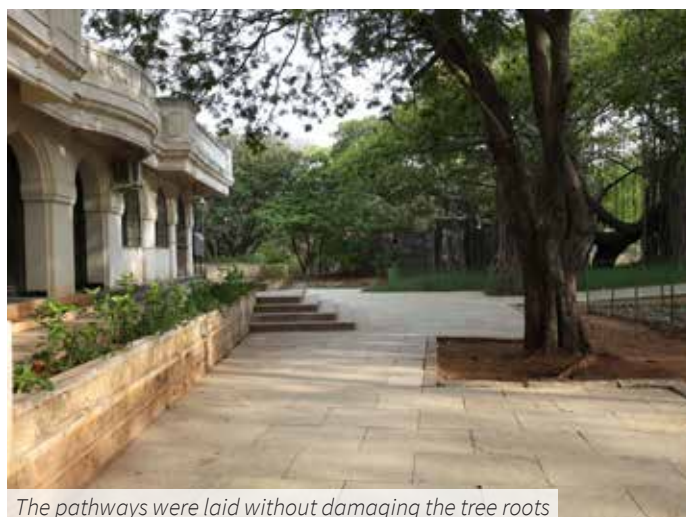
The pathways were laid without damaging the tree roots

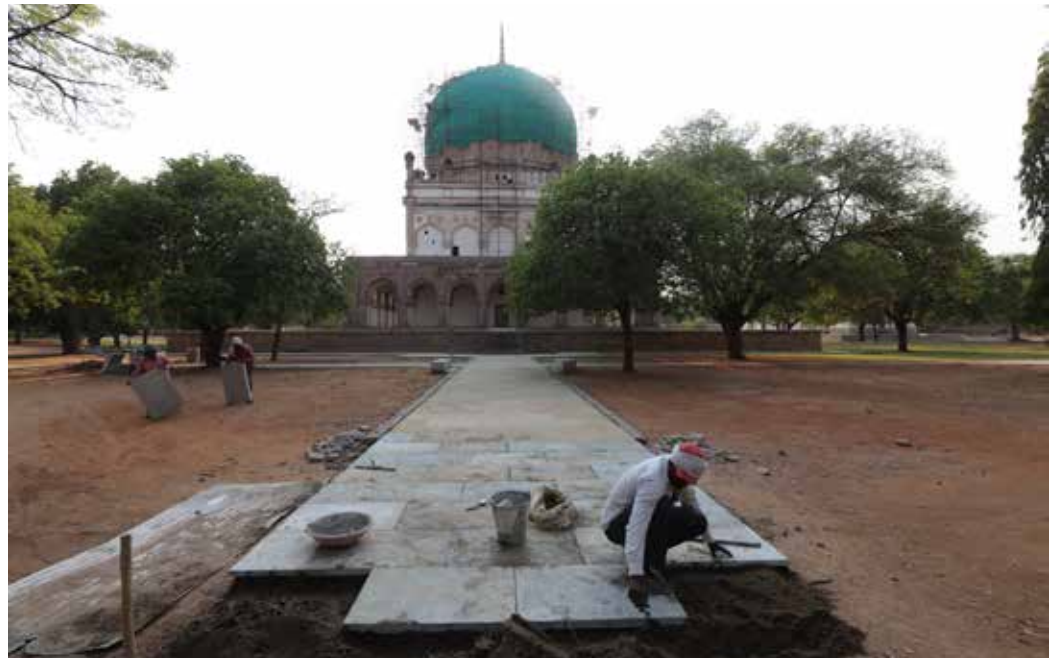
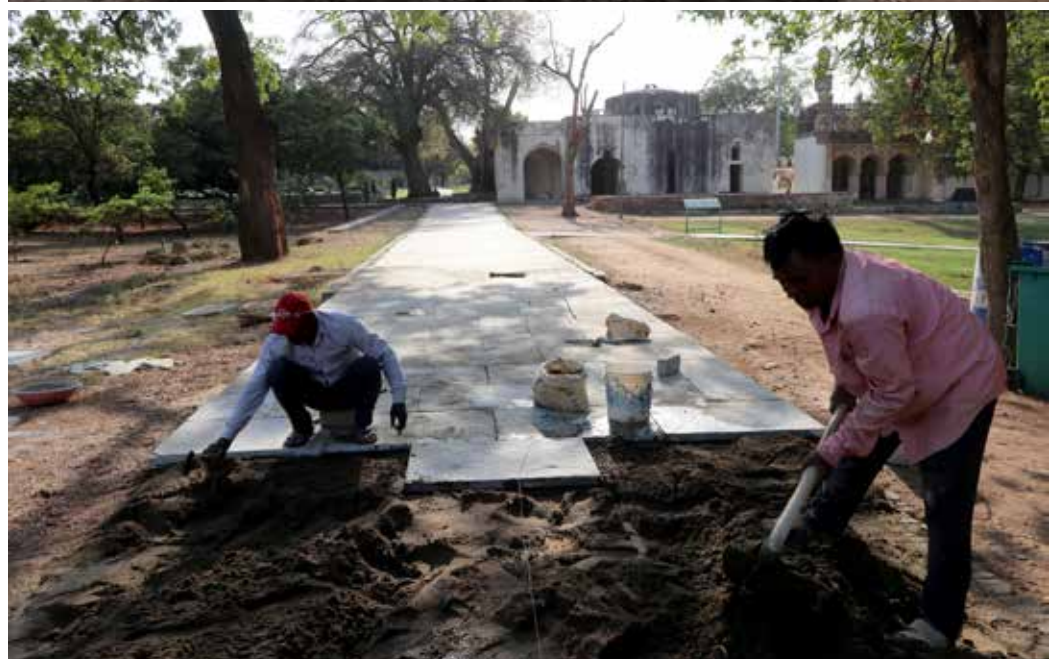
Pathways were laid from Badi Baoli to the tiled tomb of Muhammad Qutb Shah(top), west of Hakims' Tombs and east of Chickoo Orchard(bottom)

- The layout of the pathways was first marked on-site using lime powder, aligning precisely with the edges of the existing paths from start to end points.
- A foundation of 9 inch thick fly ash brick masonry was laid along both edges of the pathway over a 100 mm bed of PCC, following an excavation of about 300mm - 450 mm, depending on site conditions.
- Cement concrete, filled upto 4" below the brick masonry level,
- was manually levelled, followed by filling and levelling of another layer of PCC flushed up to the masonry.
- Uniformly cut Thandur stones were then laid by skilled masons, maintaining consistency with the existing joint patterns.
- To finish, the pathway edges were lined with 8x8 inch thick granite kerb stones, approximately 1 metre in length, set flush with the Thandur stone surface.

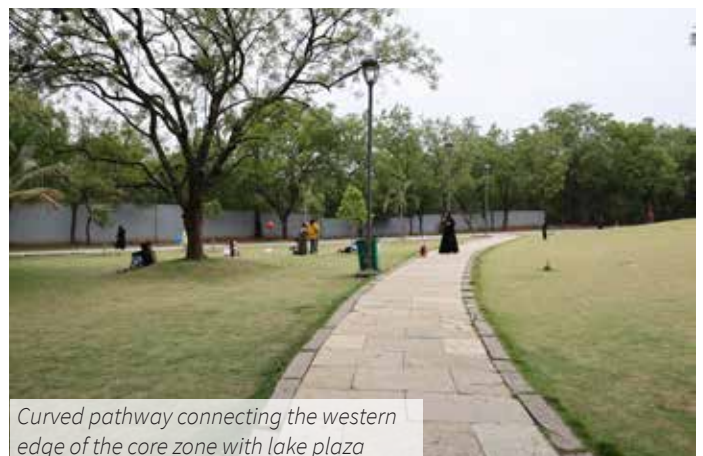
Curved pathway connecting the western edge of the core zone with lake plaza

- Multiple truckloads of earth were removed from the mound at the proposed location of the central pathway continuously for a week.
- A gradual slope was marked on site, according to the proposed ground levels, to ascertain excavation for foundation works.
- The standard pathways in the Thandur stone and 1 m long granite kerb stones were laid after setting a 100 mm thick layer of PCC.
- A 3 m wide area on either side of the pathway was levelled for surface runoff from the mounds during monsoon.
- A curved Pathway was also added in similar thandur stones and granite kerbs from Lake Plaza to the cement concrete road abutting the Southern edge of the park.

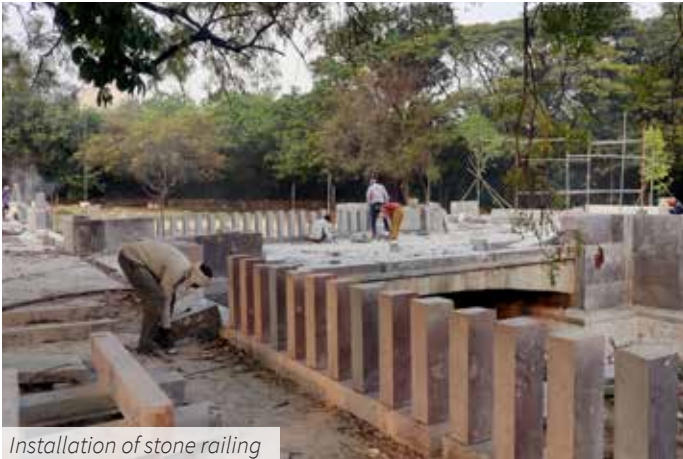
Installation of stone railing

- The red granite balusters were kept in place by laying a stone railing measuring 200 mm wide and 125 mm thick in similar mortise and tenon joints as the base.

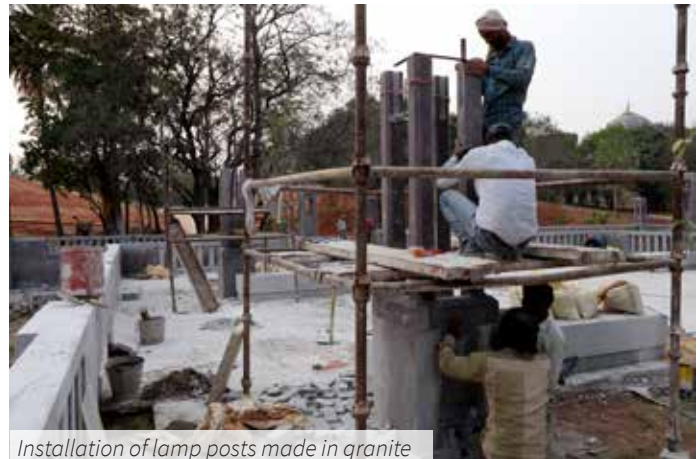
Installation of lamp posts made in granite

- The lamp posts are provided for evening visiting hours at regular intervals of stone railing. These lamp posts are designed in similar red granite to be 2 meters high and 600 mm wide with lighting fixtures mounted at top.

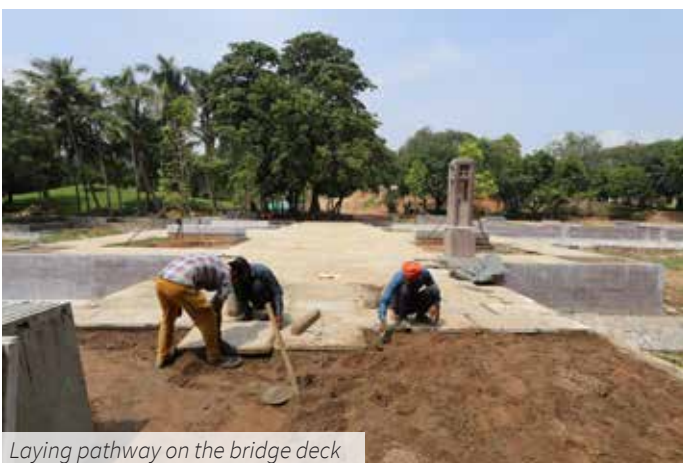
Laying pathway on the bridge deck

- The bridge decks have been paved with the locally sourced Tandur stones, similar to the paving used along visitor pathways, ensuring continuity and durability.

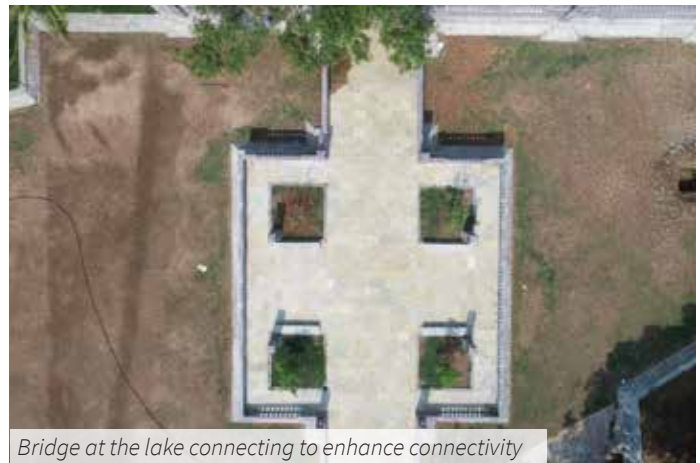
Bridge at the lake connecting to enhance connectivity

- The north and south facia of the bridge are cladded thick red granite as rest of the retaining wall of the lake to maintain uniformity in appearance and design.

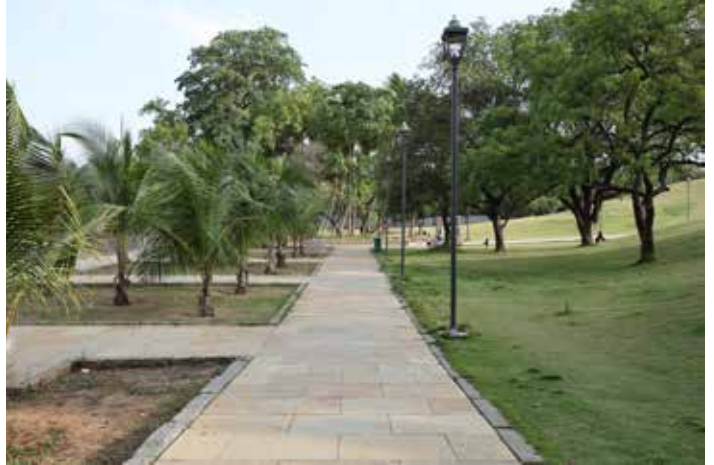
Plaza on the western part of the lake

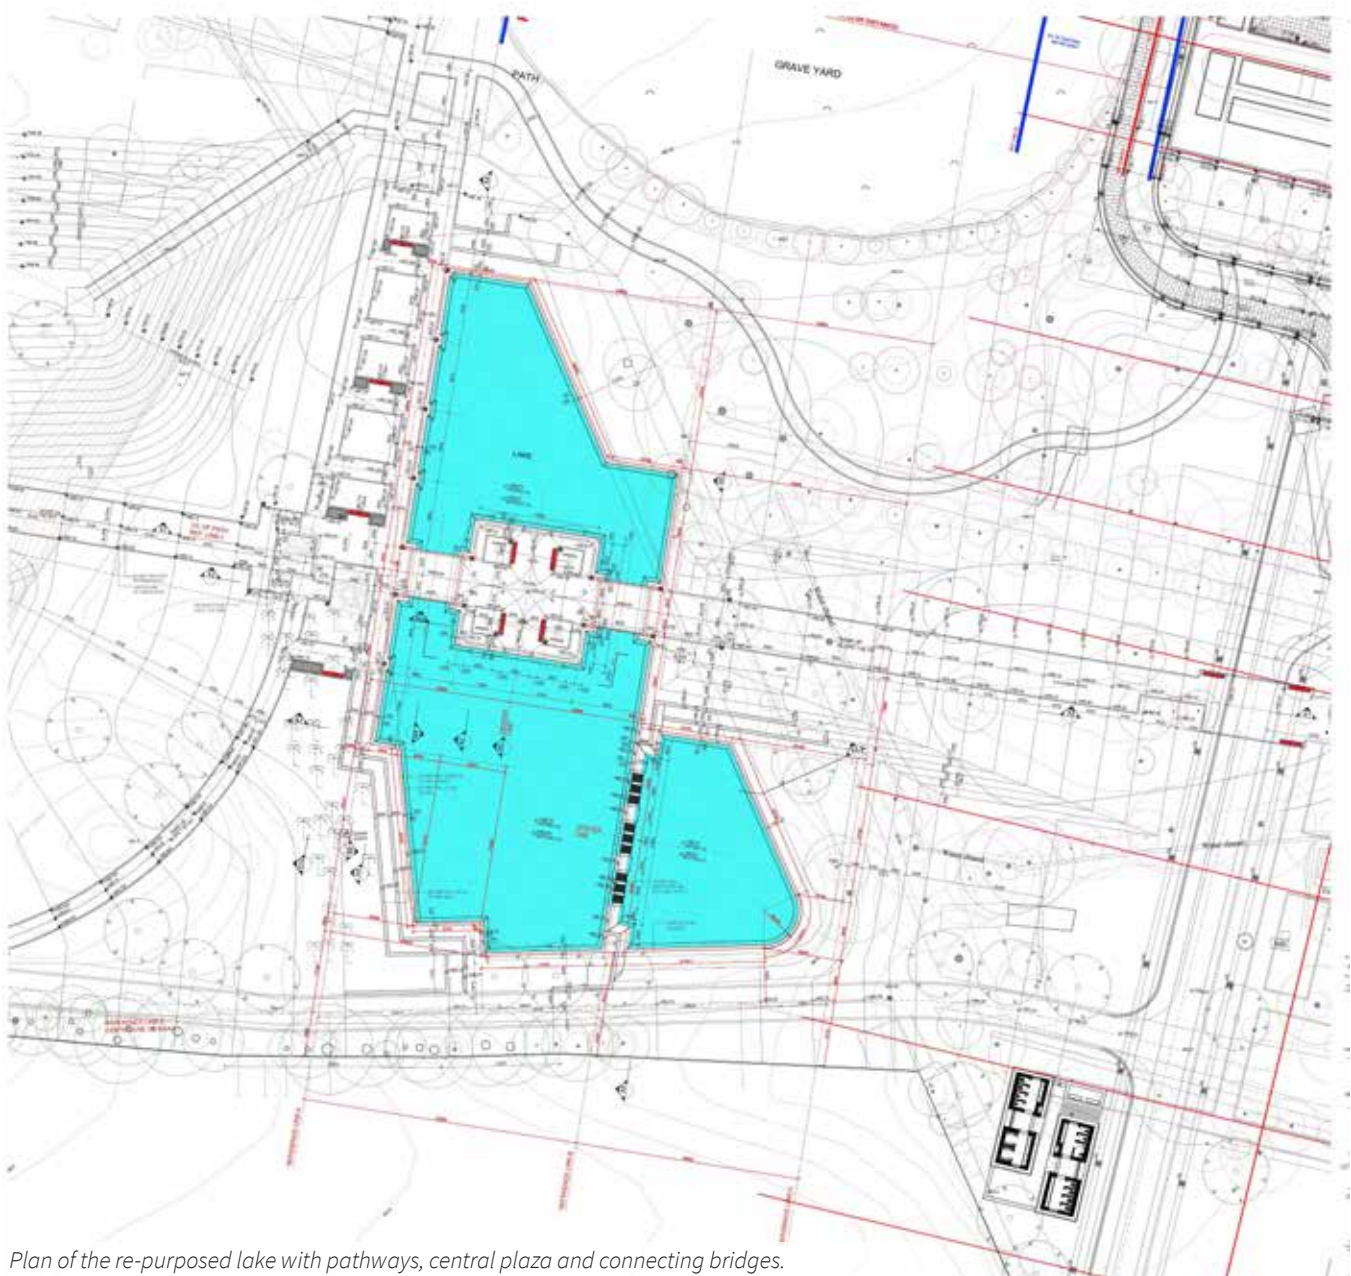
Plan of the re-purposed lake with pathways, central plaza and connecting bridges.

The water-body in the Deccan Park was in the deteriorated condition. The outline profile of the water body was retained and a shallow lake was created in the region.

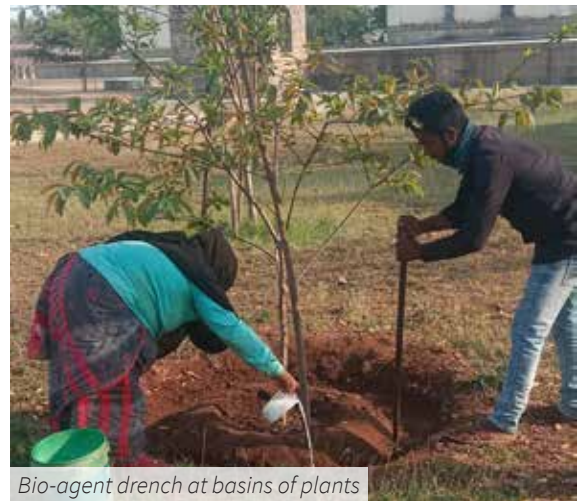
Bio-agent drench at basins of plants

To improve the physical and chemical properties of the soil, bio-agents were introduced to the various plantation areas. Bio-agents are natural organisms used to enhance soil health and also act as organic pest control agents. Based on the results of the soil tests, specific bio-agents were selected to address identified deficiencies and improve plant growth.

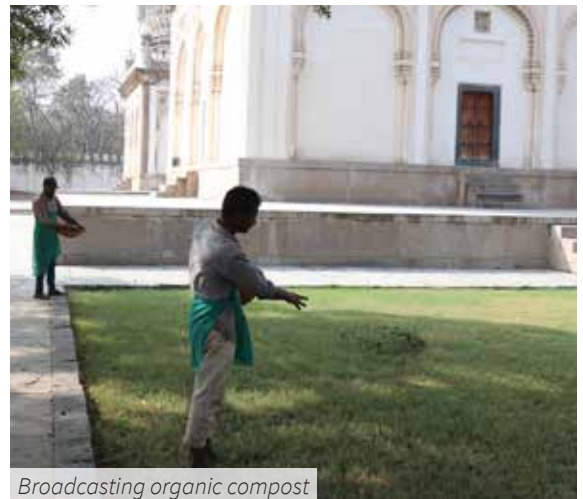
Broadcasting organic compost

To improve soil health at the Qutb Shahi Heritage Park, organic matter was broadcasted across various plantation areas, enriching the soil with essential nutrients and enhancing its microbial activity. This practice involved the seasonal application of compost and decomposed plant material to restore soil fertility, as identified through comprehensive soil testing. Broadcasting organic matter helps improve soil structure, increasing its ability to retain moisture while promoting aeration.

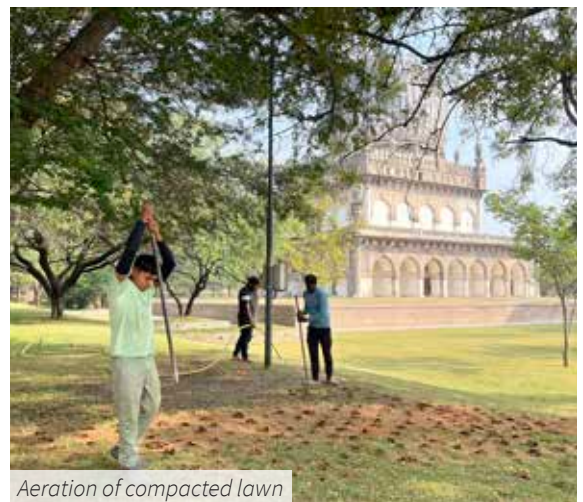
Aeration of compacted lawn

Aeration is particularly crucial in the park, especially in lawn areas that are prone to trampling. Continuous foot traffic compacts the soil underneath the lawn, leading to root thinning and restricting the grass from spreading its runners. As a result, the soil needs to be aerated once every six months to maintain dense and healthy grass cover. By loosening compacted soil and incorporating organic amendments, aeration allows air, water, and nutrients to reach plant roots more effectively. This process supports the growth of beneficial microorganisms, which, in turn, enhance nutrient availability and overall plant health. By integrating organic matter broadcasting with proper aeration techniques, the park ensures long-term soil sustainability, fostering a thriving and resilient landscape.

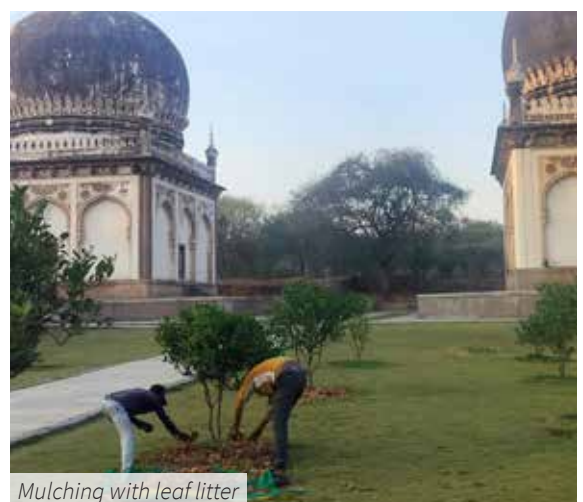
Mulching with leaf litter

Mulching is an essential practice at QSHP, particularly during the winter and summer months. It involves placing a layer of plant material, such as leaves, grass, twigs, crop residues, or straw, on the surface of the soil. Dried leaf litter is used as a cost-effective and environmentally friendly mulching material. The mulch acts as a protective barrier for plant roots, insulating them from extreme temperatures and helping to maintain consistent moisture levels in the soil. Additionally, the mulch helps suppress weed growth around plant basins.
