QUTB SHAHI
HERITAGE PARK

ANNUAL REPORT 2023-2024

Conservation & Landscape Restoration

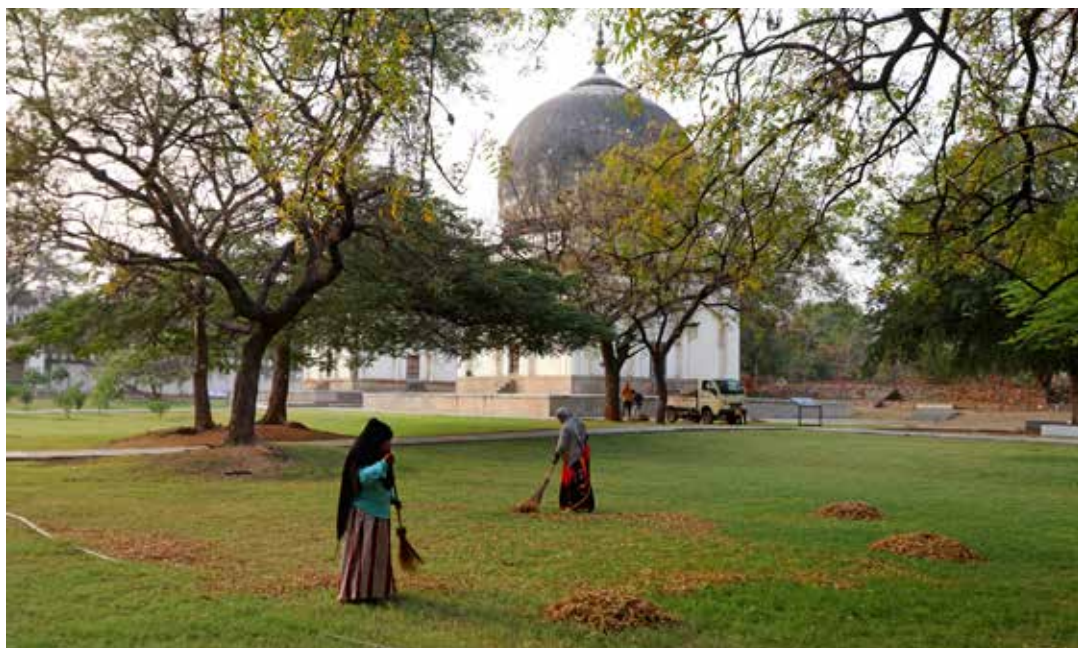
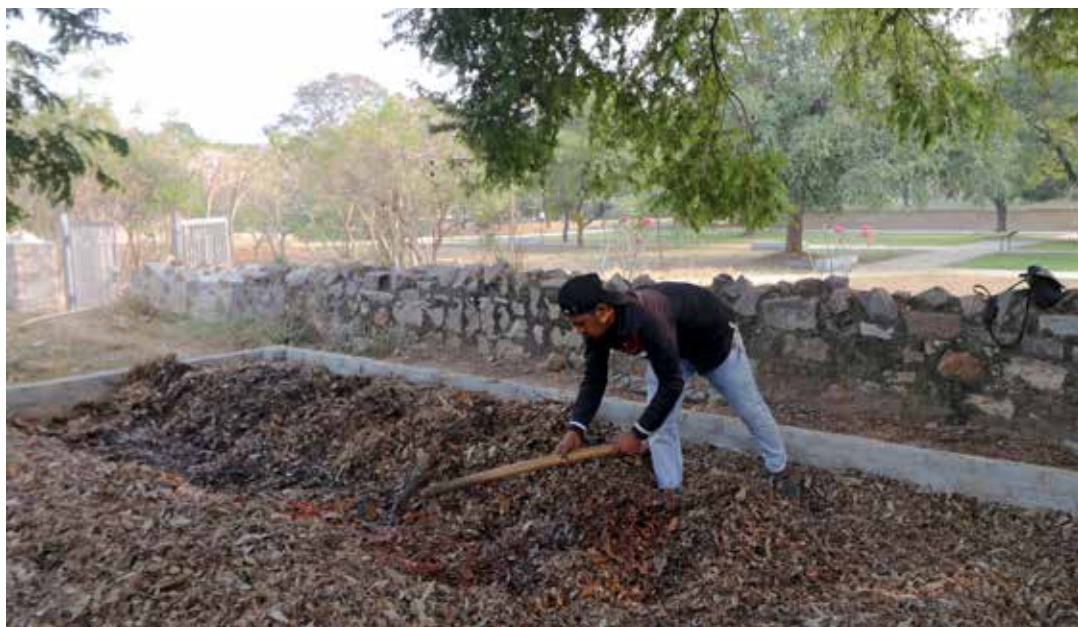
*(Top) Dry leaves and twig litter are collected from across the necropolis;
(Bottom) The collected material is piled in floored beds as compost*

The collected material is sorted and chopped, if necessary, before being piled in floored beds. Earthworms are then introduced after 15 days of partial decomposition, and a jaggery solution is used to aid the composting process. The compost is carefully monitored for temperature and moisture content, with regular checks to ensure optimal conditions.

After 45-50 days, the compost is harvested, sieved to remove large particles, and packed into 25 kg bags for use in the plantation across the necropolis. The vermicompost is rich in essential nutrients such as Nitrogen, Phosphorus, Potassium, and humus, providing a sustainable source of soil enrichment.

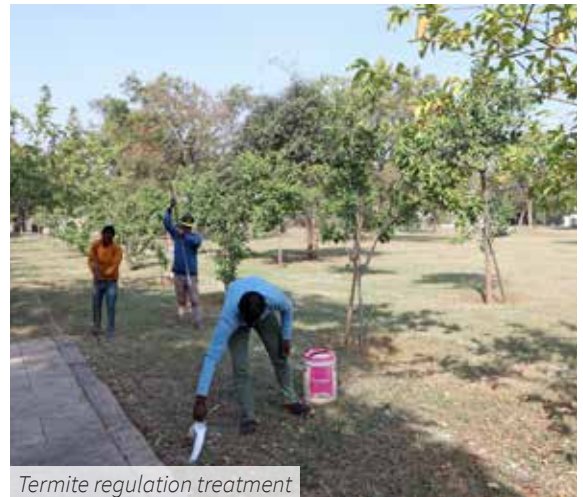
Termite regulation treatment

In certain areas at site, termite infestations were identified as a major threat to the health of the plantation, particularly in the Guava plantation west of Jamshed Quli Qutb Shah's tomb. It was noticed that termites were causing significant damage to the roots of the plants, leading to their gradual decline.

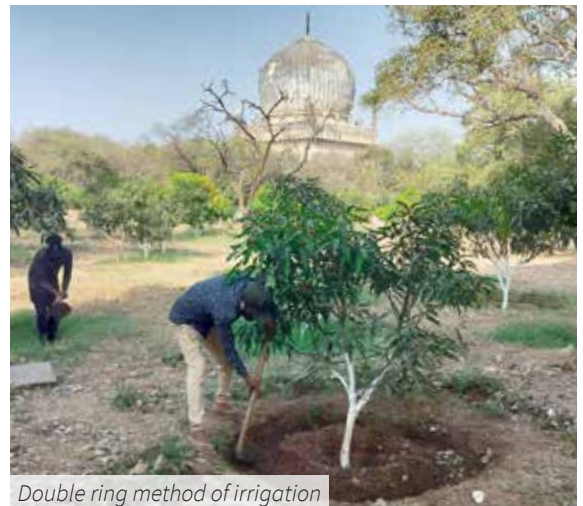
Double ring method of irrigation

To reduce the vulnerability of plants to pests and diseases, the double ring method for preparing plant basins was adopted at site. Earlier a saucer-shaped basin was made around the new plants, however, it was observed that this allowed moisture to frequently interact with the plant collar. The double ring design being used currently helps keep the collar dry and reduces the risk of fungal and pest infestations. This method has been particularly beneficial for fruit trees and moisture-sensitive plants, contributing to improved plant health over the year.

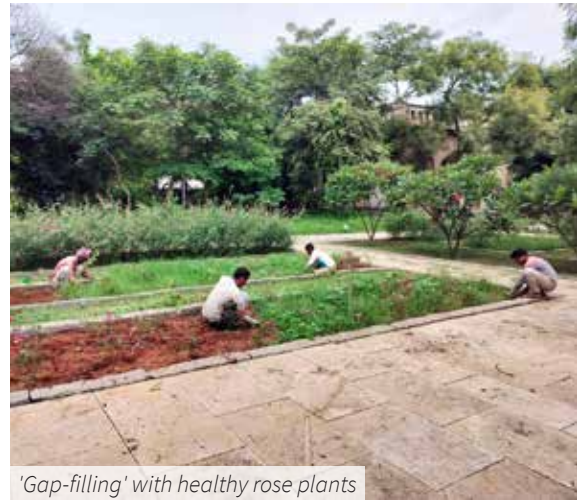
'Gap-filling' with healthy rose plants

In October, after Neem trees shed their diseased leaves affected by 'Die back' disease caused by Phytophthora, it was observed that the same fungal attack had also affected the rose plantation beneath them. Laboratory analyses of the diseased samples at the Forest College and Research Institute, Mulugu, confirmed the presence of same fungal pathogen affecting both neem and rose plants. The disease caused 40% mortality in the rose plantation. After implementing control measures, 60 percent of the existing rose plants were saved, and . gap-filling of rose plantation was carried out to restore the plantation.

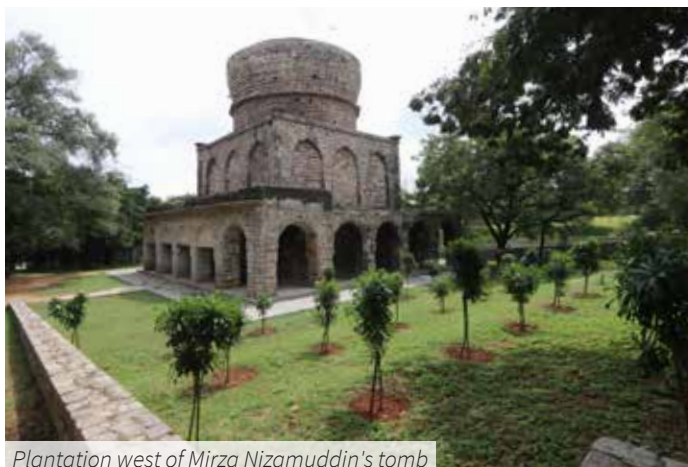
Plantation west of Mirza Nizamuddin's tomb

The area west of the incomplete mausoleum of Mirza Nizamuddin was earlier planted with white flowered Hibiscus. However, they gradually succumbed to severe root rot infestation. To address this issue, a hardier alternative from a different plant family was selected – Plumeria pudica – which also produces white flowers, while offering has better disease resistance.

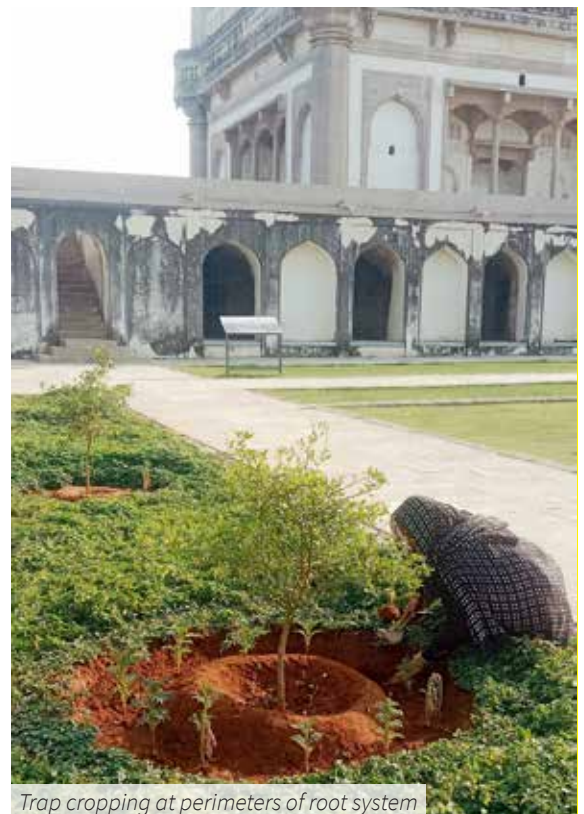
Trap cropping at perimeters of root system

To protect plants from nematode infestation, a biological control approach was implemented at the forecourt. Instead of using chemical treatments, lemon plants were introduced as a trap crop around the root zones, helping to mitigate nematode impact naturally.

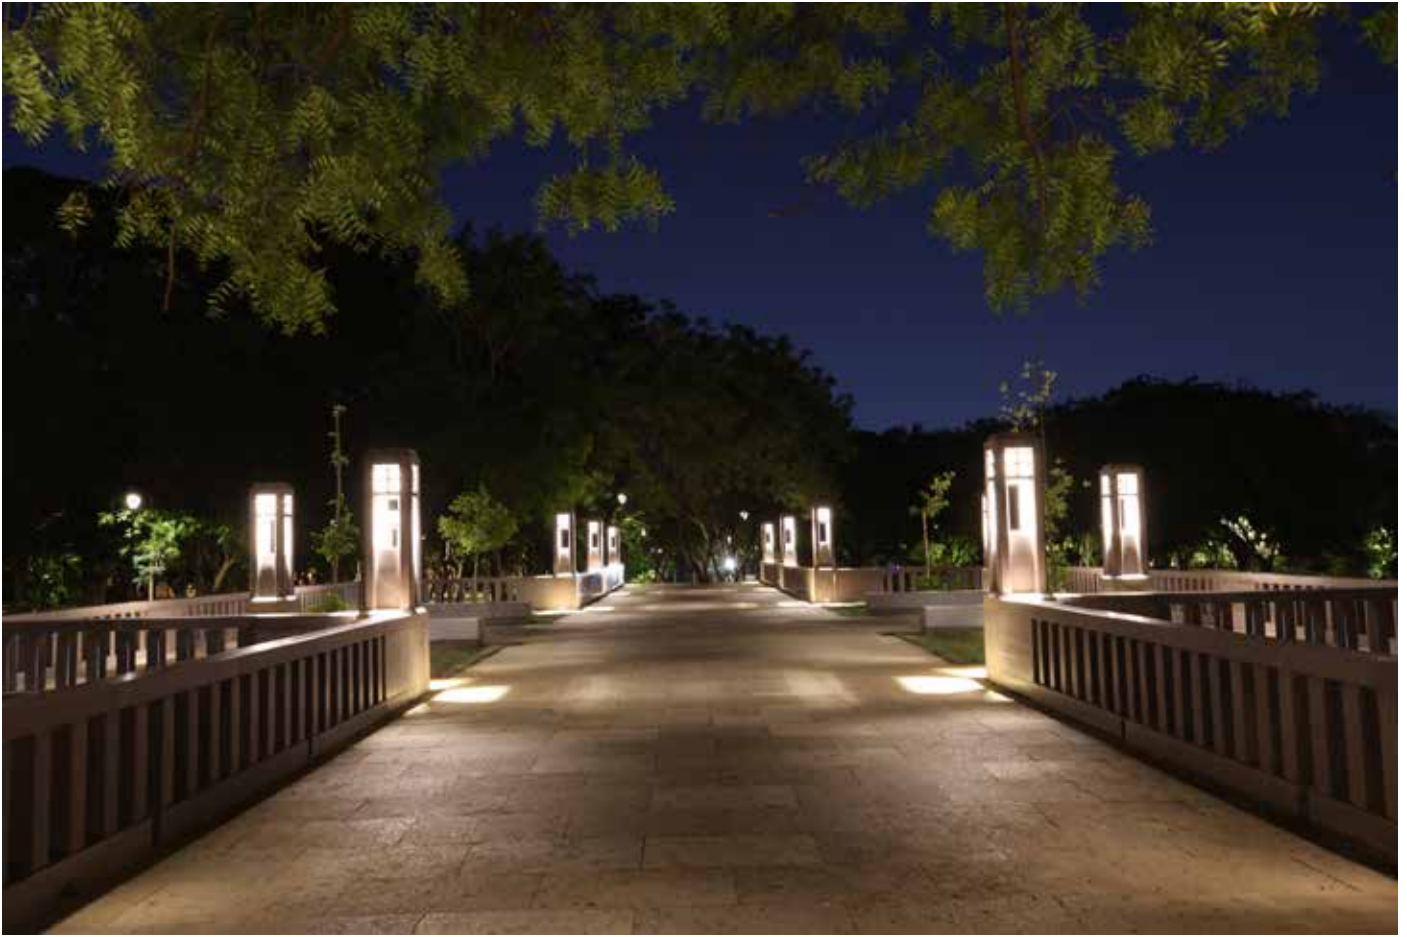
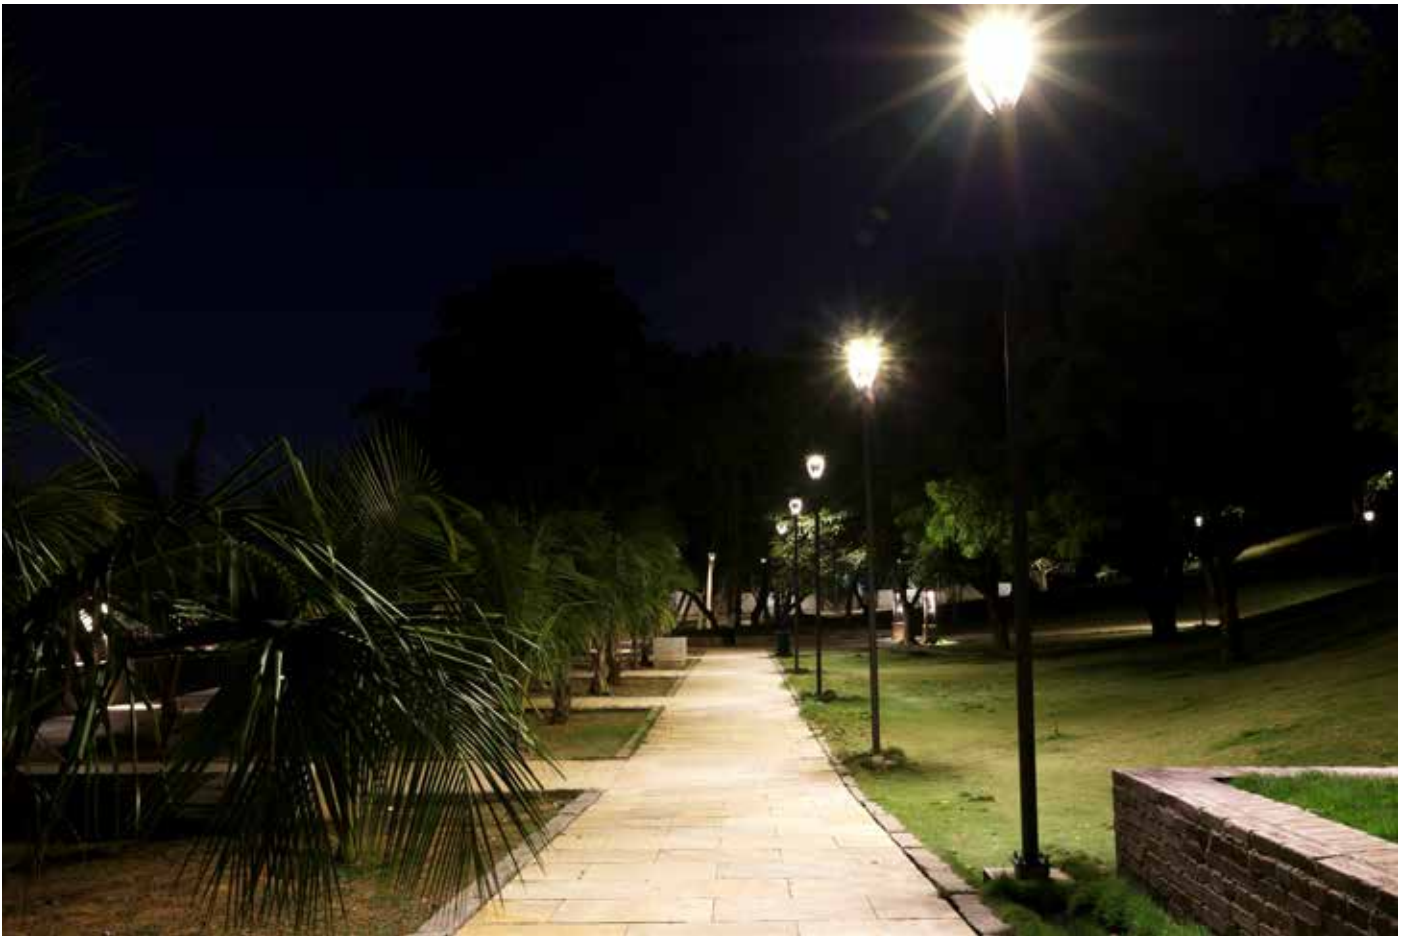
Illumination of the visitor facilities like lake, bridge, pathways at the Entrance Zone

- A pit of 1m by 1m for a depth of 750 mm was excavated for the foundation of the light pole.
- For each light pole, a foundation with a depth of 750 mm was excavated. A reinforced cement concrete (RCC) foundation column was cast to support the pole. A base plate with four bolts was embedded into the RCC foundation, allowing the light pole to be securely fastened.

- The wiring was done through the corrugated pipe connecting the laid electric line with the light pole emitting warm white light.

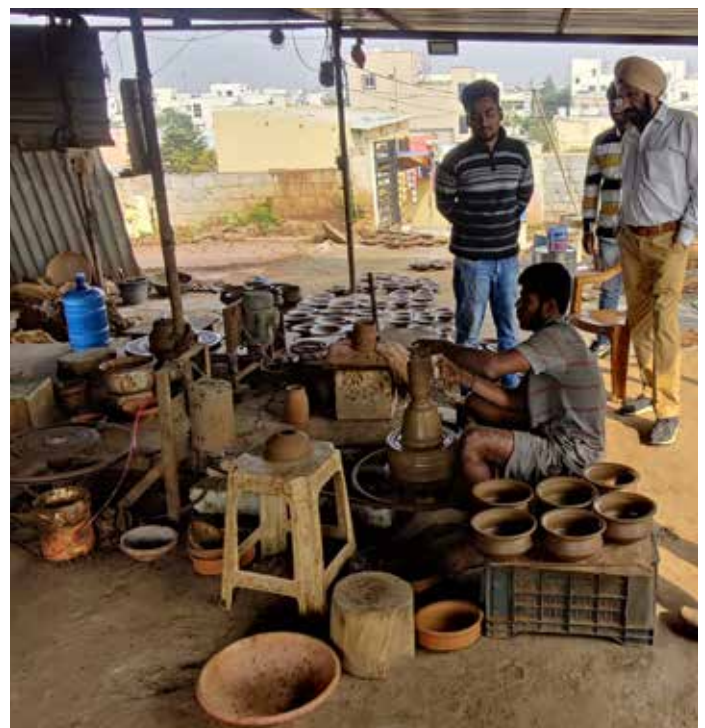
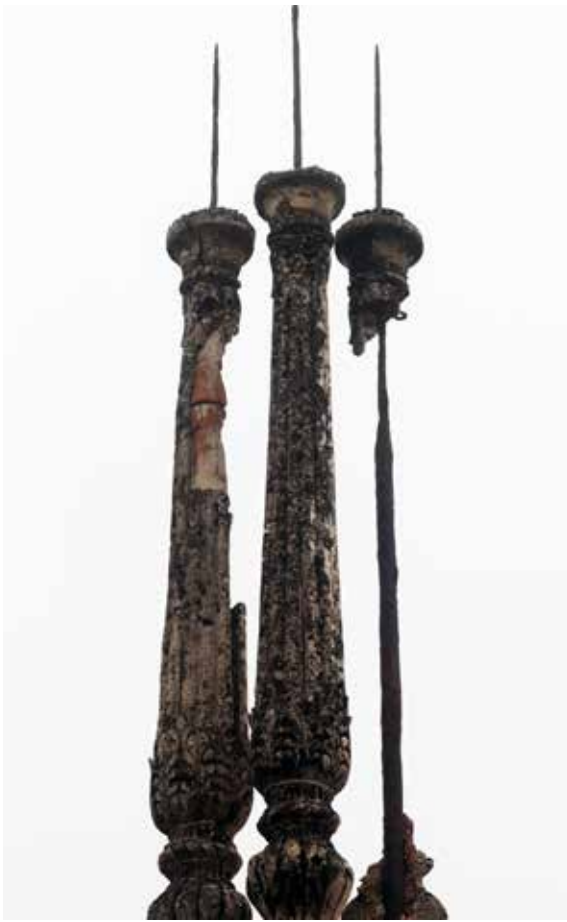
Reconstruction of missing and damaged minarets as per the traditional construction techniques by master craftspeople

- The minarets were all in an advanced stage of decay, with some missing and others had large damaged portions. Skilled craftspeople using traditional materials and tools, rebuilt several missing minarets on both external and internal parapet and restored intricate stucco plaster patterns.

- Before commencement of restoration, thorough investigation was carried out to understand the construction technique of minarets. The research revealed that the central core of each minaret comprises of stacked terracotta pipes, measuring between 10 and 12 inches in height around an iron rod. The skeleton is plastered with several layers of traditional lime mortar to achieve the required shape and size by master craftspeople.

- For restoration of the minarets, the terracotta pipes were meticulously hand-crafted by local potters, ensuring they match the historic evidence, leading to generating livelihood for local craftspeople and promoting indigenous crafts.

- It was not possible to replace the iron rod with non-corrosive stainless steel rods at all places, as some original stucco remained on a majority of minarets, so anti-corrosive treatment was provided to iron rods that were exposed.

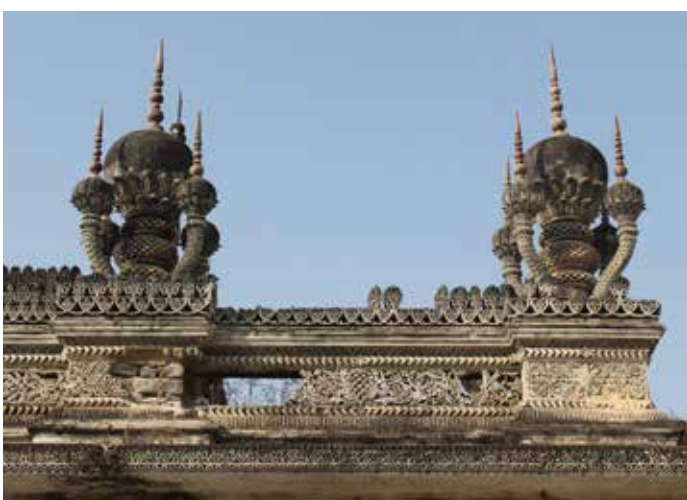
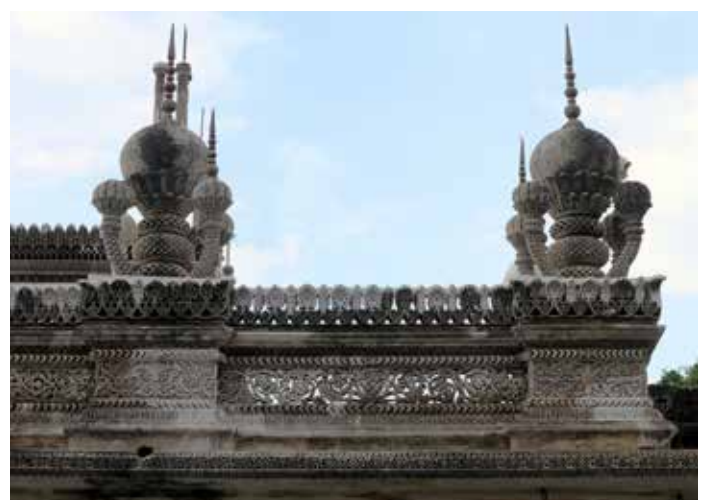
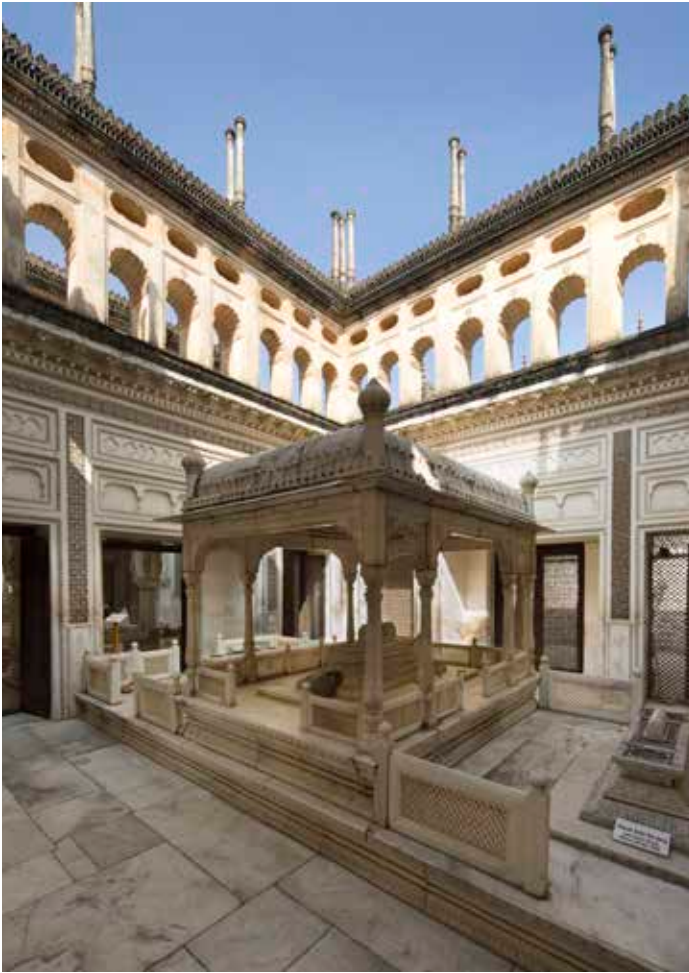
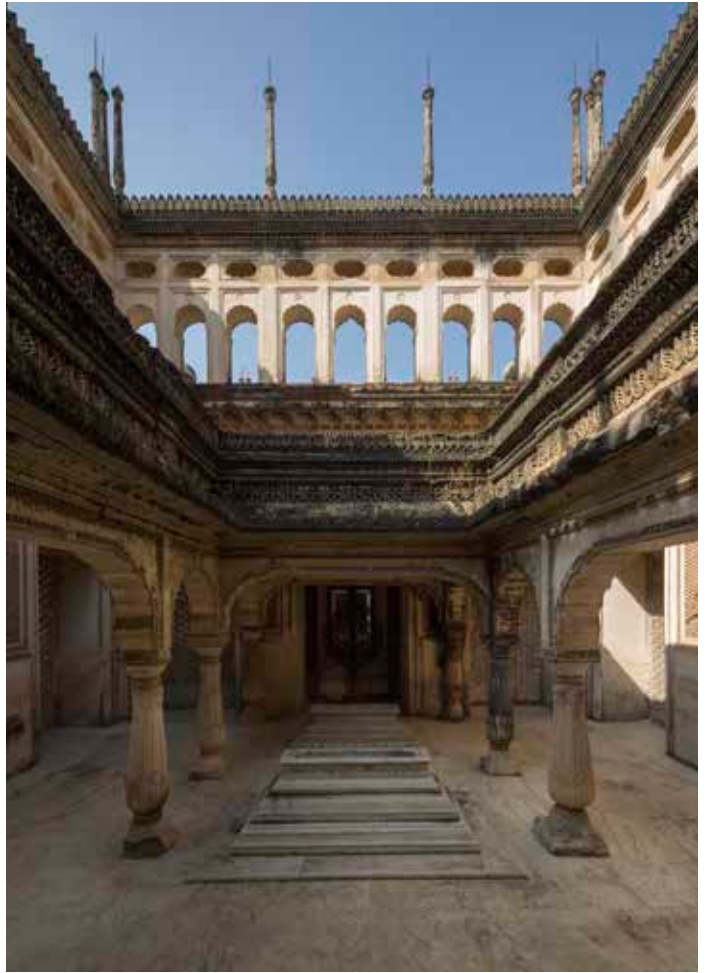
- The parapets are embellished with ornate stucco panels and intricate lattice screens, which exhibited serious damage with large missing portions, these have been carefully restored by master craftspeople using traditional construction techniques. Owing to the 50 mm depth of lattice screens, multiple layers of fine lime mortar was applied in three stages making it a tedious and time consuming process.

Highly intricate lattice screen has been carefully restored by master craftspeople

- Patterns of the lattice screen were simplified to understand their geometry and to identify the size of required terracotta tiles. The tiles are less than 2mm thick and are being crafted by local potters, reviving indigenous crafts and construction techniques. More than 20,000 tiles are required to restore 230 square feet of missing lattice screen.

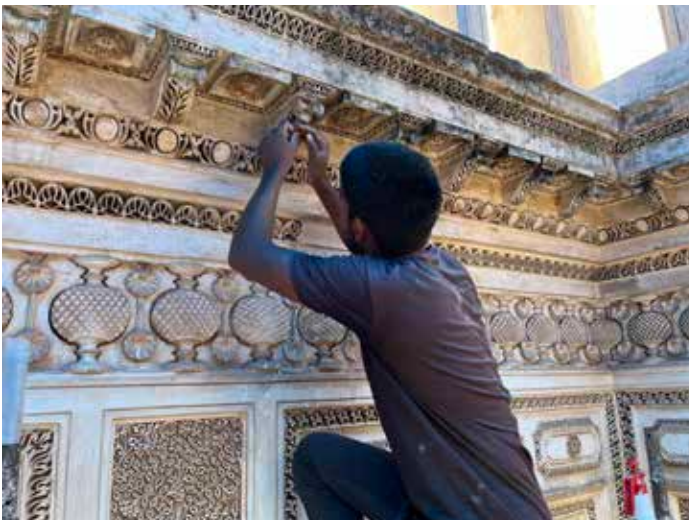
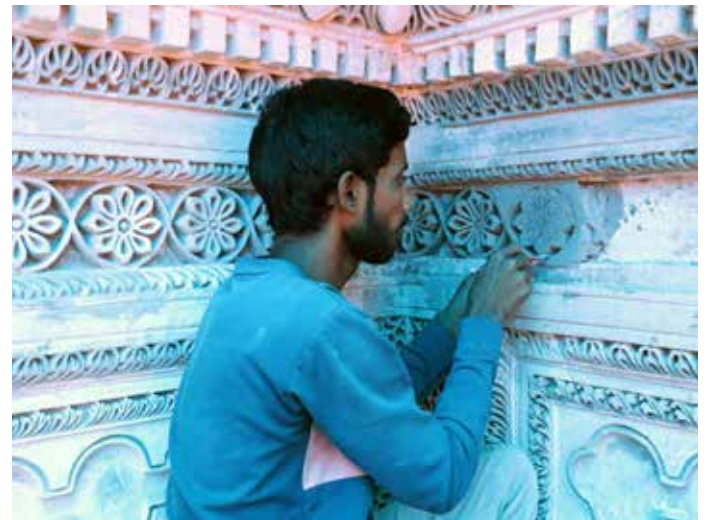
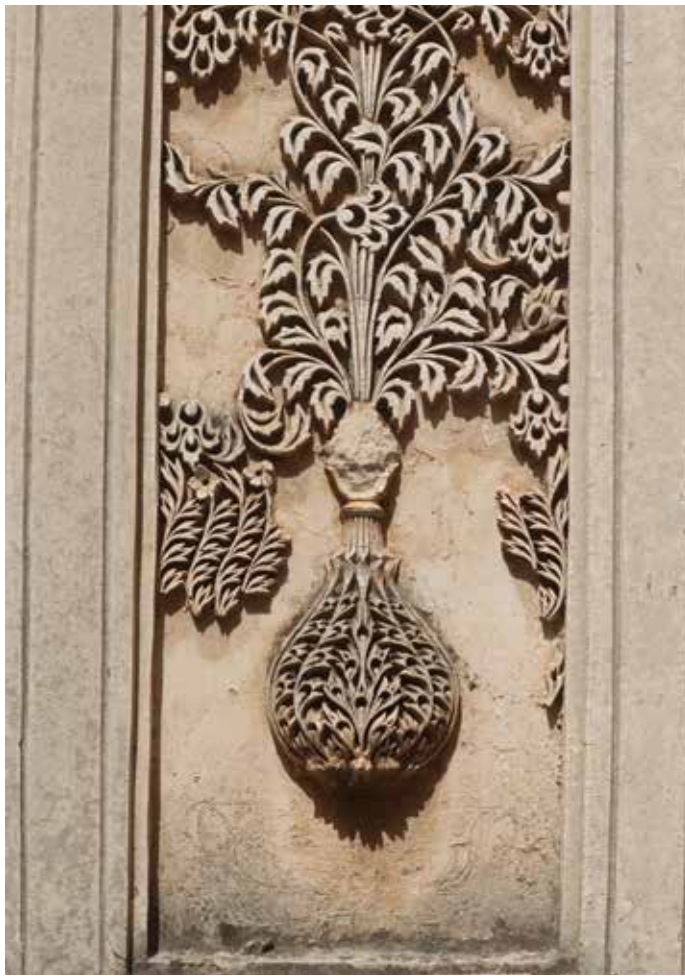
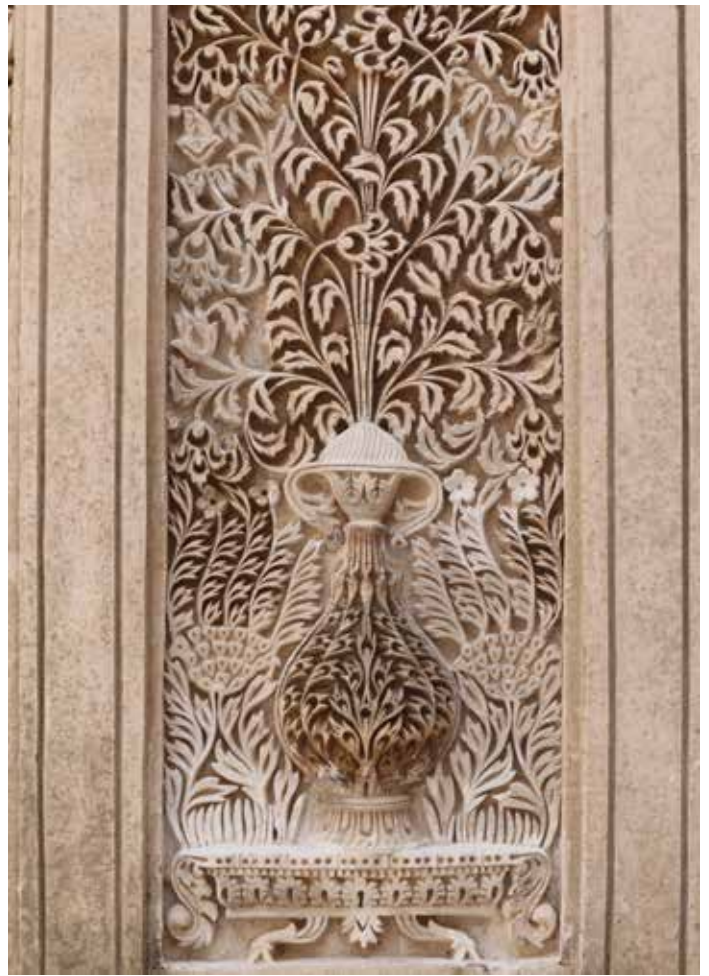
The grave enclosures exhibit significant damage, including large missing portions of intricately carved lattice screens and damaged, decayed ornamental stucco patterns and floral bands. However, compared to the other areas, the enclosures are in a comparatively better state of conservation.

More than 500 meters of intricate floral bands have been painstakingly restored by master craftspeople in grave enclosures

Tomb of Latifunnissa consists of elaborate intricately carved panels, large portions of the missing ornamental stucco in these panels have been carefully restored by master craftspeople

- Minute cleaning of all the ornamental and plain plastered surface was carried out to remove algae and other deposits.
- Walls of Latif-un-nisa's mausoleum are adorned with elaborate ornamental stucco in lime mortar, large portions of these were missing and have been painstakingly restored by master craftspeople matching the original design in hand ground fine lime mortar.
- The cornice band, composed of multiple ornamental stucco bands, showcases floral patterns and pineapple motifs. Large number of missing pineapple motifs have been restored by master craftspeople using hand-tools along with repairs of more than hundred meter of floral band.

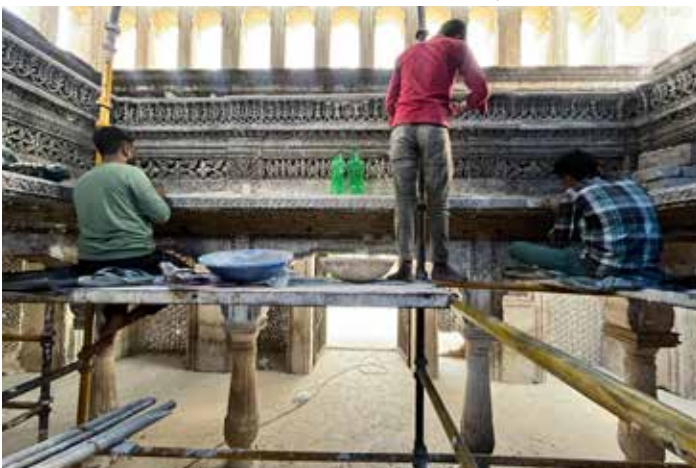
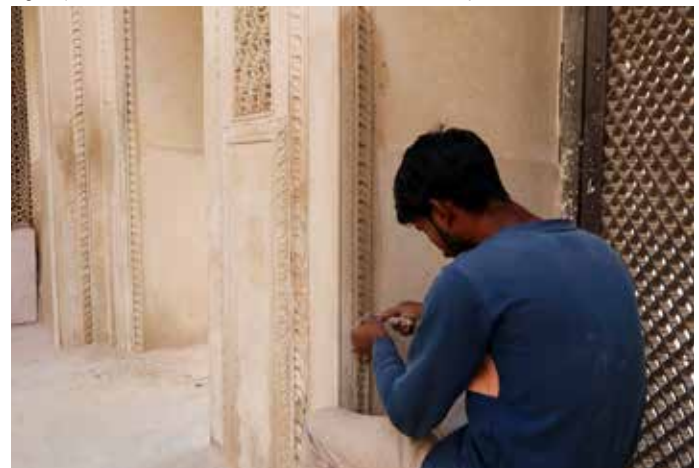
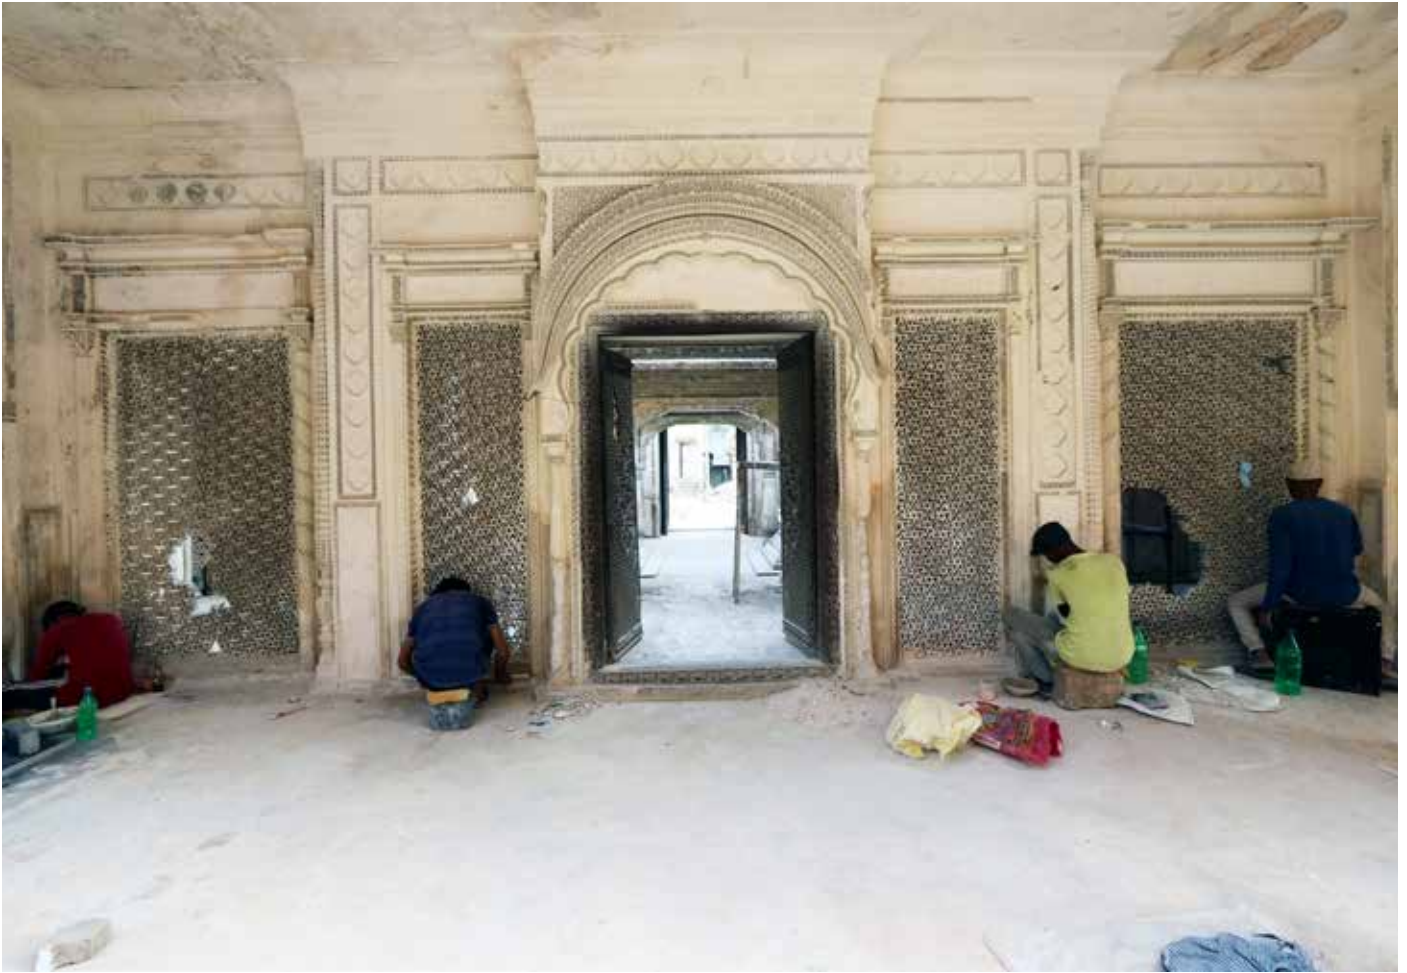
The intricate details at the monuments were minutely cleaned, and the damaged plain and decorative surfaces were carefully restored

Master craftspeople restored the decorative bands at the tombs of Ladli Begum, Latifunnisa and Rashiduddin

- In Ladli Begum's mausoleum, the cornice is supported by highly ornate brackets, several of these brackets were rebuilt matching the original design by master craftspeople using traditional techniques and materials.

- Mausoleum of Rashiuddin has a unique layout where a low height arcade is placed inside the enclosure. Both the arcade and walls of the enclosure are adorned with ornamental stucco bands of varying thickness which were largely damaged. More than 100 meters of ornamental bands were restored by master craftspeople matching original design.

- Extent of deterioration in the Tomb of Bashir-ud-Daulah, Tomb of Nawab Fakhruddin Khan is limited and largely concentrated on the mouldings and linear floral bands. After minute cleaning of plain and decorative surfaces, the damaged mouldings and floral bands were carefully restored in hand ground lime mortar by master craftspeople.

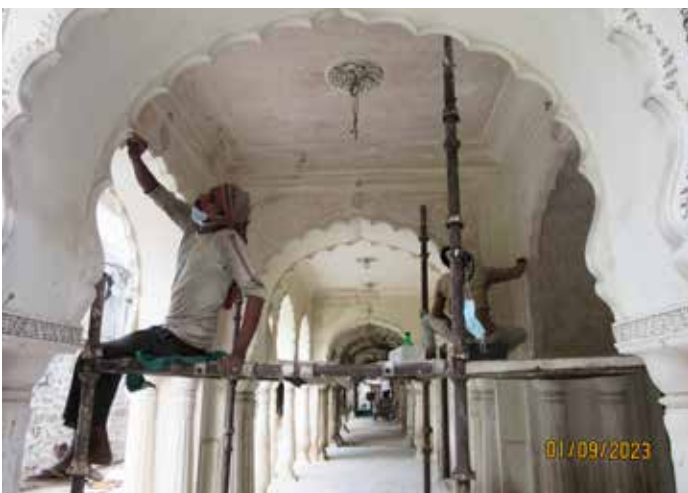
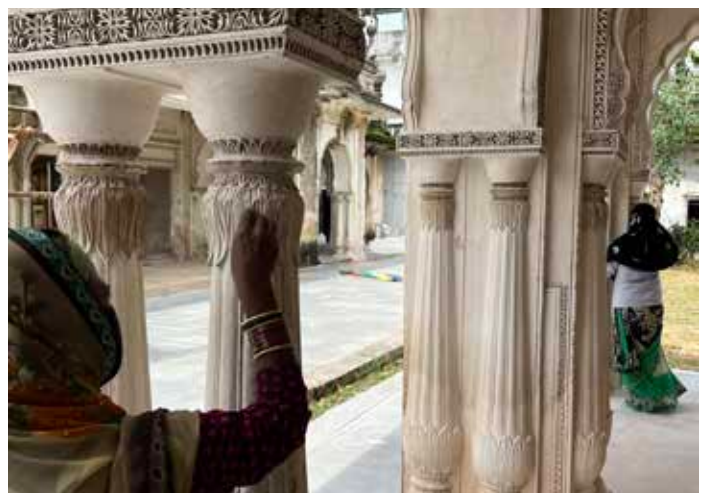
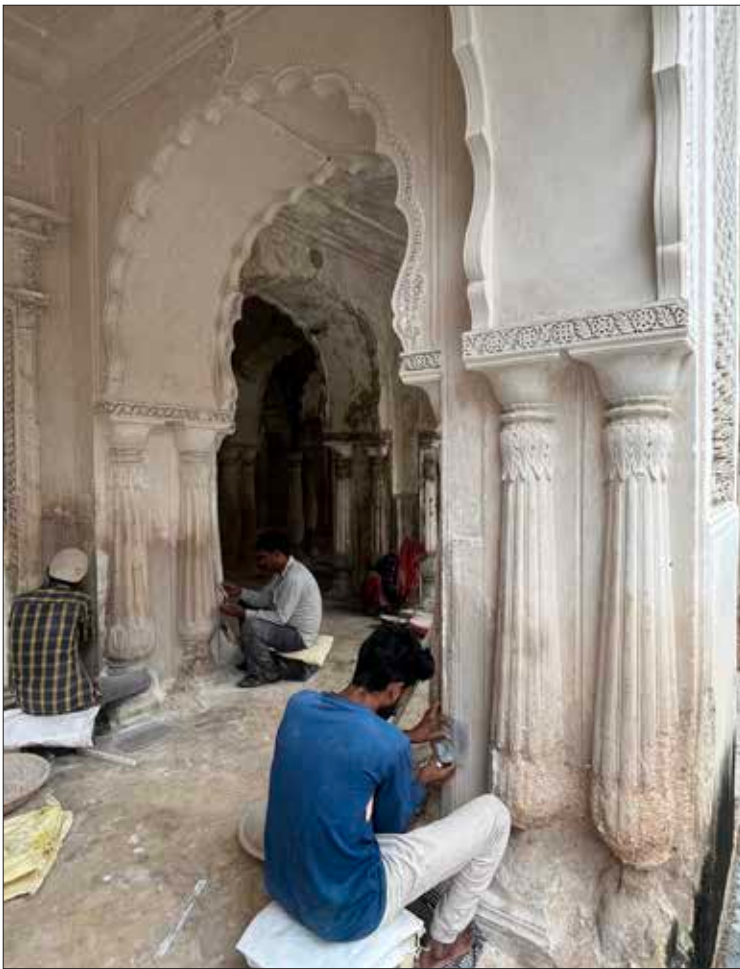
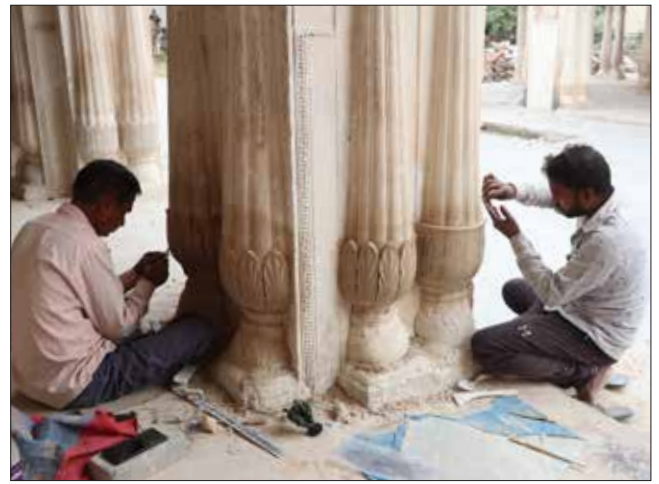
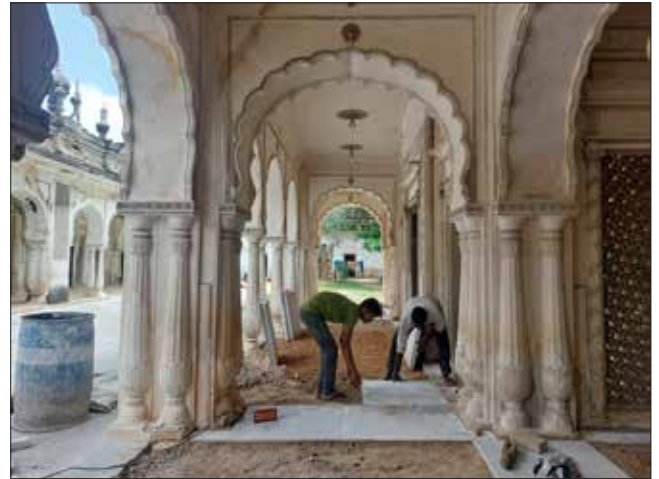
Algae deposits from the plain and decorative surfaces was cleaned

Master craftspeople painstakingly worked for 10 days to rebuild the pillars, matching the original design using traditional material and construction techniques. This was followed by replacing the 20th century cement concrete flooring in the corridors with marble flooring laid in an appropriate slope.

- Ornamental base of pillars and pilasters in the corridors have been damaged due to water seepage and extensive algae deposits and some have been disfigured by incompatible 20th century repairs. These have been carefully cleaned, following which the damaged and missing portion are being meticulously restored matching the original.
- Several pillars were severely damaged, exposing the stone base.
- The intricately carved pilasters flanking the doorways in all corridors sustained significant damage, exposing the stone masonry

underneath. To address this, master craftspeople meticulously undertook the restoration of all 40 pillars and spent a total of 250 workdays.

- Later added 20th century cement concrete flooring has been carefully dismantled and marble stone flooring has been laid in an appropriate slope in lime mortar in four monuments - Tomb of Nawab Abul Khan, Tomb of Ladli Begum, Tomb of Nawab Rashiuddin Khan and Tomb of Latif-un-nisa.

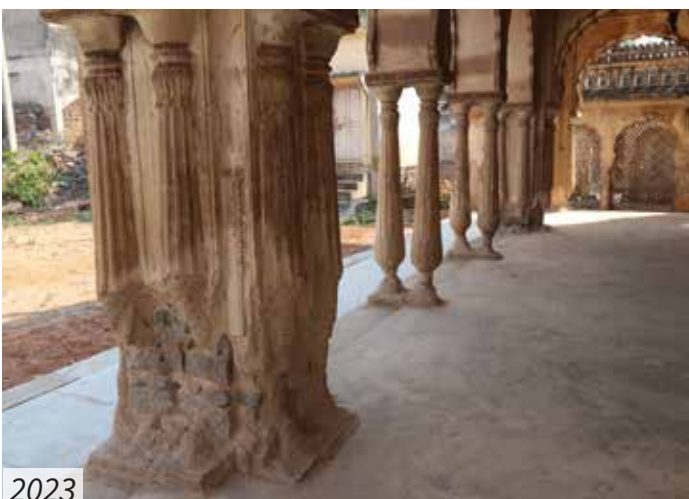
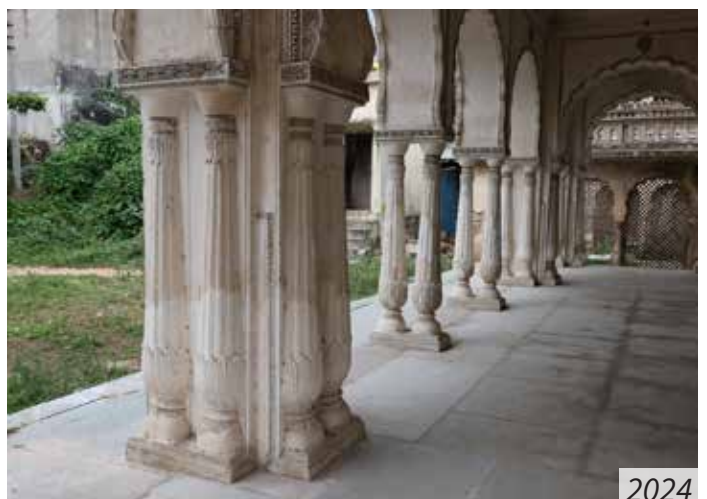
2023

- Corridors of three mausoleums - Tomb of Bashir-ud-Daulah, Tomb of Nawab Fakhruddin and Tomb of Ladli Begum are adorned with nine different designs of floral pendants suspended from the eaves. For restoring the intricate floral pendants, experimentation with 3D modelling and 3D printing are being undertaken, as well as silicone moulds are made for each flower, after manually cleaning and minute repairs.

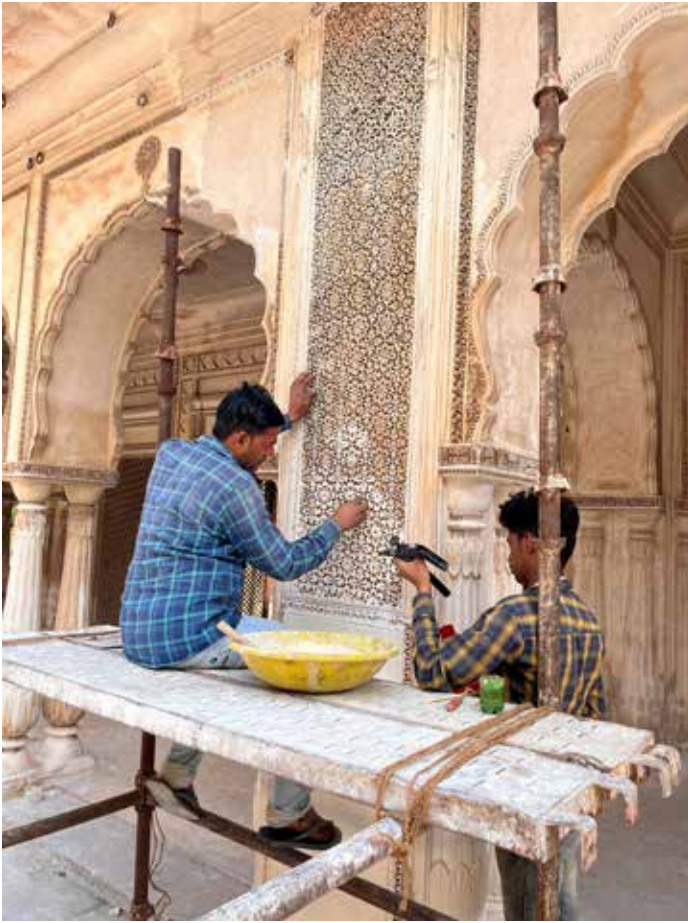
Facades of all the mausoleums are adorned with intricate stucco work - missing portions are being meticulously restored by master craftspeople

The façade beneath the eaves exhibits significant deterioration, including damage to intricate stucco patterns, missing arch crowns, and widespread deterioration of plain plaster. Additionally, each monument consists of four highly ornate circular pilasters, one at each corner, several of them are completely missing. Presently, the works have been completed at Tomb of Nawab Abul Khan, Tomb of Ladli Begum, Tomb of Nawab Rashiuddin Khan and Tomb of Latif-un-nisa.

- Highly skilled craftspeople meticulously restored intricate stucco panels on the facade, with less than 5mm thickness, requiring ten work days to complete one square foot area.
- Arch crowns with varying designs have been carefully restored matching the original design using traditional material and techniques.
- The four ornate circular pilasters in each corner of the mausoleum showcase exceptional craftsmanship and seven of them at the Tomb of Ladli Begum and Tomb of Rashid-ud-din were largely damaged. Master craftspeople painstakingly restored the pillars matching the original design in around 75 days.

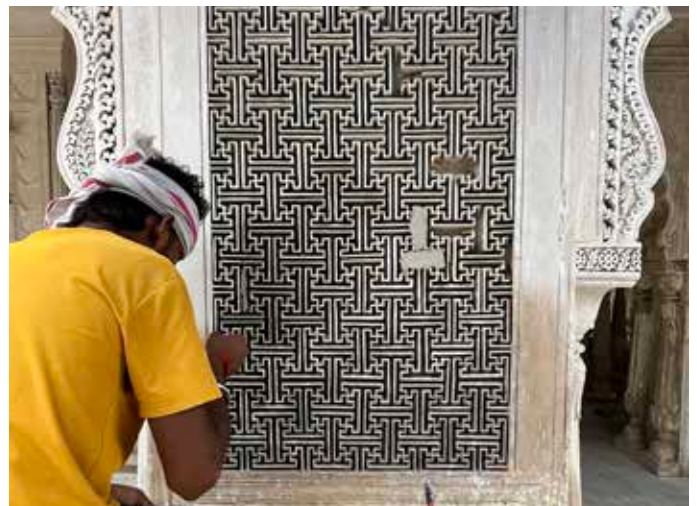
The lime stucco panels on the facades were damaged in several areas and were meticulously restored using hand-ground lime mortar
