QUTB SHAHI
HERITAGE PARK

ANNUAL REPORT 2023-2024

Conservation & Landscape Restoration

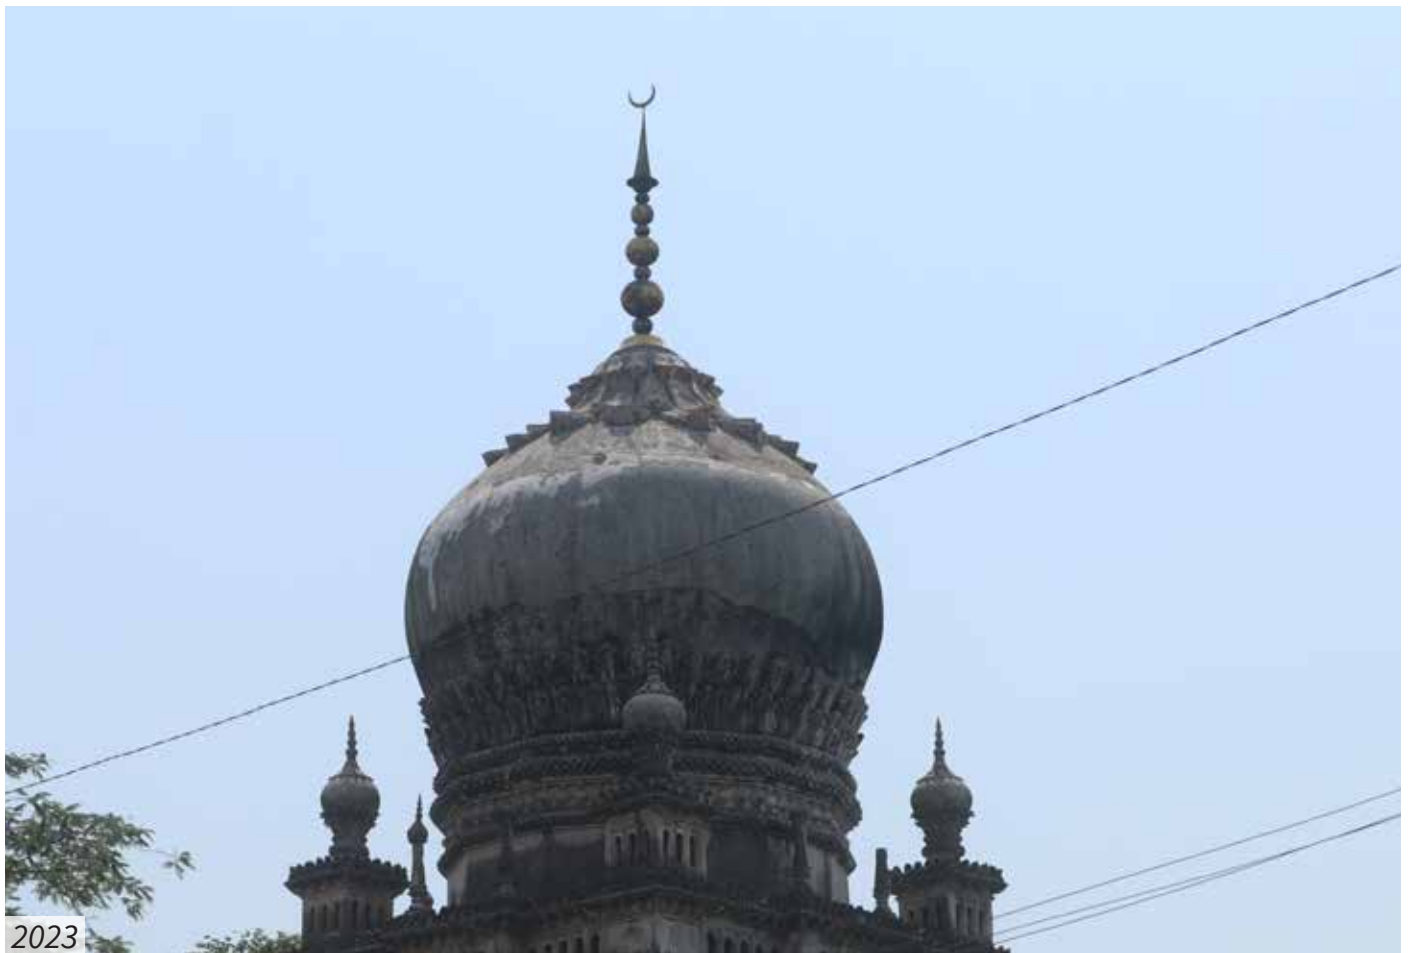
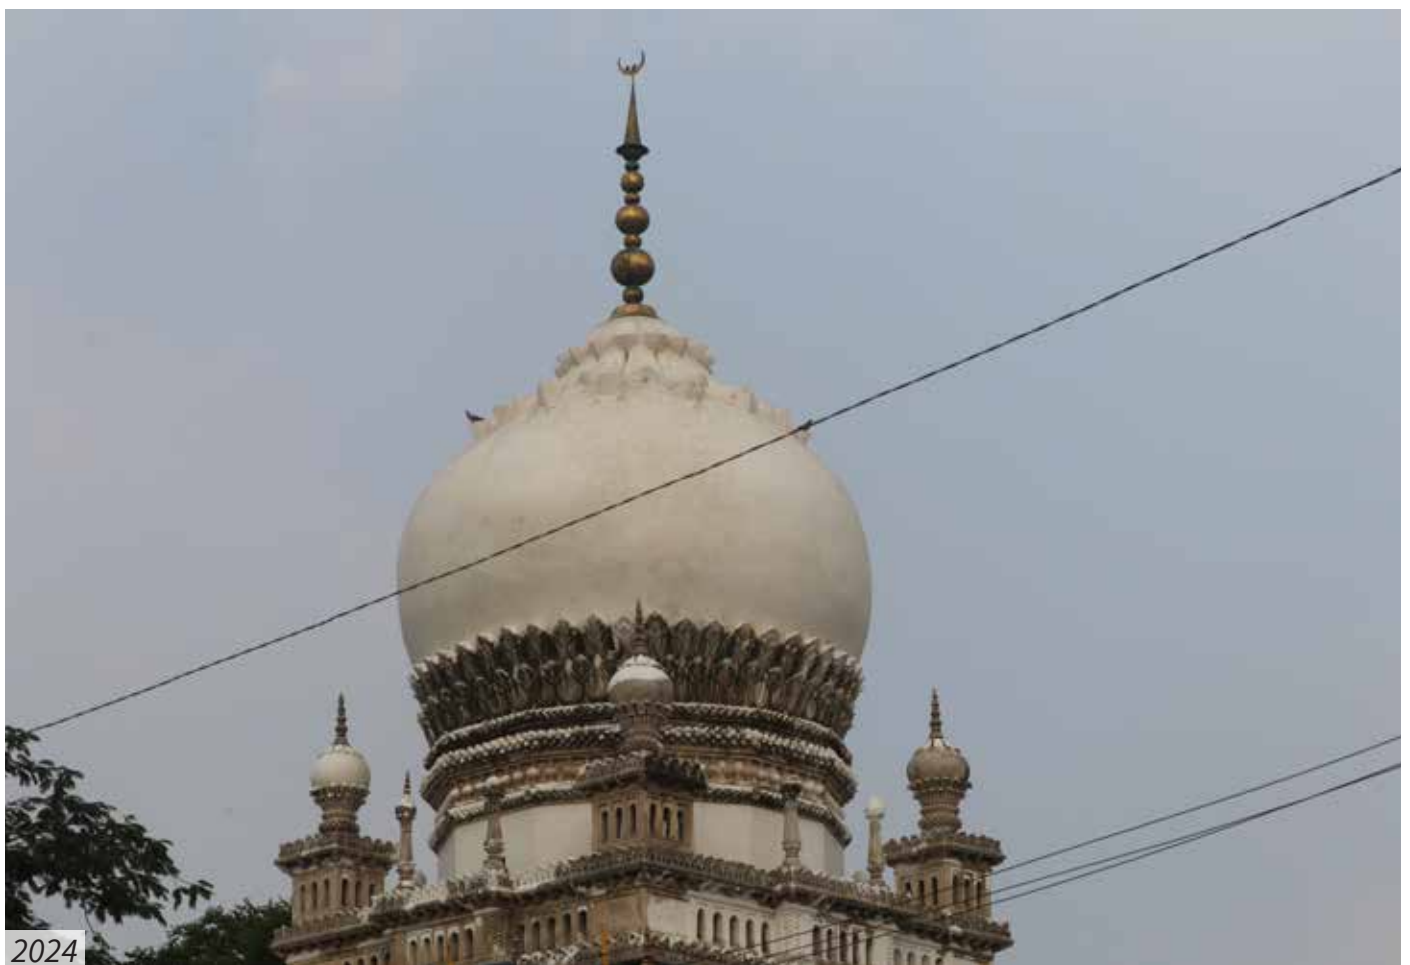
Final lime punning of the dome was completed after surface repairs and replastering

Prior to conservation, a detailed condition assessment revealed a critical situation for the historic dome. A thick layer of modern cement plaster (5 inches) that had been applied over the original surface, trapped moisture, causing internal water damage. Moreover, the cement plaster had distorted the original form of the dome. The decorative elements on the dome including the uppermost petals, double-petaled band, and intricate neck bands, all exhibited erosion. Furthermore, closer inspection exposed prior repairs using cement plaster, necessitating their dismantling for proper restoration.

- The repairs works at the dome started with erecting a scaffolding system up to the height of 90 ft all around the dome.
- At the onset, external limewash layer on the petals was cleaned followed by tracing the original profiles on the three bands. The 48 tri-layered petals were cleared of the 20th century cement plaster and restored to their original shape in lime by master craftspeople.

- A comprehensive restoration effort addressed significant damage to the dome. The inappropriate modern cement layer, up to 5 inches thick, was meticulously removed by hand, revealing the original lime plaster beneath.

- The dome's restoration extended beyond its surface. Following a meticulous cleaning, the 96 ornamental petals below the dome were repaired and coated with a thin layer of lime punning. This process involved recreating damaged profiles using traditional techniques and materials. Similarly, the surrounding decorative bands—including the rope band, diamond band, and the distinctive pot-shaped band—were conserved in detail. Craftspeople also reinstated the missing floral medallions (150 mm in diameter) along the rope bands.
- The twelve-sided drum of the dome, with each side measuring approximately 1.35 by 1.4 meters, had also been covered with an inappropriate modern cement layer. This was carefully removed and replaced with a traditional lime mortar base and punning. This ensured consistency in both structural integrity and historical authenticity throughout the entire monument.

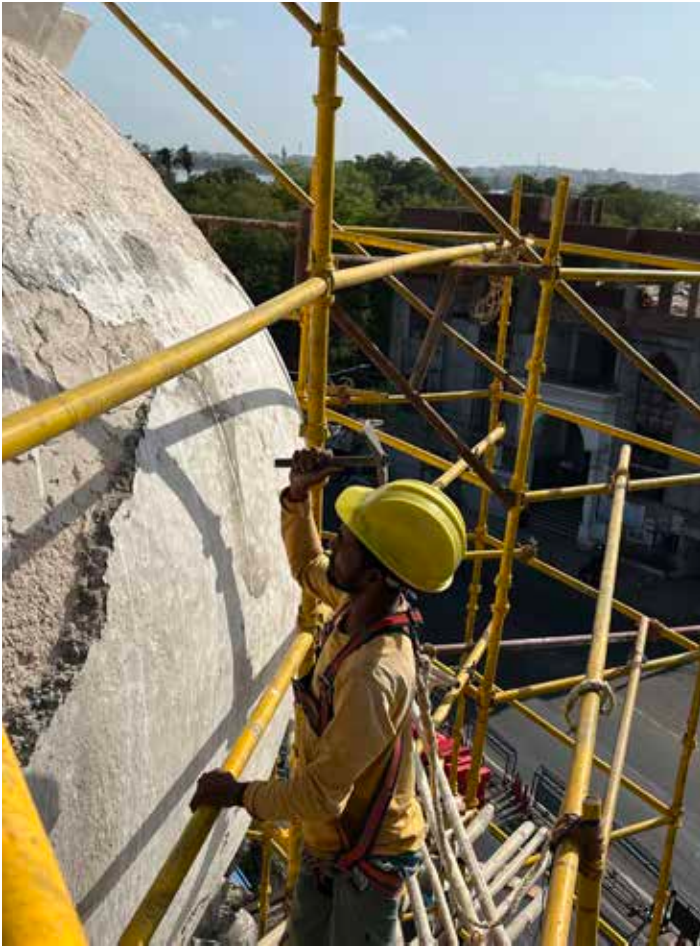
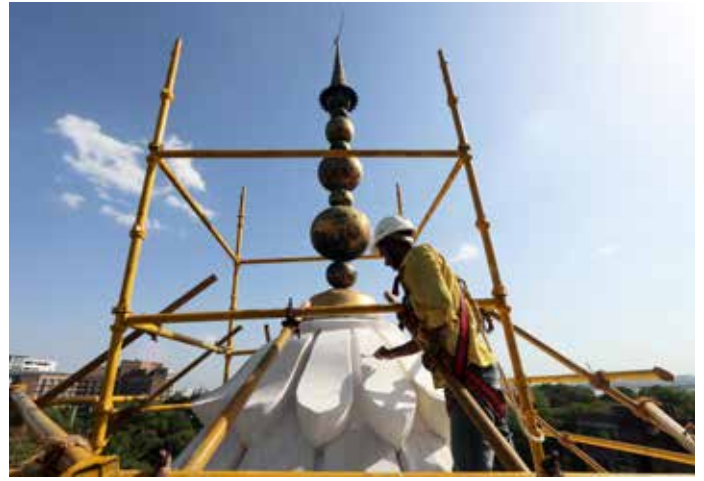
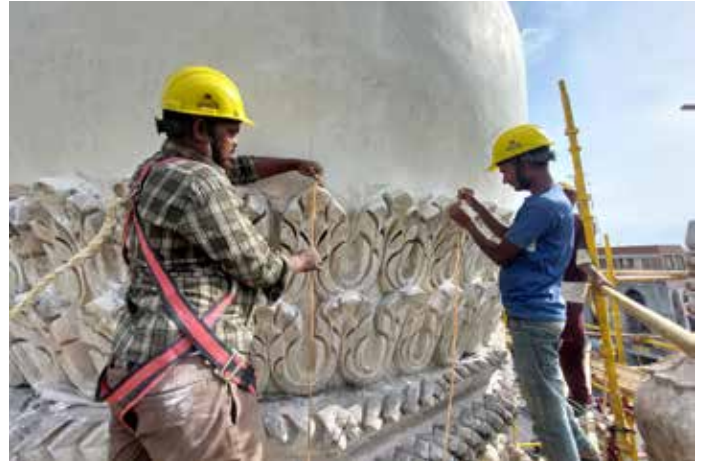
(Clockwise from left) A 5-inch thick layer of cement plaster had been applied to the dome during previous repairs, which led to water seepage. This cement layer was manually removed to expose the original surface; The decorative finial base, was restored using rich lime mortar; Ornamental lime stucco petals at the neck of the dome were restored with high precision by the lime craftspeople

- A team of twelve craftspeople then applied a base coat of lime mortar to even the surface and retain original profile, followed by multiple layers of traditional lime punning for a smooth and restored finish. This painstaking process not only addressed structural concerns but also ensured the dome's historical integrity was preserved.

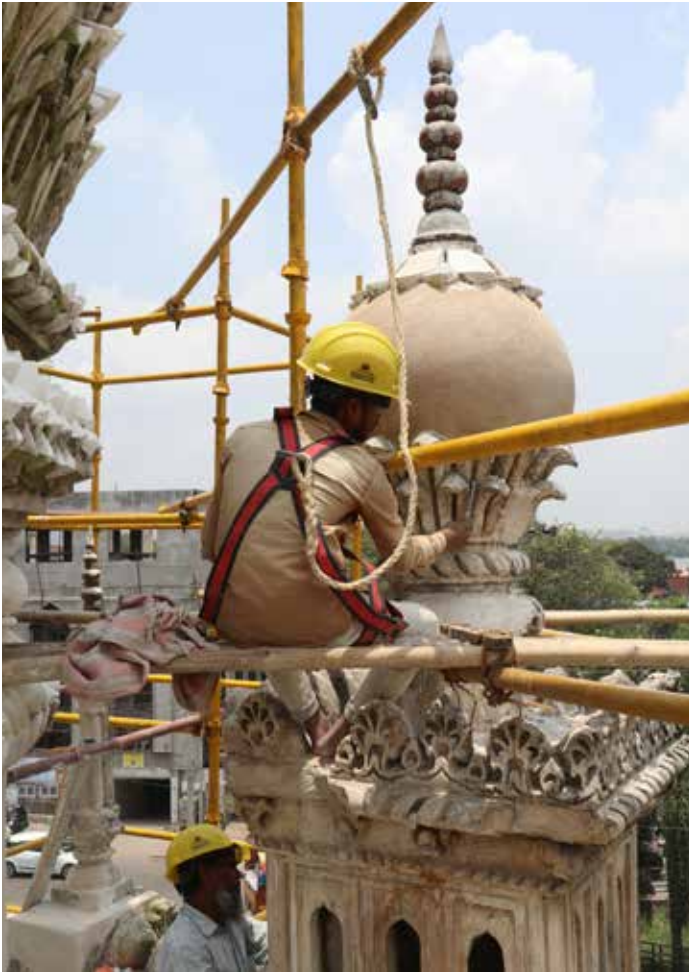
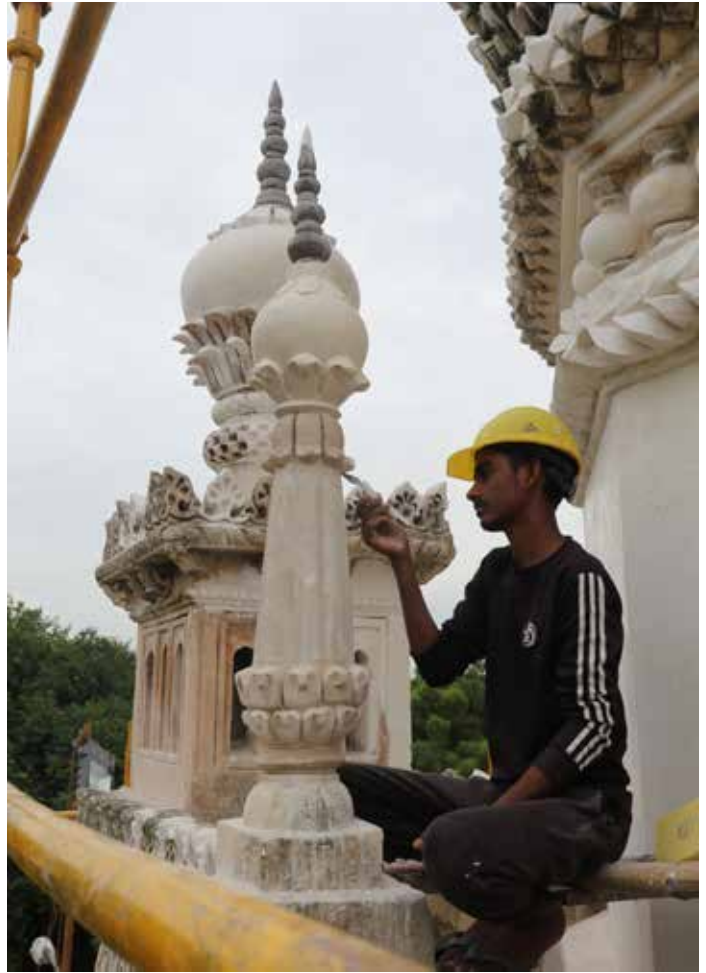
The dilapidated minarets were restored by repairing broken elements and recreating missing details

It was observed that the parapet wall had algae deposition on the surface. The motifs were also damaged and missing at various instances. The corner and parapet minarets also showed signs of dilapidation in the form of vertical cracks and missing petals at the capital and base. The bulbs on the corner minaret required a fresh layer of lime punning as the original withered over time.

- The repair works started with cleaning of the lime surfaces using wire brush to get rid of the algae and other unwanted finishes. Two teams of 3 craftspeople each repaired the minarets and the lime motifs, respectively. The bulb of the northwest corner minaret had to be replastered due to multiple cracks and missing leaf motifs at its base. The laborious task of removing snow-cem finish from the granite brackets was also completed manually.

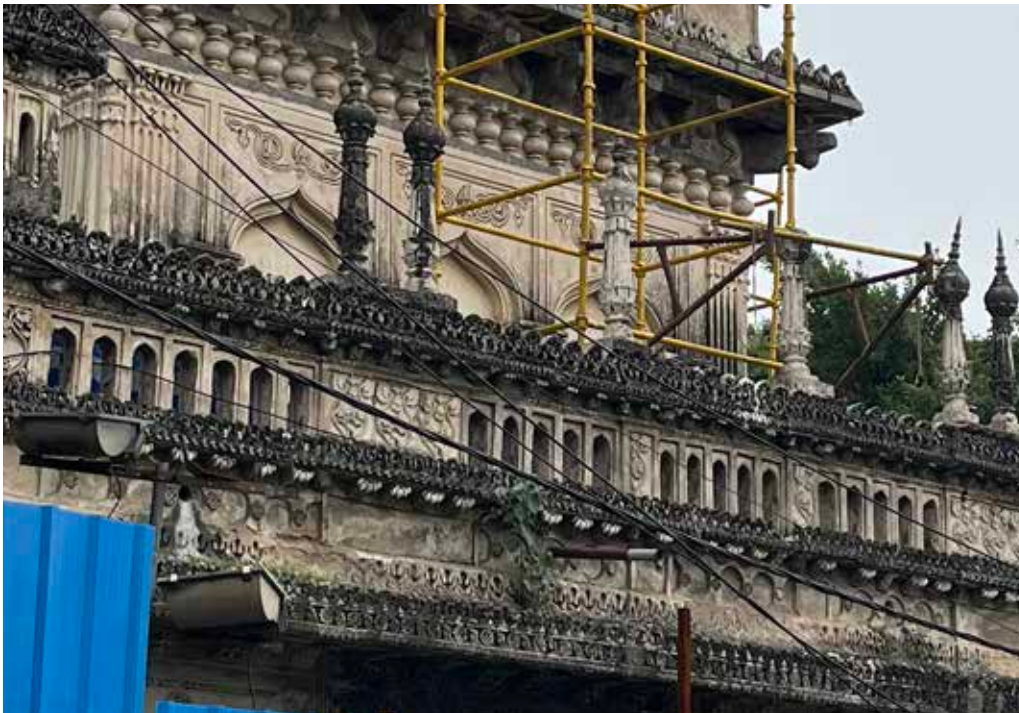
During previous repairs, the original decorative lime stucco panels were replaced with pre-cast cement motifs

- However, successive repairs in the 20th century resulted in the original panels in lime replaced by pre cast design motifs in cement which were replicated according to the size of the panel. These cement motifs were removed from the parapet to look for any in-situ evidence or remains of the original design panels. The remains of the original designs in lime were completely lost and had to be retraced by conservation architects from the sole surviving evidence of the 1880s' archival image. These original designs found their home back on the monument and significantly contributed to restoring its integrity. Eight master craftspeople worked meticulously in chiselling out the same curves and motifs and finished all 24 panels with a rich layer of lime punning..

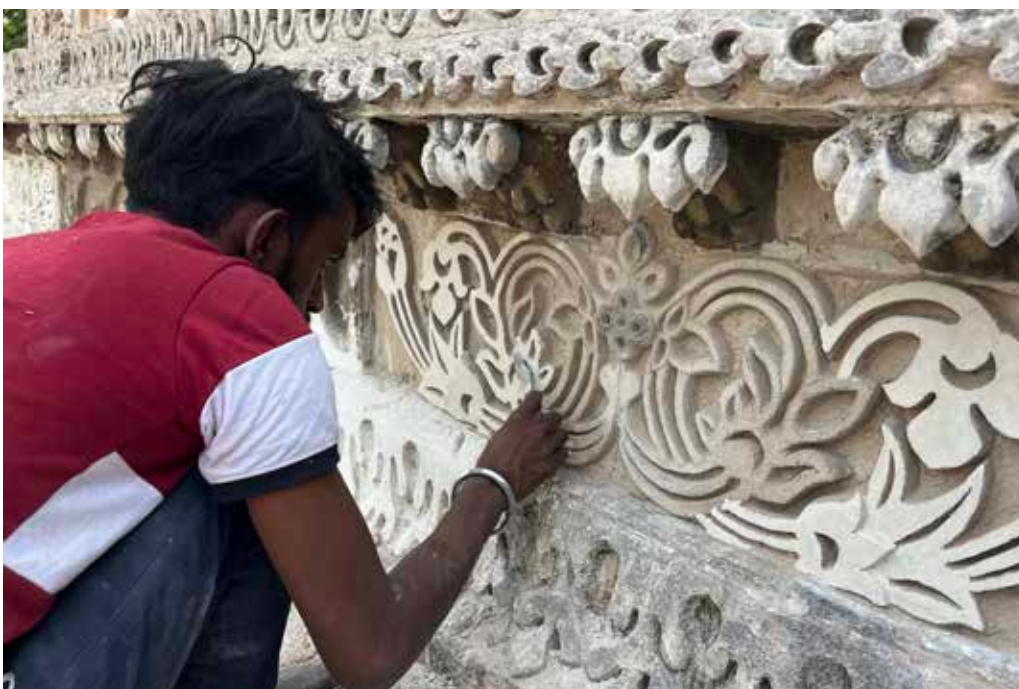
Taking cues from the archival image, master craftspeople skillfully recreated the parapet's original design using traditional materials, replacing the pre-cast cement panels

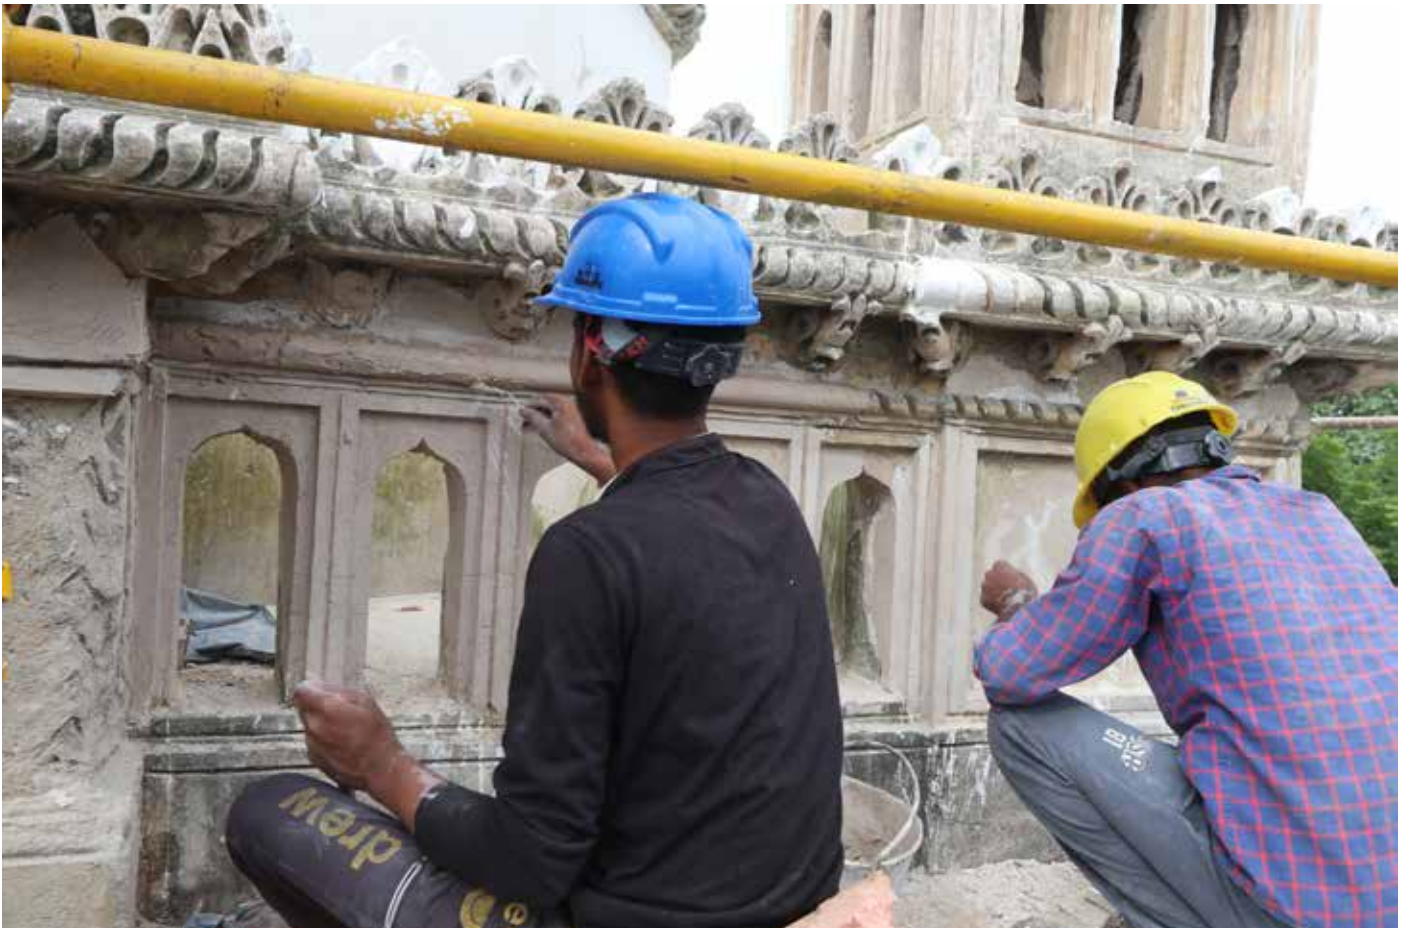
Broken portions of the parapet were repaired and restored using lime mortar

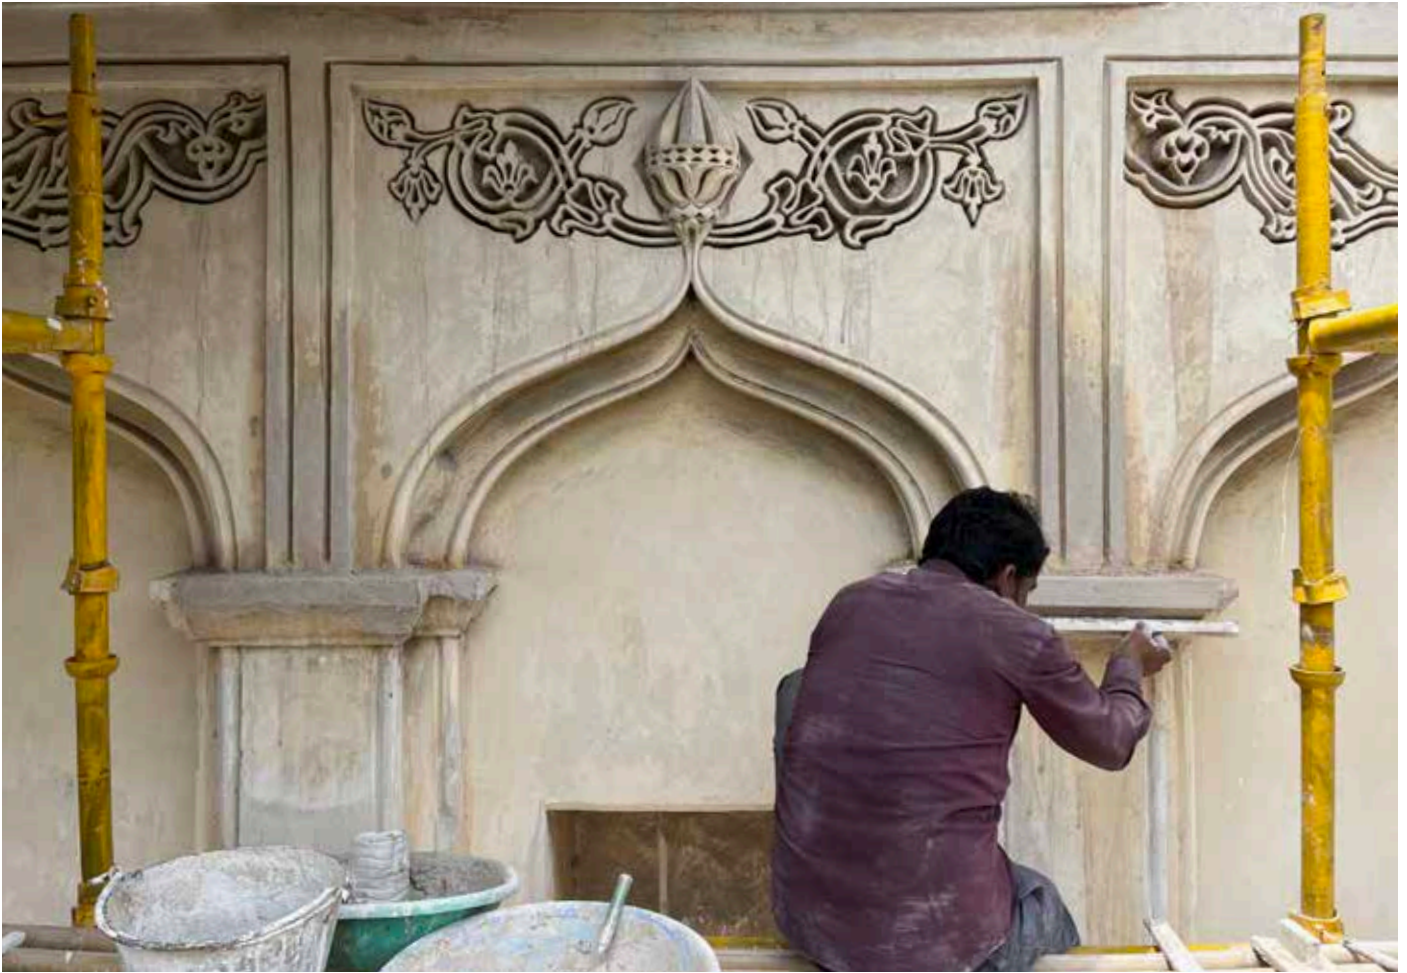
Damaged capital bands repaired using traditional lime plaster at the middle level facade

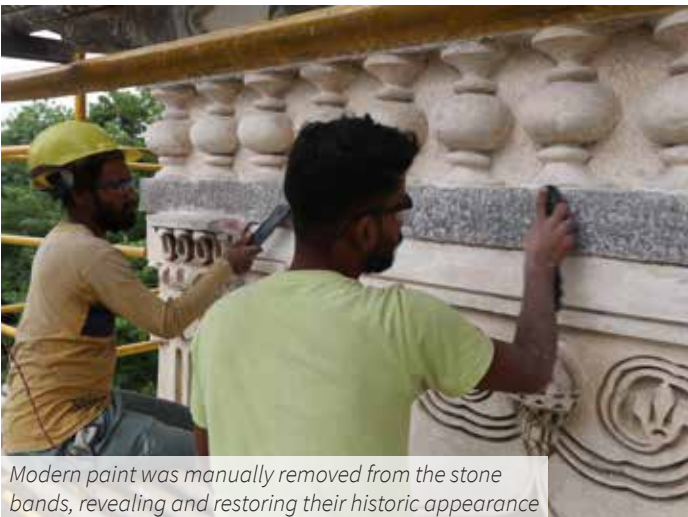
Modern paint was manually removed from the stone bands, revealing and restoring their historic appearance

- The recessed arches had no major defects, except for the algae deposition on surface due to rain exposure, and the lime plaster at the corner flutes had come loose from the wall surface which needed repairs. The stone bands, like the brackets, were also painted with modern paint, hiding the rich texture of hand dressed granite.
- Lime craftspeople worked on the dilapidated corner details based on the existing on-site evidence. The repaired flutes were matched to the original in lime and later coated with lime punning. The manual removal of modern paint from the stone surfaces enhanced the appearance of the arched façade and, in turn, restored the monument closer to what was envisaged by the original builders.

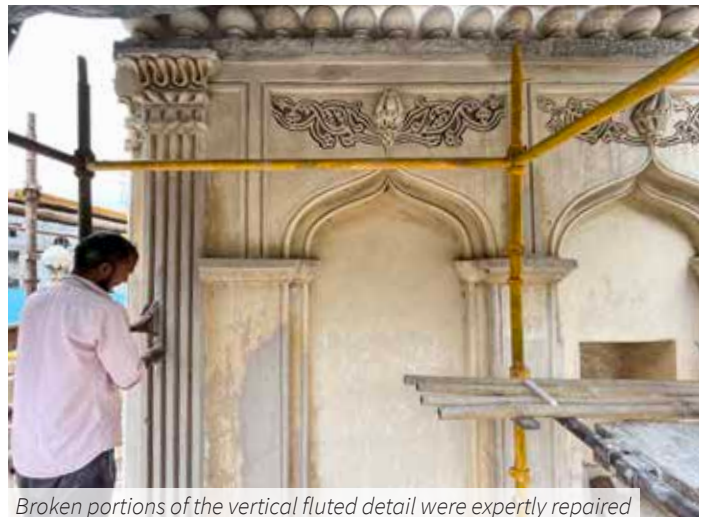
Broken portions of the vertical fluted detail were expertly repaired

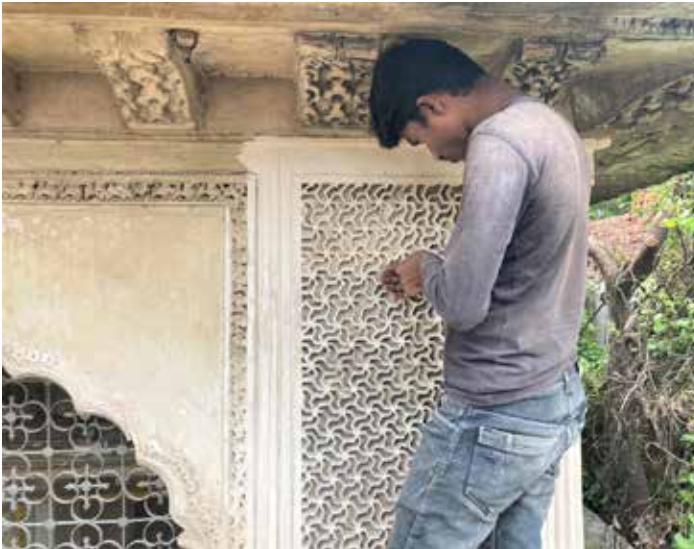
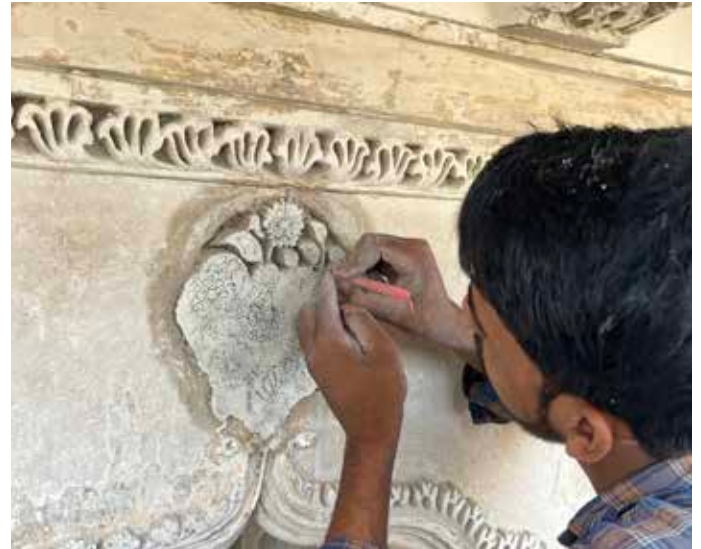
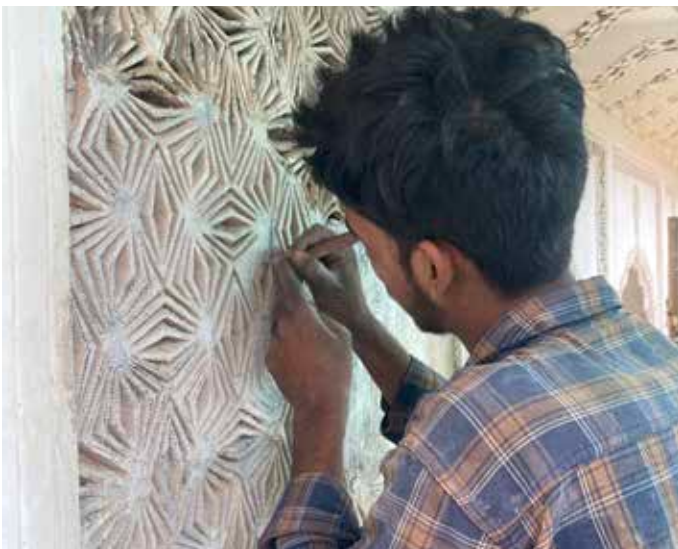
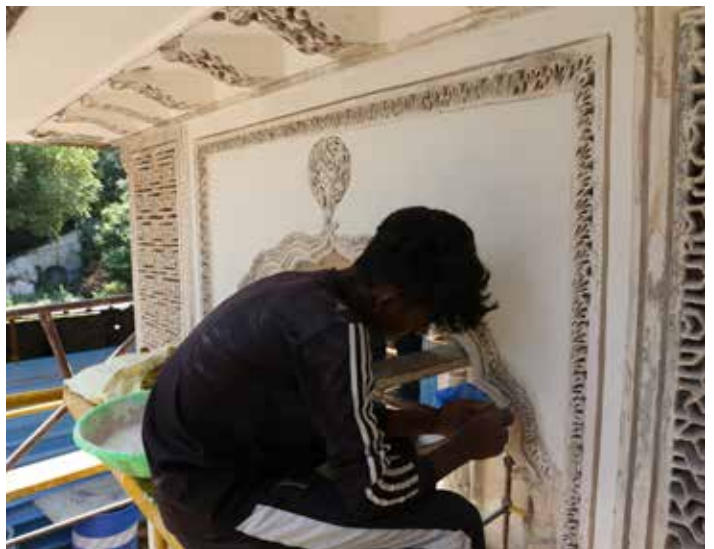
The façade had been coated in multiple modern paint layers in earlier repairs, which concealed the intricate details of arch crowns and arch borders. Algae had formed and dried in the dense geometric pattern of the external panels compromising their strength and design in several instances. Continuous water dripping from the overhang chhajja also defaced the lime brackets. The columns also suffered from missing and broken leaf details at the capital and base.

The missing and damaged portions of the decorative stucco details on the facade were restored by master craftspeople using traditional materials, tools, and techniques

- The primary task was to remove all the modern paint layers so that repair works of the broken or missing details could be estimated. A team of eight highly skilled artisans carefully removed the paint which had penetrated the depressions and curves of intricate details, working on two facades at a time. The dense arrangement of design on the geometric panel was cleaned using specific narrow tools which could reach the depth of 30 mm, effectively removing all the algae deposits.

- The cleaning revealed the damaged portions which needed repairs, such as the panel on the west façade. An area of about 10 sq ft had to be repaired due to completely missing and damaged details. Architects traced the original pattern and aligned it precisely with the missing area.

- The master craftsman then began the repair work, starting with a base plaster layer, followed by a coat of fine plaster. The original pattern was traced onto this surface and the intricate details were carefully carved out.

- Meanwhile, another team of lime craftspeople repaired the arch crowns, arch borders, pendant details, and restored the leaf motifs at base and capital of pillars wherever they were missing.

- The arch borders on the southern facade had come loose on all five arches and had to be restored from scratch, which took approximately 100 manhours to complete.

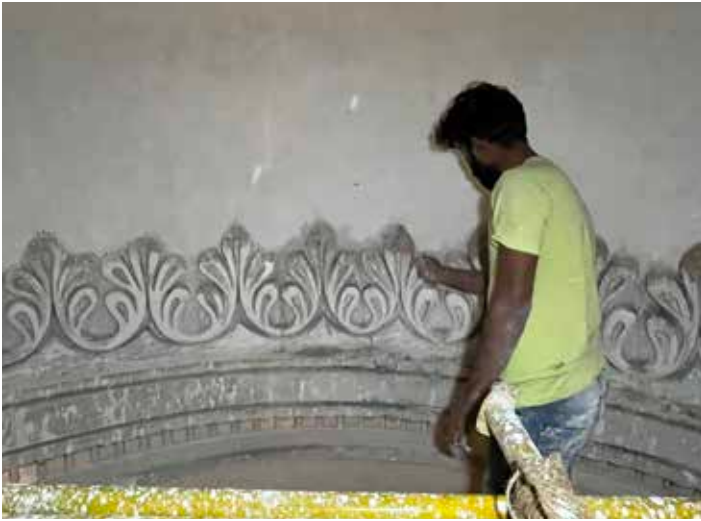
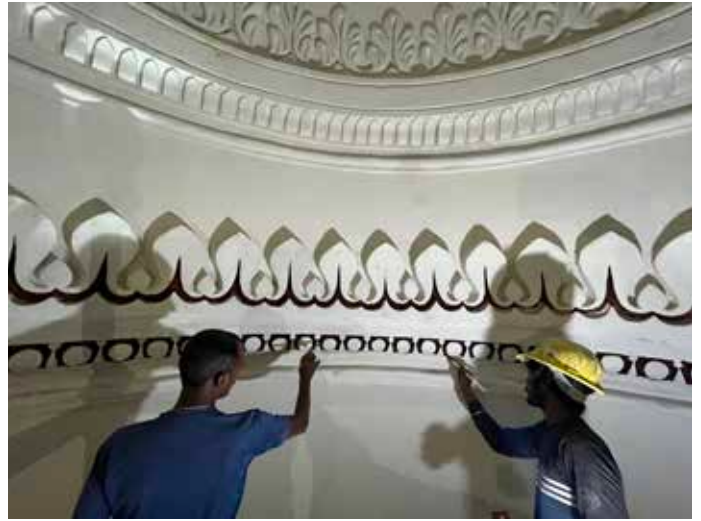
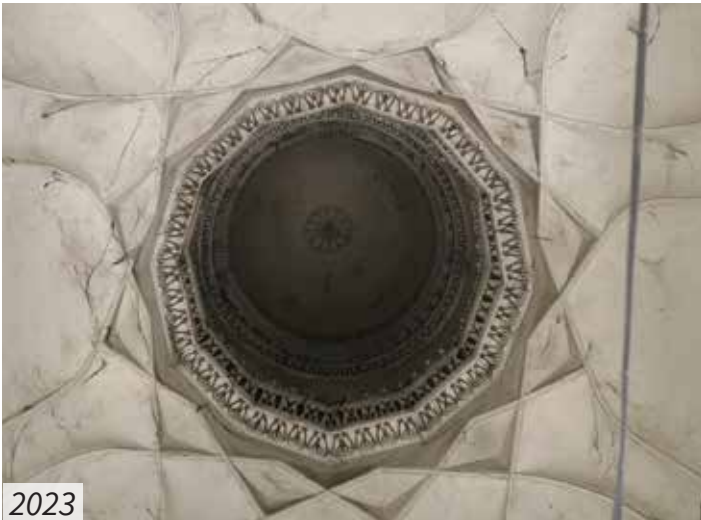
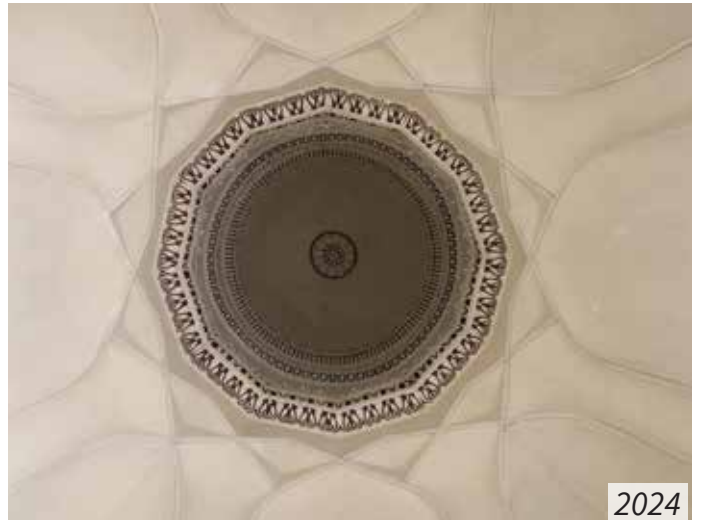
Damaged decorative motifs at the internal dome were restored. Organic red ochre was reapplied to the ornate bands based on in-situ evidence

Like other surfaces on the monument the hemispheric ceiling and design bands were also coated in modern paint layers. The motifs showed broken edges due to birds nesting in them after which iron grills had been installed below at the arches. The organic red ochre was also hidden below the modern paint in various bands.

- A scaffolding system was erected to reach the height of 16 meters. Since the dome is placed above an underground sanctum, its roof was first supported with wooden struts to strengthen and bear the load of the scaffolding above.
- Once the scaffolding was in place, artisans manually removed the modern paint layer from the internal surface of the dome. Cleaning the ceiling and medallion revealed water stains on the surface. Upon further inspection, it became clear that the water stains were dry and no water had seeped in after the plastering from the dome from outside.
- The medallion was restored and finished with rich lime punning, along with the ceiling. The series of ornate bands were also meticulously repaired by artisans and craftspeople and finally coated with organic red ochre in the grooves based on the in-situ evidence.

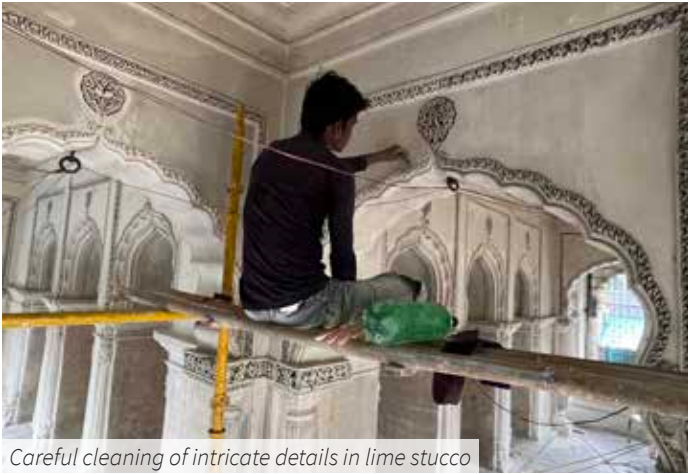
Careful cleaning of intricate details in lime stucco

- The internal chamber had a thick layer of modern paint over the original lime base, and damaged details on the decorative bands. This modern layer was carefully scraped off, revealing the original lime surface below.
- Lime repairs were carried out on the medallions and decorative bands by a team of four master craftspeople
- The lower details of the archways, which were damaged due to regular use, were also repaired in lime with detailed craftsmanship. Following this, all the repairs at the chamber were coated with a fine layer of lime punning.
- The raised platform of the internal chamber was subsequently paved with 16 mm granite to ensure no further damage to the lime flooring beneath.

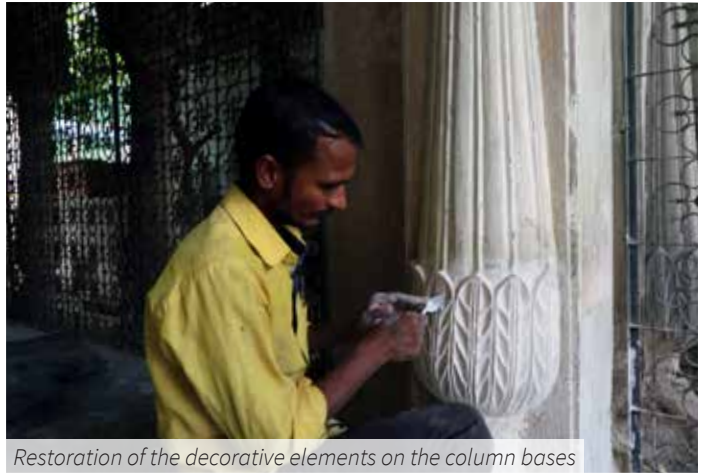
Restoration of the decorative elements on the column bases

- All the pillar bases in the internal area had to be dismantled to replace the cement repairs with lime-based restoration. The craftspeople first applied a base plaster and chiselled it into the original profile, and later a fine plaster was applied to carve out the details and grooves. All the repairs were finished with 1 mm layer of rich lime punning.

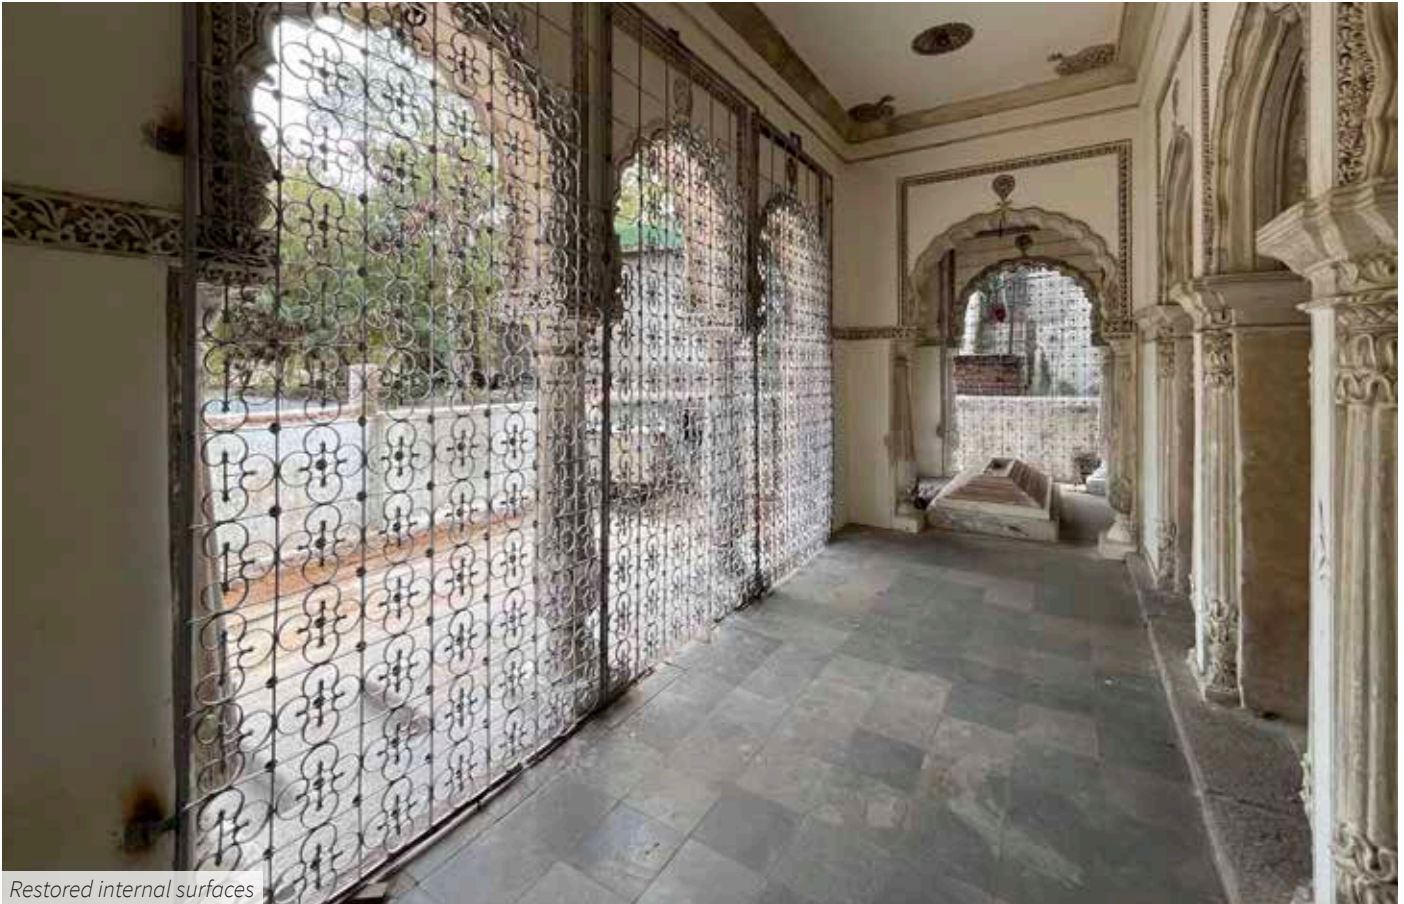
Restored internal surfaces

- A rich layer of lime base was applied to damaged portions by craftspeople, followed by a fine layer of punning on the ceiling and plain vertical surfaces.

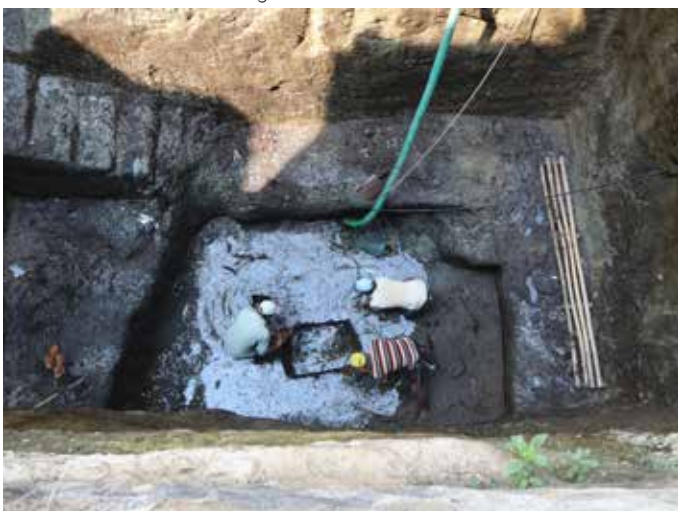
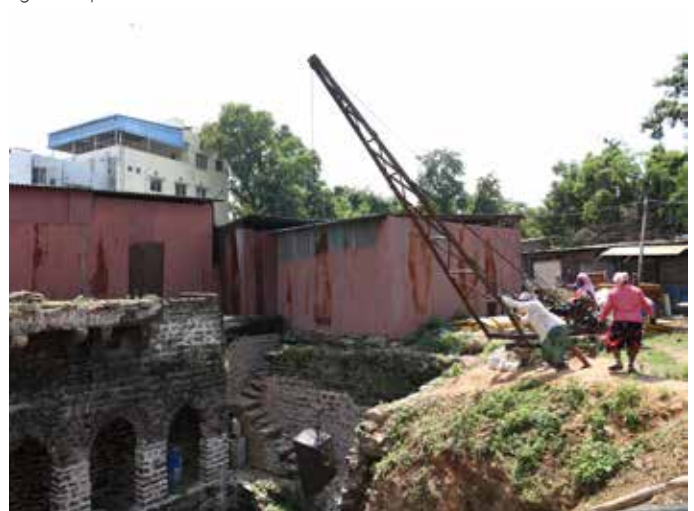
The baoli had remained neglected for several years, leading to the accumulation of unwanted vegetation and garbage, turning it into a dumping ground. A major desilting and cleaning effort was undertaken to restore its original form and reveal its architectural features.

About 17 truckloads of sludge was removed from the Baoli before commencing the repair works

- Water was mechanically pumped out continuously over a period of four days, and then a specialized team manually cleared the remaining sludge, requiring 100 man days of effort to remove 17 truckloads of sludge and debris from the baoli.
- The desilting process revealed an arrangement of tanks made through carving out the sheet rock, highlighting the original water management system.
- Access steps on either side of the ramp were cleaned, along with the stone retaining walls, helping determine original extent of the stepwell.
- The ramp was cleared of vegetation, exposing the original water channels and water trough.

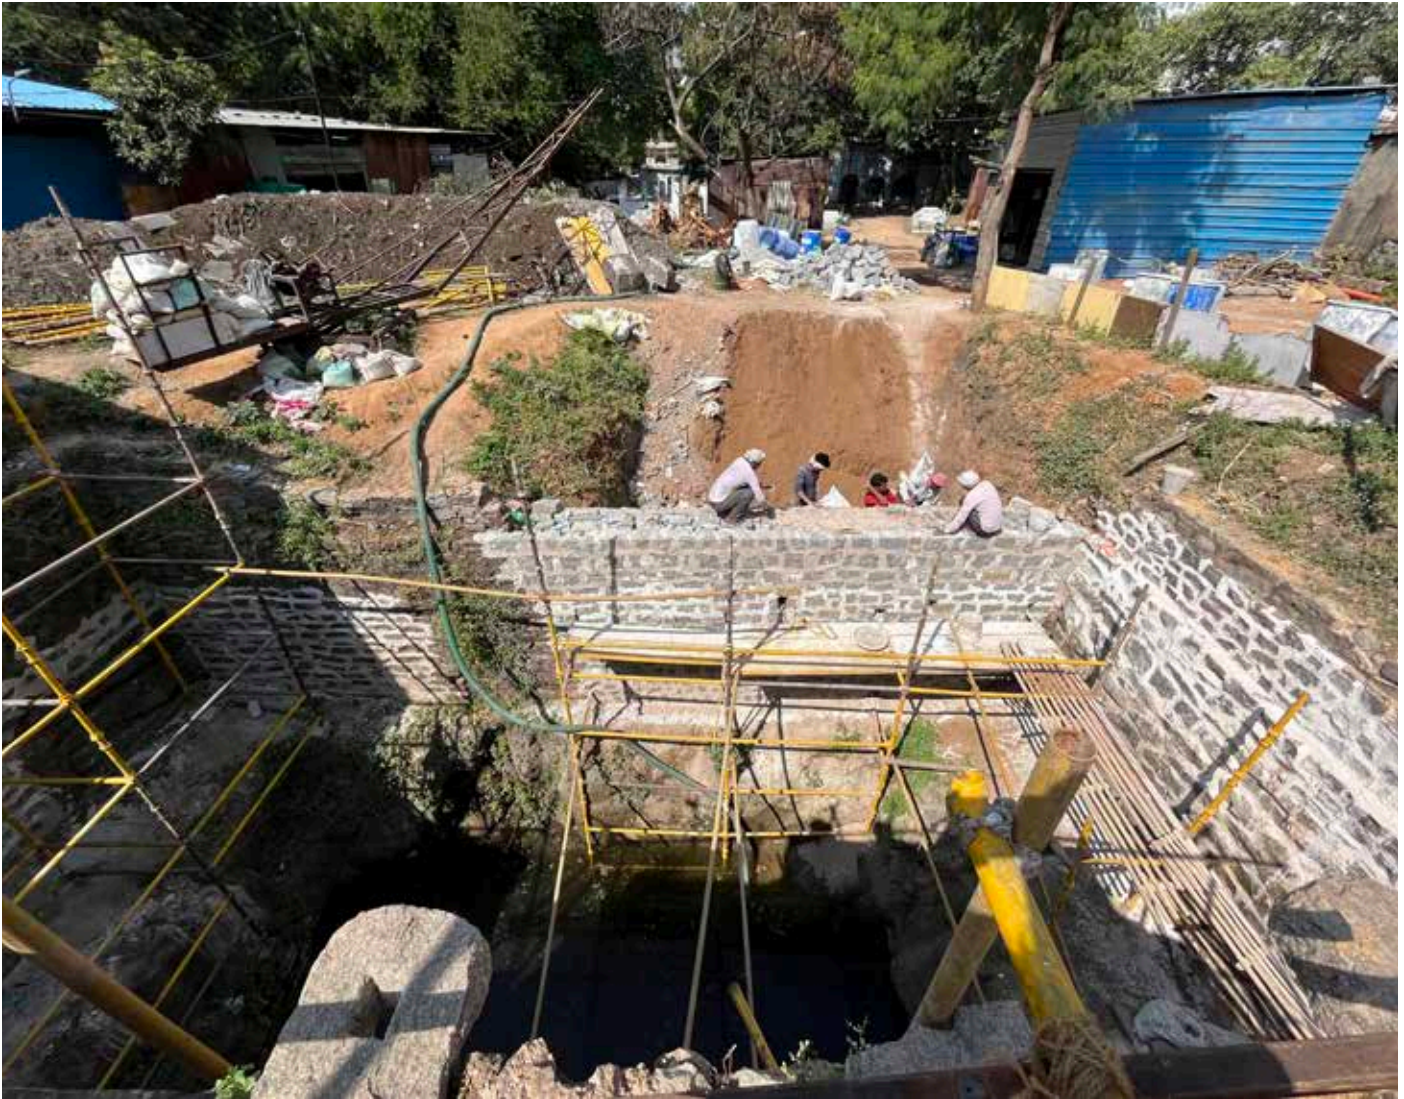
The collapsed western wall of the baoli was rebuilt to match the original offsets, and weepholes at intermediate levels were provided to facilitate drainage

Over the years, the structure had suffered significant deterioration—most notably, a patch of about 8.9 m of the western wall near the northwest corner had collapsed. The top masonry courses of the shorter length walls were also missing, along with vegetational growth at various instances. The steps on the north were also obstructed by debris.

- The walls were surrounded by 2 – 3 meters of vegetational growth, which was manually cleared to commence the repair works.
- A horizontal trench, 1.2 m wide and 750 mm deep, was then dug at the collapsed portion to lay a stable foundation. The western wall was rebuilt following the same offsets of the original wall, and provided with weep holes at intermediate levels to allow proper drainage.

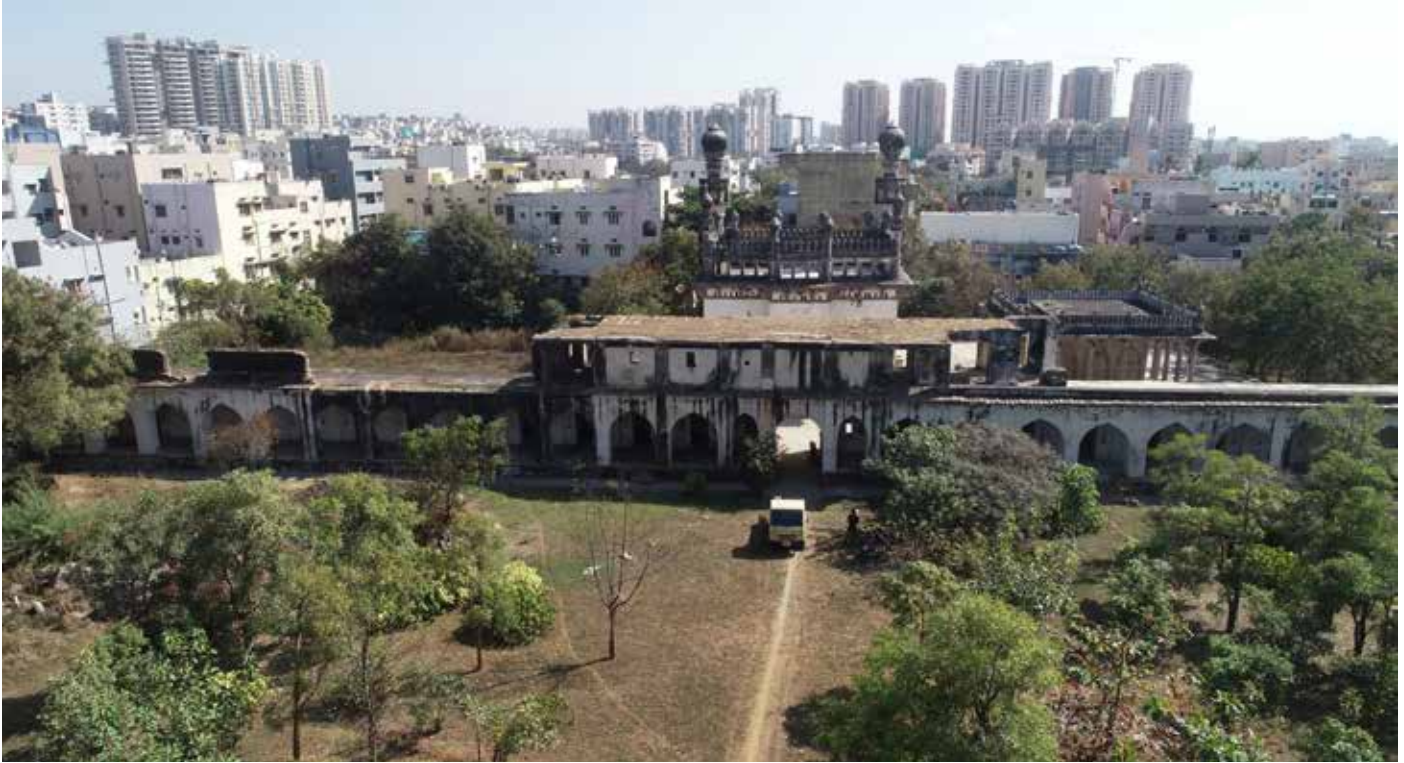
Shaikpet Sarai complex: before conservation

- The Shaikpet Sarai complex, though architecturally significant, has undergone substantial changes over time, particularly due to repairs carried out in the 20th century using incompatible modern materials. These interventions have not only altered the structure's historic character but also accelerated its physical deterioration.

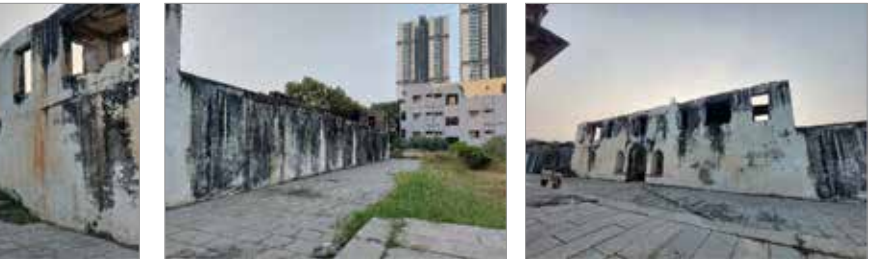
- Black Crust, flaking of platelayer , deteriorated plaster layer, water seepage

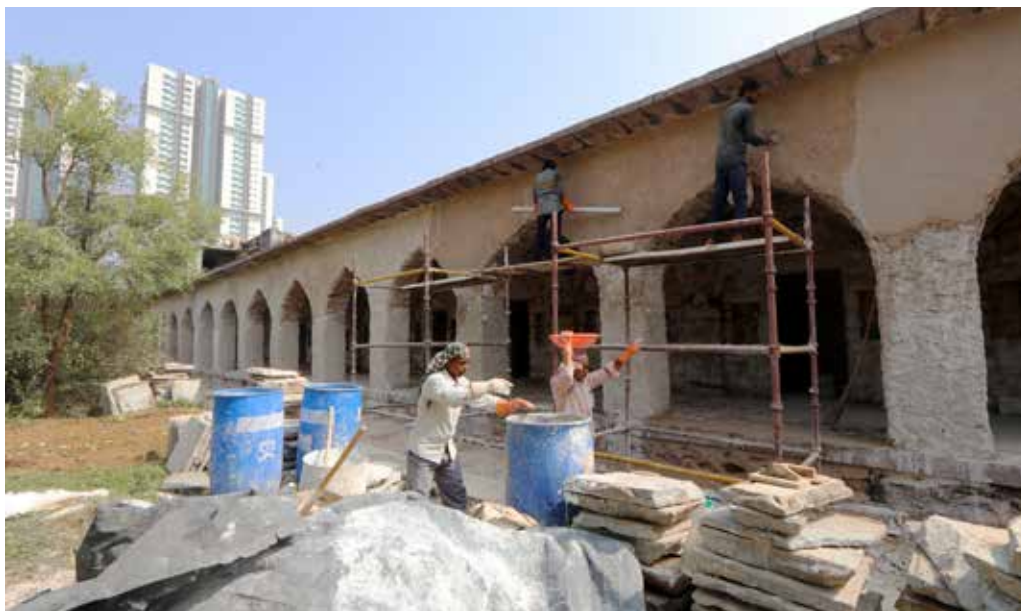
Replastering the arches of the facade with traditional lime plaster after removing the 20th century cement plaster
