QUTB SHAHI
HERITAGE PARK

ANNUAL REPORT 2023-2024

Conservation & Landscape Restoration

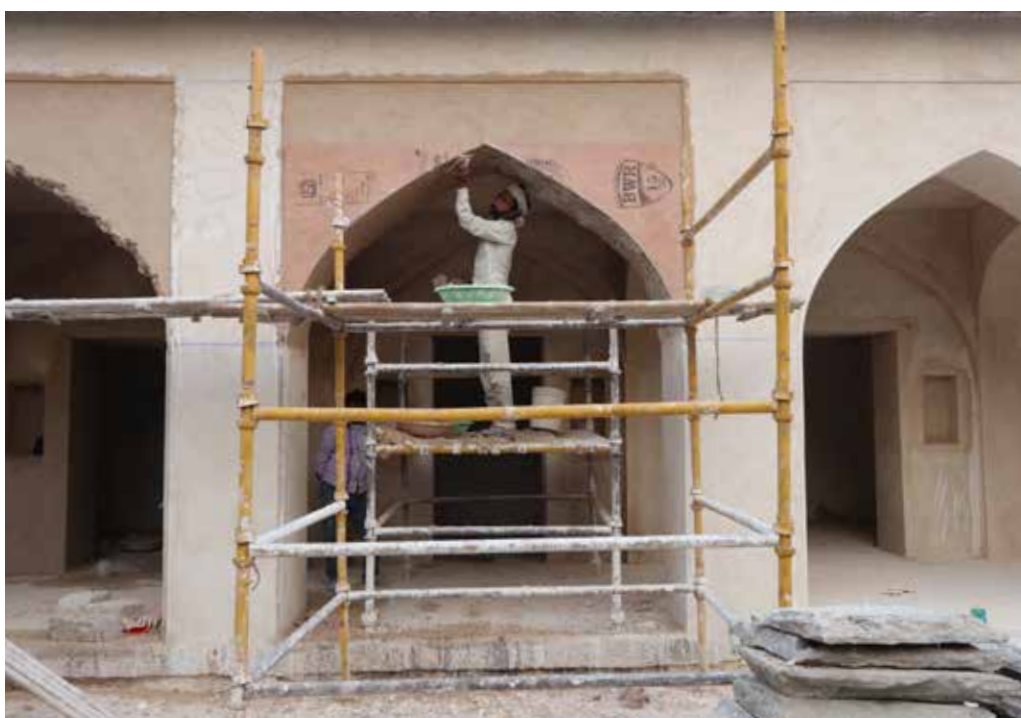
Reinstating the arched facade of the Sarai to ensure uniformity in level, size, and shape

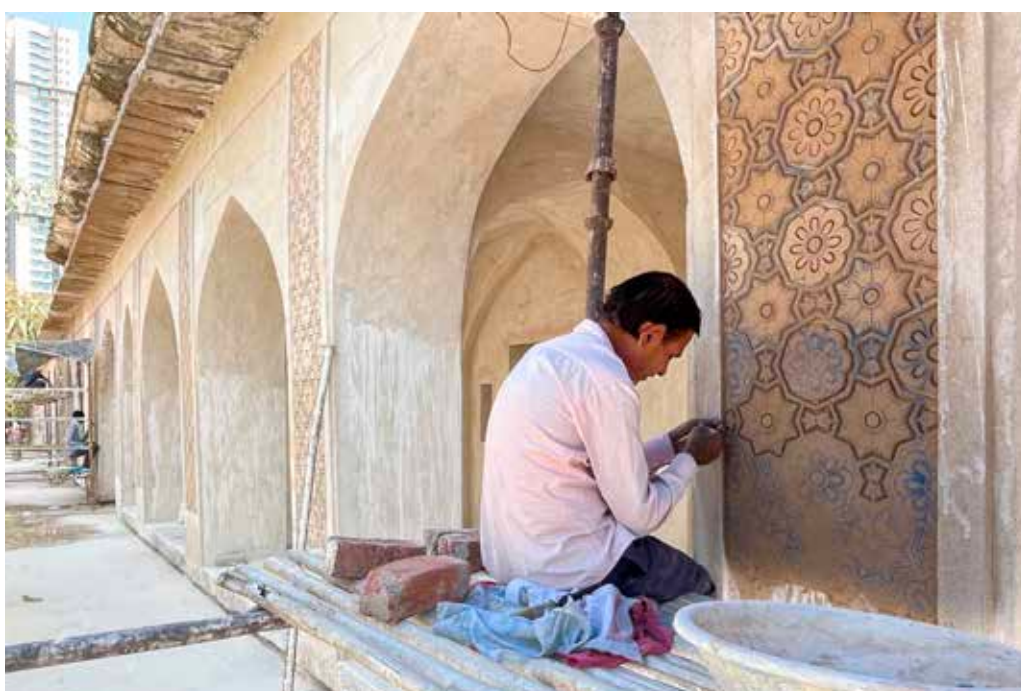
Taking cue from the existing ornamentation on site, missing lime stucco work was restored by skilled craftspeople

- Plain plaster surfaces and arch mouldings were finely finished with 1mm thin layer of lime putty mixed with organic additives.
- Restoration of ornamental panels, featuring three distinct designs, was undertaken by skilled masons and craftspeople. Missing ornamental panels on the ground floor were reinstated based on surviving evidence of the first floor, particularly focusing on the 10 central bays and 2 bays at the either end.

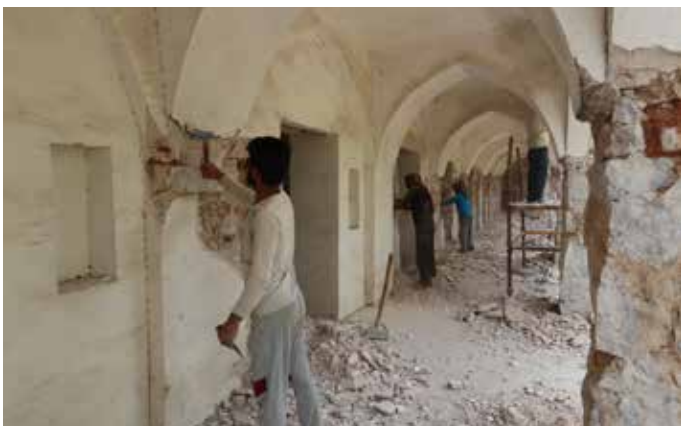
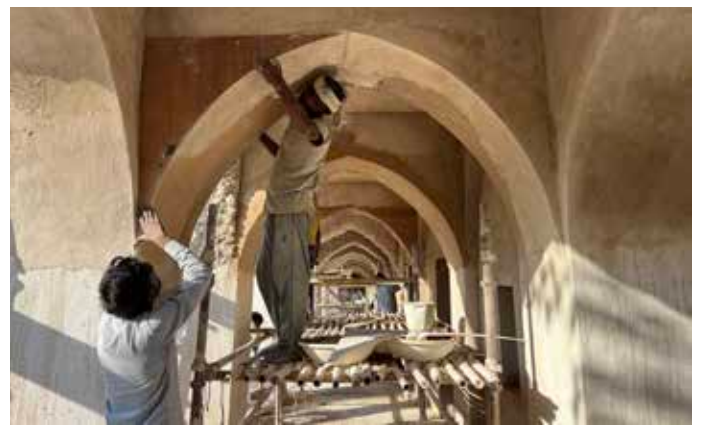
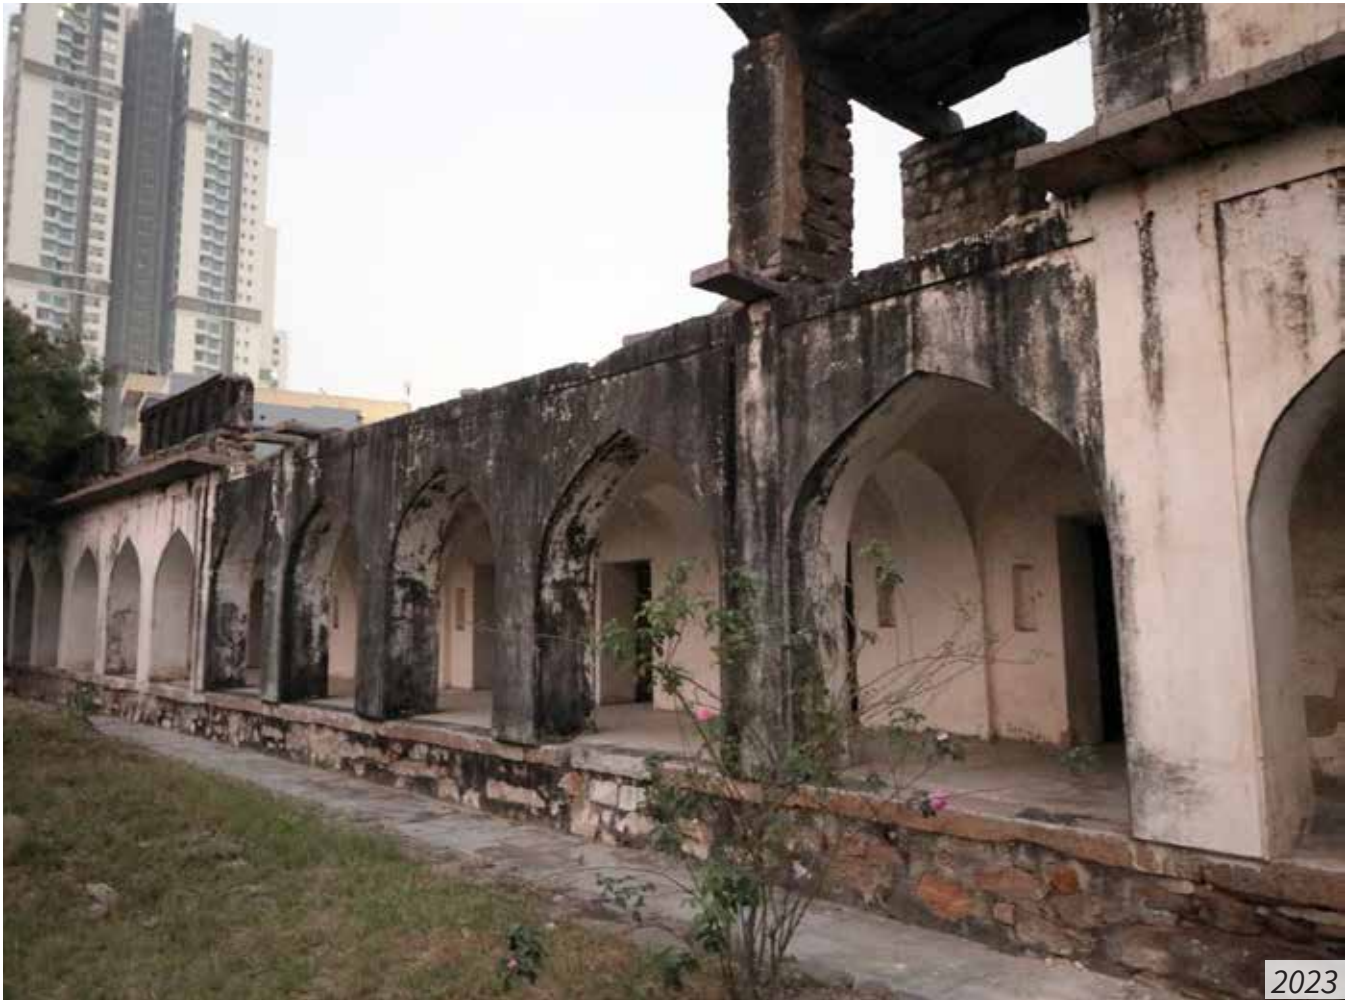
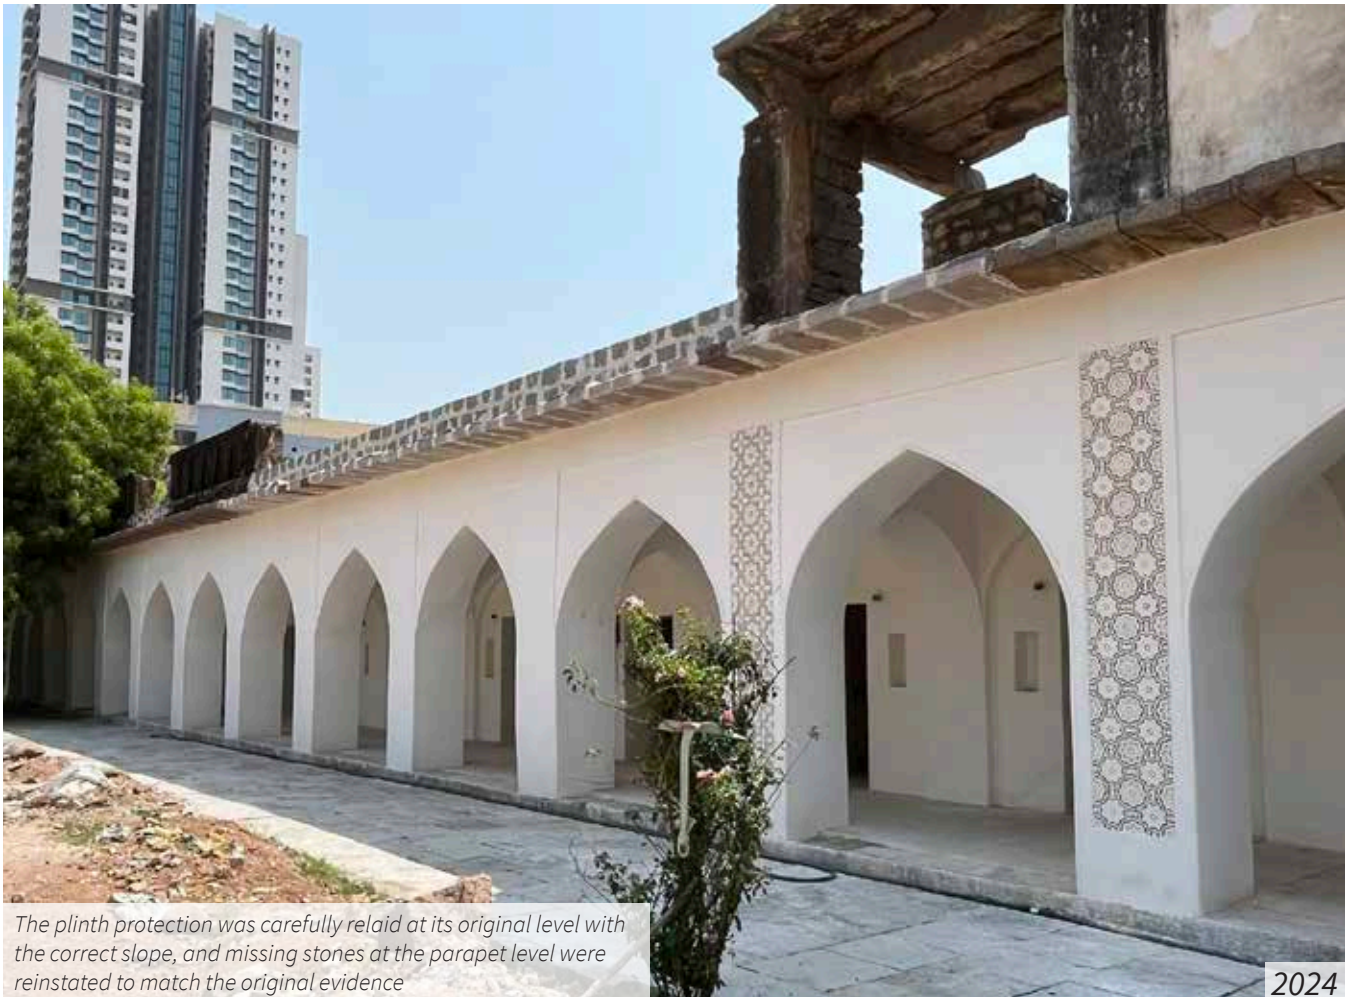
20th century cement layer was removed from the arcade, and the corridor surfaces were repaired by correcting the arch profiles and ensuring uniformity in level, size and profile

- Ornamental details across the surfaces were carefully finished with a 1 mm thin layer of lime putty mixed with organic additives. Metal angles were strategically installed at the door opening level to securely fix the wooden doors in place.

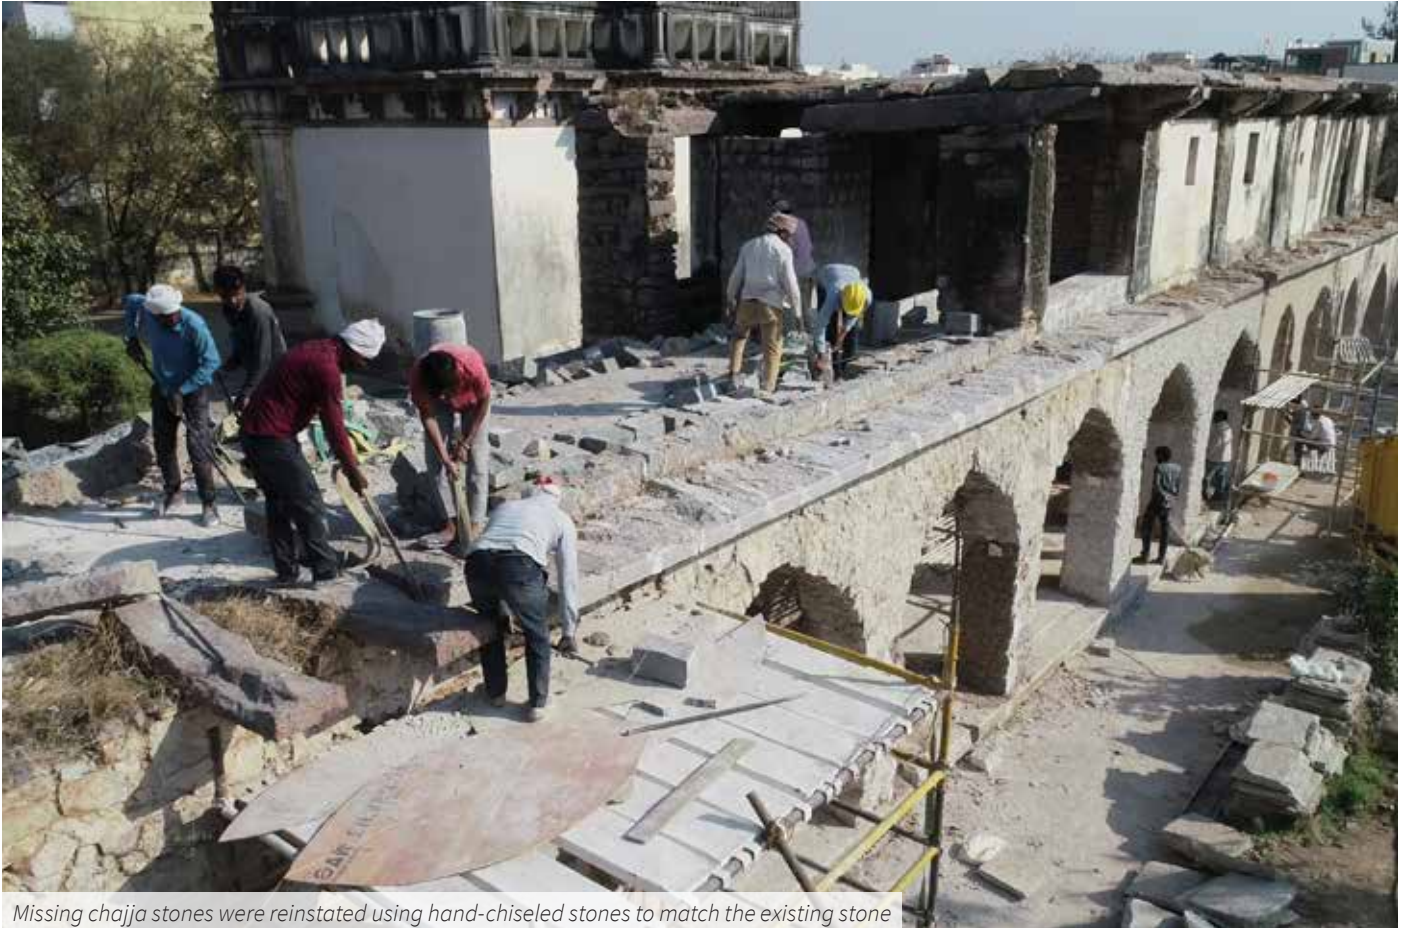
Missing chajja stones were reinstated using hand-chiseled stones to match the existing stone

- Approximately 40 missing chajja stones on the northern side of the western façade, each measuring 1.5 meters in length and 0.45 m width, were painstakingly hand-chiselled and installed by the skilled masons to match the existing stones, ensuring a seamless integration with the structure.
- A 450 mm thick parapet wall, made of stone masonry, was constructed in the area where a large portion of the chajja was missing, serving as a counterweight to support the chajjas.

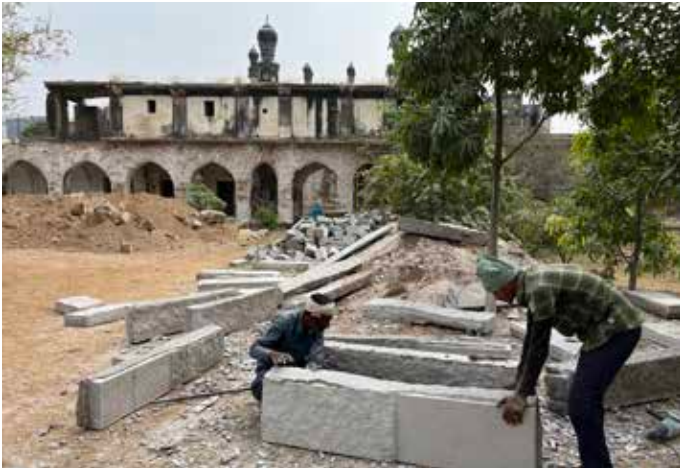
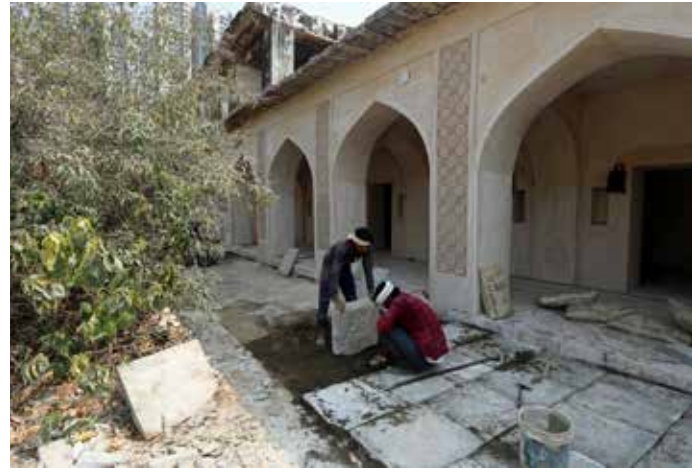
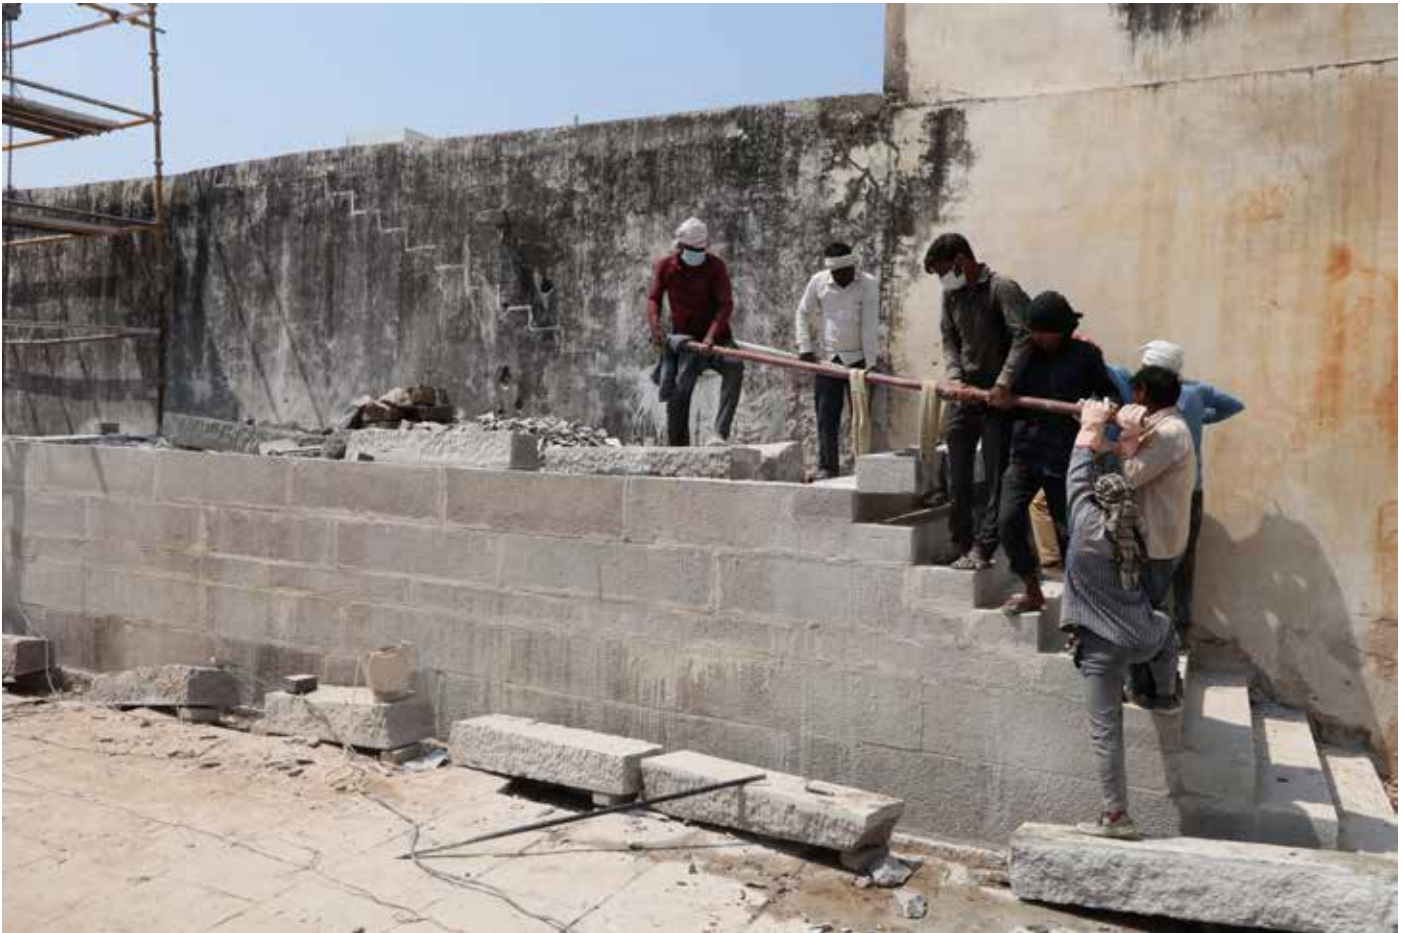
(Clockwise from left) Skilled stone masons prepared hand-chiseled stone blocks for reinstatement at the parapet level and for the staircase; The plinth protection was carefully relaid at original levels in an appropriate slope; Stone craftspeople painstakingly installed a 1.8-meter-wide staircase with 6-inch-thick hand-dressed granite steps to provide access to the terrace/first floor level of the Sarai

- To facilitate access to the eastern part of the complex, a C-shaped set of three steps, crafted from hand-chiselled granite stones, was meticulously installed by the skilled craftspeople at the central bay of the Serai.
- To provide access to the first-floor level of the structure, a straight flight staircase, 1.8 meters wide, featuring 6-inch-thick steps made of hand-dressed granite stones, was meticulously constructed on the eastern side.
- Over 90 stones were painstakingly hand-dressed by skilled stone craftspeople, for the installation of this staircase, ensuring both functionality and seamless integration in the historic setting.

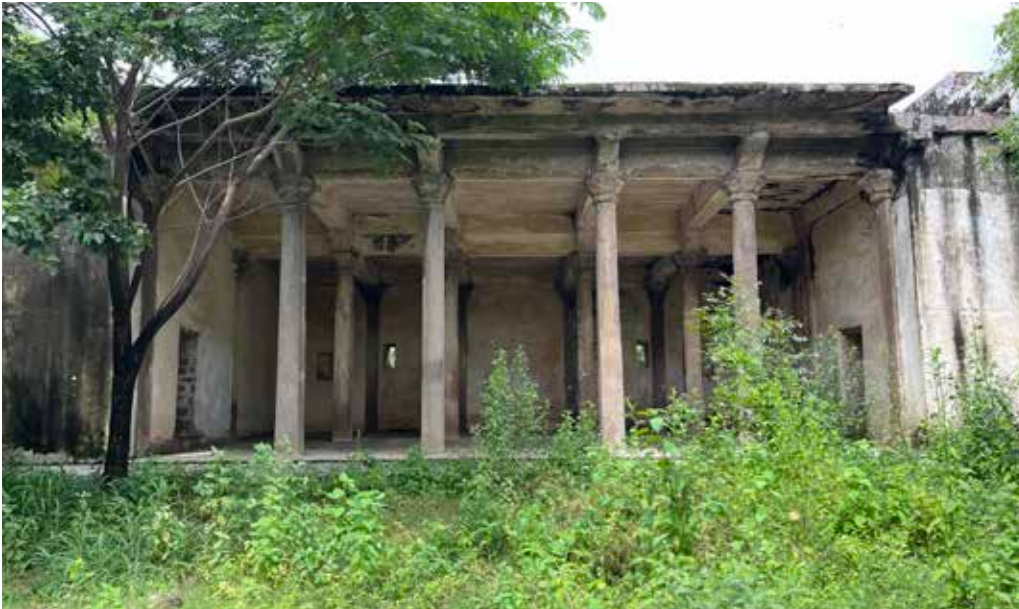
The main facade of Stable: Before Conservation

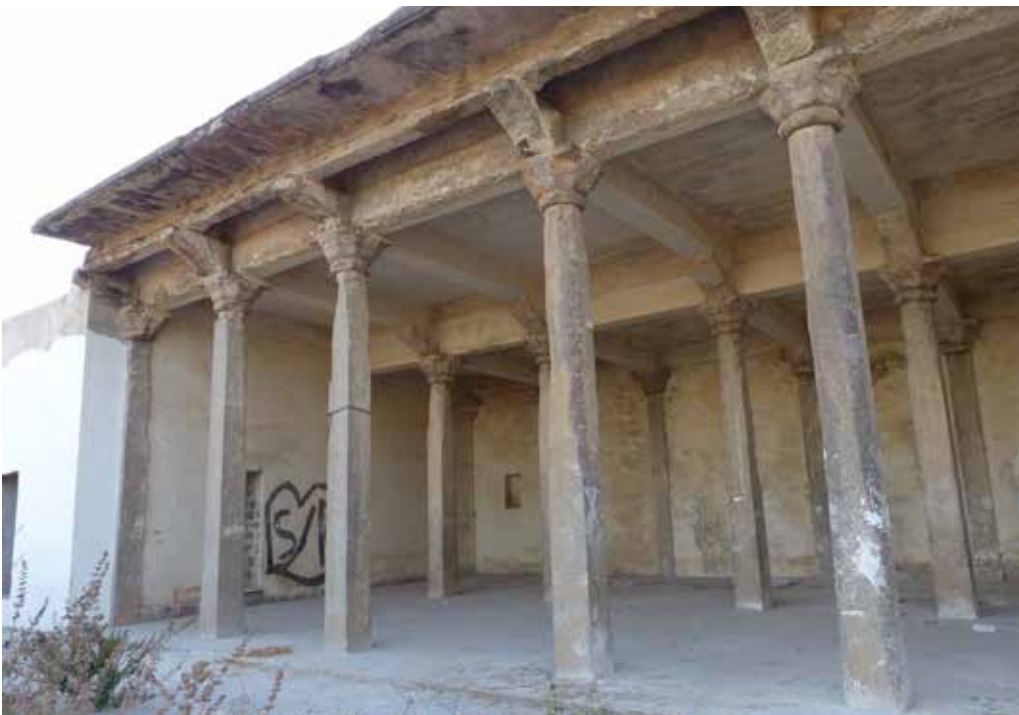
The interior of the stable before conservation, featuring high hand-chiseled granite stone columns

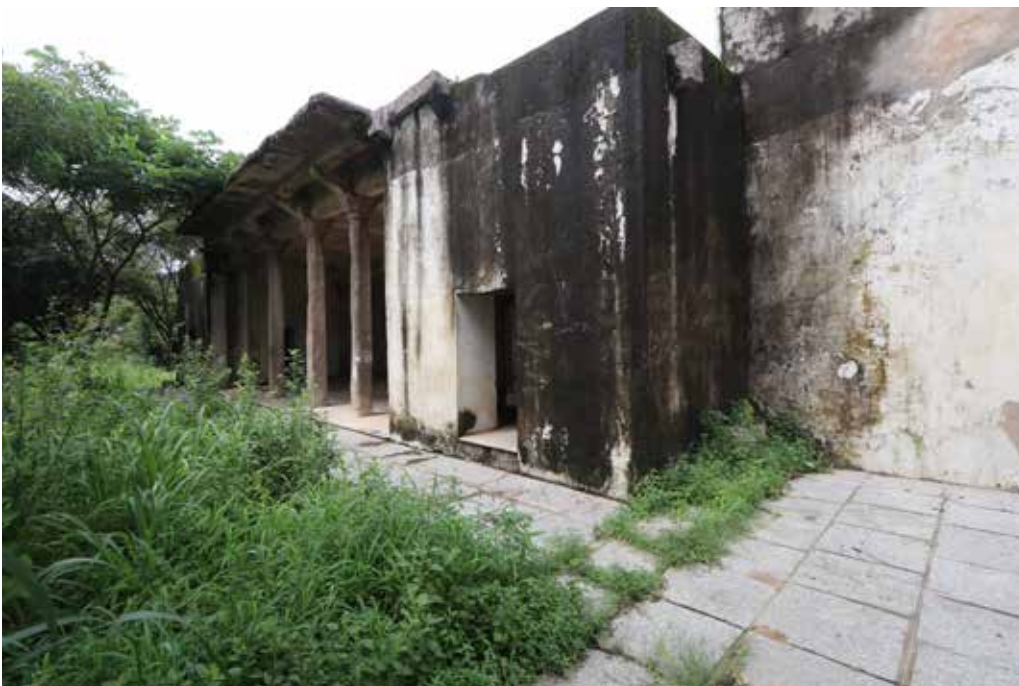
Algae deposition from water seepage has severely damaged the external facade of the stable

- 20th century cement plaster was carefully dismantled from external surfaces, which were then replastered with traditional lime mortar.
- Rainwater from the stable's roof flowed directly onto the western wall, causing deterioration. The existing concrete roof has a slope of 1:55 and includes niches to drain rainwater. To prevent further deterioration of the western facade, seven 450 mm high upstands with waterspouts were installed at the locations of the existing niches on the western side. These upstands divert rainwater away from the monument's roof, safeguarding the external facades, particularly on the western side.
- During the excavation for the proposed performance area, a series of steps—possibly serving as approach steps to the stable—were unearthed. These steps were meticulously documented with levels, sizes, and extent.

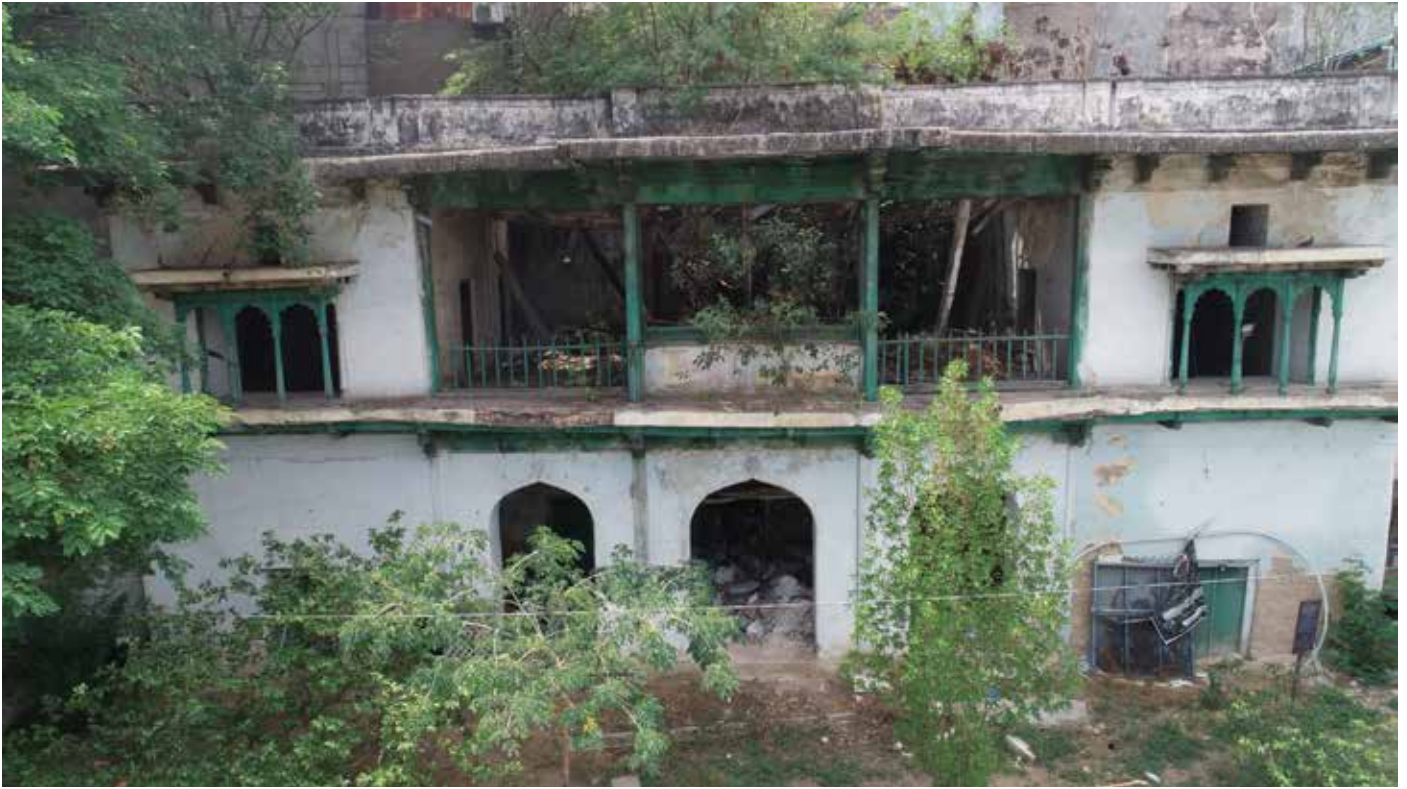
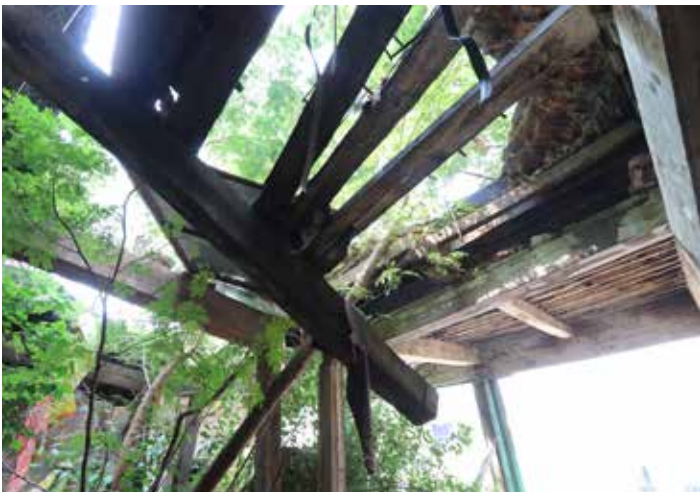
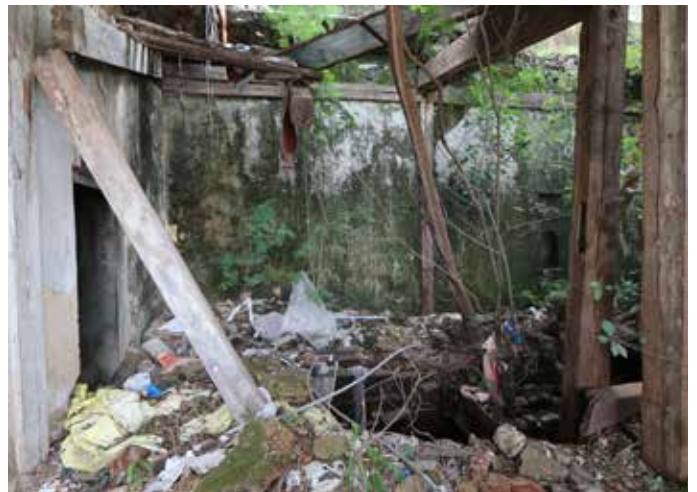
Before commencement of conservation works the building was in a highly vulnerable state, Buried under piles of garbage, overgrown vegetation, and accumulated debris. The damage was extensive, with a large section of the first-floor roof partly collapsed.

Conservation efforts at the Ashoorkhana are centred on stabilising and restoring its deteriorating timber roof and structural framework. Due to the critical condition of these elements, temporary supports were installed in 2020 by the Aga Khan Trust for Culture (AKTC) to prevent further damage.

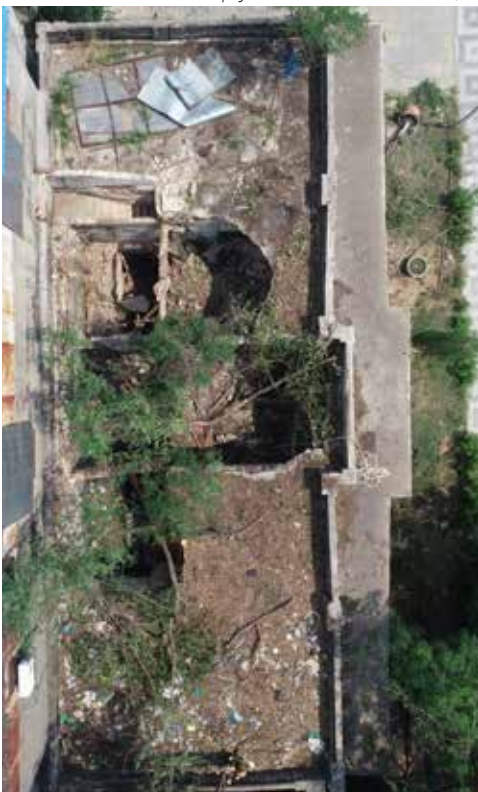
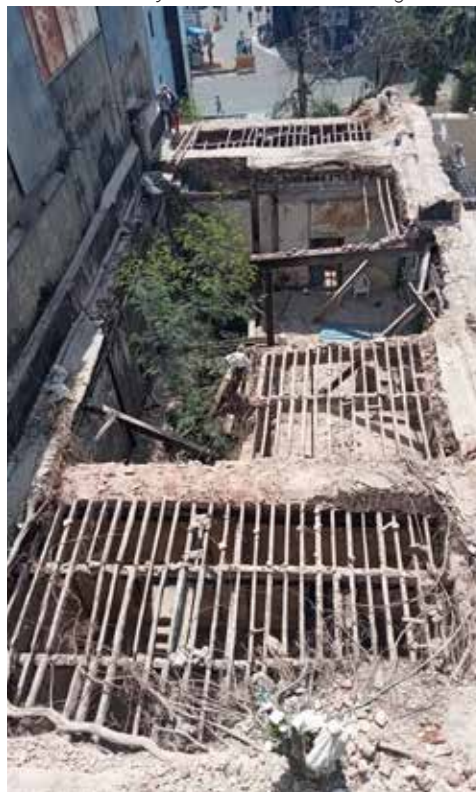
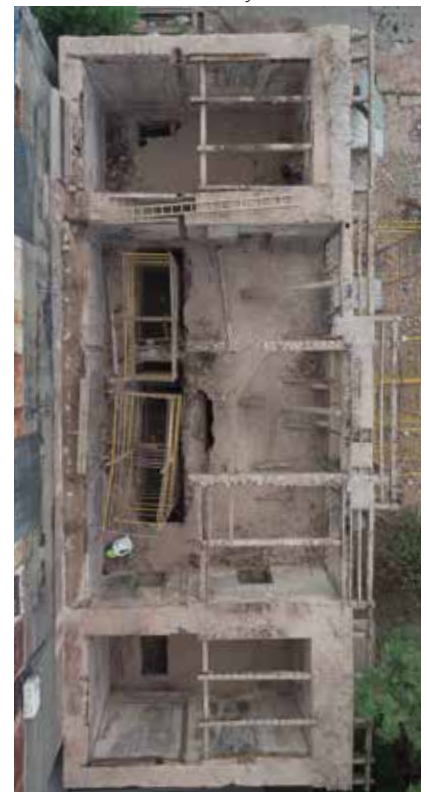
A large portion of the roof had collapsed, with several trees embedded inside the historic lime concrete. Additionally, the eave on the principal(east) façade at the terrace level had been extended using RCC, and a brick masonry parapet had been added on all four sides. Later additions and the extensive vegetation growth have accelerated the deterioration of the structure by adding extra dead load and damaging the historic roof.

Roots of trees were deeply embedded in the roof, which were carefully removed and the damaged wooden members were carefully dismantled

- The later added brick parapet and RCC chajja were carefully dismantled to reduce the excessive dead load on the structure and to help restore the building's original architectural character.
- The lime concrete and brickwork of the dilapidated roof were meticulously dismantled,, ensuring no damage is made to the historic fabric.
- After dismantling the slab, deeply embedded tree roots trees were carefully removed. This was followed by the dismantling of damaged and decayed timber beams, planks and rafters.

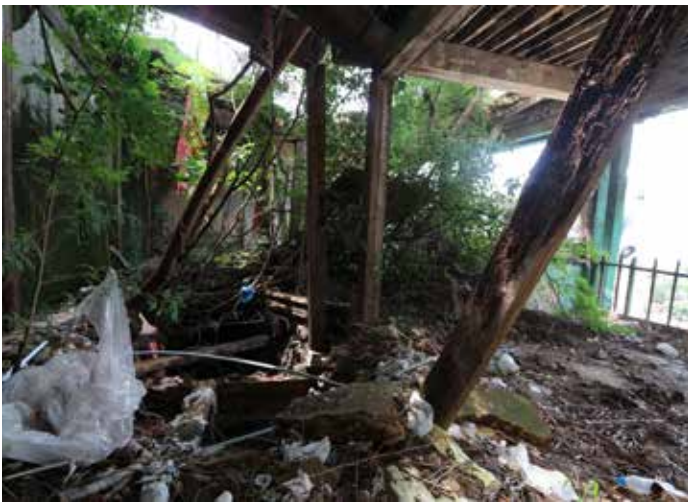
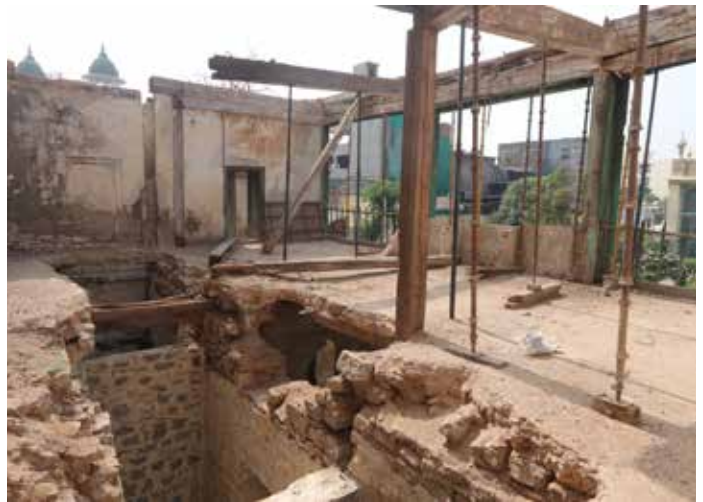
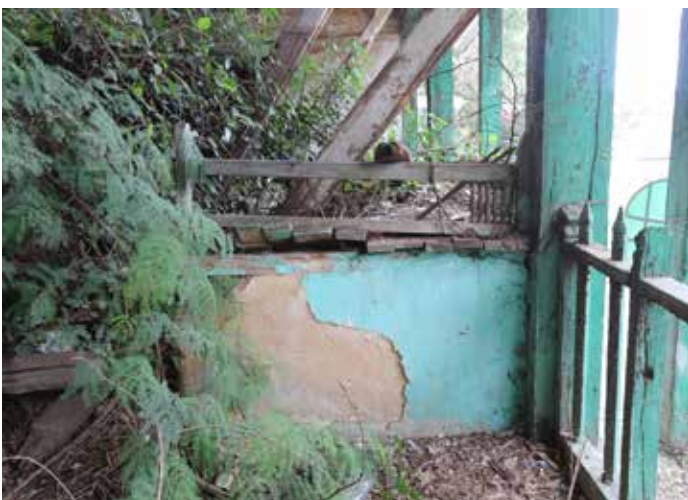
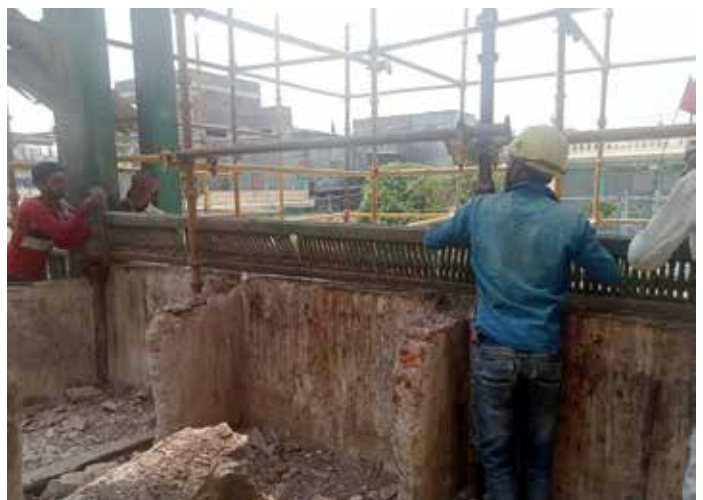
The first floor is characterized by a spacious central hall with a timber structure, flanked by rooms at both ends. Several timber beams in the central hall have collapsed, and the timber elements of the principal façade are significantly damaged. Additionally, trees with large girth have taken root within the stone masonry, contributing to further structural distress.

Collapsed beams were carefully removed and temporary supports were provided to damaged beams to secure the structure to facilitate conservation works

- Collapsed columns and beams have been carefully removed, while members attached to the principal façade have been supported and retained.
- Damaged lime concrete on the wall projection on west side has been carefully dismantled, and the area has been cleared of all loose debris.

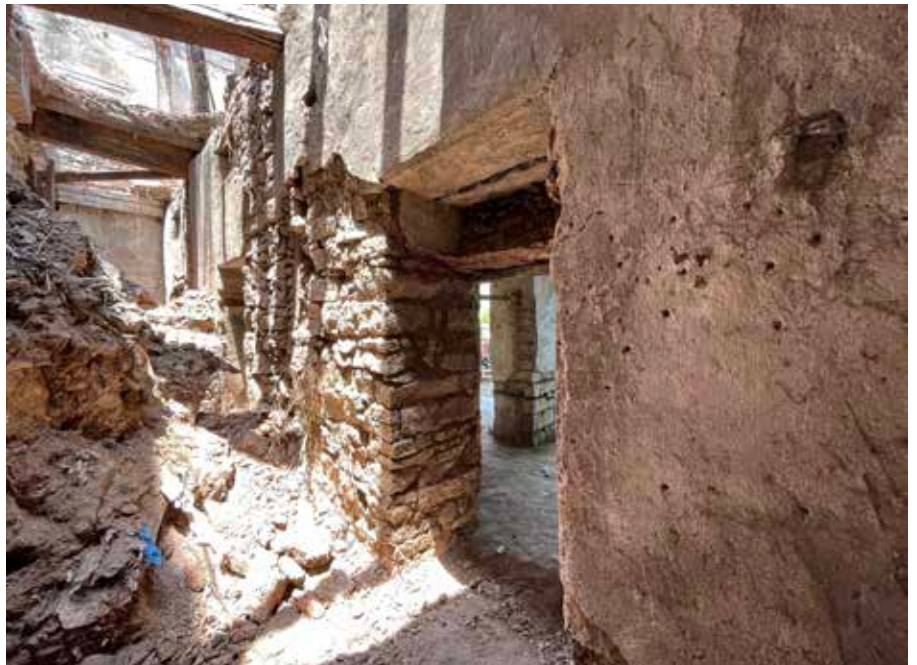
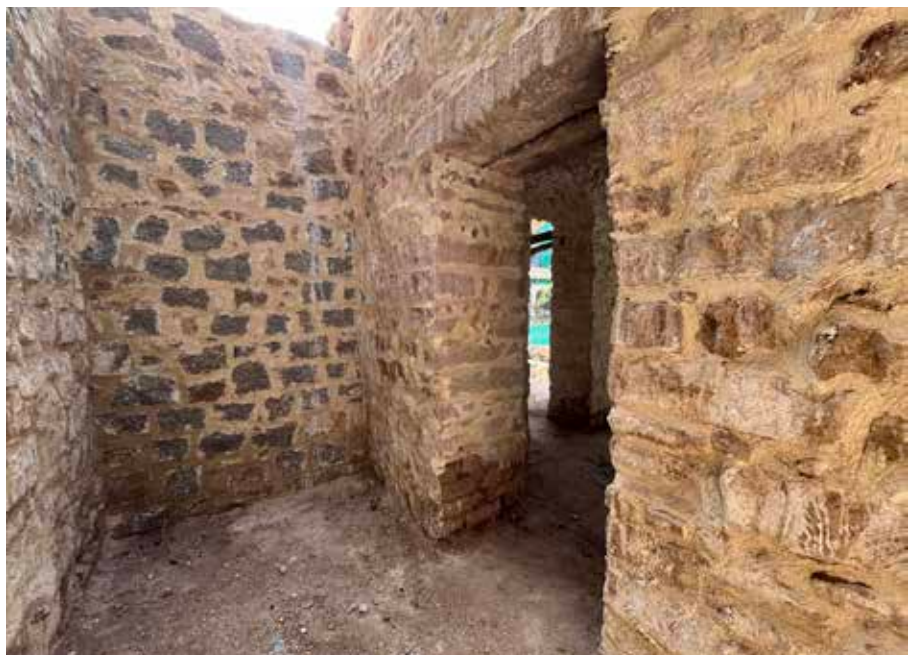
Partly collapsed stone masonry wall is reconstructed to restore the original layout of the building

- Two collapsed partition walls at the rear, constructed in stone masonry, were reconstructed matching the historic profile.
- Upon dismantling the damaged plaster layers from the ground floor walls, it was understood that lime mortar was missing from the stone masonry joints. Repointing of all the wall surfaces was carried out.

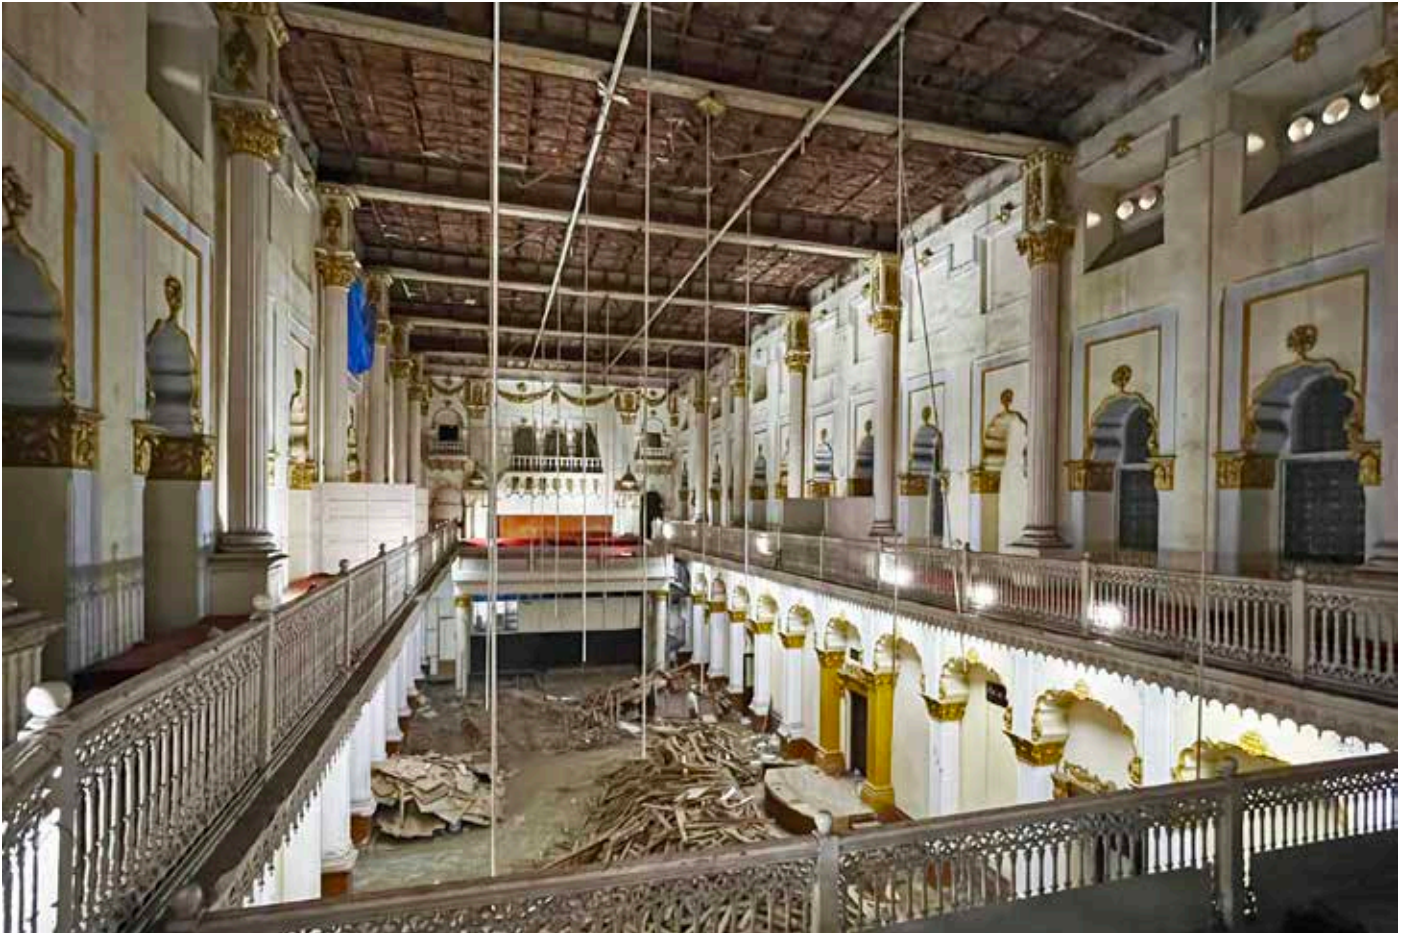
View of the Main Hall after dismantling of later added asbestos ceiling, revealing the historic jack arch ceiling

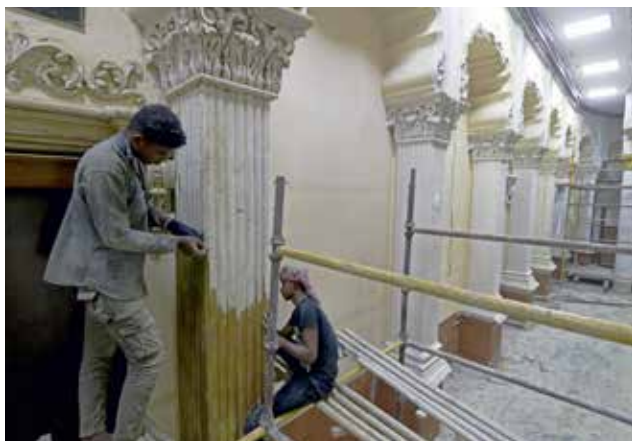
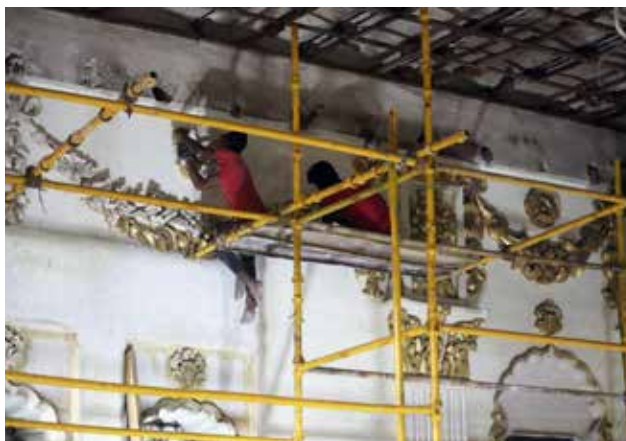
'later added golden enamel paint obscuring the original stucco patterns has been carefully cleaned to reveal the original details.

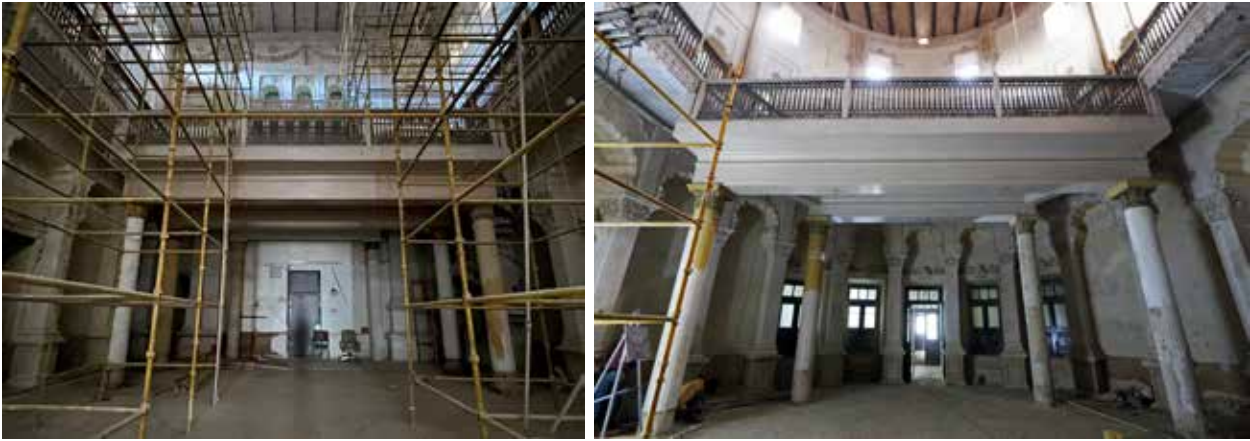
During architectural documentation, it was determined that the balconies on the main hall's shorter sides were later additions. These additions compromise the hall's original layout and obstructs the highly ornate arched surfaces, thereby altering both its grandeur and the original builder's intent. To illustrate and facilitate the restoration of the hall's original grandeur, 3D visualizations depicting its historic layout were prepared for stakeholder review and consideration

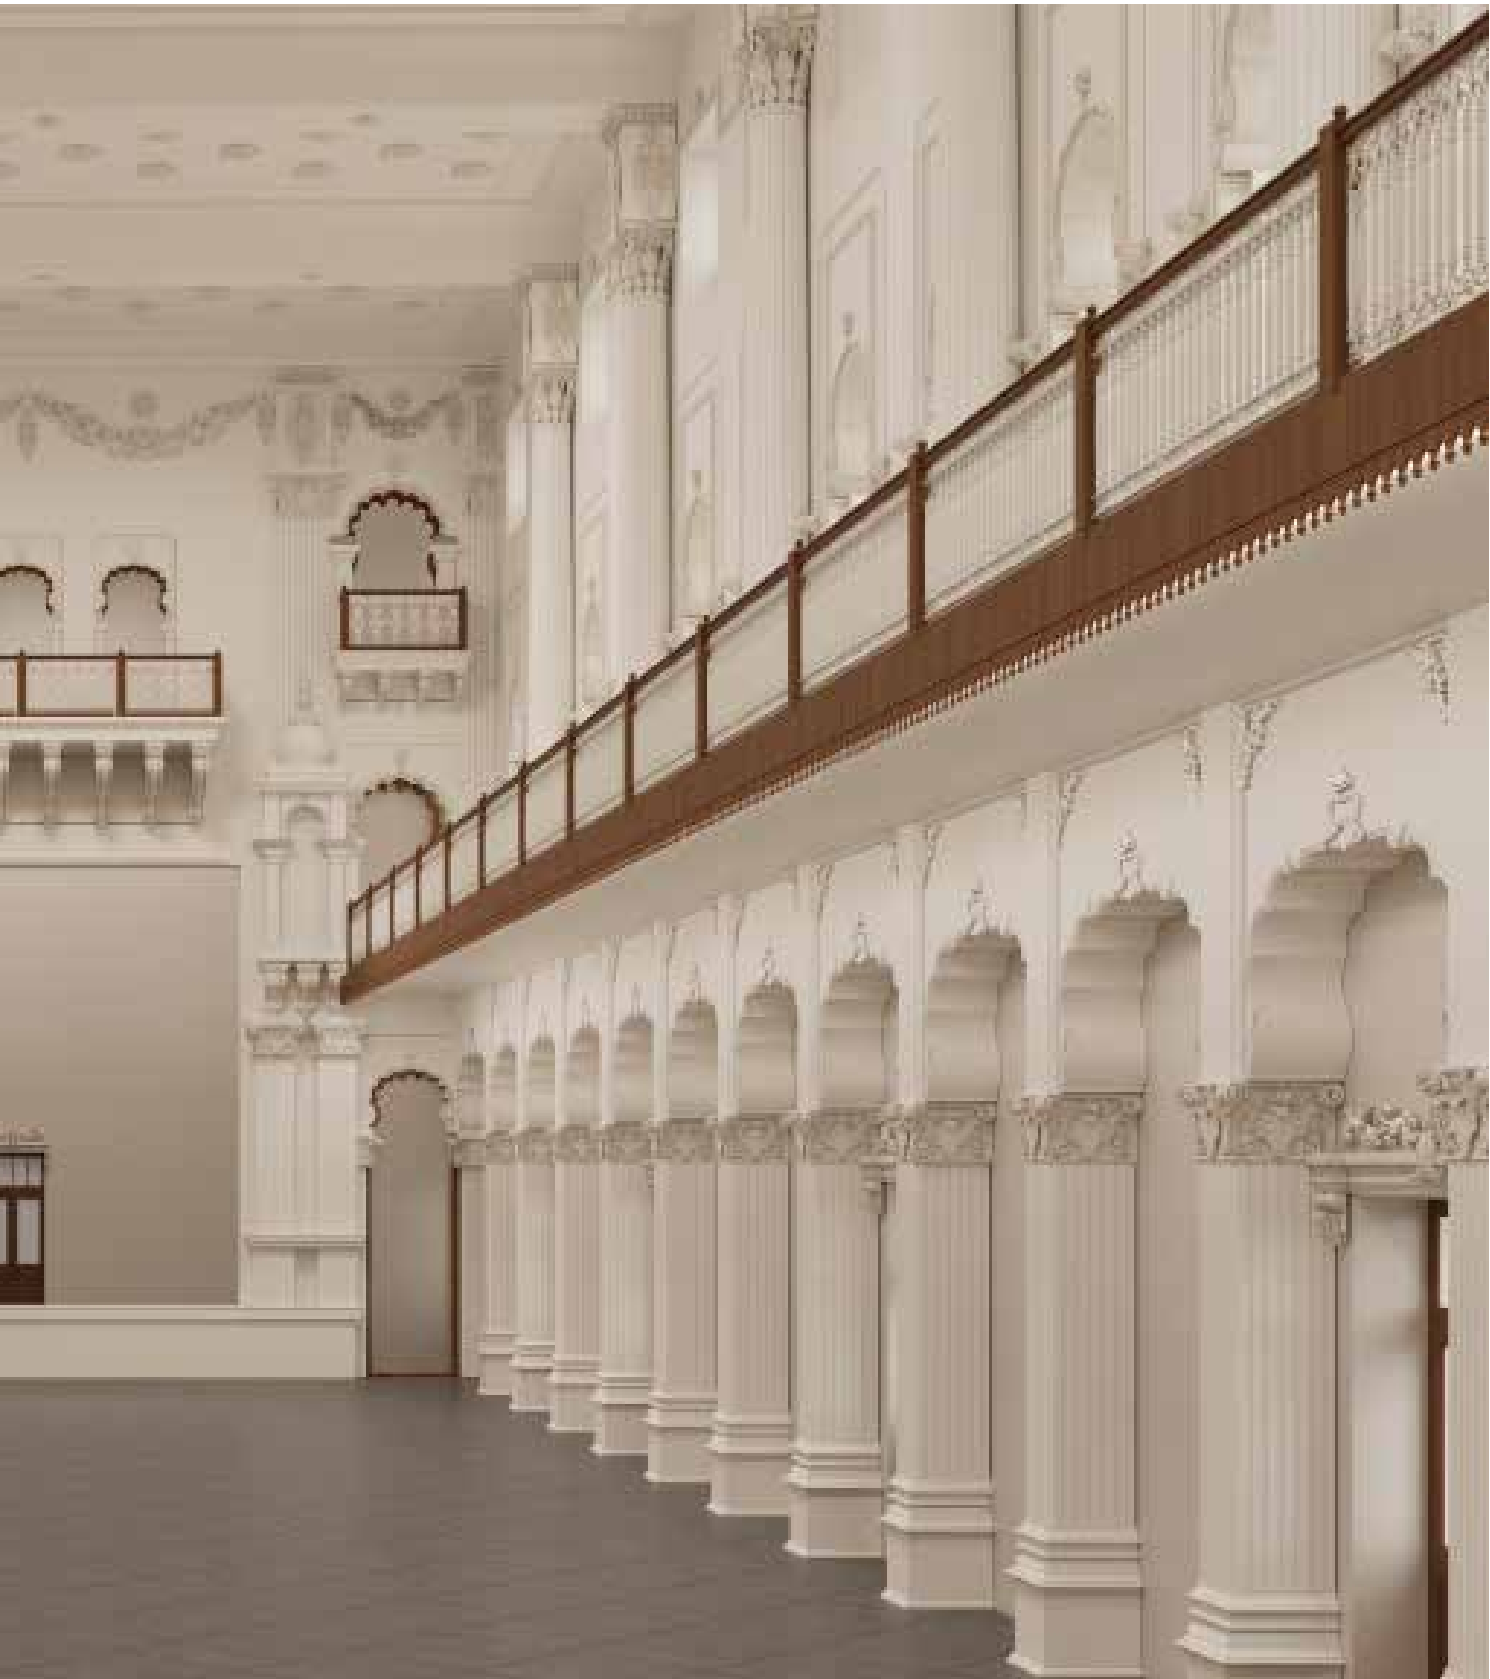
Proposed view of the main showcasing it's grandeur after dismantling of later added R.C.C structure
