QUTB SHAHI
HERITAGE PARK

ANNUAL REPORT 2023-2024

Conservation & Landscape Restoration

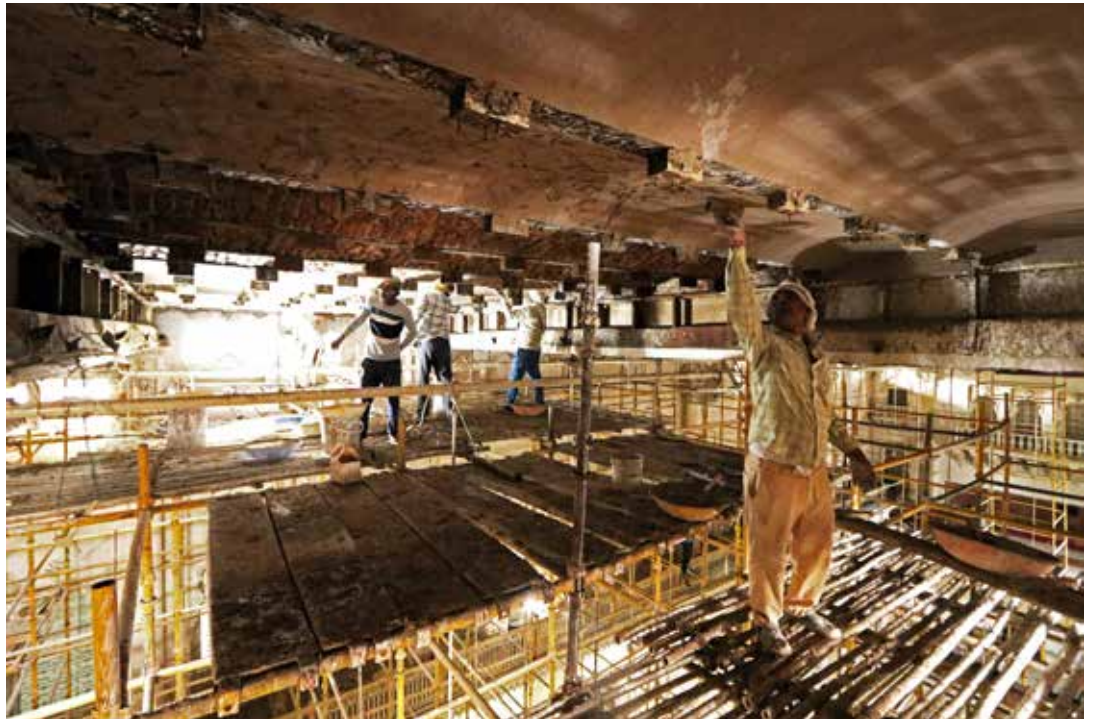
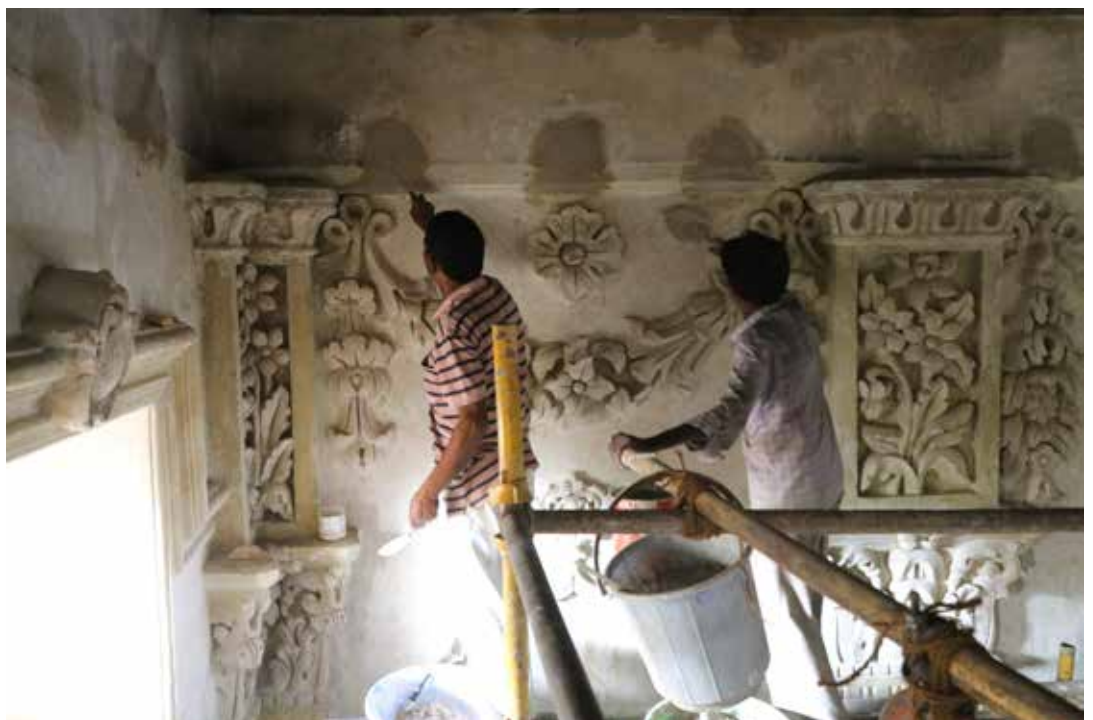
(Top) Exposed jack arches have been carefully plastered with traditional lime mortar for long-term preservation; (Bottom) Damage ornamental lime stucco details restored by master craftspeople

- Upon removal of paint, several small repairs—previously executed in cement mortar or not matching the original design—were revealed. Extensive repairs of ornamental stucco were undertaken by master craftspeople using traditional lime mortar to restore the original grandeur of the hall.

- For long-term preservation, the exposed jack arch ceiling was plastered with traditional lime mortar, and anti-rust treatment was applied to the exposed ISMB sections.

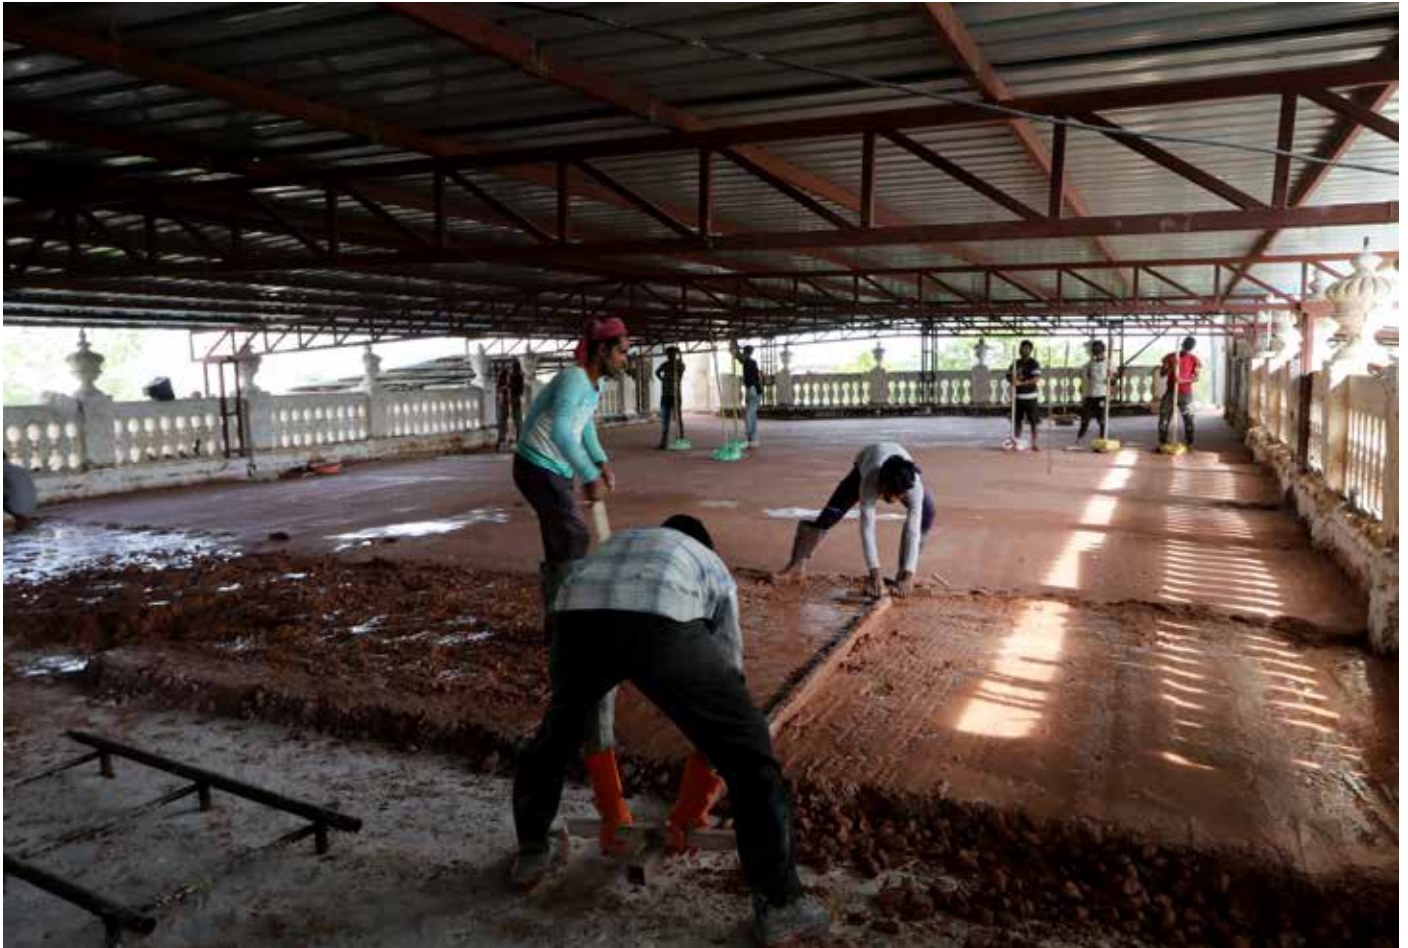
Laying lime brick jelly concrete on the main hall terrace to adequate slope, after dismantling of later added cement concrete

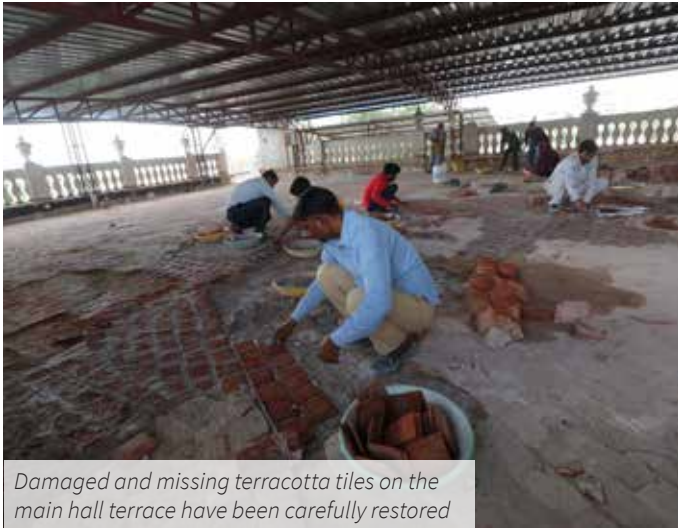
Damaged and missing terracotta tiles on the main hall terrace have been carefully restored

- Furthermore, for additional protection, grouting was carried out throughout the surface of the terrace by making a grid of 1 meter by 1 meter.
- The dismantling of cement concrete revealed that the roof was originally finished with multiple layers of terracotta tiles. Many of these were either missing or partially damaged due to bonding with the later-added concrete. To reinstate the original roof composition, over 750 customized tiles were prepared to match the historic design and reinstalled.

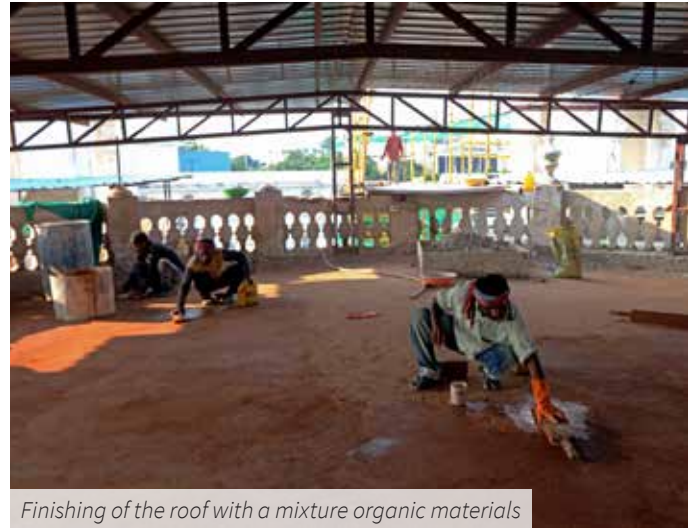
Finishing of the roof with a mixture organic materials

- A 4-inch thick lime concrete layer, matching the original

composition, was relaid over the tile surface with a consistent slope to ensure effective drainage. Khurras (sloped channels) were prepared at all required discharge points for improved rainwater flow.

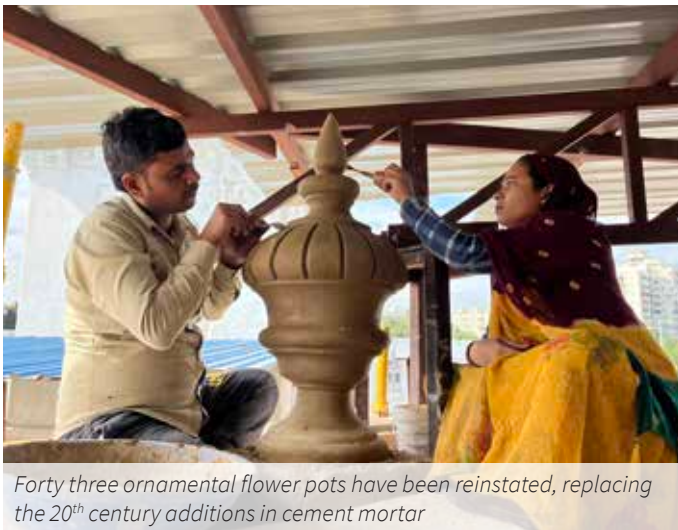
Forty three ornamental flower pots have been reinstated, replacing the 20th century additions in cement mortar

- Architectural and decorative elements at the terrace level of the Main Hall were also restored. The process began with careful cleaning to remove later paint layers, followed by a detailed condition assessment.
- The parapet of main hall terrace is decorated with 750 mm high ornamental flower pots. Many had significantly deteriorated due to incompatible cement mortar repairs. A total of 43 of these flower pots were reconstructed in brick masonry and further plastered with lime mortar. To prevent corrosion and ensure long-term preservation, the central iron rods were replaced with stainless steel pipes.

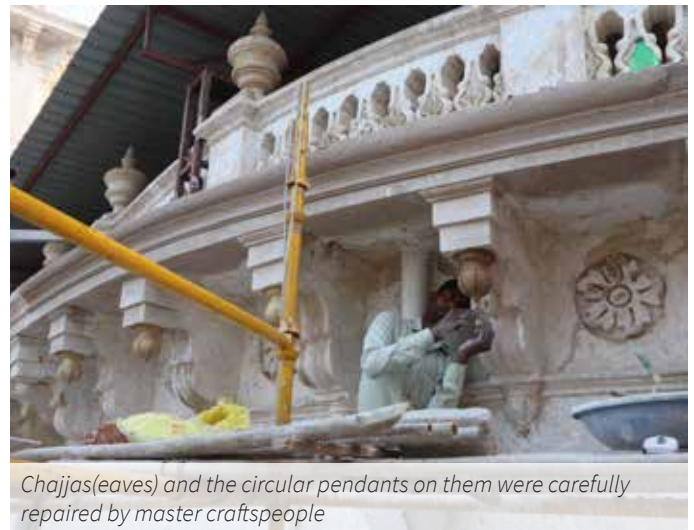
Chajjas(eaves) and the circular pendants on them were carefully repaired by master craftspeople

- The parapet also features an ornate balustrade and an intricate 9 inch wide moulding. Damaged portions were restored using traditional lime mortar by skilled craftspeople employing hand tools.
- Significant damage was also observed on the chajjas (eaves) and their supporting brackets. In many cases, corrosion of internal mild steel angles had caused sections to collapse. Over 30 meters of chajja were reconstructed in brick, and damaged portions of the brackets, including their suspended circular pendants, were reinstated. Exposed steel components received anti-rust treatment.
- Several decorative floral medallions located between the brackets, along with mouldings of varying widths, were also meticulously restored by master craftspeople using traditional lime mortar techniques.
