QUTB SHAHI HERITAGE PARK

CONSERVATION & LANDSCAPE RESTORATION

ANNUAL
REPORT
2014

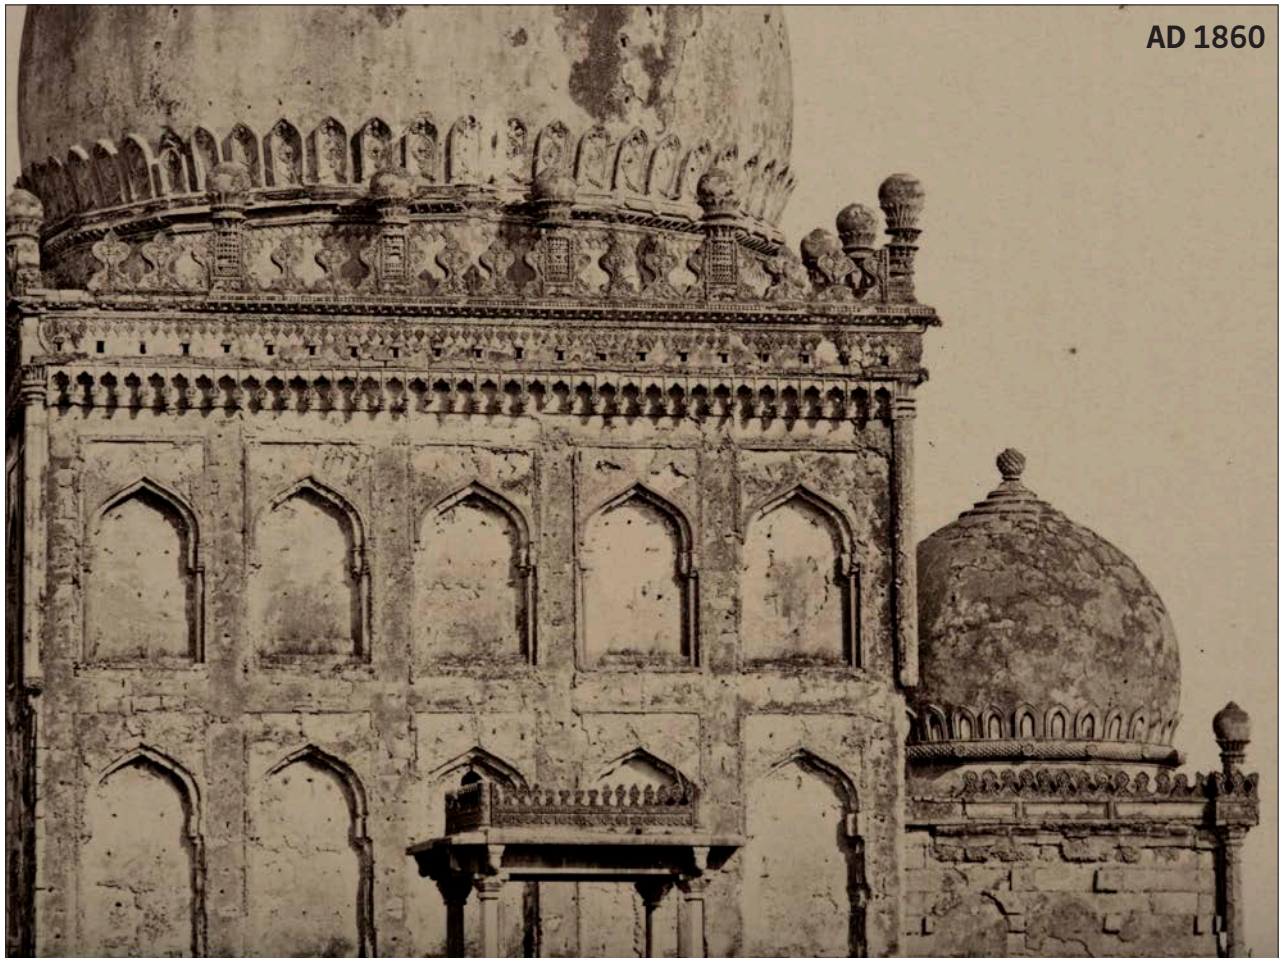
AD 1860

(Right) Study of an archival image (Top) dating from early 1860's by J.H. Nixon of Ibrahim's Tomb shows the extent of 19th century alterations (Bottom); Copyright: Alkazi Foundation

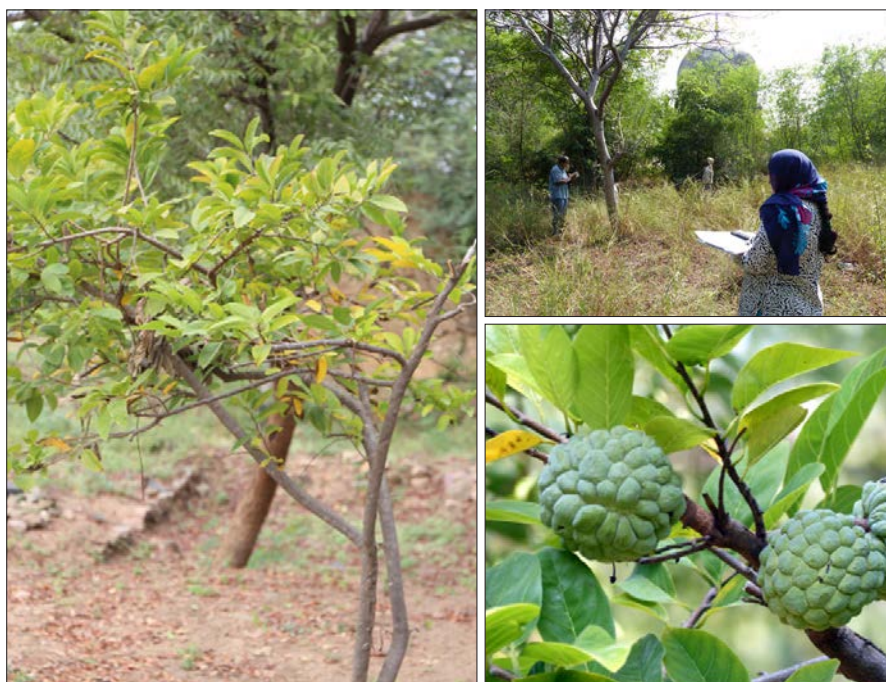
Total No. of Trees Mapped 2450
Total No. of Species Found 59
Native to Site 30

(Above) The tree mapping exercise, which began a year ago, includes measuring and recording the height of the tree, girth of its bark and the size of its canopy

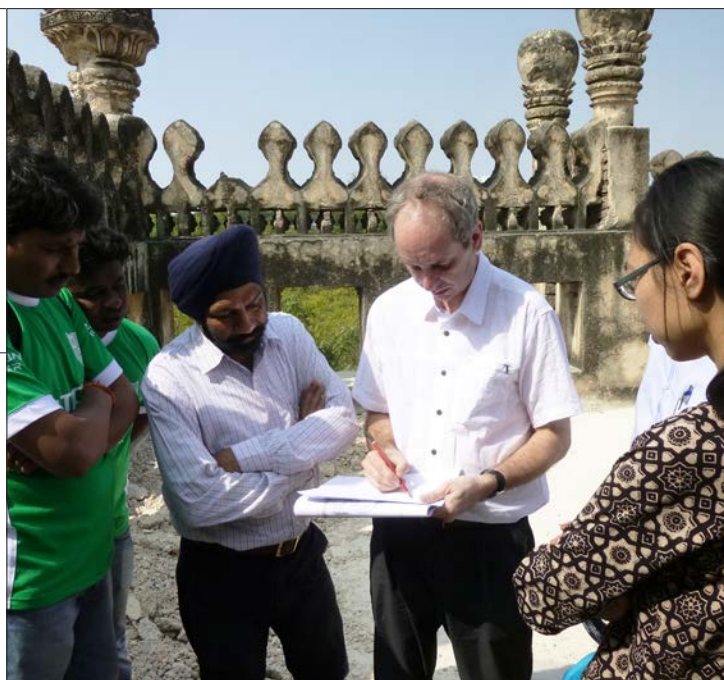
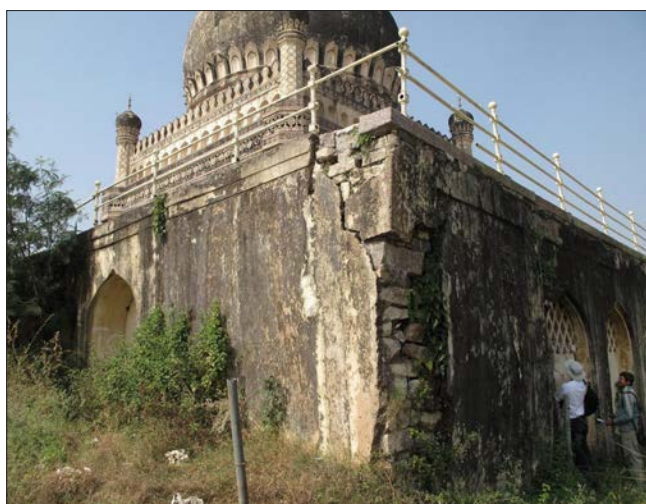
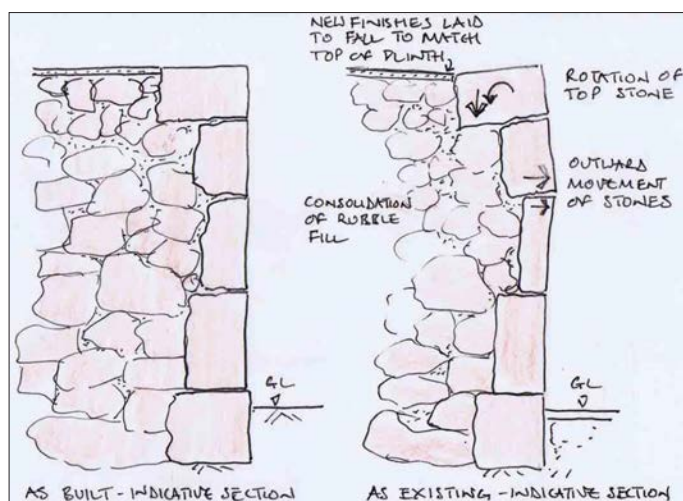
- A summary for the urgency of the structural works in the monuments was recommended.
- The larger domed tombs demonstrate the masons had an excellent understanding of the structural principles for this form of construction. Mohammed Quli Qutb Shah's tomb, the grandest structure in the complex, contains sophisticated techniques to address particular structural challenges with the design. Most of the structures are in a reasonable condition for their age and type of construction. The majority of structural issues arise from a lack of maintenance and inappropriate repairs. Common problems include root damage by vegetation growth and changes to the falls at roof level which have compromised the drainage of rainwater and resulted in accelerated deterioration.

(Above) Structural engineers assessed the monuments with the team and prepared a summary (Below) of the existing structure, the structural defects and their likely cause(s), and a summary of the structural repairs that are required.

Close monitoring of structures where cracks or settlement is noted as well as undertaking emergency repairs where required.

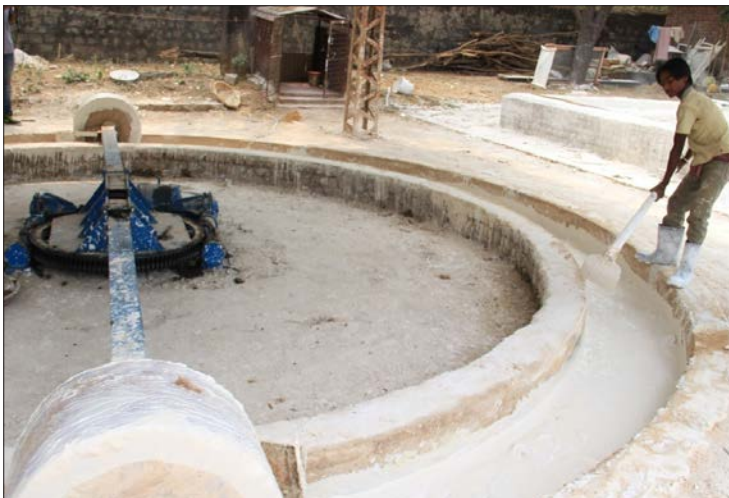
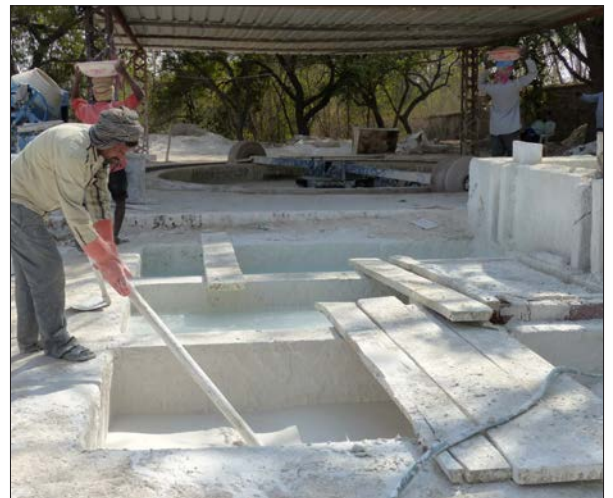
(Below) A mechanised lime grinding mill has been set up which can produce over 500 cubic feet of lime mortar in a day

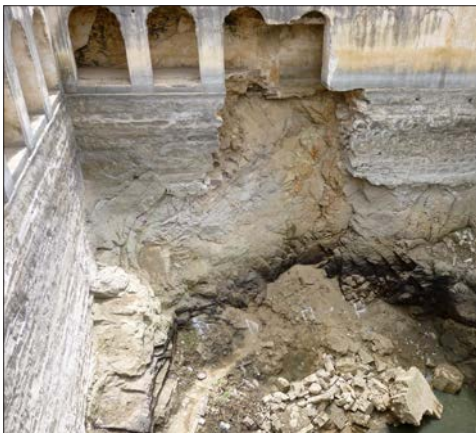
The initial collapse
March 2013

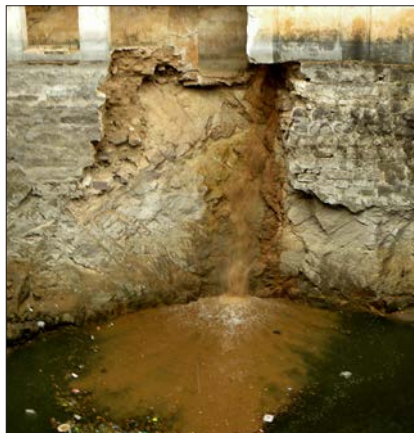
Further failure
September 2013

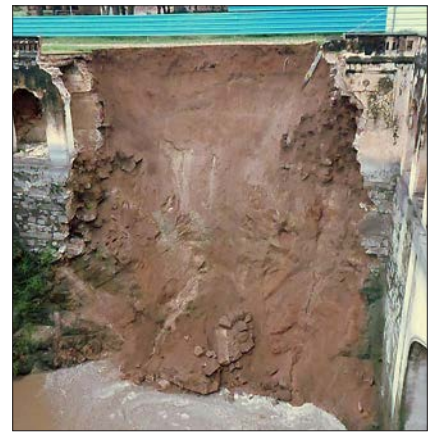
After the final collapse
October 2013

The western face of the Badi Baoli collapsed during the years 2012-13 requiring the structure to be closed to public while major repairs are carried out by the project team.

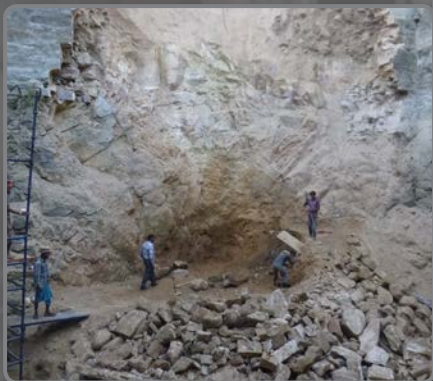
Debris Cleaned

Over 4000 man-days of work done to remove all the debris and loose masonry which amounted 450 cum.

Following the near total collapse of the west side wall, the Baoli was cleaned of all the building debris, which consisted of stones, earth, lime and masonry. In this process the Baoli was de-silting and cleared of any loose portions of masonry wall.

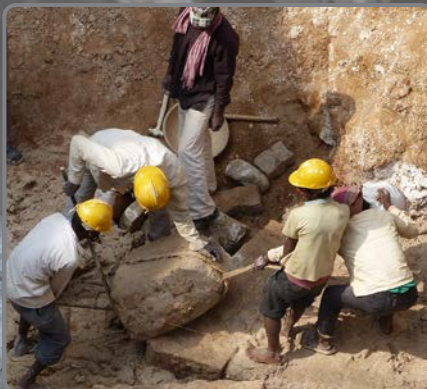
Consolidation of Baoli

RCC raft footing was laid on the existing rockbed, and upto 8 ft long stones were used in the construction of the retaining wall, which were mostly the recycled stones.

- The masonry required a 1.5 meter wide and 0.5 meter thick RCC raft foundation, 11 meters long at a depth of 22 meters from the ground level.
- The bottom half of the stone masonry, built in lime mortar, was built as a buttress also as not enough width was available due to portions of bed-rock still standing.

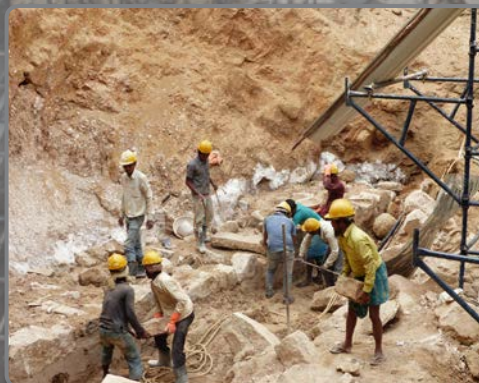
For strengthening and safety of the structure, a RCC Raft Footing of 75 cum. was laid at the lower portion of the baoli. 600 cubic meters of stone masonry, 17m high was rebuilt using lime mortar.

The reconstruction of the solid stone masonry wall in lime mortar within a very short duration of time was necessary to prevent further collapse and deterioration of the Badi Baoli, three sides of which were still standing.

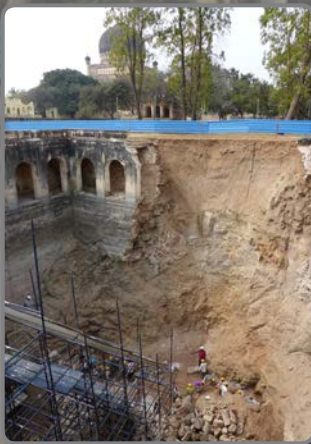
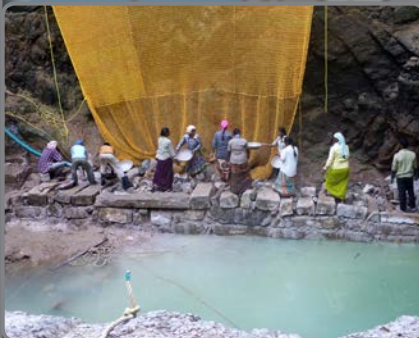
Reconstruction of Steps

Reinstated the west side access from the ground level to the lower arcaded terrace of the baoli.

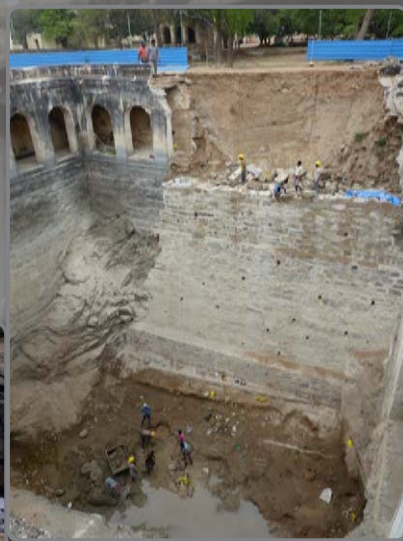
Out of 17 steps, 10 steps along the western wall had collapsed. These granite steps were reinstated.

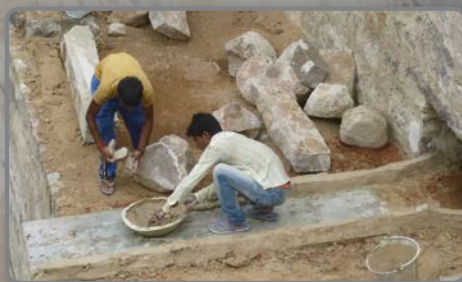
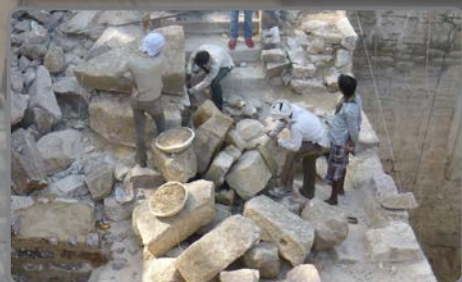
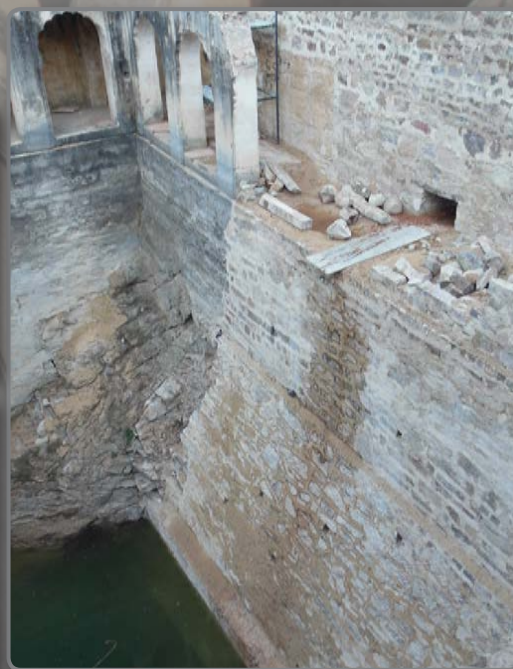
Re-channeling Surface Water

To ensure surface water drains directly into the baoli through the channel without affecting the structure, a channel of size 2X2 ft was built with adequate slope.

Since the Badi Baoli served as a natural catchment for rainwater from a large area of the Qutb Shahi Heritage Park, it was necessary to make an appropriate arrangement to allow the water into the Baoli. Previous evidence of channelization of rainwater was also found on the ground. However, as this directed large quantities of water down the steps, it was considered to be leading to deterioration and was considered inappropriate.

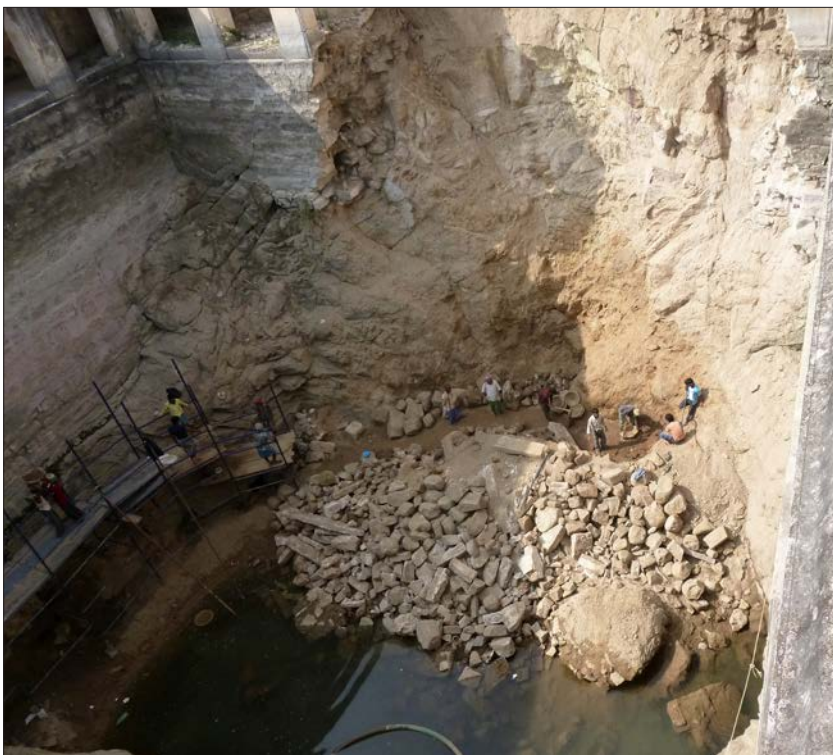
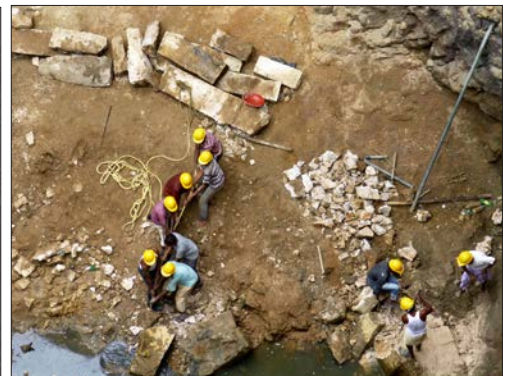
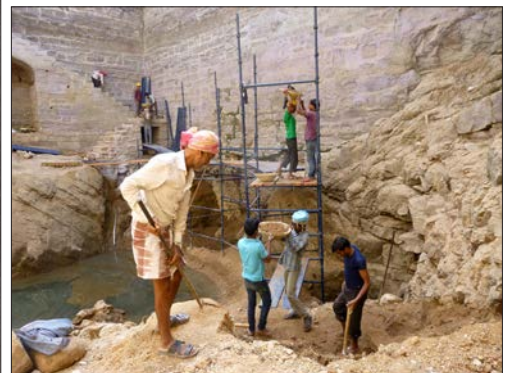
(Below) Removal of Earth and silt from the Baoli

- At the onset, 2, 00, 00,000 litres of water was required to be pumped out and fed into other adjoining step-wells. Following the initial removal, the pumping out required to be continuous to allow the well to dry out.
- Over 450 cubic meters of stone debris and silt was lifted to the ground level from the 21 m deep bed of the Baoli.
- All stone thus lifted was cleaned of mortar for re-use in the re-construction of the collapsed masonry.
- Over 4000 man days of work was required to clear the Baoli of collapsed masonry, existing silt and other accumulations.

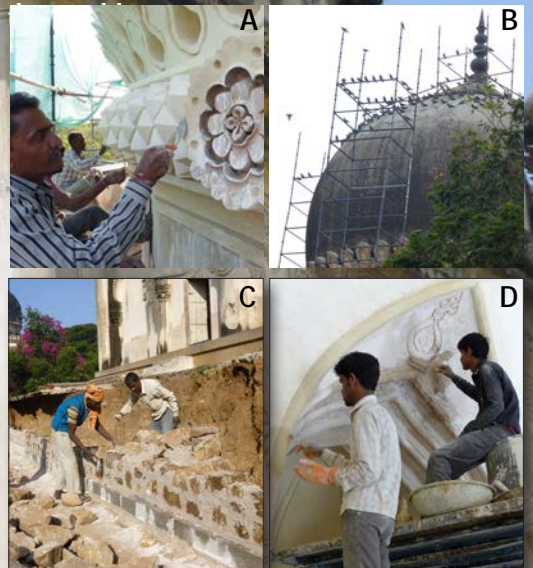
Plinth collapse at Fatima Sultana's
▼ Tomb in October 2013

Following heavy rains in 2013, the southern plinth had partially collapsed, thus severely compromising the structural integrity of the monument. As with the Badi Baoli, conservation works on this monument were taken up on an emergency basis to ensure no further damage occurs to the monument.

- A study of the plinth revealed that repairs had been carried out several times and during past repairs inappropriate alterations such as use of mud mortar as well as not reinstating the base band of dressed granite, amongst others, have been carried out.

- The entire section of the masonry for the southern plinth wall as well as sections of the western wall required to be dismantled. This was especially necessary for sections where the base band of dressed granite was missing and required to be reinstated.

- The cement layer, 1" thick, found on the plinth was also dismantled.
- The steps found on the western side were dismantled and rebuilt on the southern side where the entrance to the tomb chamber is located.

- The cement layer on the plinth will be replaced with 30 mm thick granite slabs to ensure long term preservation and preventing future water percolation as this had led to the collapse.
- The ground on all the sides of the plinth would be graded adequately to expose the lower band of dressed stones.

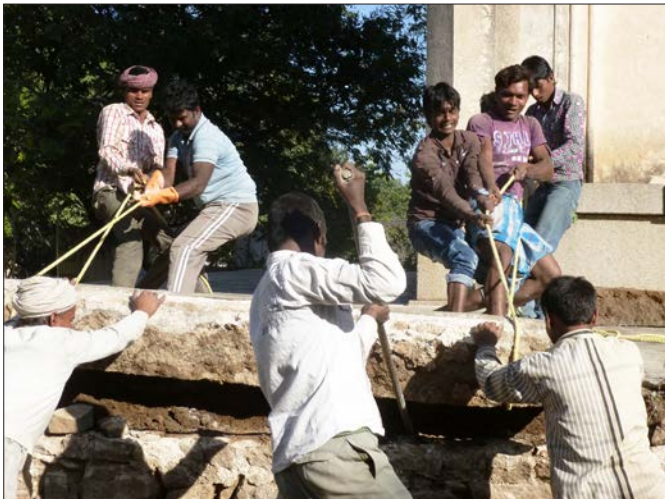
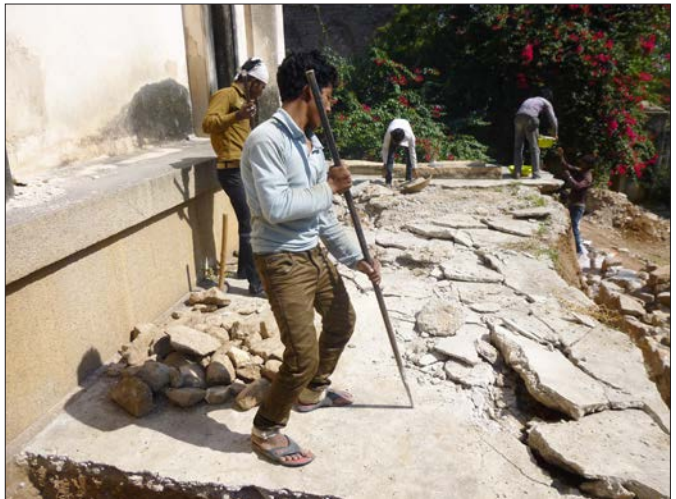
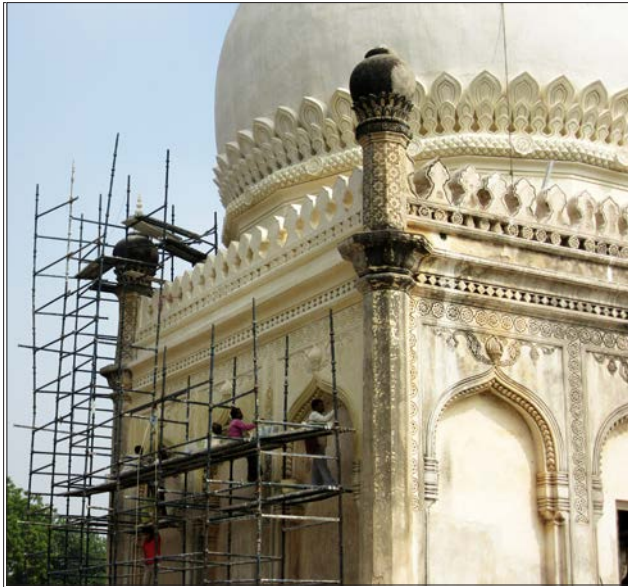
(Opposite page) A: Removing cement plaster and restoring historic plaster on the facade; B: Vegetation removal from the dome and facade; C: Emergency repair works carried out on the lower plinth after its collapse in 2013; D: Cleaning of the internal surfaces and restoring decorative motifs; (Below Left) Craftsmen lift stones to build the plinth; (Below Right) Removal of cement concrete from the plinth

(Above) Replastering and repairing of the exteriors

- Rank Vegetation from the dome was removed manually and the spots were treated to prevent the growth of other plants and trees.
- Cement layers and all dead/loose lime plaster was carefully dismantled.

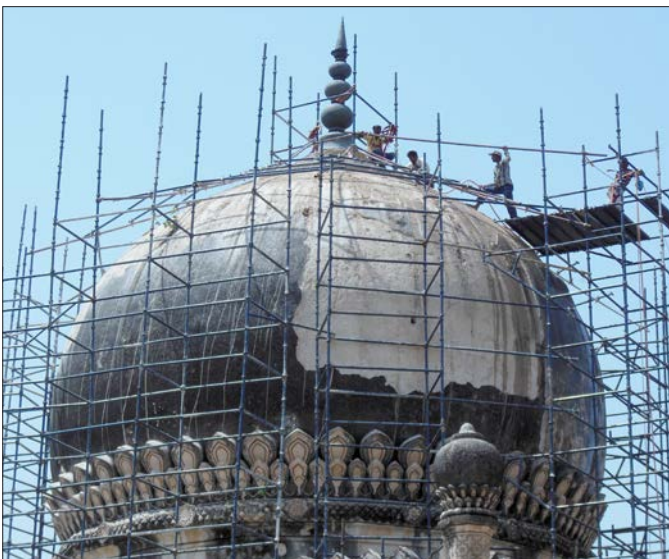
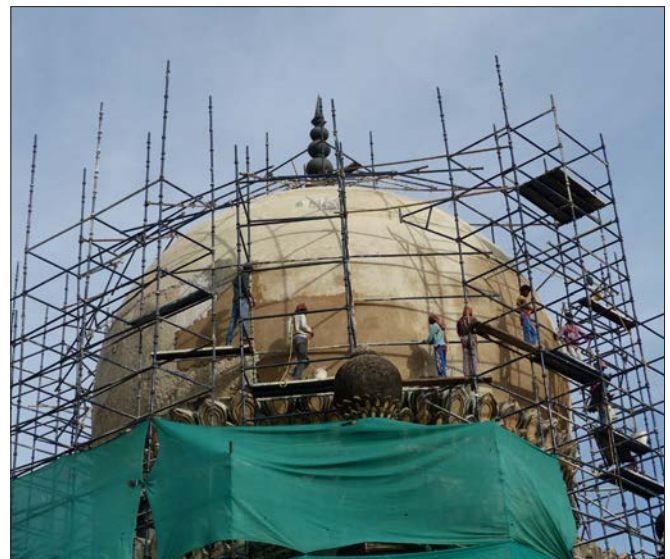
(Left) Removal of cement mortar from the dome (Right) prior to replastering with lime mortar

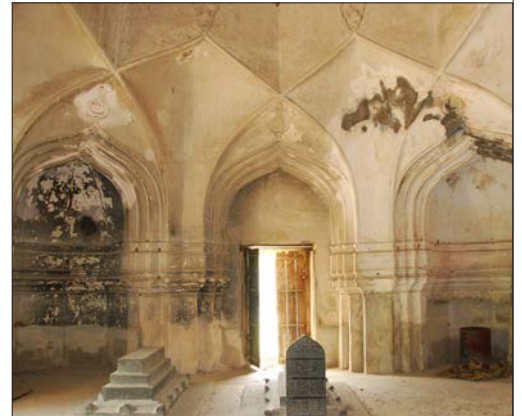
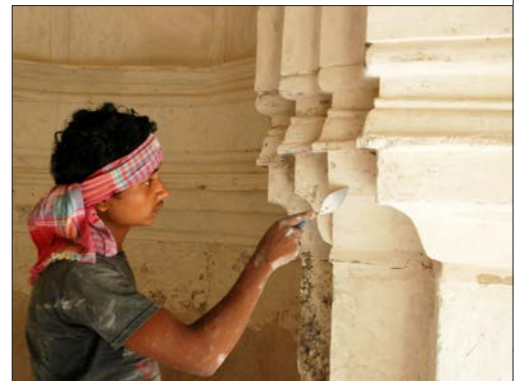
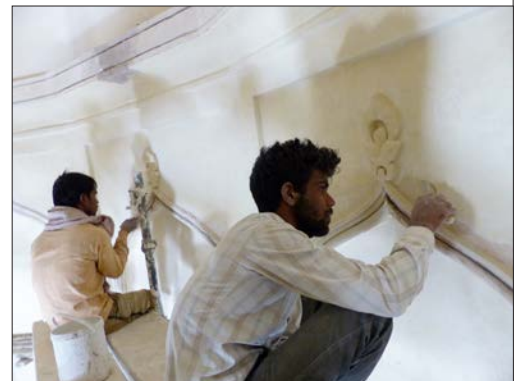
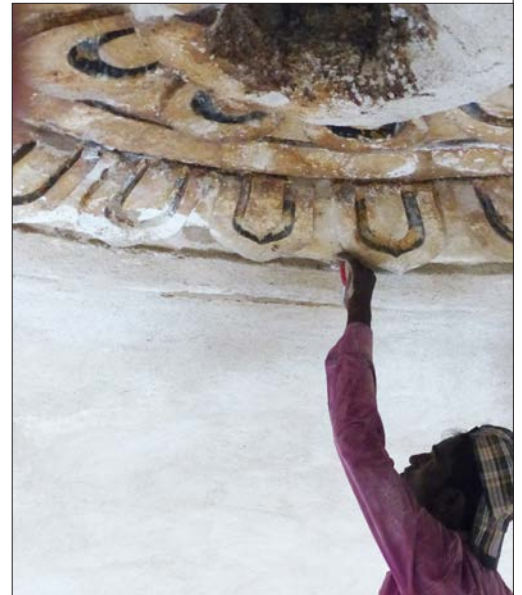
(Right) As with the exterior surfaces, the interior walls were also stripped of cement mortar and lime plaster applied; stucco plaster patterns required restoration by master craftsmen

- The internal surface of dome was dismantled of all the loose plaster as well as 20th century cement plaster layers.
- Wall surfaces were re-plastered and repaired using lime mortar, after which the final layer of lime punning was applied.

- The central medallion under the dome was also measure and repaired. The green colour polychrome found here was restored.
- The arch-posts below the dome were repaired and plastered with lime mortar and finished with lime putty.

- The medallions above the arch quiches, which were found to have black paint in the groves, have been repaired and colour restored.
- Also black polychrome was discovered in the groves at the parapet height and along the traverse ribs above the quiches of the arcade.

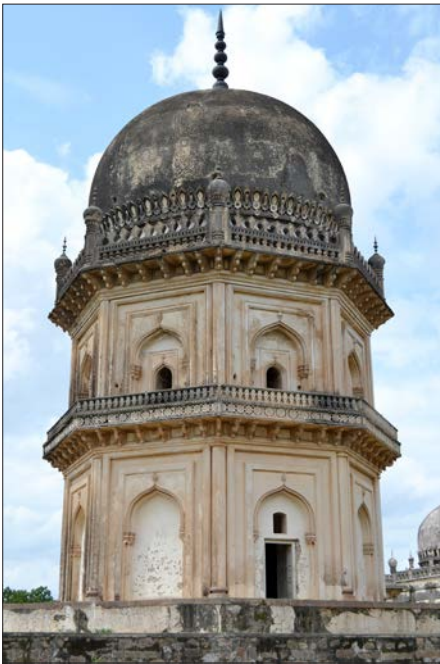
April 2013

Prior to commencement of works, the complete facade was covered with a layer of new finish – replacing the historic lime plaster. The thick algae deposits as well as along the rain water flow due to flushed water outlets will be repaired. Proposed works includes restoration of the facade plasterwork, internal dome and decorative features with stucco work and repair of the dome.

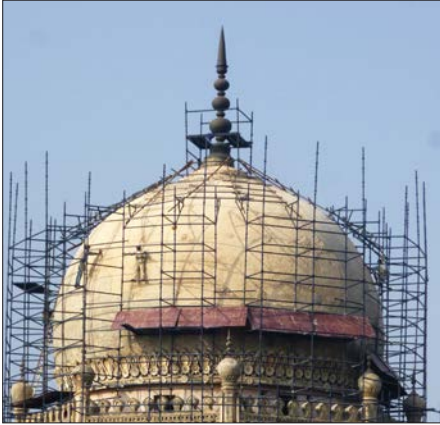
Removal of Cement Plaster

- Exhaustive documentation of the stucco plaster patterns was carried out and this was studied to understand extent of variation on motifs.
- A template was prepared to allow scientific decision making on the extent of dismantling followed by restoration. Variation between adjacent patterns on each side was considered acceptable and only in case of excessive deterioration/ use of cement/ variation in excess of 20% between adjacent motifs was replacement considered necessary.

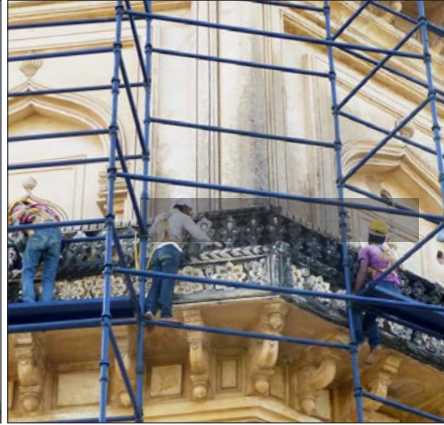
Restoring Ornamental Stucco Plaster

- Conservation works – repairs to restoration – on the highly decorative merlons stucco plaster patterns on the parapet walls on the upper terrace have been repaired and finished with lime putty.

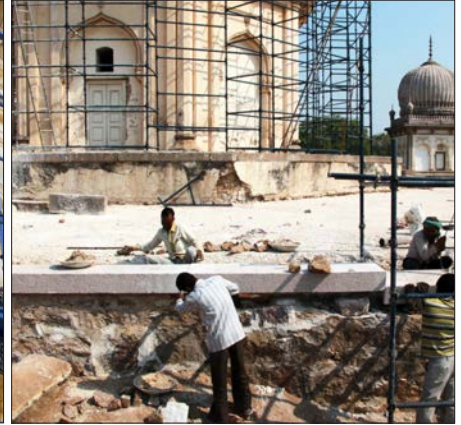
Installing Stone Edging on Plinth

- Over 100 cubic meters of cement concrete was dismantled from the plinth and the plinth was lowered to its original level.
- Over 150 meters of stones of matching colour were hand chisel dressed on top and sides to match the texture of the existing and were used as plinth edge band.
- 80 cubic meters of lime concrete have been laid on the plinth.
- Steps which were inappropriately placed on the west side of the square and octagonal plinth were dismantled and reinstated on the east side as found in the archival images.
- Over 350 square meters of lime plaster has been done on the plinth wall.

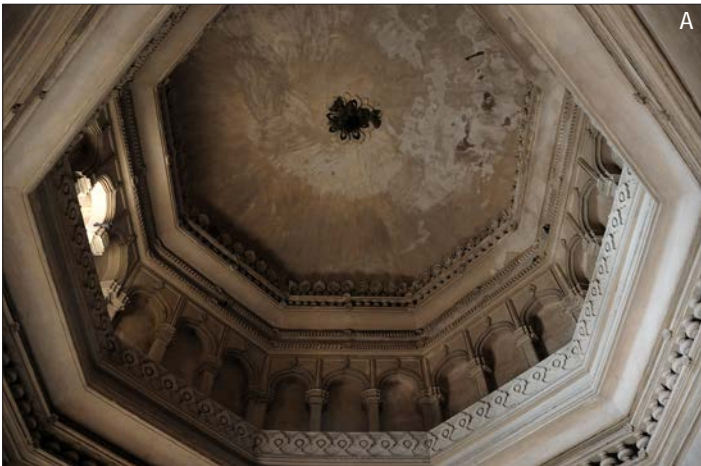
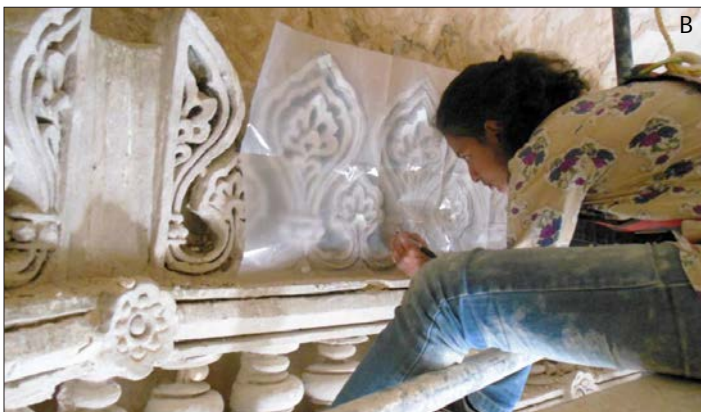
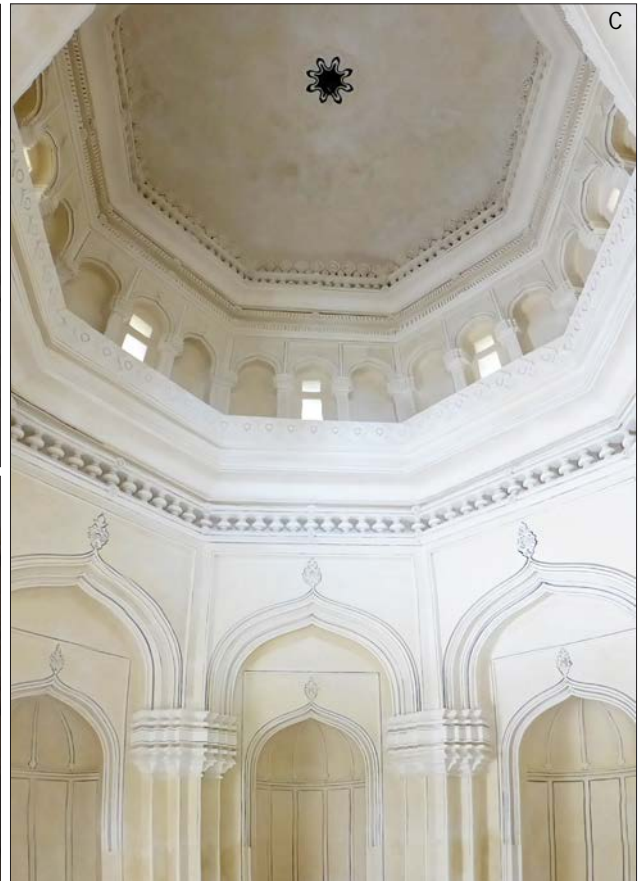
A: Interior chamber of the tomb before conservation in 2013; B: Detailed documentation of plaster motifs was analysed to determine the conservation strategy; C: Interior chamber after conservation in December 2014. Note that the central arched openings on all eight sides have been re-opened.

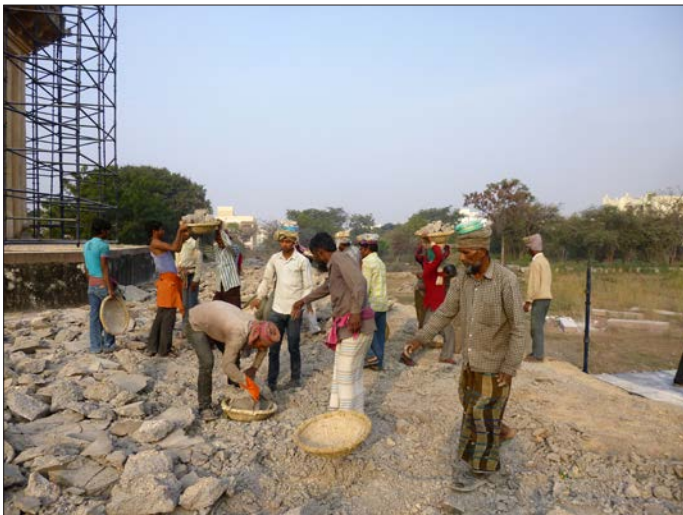
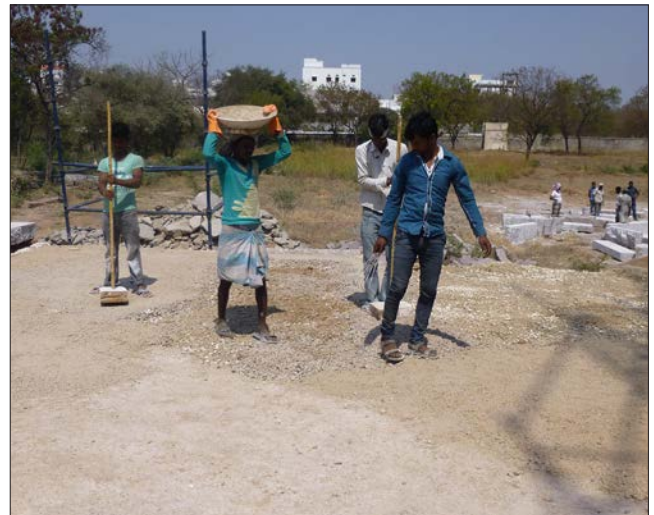
(Left) Removal of cement concrete from the plinth to halt further deterioration and (Right) laying of lime concrete

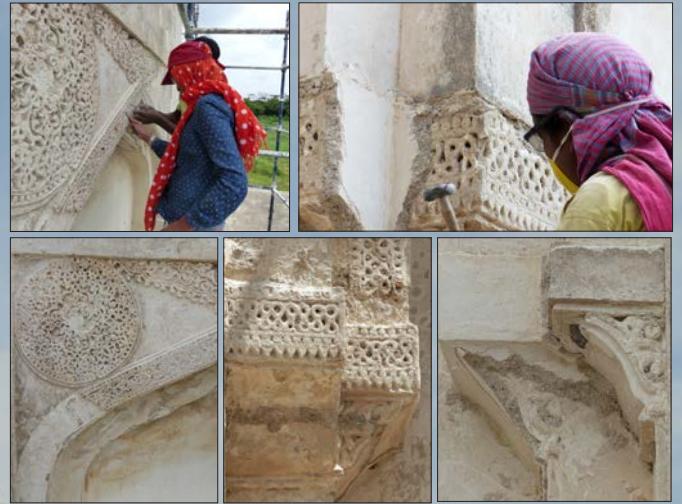
◀ August 2014

Removal of layers of cement plaster from the facade revealed historic stucco plaster in September 2014

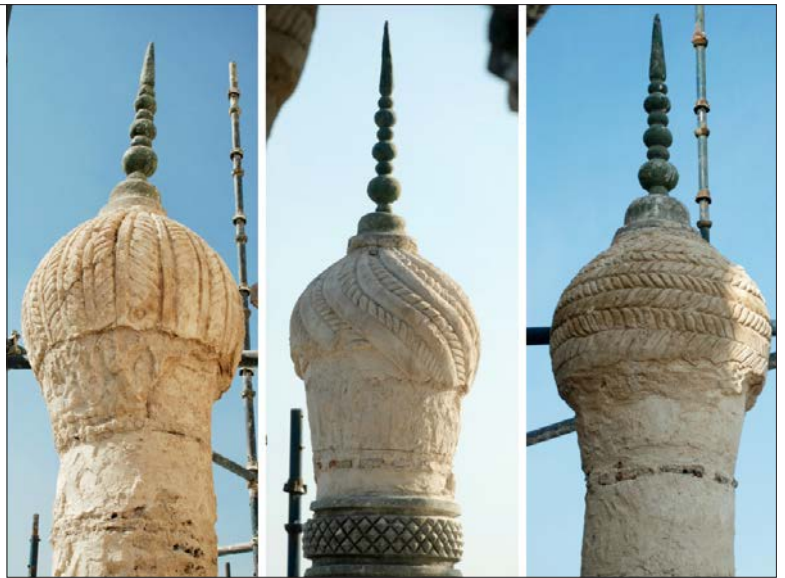
The archival images of 1860s depicted the Tomb of Sultan Quli Qutb external surface to be covered with ornate lime stucco works on the walls. The arches were crowned with medallions. The minarets had ribbed plaster and the merlons were studded with highly ornate lime stucco. However, mid-20th century repairs have obliterated original details and the tomb was found covered with a layer of cement plaster.

- Careful cleaning and dismantling of the plaster on both internal and external wall surfaces revealed traces of original lime stucco as well as incised plasterwork on elements such as the merlons, petals on the springing point of the dome, domes of the minarets, on the arch bands, spandrels of the arches, amongst others. .

- All the capitals of the recessed arches still have traces of the ornate plaster.
- On top, the petals below the dome were found to be of a different size and design which was changed with layers of later additions. These petals have been cleaned to reveal traces of the ornate plasterwork.

- Based on the revelations found on the surface, patterns will be traced and are proposed to be restored wherever found missing.
- The original designs found on the minarets will be repeated in pattern as revealed.
- Patterns visible in the archival images on the band below the merlons will also be restored.

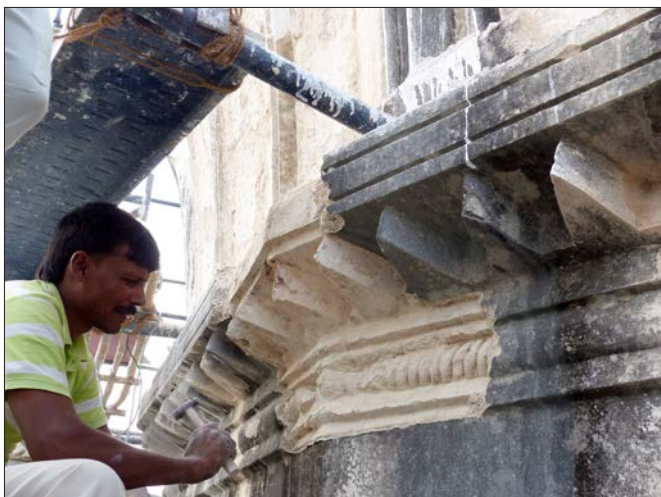
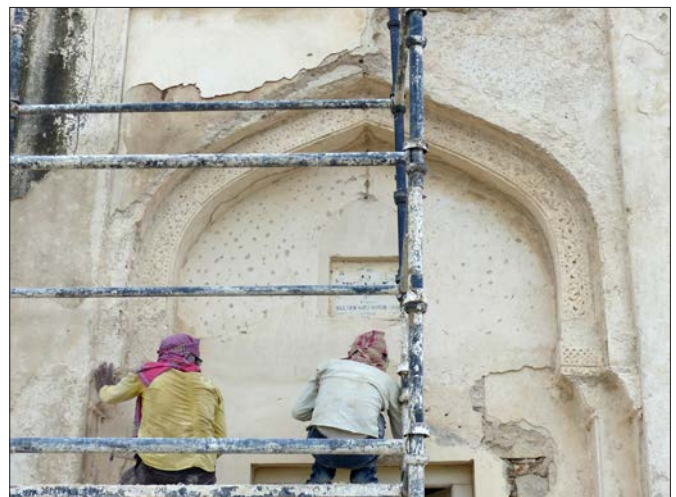
Over 2 layers of cement, brick and loose lime plaster carefully removed using small hammers and chisels on the external surfaces and revealed intricate lime stucco works on the springing of dome (Left) and east entrance of the tomb (Right)

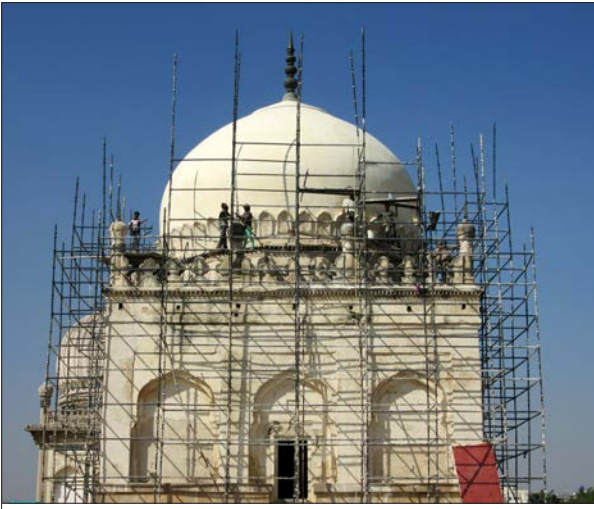
(Left) 20th century cement plaster from the dome and walls will be removed and replaced with a traditional lime plaster

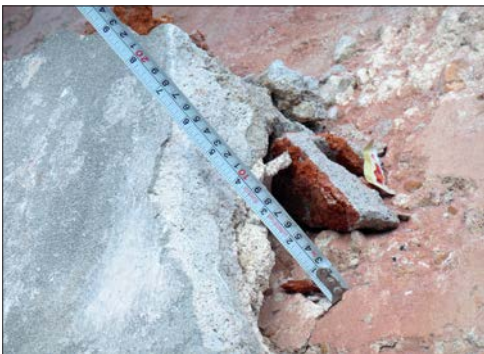
(Left) 6" thick layer of modern plaster with brick infill was removed from the dome prior to replacing with lime plaster

- Around 200 square meters of cement plaster was dismantled from the dome.
- Removal of cement plaster revealed loose portions and holes which were filled with lime concrete and stone and finished with rough plaster.
- 5 cm thick lime plaster was applied to the dome surface upto the top of drum and finished with a final coat of lime punning.
- The drum was cleared of the loose lime plaster revealing original layer of intact lime plaster.

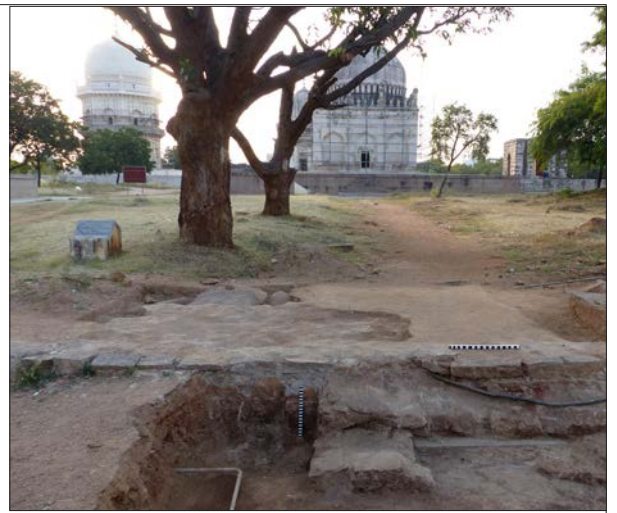
(Above) Excavation carried out in November 2014

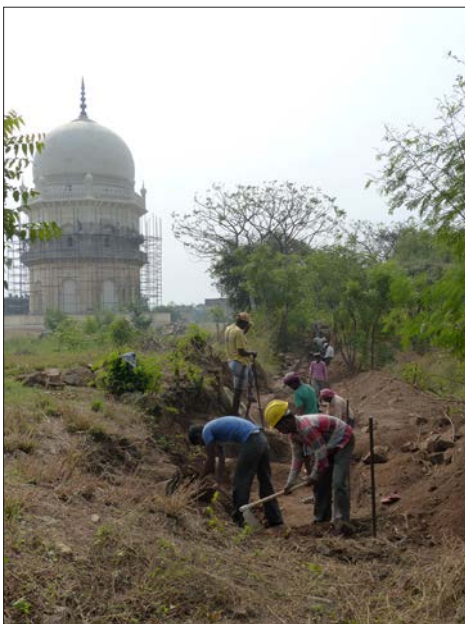
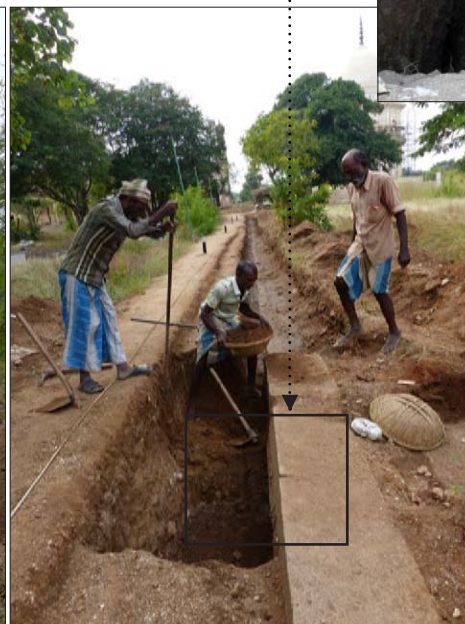
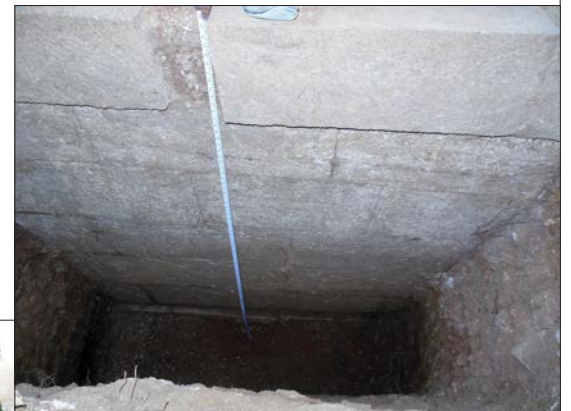
(Left) Excavations unearthed enclosure wall for this tomb on all four sides, giving evidence of the garden enclosure which will be restored. At places, the depth of wall goes down to 7ft from the present ground level.

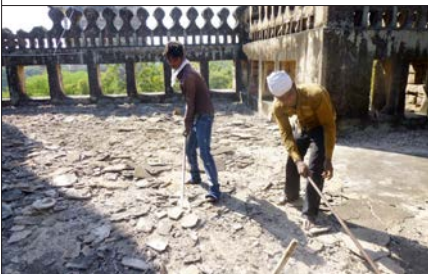
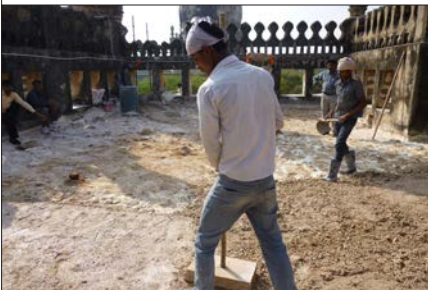
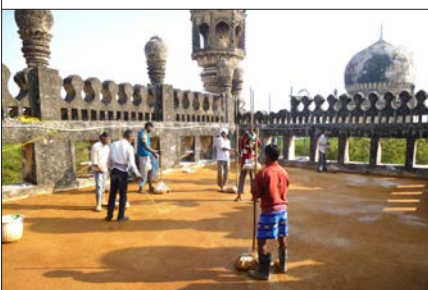
Inappropriate 20th century repairs had caused significant deterioration to the structure and the mosque committee approached the Wakf Tribunal seeking urgent repairs by the Department of Archaeology. AKTC was in turn requested to undertake the repairs.

- Following investigations, over 40 cm of cement concrete and loose lime concrete weighing over 120 tonnes was removed from the roof of the Mosque.
- The existing water spouts were cleared of vegetation and repaired to ensure quick disposal of rainwater.

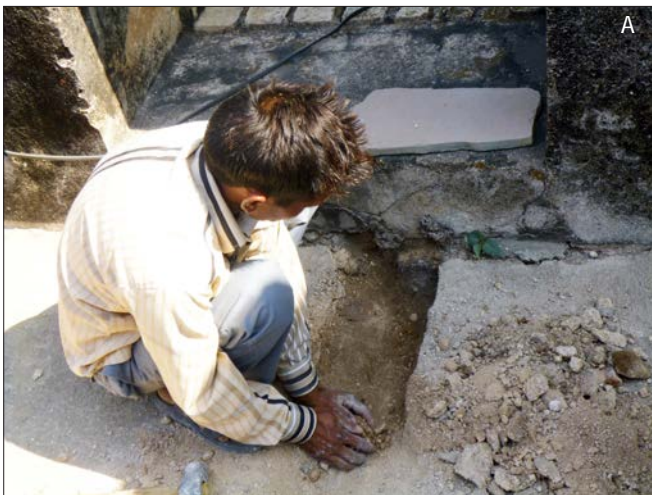
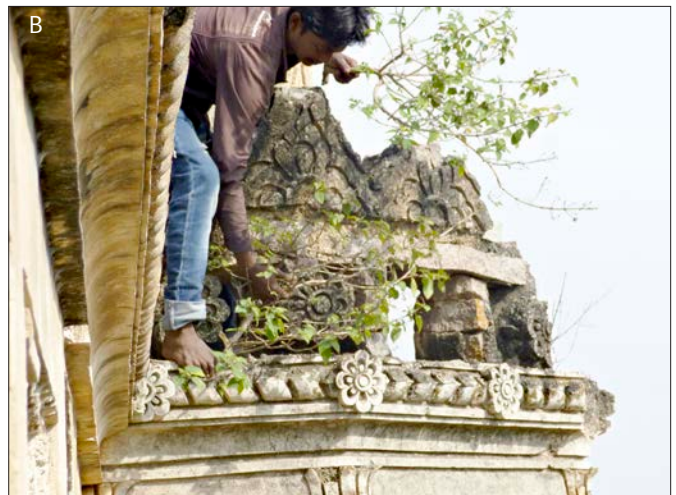
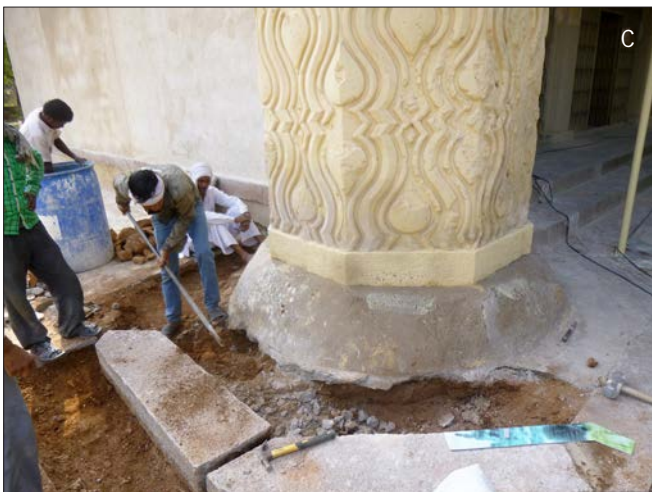
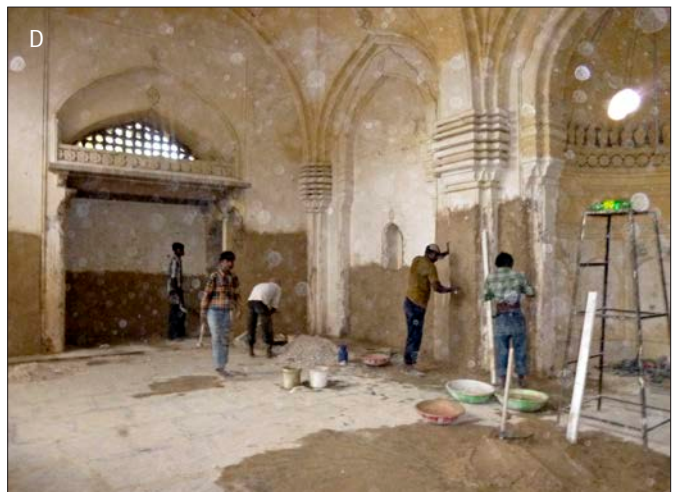
A: Opening of rainwater spouts; B: Vegetation removal; C: Replacing missing dressed stones on the base of minarets; D: The internal surface have also been cleaned of the cement and a coat of lime plaster is now being applied.

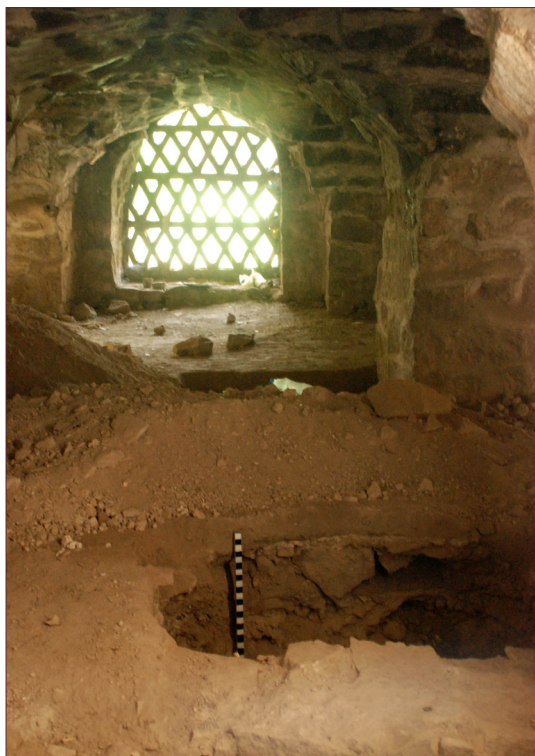
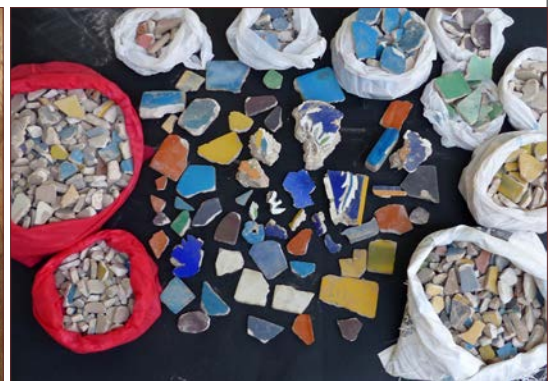
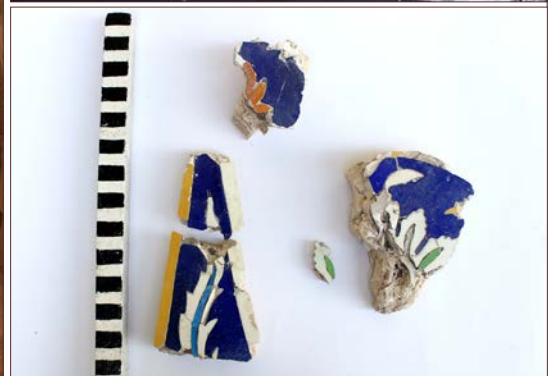
(Below) Several trial trenches were made in 5 locations in the lower chamber of the monument to help determine the original level at the chamber level as well as get a better understanding on the structure of the monument. One of the trenches revealed a heap of glazed tiles of different colors like orange, yellow, white, turquoise, blue, green, grey and violet.

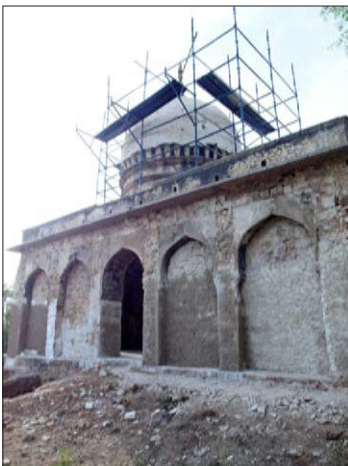
(Below) Intensive conservation works included removal of cement plaster from internal and external surfaces, followed by replastering with lime mortar. A plinth protection and granite steps have also been added.

A: Replastering dome in lime mortar; B: Adding granite plinth protection; C: Replastering internal surfaces with lime plaster; D: Cement flooring replaced with stone

- The clogged rain water spouts which were cleaned and repaired.
- The dome was replastered with lime mortar and finished with thin layer of lime punning.
