QUTB SHAHI HERITAGE PARK

CONSERVATION & LANDSCAPE RESTORATION

ANNUAL
REPORT
2014

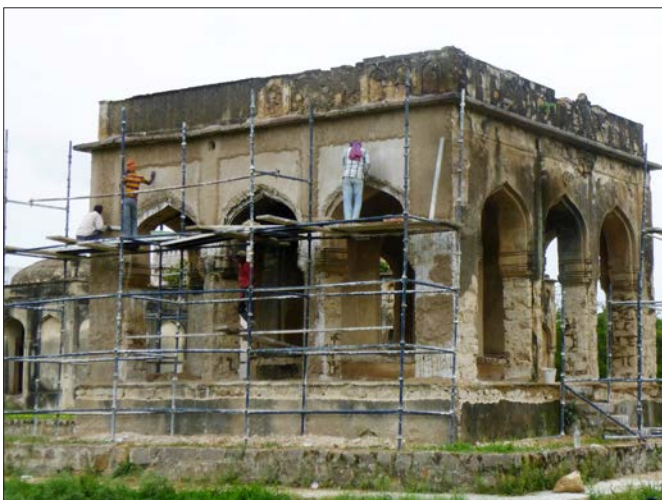
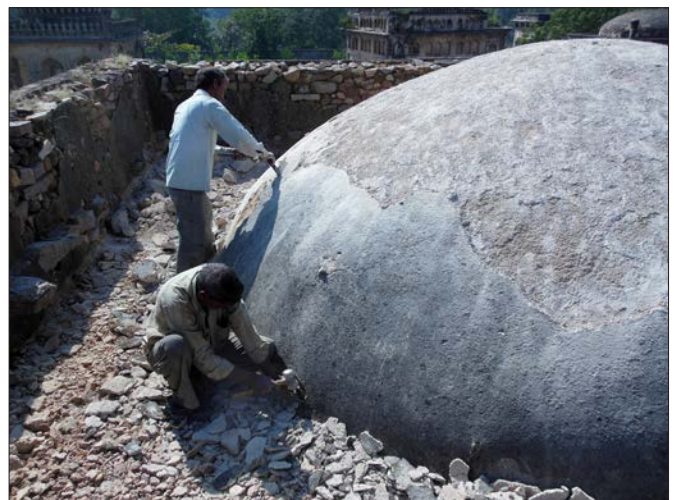
(Left) Replastering of external portions where cement or loose lime plaster was removed; (Right) Loose lime plaster and concrete was removed from the dome

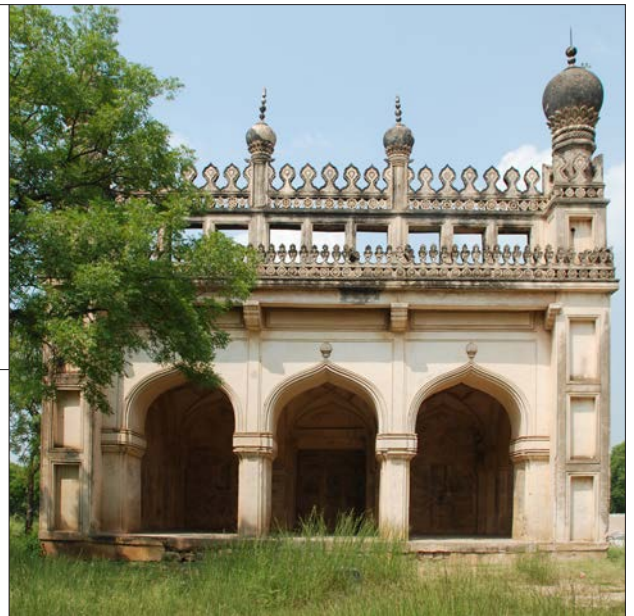
(Above) The external surface plaster was dismantled and fresh lime plaster was applied to the rear, north and south sides

- Final finish of the internal surface with a coat of lime putty.
- Repair of the merlons and other decorative medallions on the front face.
- Final finishing of the external surface with a coat of lime putty revealing all the ornate details.

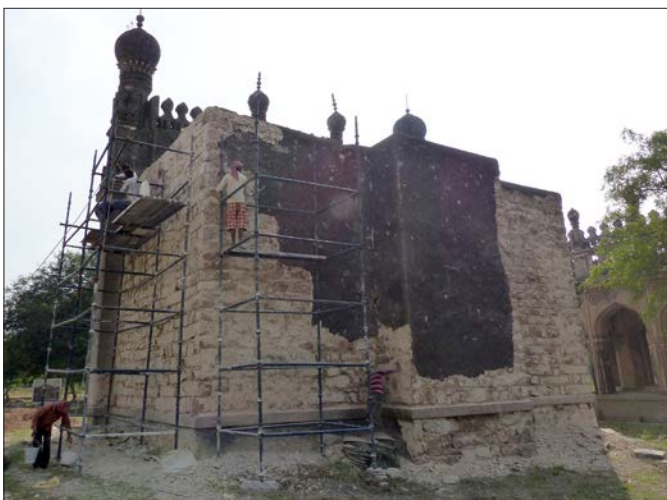
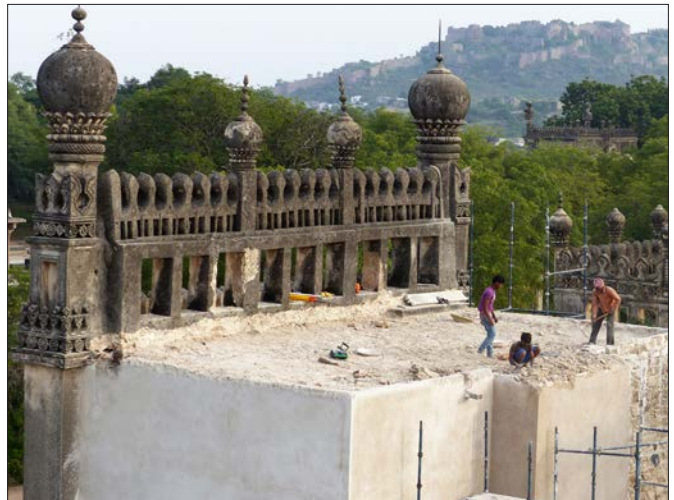
A typical mosque measuring around 16 meters in front and 6 meters on sides, the front facade of the mosque was found largely intact. However, the external facade on the rear and the north and south sides had signs of cracks in plaster and were loose. The roof was also found to be leaking and signs of moisture could be seen on the internal side of roof.

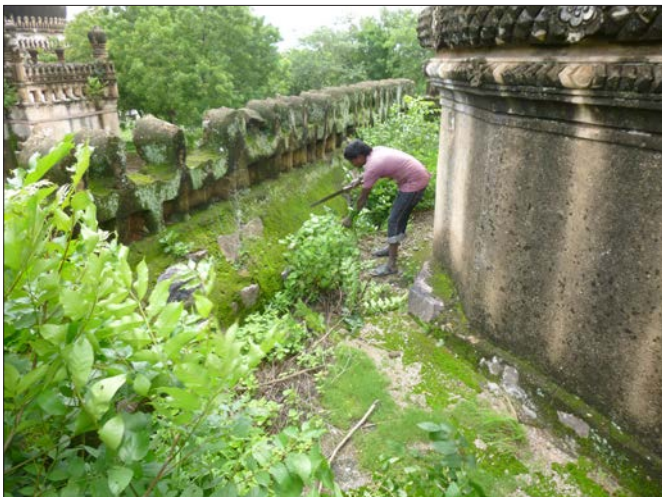
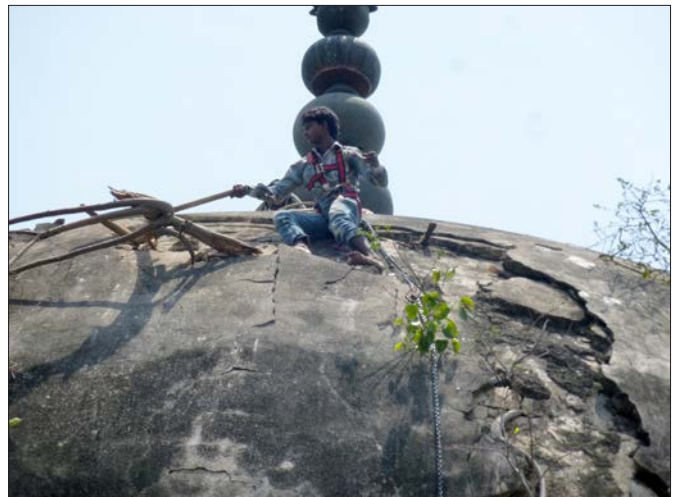
(Below) Almost each of the 72 monuments had a profusion of vegetaton causing excessive damage. On the larger structures 20 feet of roots have been removed. This exercise will require to be undertaken annually untill conservation works are completed.

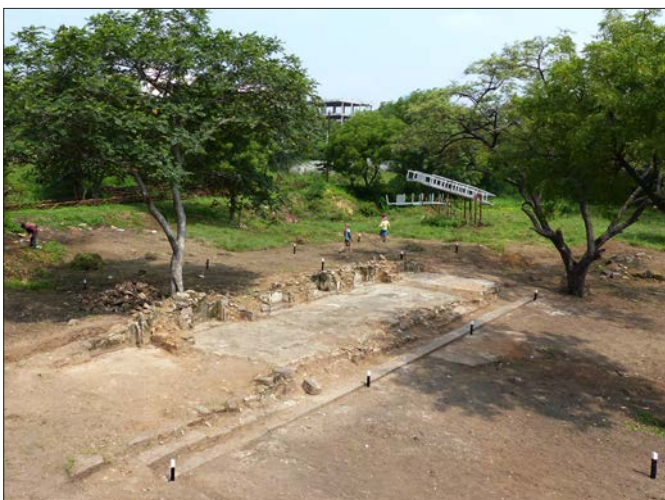
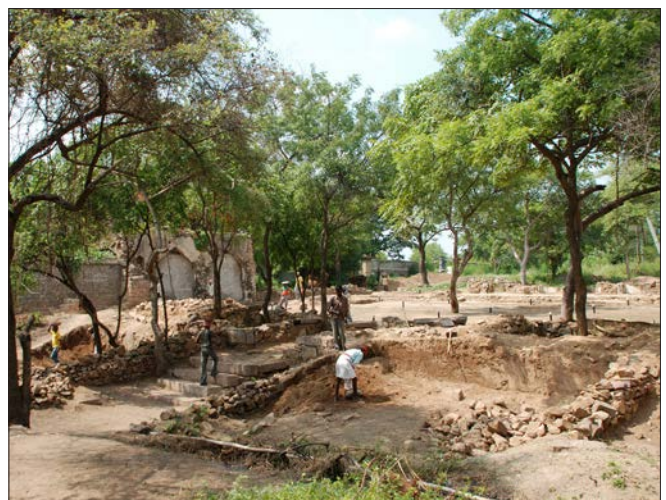
(Below) An extensive labyrinth of structures have come to light in the section north of the Hamaam. These include many living quarters.

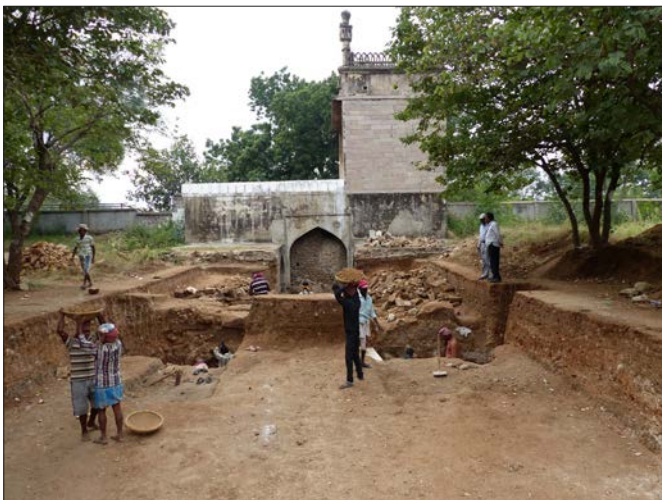
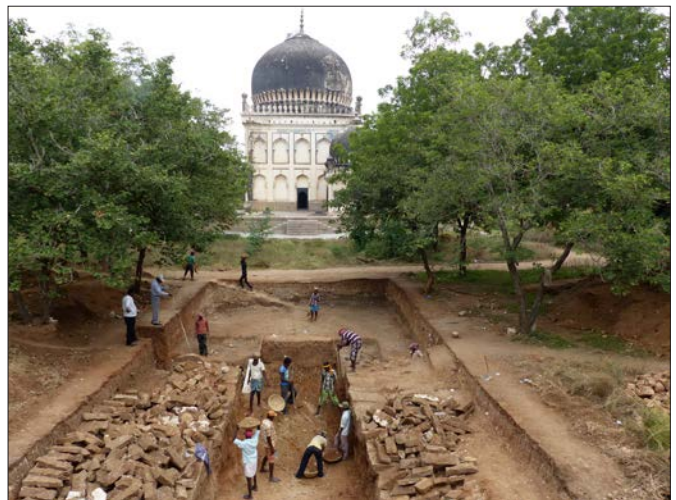
- Careful removal of earth has led to the pathway and retaining walls to be revealed
- The exposed remains have been photographed and measured drawings conducted.

(Below) Scientific trenching at the South Gate

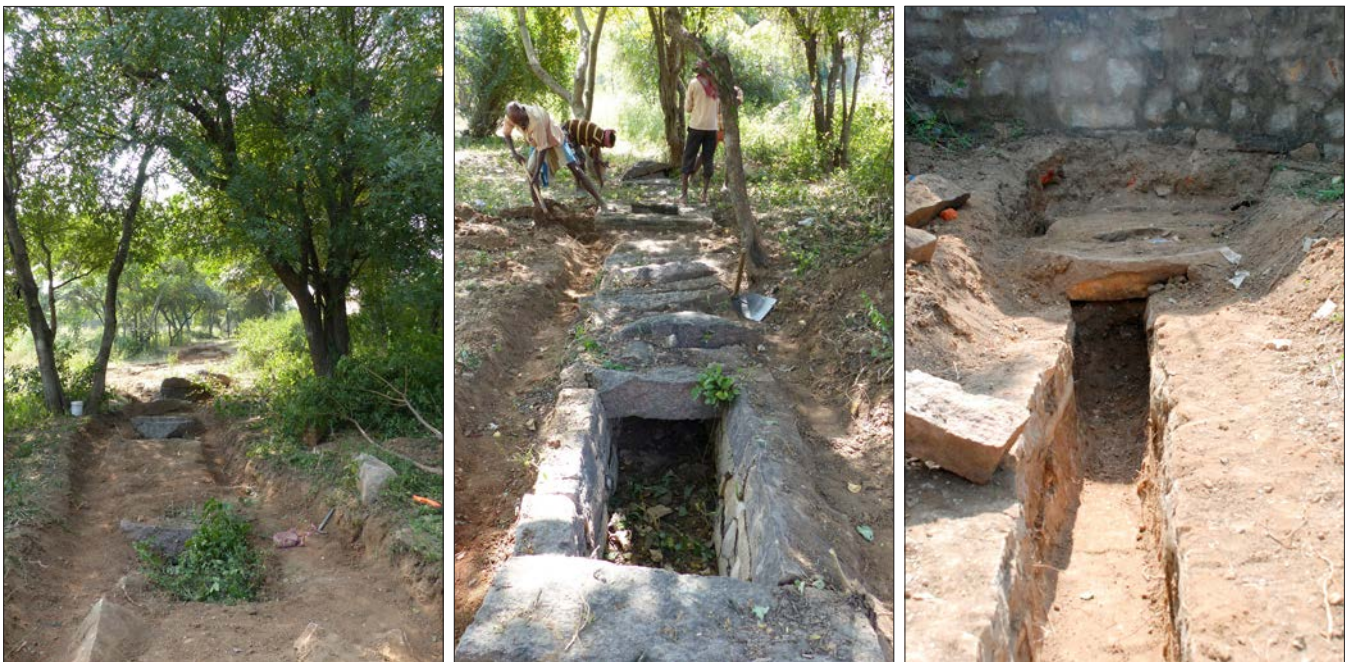
30. Exposure of Aqueduct

An aqueduct belonging to the period of Qutb Shahi dynasty was exposed partially from the northern side up to the southern side of the site along its western edge.

(Below) The Qutb Shahi aqueduct was traced and exposed. On the basis of the study of the slope of the floor level of the aqueduct, it is reasonably felt that it was for conserving the water inside Bagh-i-Faiz. The exposed length of the aqueduct measures 246 meters.

- Removal and resetting of the stone blocks covering the channel.
- Pointing to strengthen the structure and water tightening so that the vegetation growth is arrested.

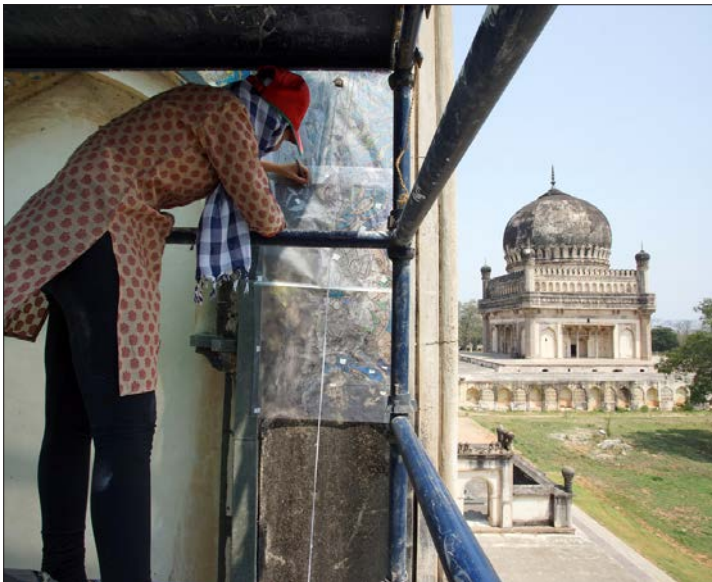
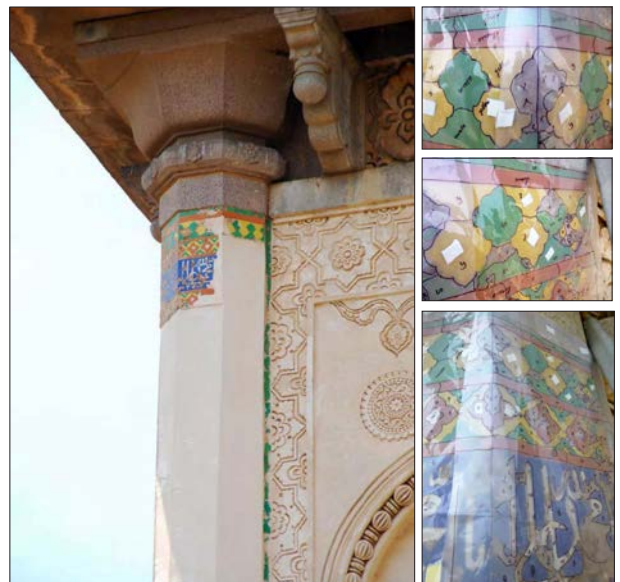
(Below) Each of the tombs have been extensively documented with the tile work being traced and measured along with a conditional assessment

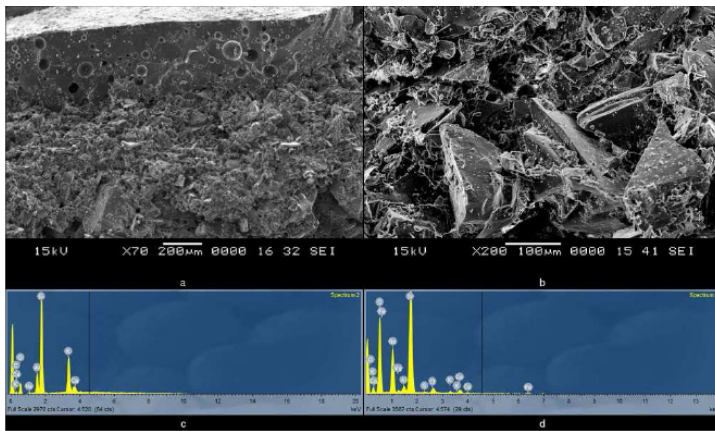
Dark Blue Tile

The tile samples were first observed using a simple low-power binocular microscope to record their macro characteristics. Detailed compositional and microstructural analyses were then performed using a Jeol 5910 scanning electron microscope (SEM) equipped with an Oxford Instruments Inca 300 energy dispersive X - Ray analyser (EDA).

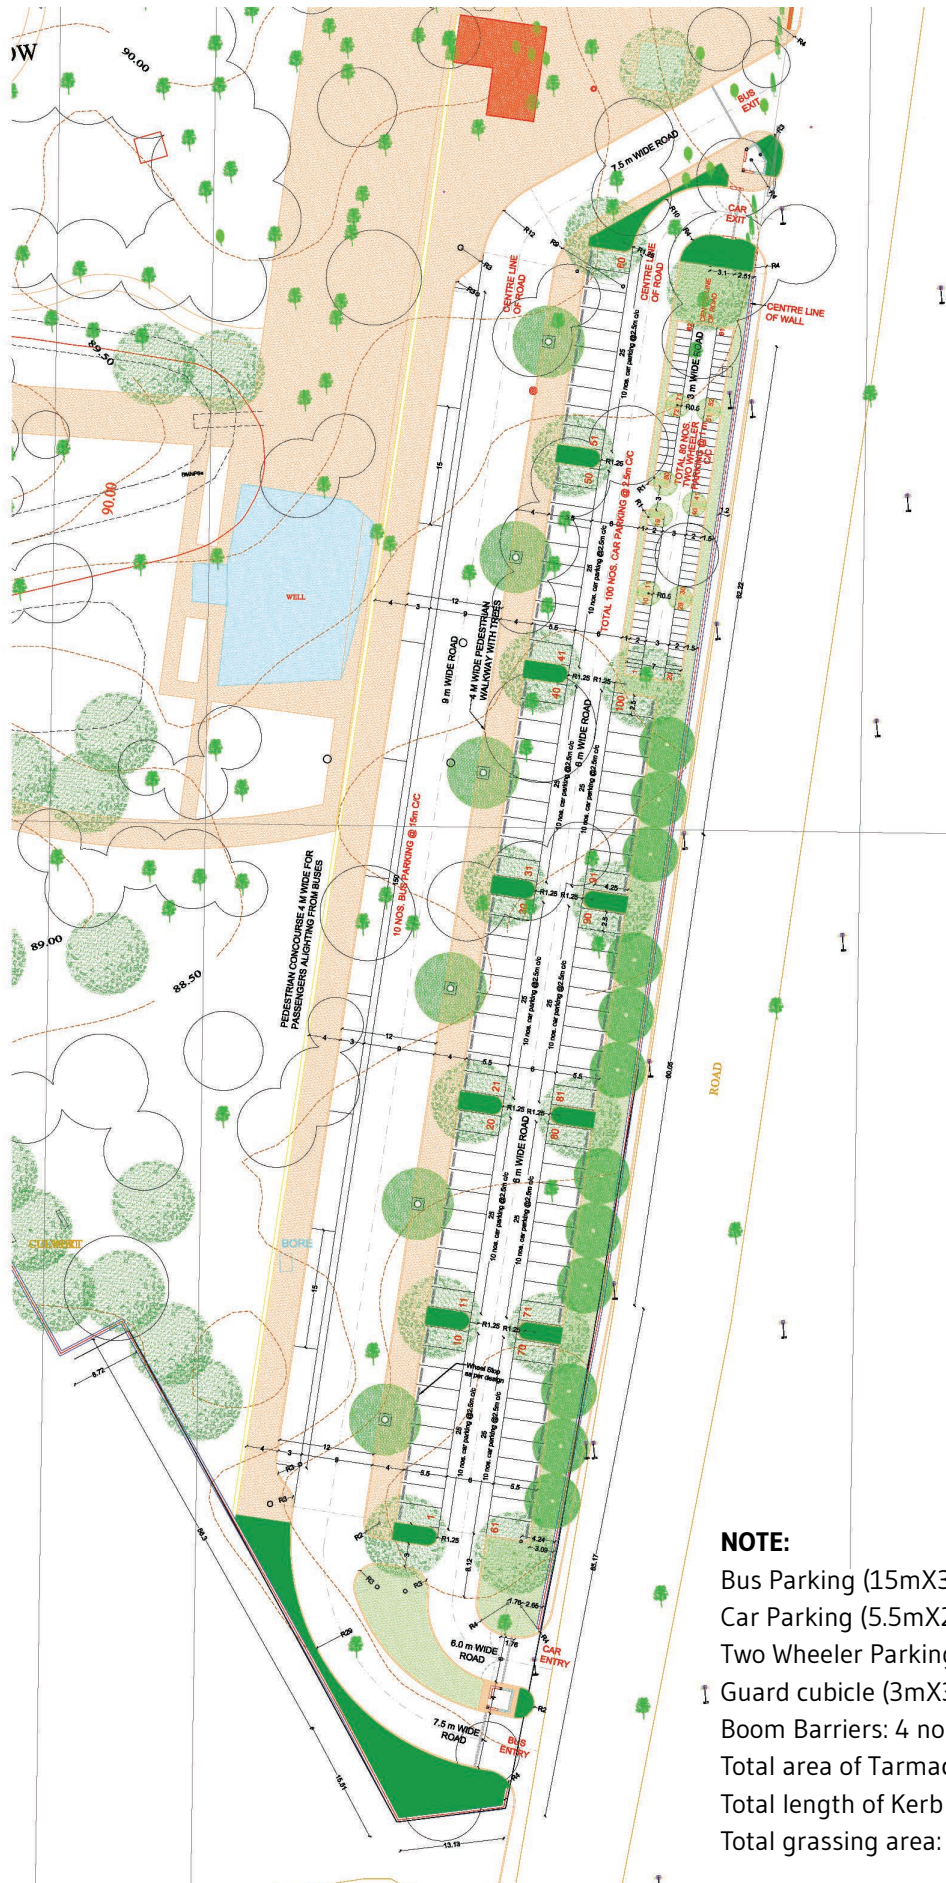
Proposed Parking Layout at Qutb Shahi Heritage Park

At present the Qutb Shahi Heritage Park lacks parking facilities for visitors. To facilitate the needs of vehicular parking for the Park, a parking area has been proposed along the main access road – with the assumption that Deccan Park will eventually be re-integrated with the heritage area which it was once a part of.

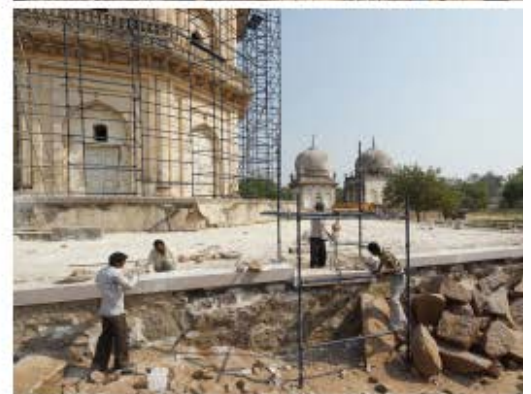
Conservation works commenced after (Top) exhaustive documentation, condition assessment, surveys, research was carried out by the multi-disciplinary, followed by emergency repair works at Badi Baoli and Janashd Quli Qurb Shah's Tomb (middle and bottom)

As a priority, over 600 cu.m. of stone masonry walls of the Badi Baoli were rebuilt prior to monsoons in 2014. Conservation works here included removal of 400 cu.m. of collapsed masonry from within the well in a dangerous operation.

At Jamshed Quli Qutb Shah's Tomb, the removal of deteriorating cement plaster from the domed surface and restoration of traditional lime mortar was carried out to prevent further water ingress which was causing significant cracks. The stucco plasterwork is also being restored on both the internal and external wall surfaces as is the stone edging of the lower plinth – clearly visible in archival images. On the request of the local community emergency repair works have also commenced on the Abdullah Qutb Shah's mosque, the roof of which was leaking and from where over 400 mm of cement concrete weighing over 110 tones was manually removed.

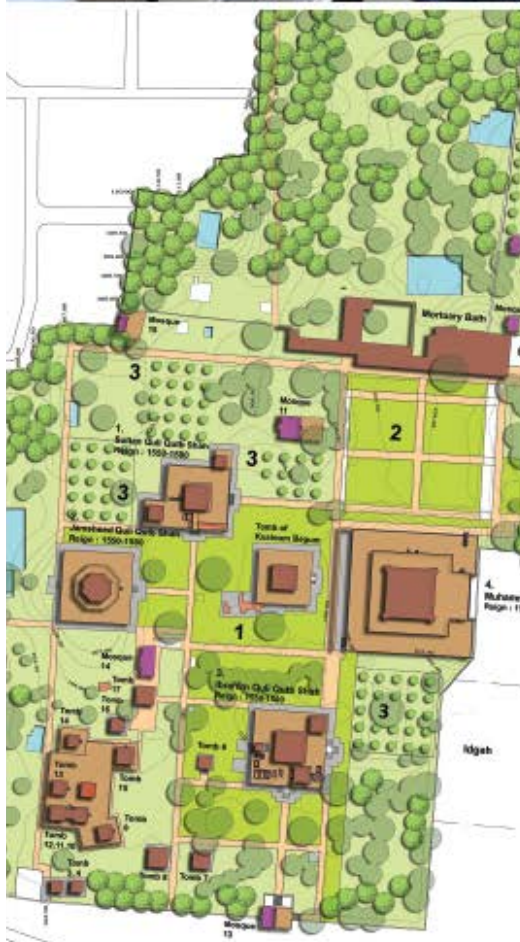
The proposed landscape plan would appropriately utilize the space of the 'Deccan Park' as a generously proportioned entrance zone hence establishing an effective presence on the public road, and avoiding the present anomaly of the indirect approach that does not encourage an even spread of visitor activity across the complex. Judicious modification and re-organisation of entrances and paths will increase accessibility of the older parts of the complex and allow visitors to easily traverse the whole site and understand its sequential development rather than restrict their experience to only a part. A path system based on the history of the place would play a vital role in enriching the visitors' experience of this large, deep and complex historical site.

(Top) Mr. Somesh Kumar (IAS), Commissioner, Greater Hyderabad Municipal Corporation (GHMC) with AKTC team discussing works at the site ; (Bottom) Proposed Landscape Masterplan for Qutb Shahi Heritage Park
