AGA KHAN DEVELOPMENT NETWORK  
QUTB SHAHI HERITAGE PARK  
CONSERVATION & LANDSCAPE RESTORATION

2016  
ANNUAL REPORT

Conservation & Landscape Restoration

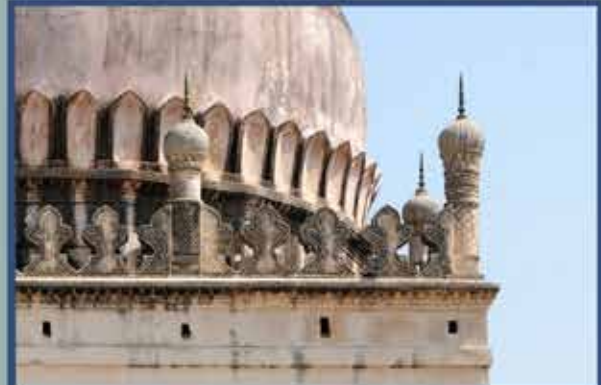
*However, mid-20<sup>th</sup> century repairs had obfuscated original details and the tomb was found covered with a layer of cement plaster*

*As part of the conservation efforts, several layers of cement, which were added during 20<sup>th</sup> century repairs, were removed.*

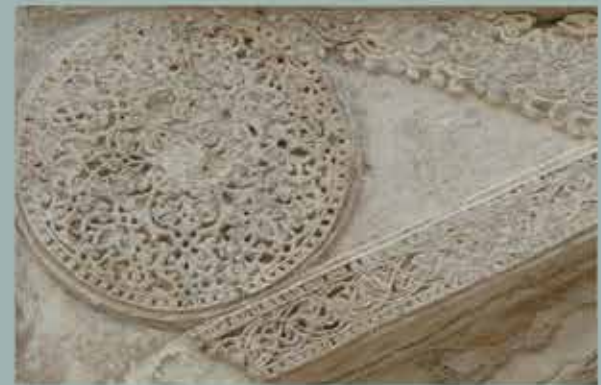
*This revealed intricate stucco medallions and arch crowns on the North facade. Similar patterns were found on the arched openings.*

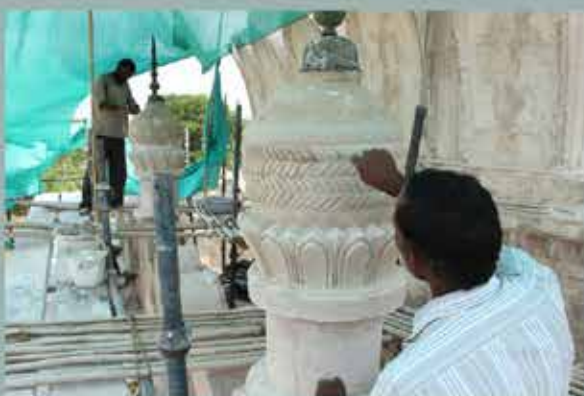
*Discovery of these patterns in-situ allowed a scientific restoration of the patterns where these were missing. Restoring historic details using traditional techniques and materials.*

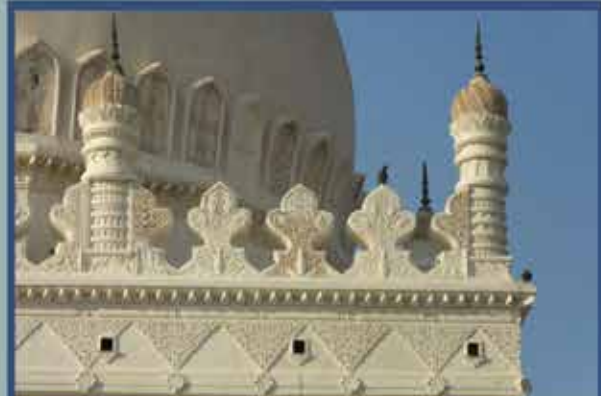
*The restored structure rich with all the original intricate detailing.*

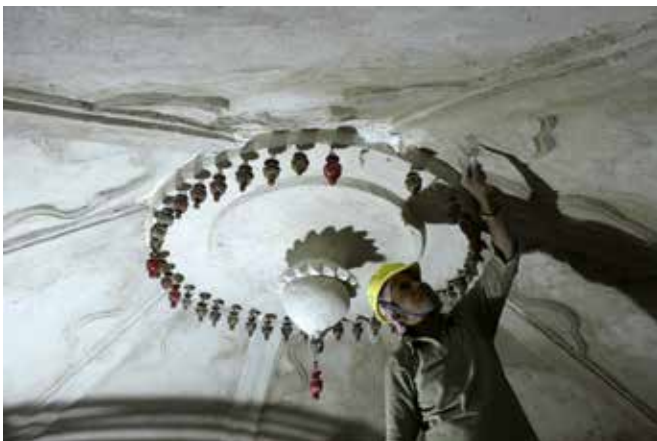
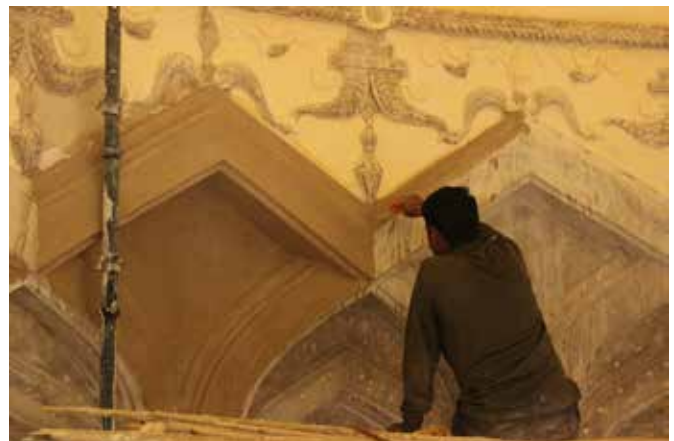
*(Left) Repair of the damaged central medallion on the dome ceiling*

*(Right) Restoration of the missing portions of the original details by master craftsman*

- 20 of the 32 missing wooden pendants of the central medallion at the dome ceiling were reinstated as per evidence.
- The damaged central medallion on the dome ceiling was repaired with lime mortar and finished with lime putty and organic colors as per the physical evidence.

- The ribs on the internal dome were scrapped of the later added layers and repaired with lime plaster.
- A number of original details were obfuscated by addition of modern plaster. This was carefully removed in order to mitigate any unintended damage to the original details. The missing portions were restored based upon the existing site evidence.

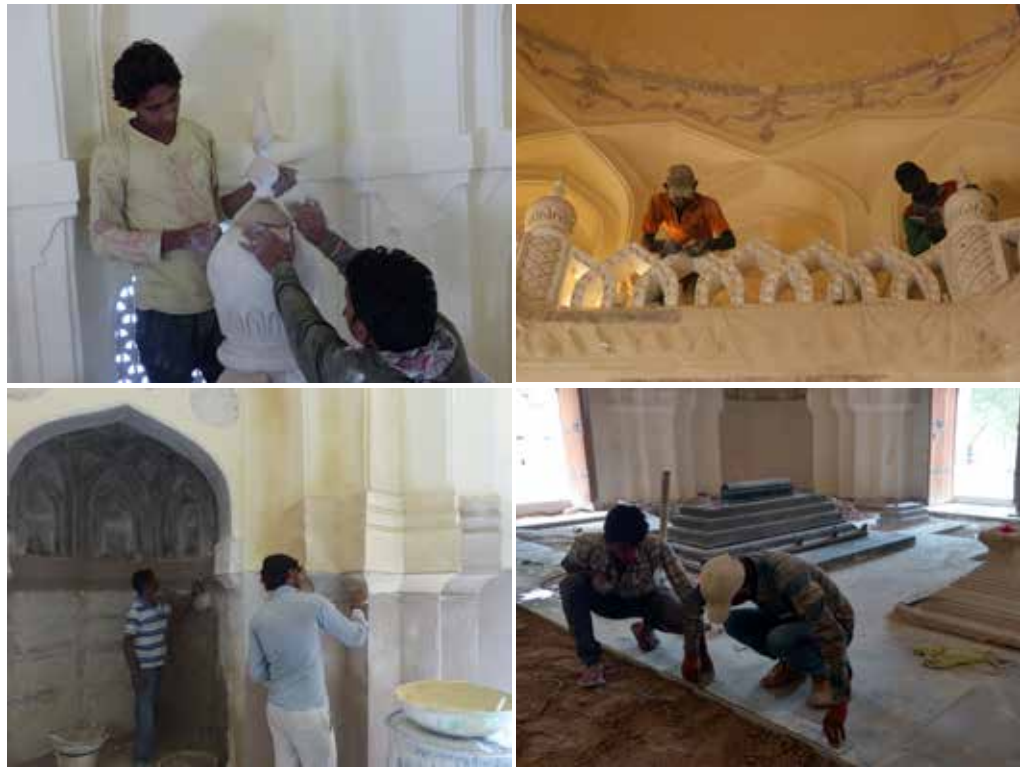
*(Clockwise from left) Missing finials on minarets reconstructed using lime mortar; later added lime wash was scrapped off from the intersecting arches above the gallery level to reveal the original profile and ornamentation; rich lime mortar applied on the entire internal surface after necessary repairs to the existing details; 30 mm thick granite stone slabs laid to appropriate slope and approved pattern*

- Missing finials on 3 minarets were reconstructed using lime mortar as per the existing design and installed.

- The bulb of one minaret was missing and had to be reconstructed using traditional lime mortar and stones.
- During investigation at the arch gallery level, an intricate rope band was revealed after the removal of later layers and this was duly restored.

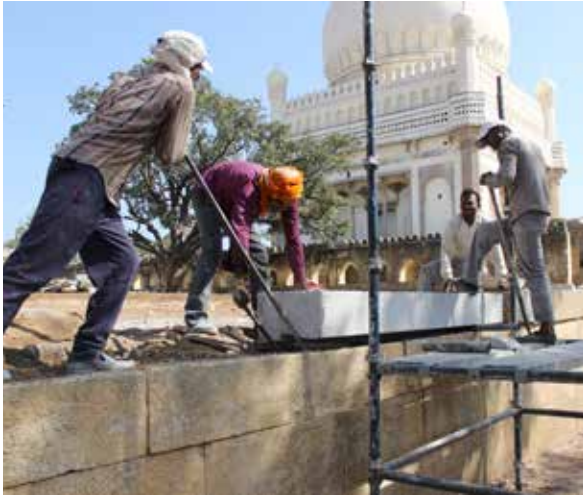
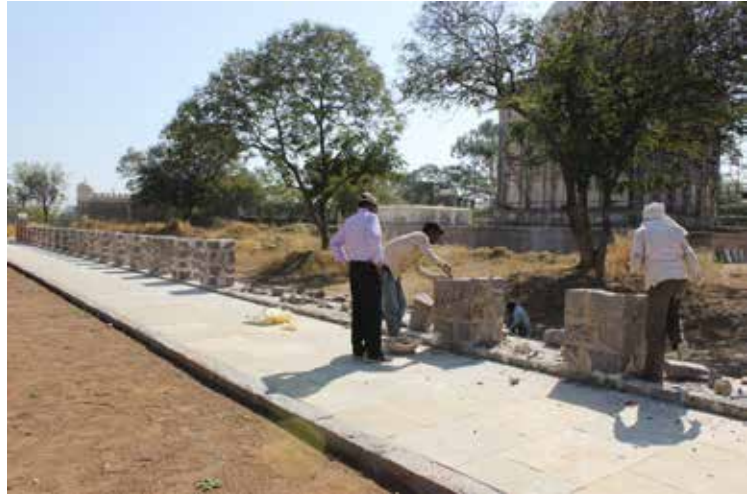
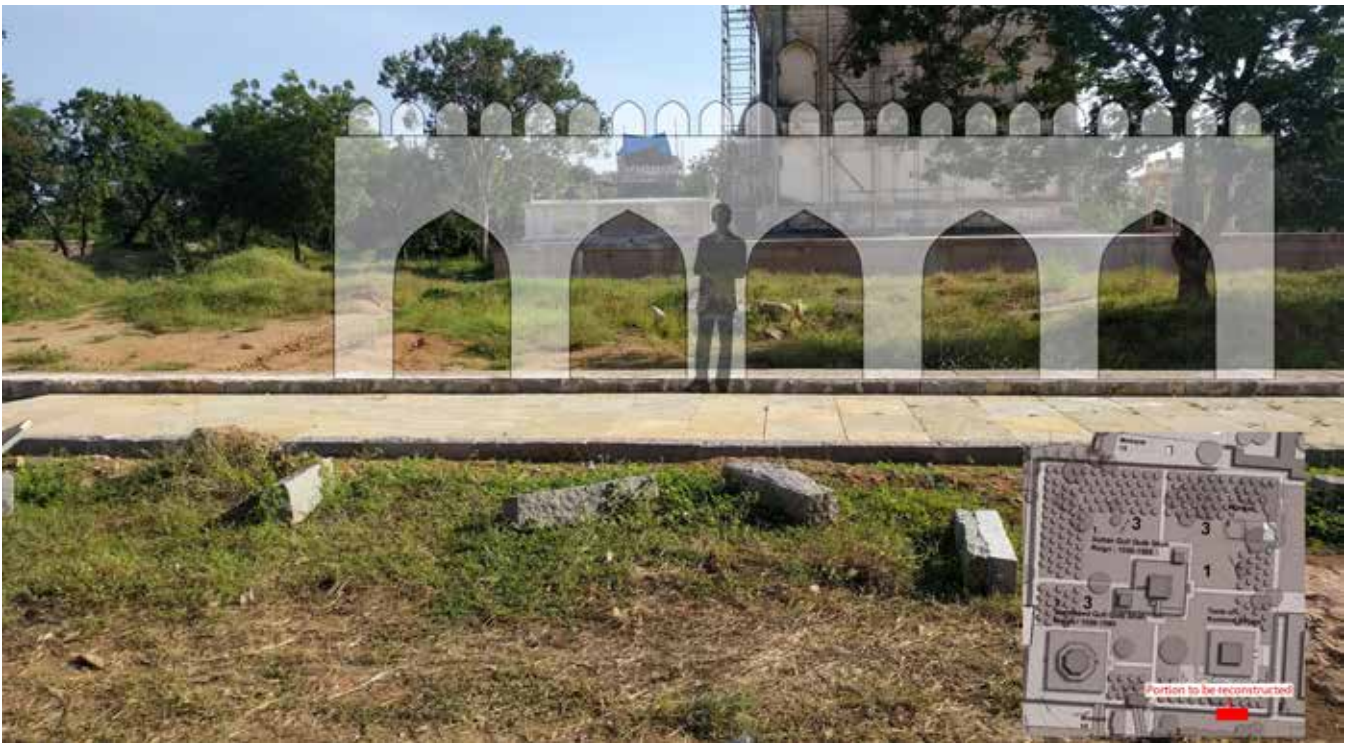
(Top Left) Missing coping stones were fixed on the enclosure wall;  
(Top Right) Columns for the arches were made  
(Below) Illustration showing proposed arcade on the enclosure wall

- A total of 150 stones for coping were hand chisel dressed by over 50 stone craftsmen to match the existing stones.
- The coping stones have been fixed on the enclosure wall starting from the south east corner near Mohd Quli's mausoleum to the south west corner up to the Baoli near Jamshed.
- Portions of missing dressed vertical stones on the south side have been fixed in place.
- Masonry behind the coping stone has been completed on the south side.
- The missing arcade was marked on the wall and columns for the arches were made for the south east corner of the enclosure.

- The missing arcade over the 16<sup>th</sup> century enclosure wall on the south, west and north to be reconstructed thus reinstating the sense of enclosure envisaged by the original builders.
- Battlements and ornamental mouldings matching the existing on eastern arcade to be restored along the entire span of arcade to be reconstructed to reinstate the original appearance.
- Hand dressed coping stone to be installed on existing enclosure wall in the northwest corner to ensure subsequent reconstruction of the missing arcade over a length of 90 meters.

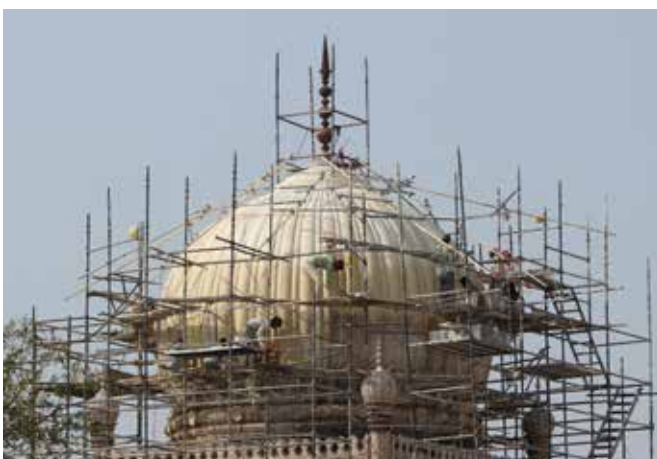
*Later added plaster layers from the dome were removed to reveal the original curved profile of the ribs, and repaired using lime mortar*

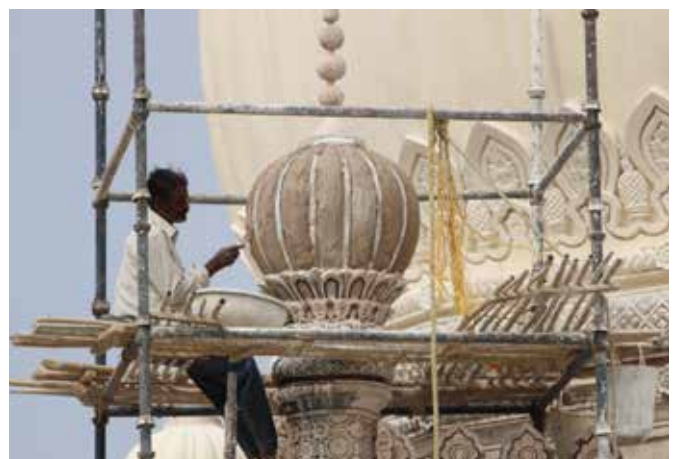
*The cemented portions of minars were removed and repaired in lime mortar*

- The profile of the bulb of the corner minarets was drastically altered as a result of inappropriate 20<sup>th</sup> century repairs in cement. The cemented portions were dismantled and profile of the bulb was restored as per the existing.

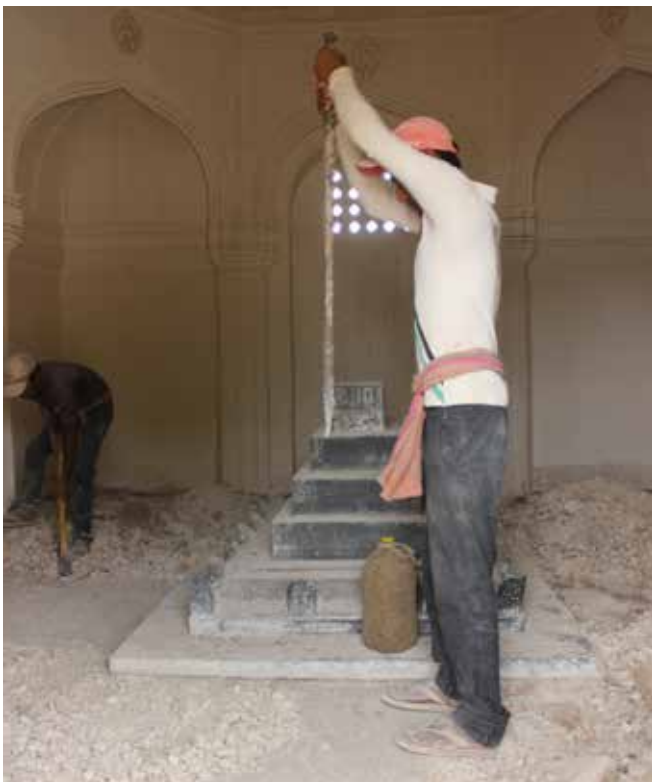
*(Left) 20<sup>th</sup> century cement flooring was dismantled  
(Below) Final lime finish of the internal surface*

- Minor repairs were carried out on the ceiling medallion using lime mortar.
- Dilapidated plaster on the ceiling of internal dome and the drum below was dismantled and re-plastered with lime mortar.
- Ornate ribs were scrapped of lime wash to reveal the original details.
- Moulding bands below the neck of the dome were partially restored.
- The lower surfaces were re-plastered with lime mortar and finished with lime punning.
- Most of the vertical circular moulding were found to be covered with cement and were subsequently repaired with lime mortar.
- The internal cement flooring was dismantled and replaced with 30 mm thick granite stone slabs laid to appropriate slopes and approved pattern.

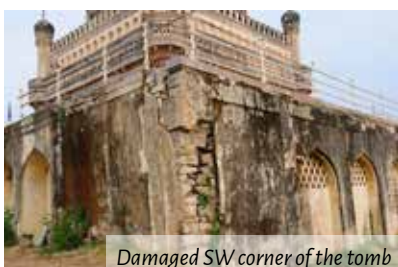
Damaged SW corner of the tomb

- Collapsed south-west corner of the lower tier of upper plinth was reconstructed using rubble stone and lime mortar. As this corner has been historically prone to structural failure, care was taken so as to interlock the masonry at the south-west corner junction and interlocking the junction of the reconstructed masonry course-by-course individually with southern and eastern edges.

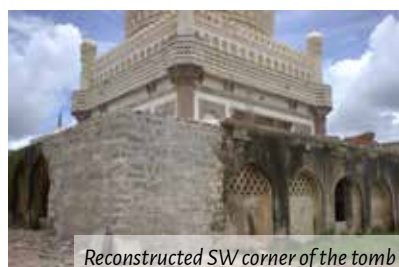
Reconstructed SW corner of the tomb

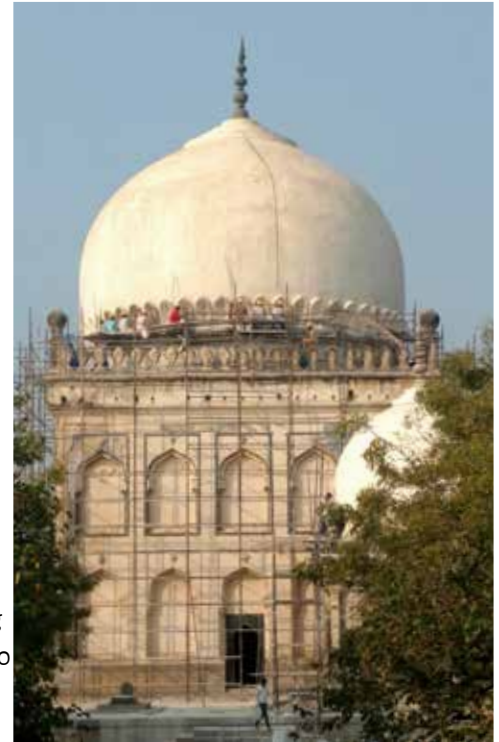
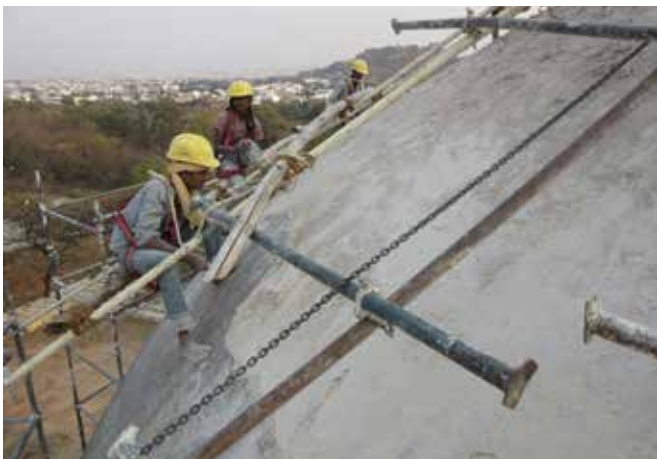
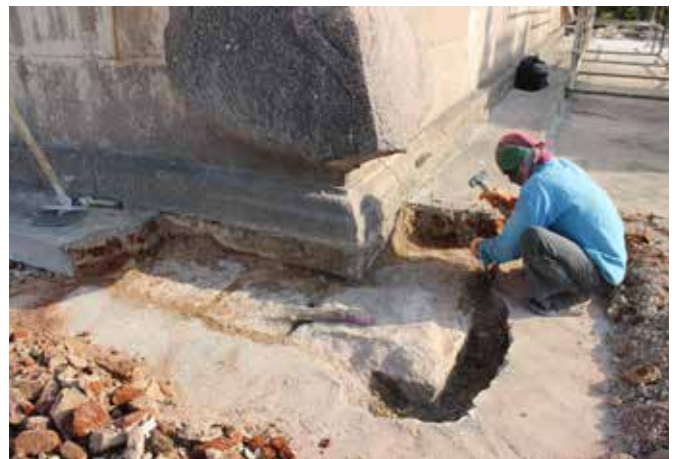
*Dismantling of damaged and loose cement plaster from the dome    20<sup>th</sup> century cement and brick paving abutting the main cenotaph removed*

- Dismantling of multiple layers of damaged and loose cement plaster on the dome was carried out along with removal of thick plant root growth. Following this, repairs in lime plaster on the external surface of the dome measuring 5500 square feet were completed in 2 days with 24 master masons.

- On the external surface, the paving in brick and cement abutting the main cenotaph was removed. This has revealed original stone edging on all sides.

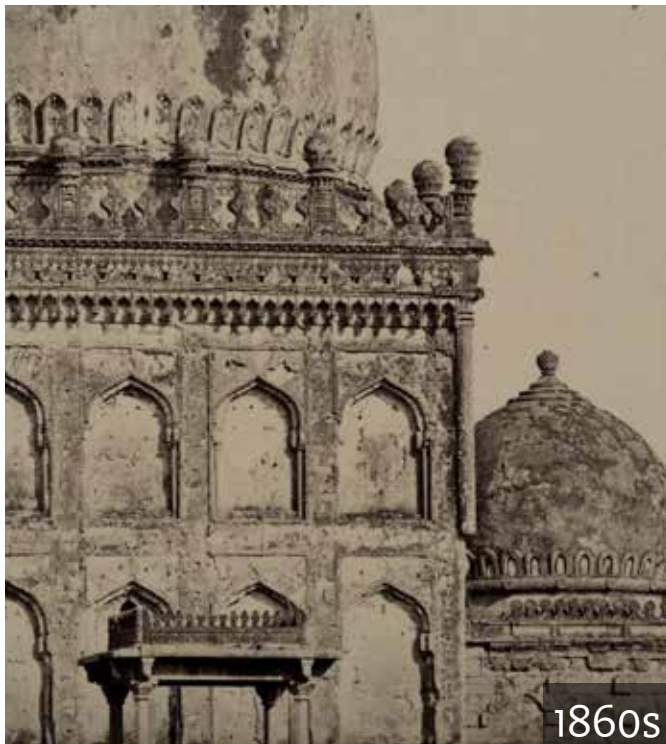
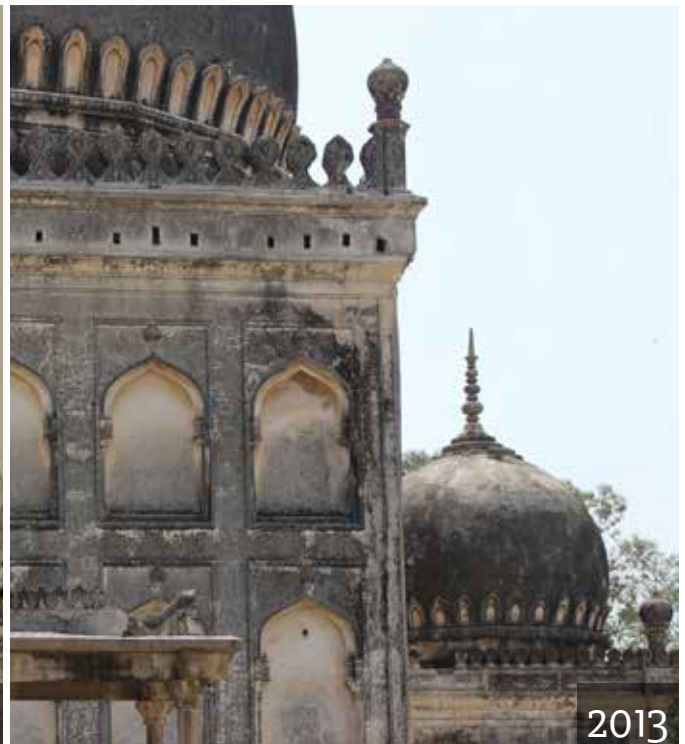
The 1860s image shows the tomb of Ibrahim Quli Qutb Shah with profuse ornamentation on the parapet - these were replaced in a later alteration, as seen in the image taken before conservation in 2013.

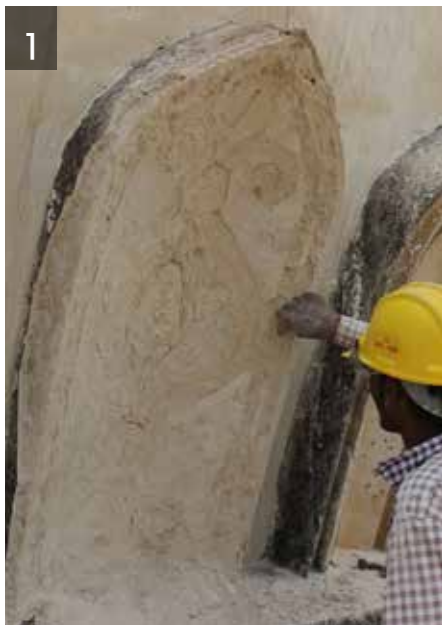
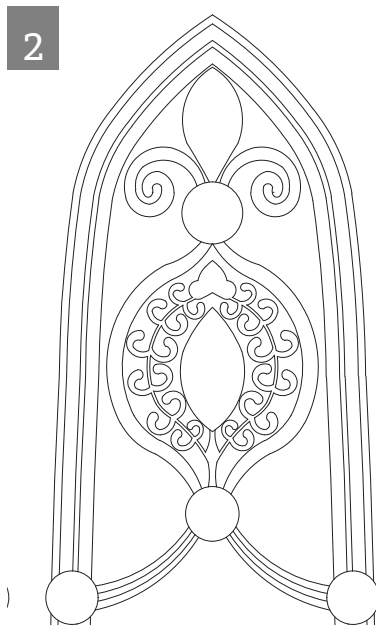
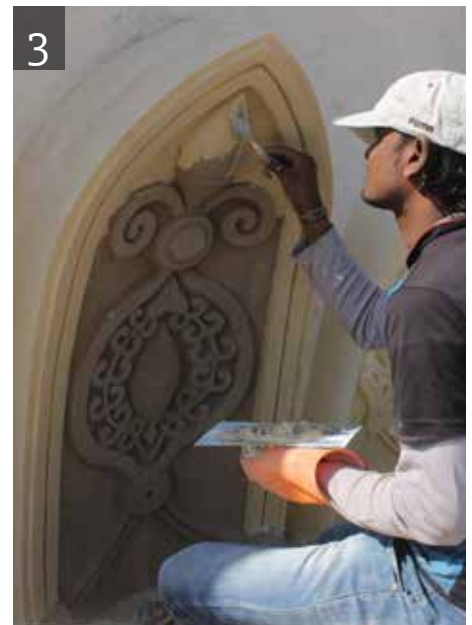
1. Investigations carried out on the basis of archival research revealed the traces of original details.
2. The detail was documented in precise detail, to create an AutoCAD drawing which is used to create a template of the pattern.
3. After carving the motif in lime plaster using the template made, craftsman finishes the pattern in the final layer of fine lime plaster.

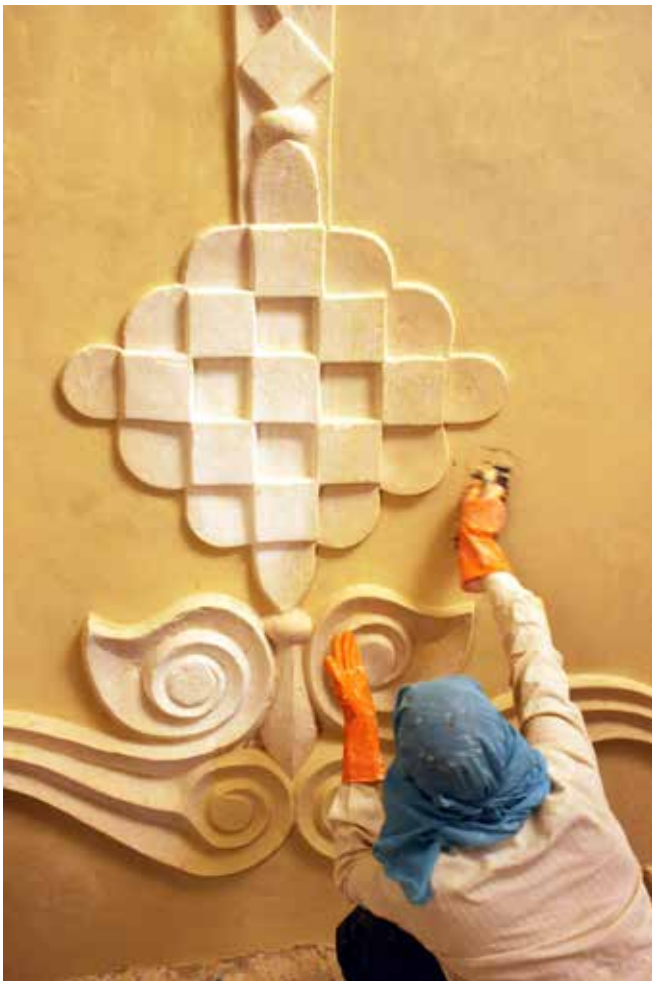
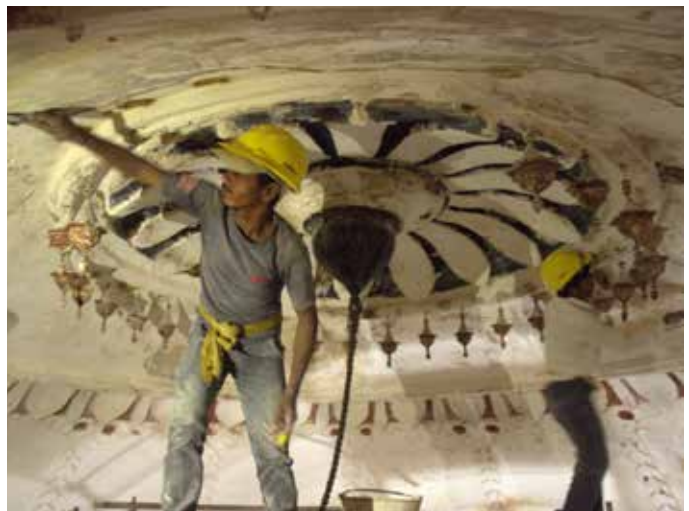
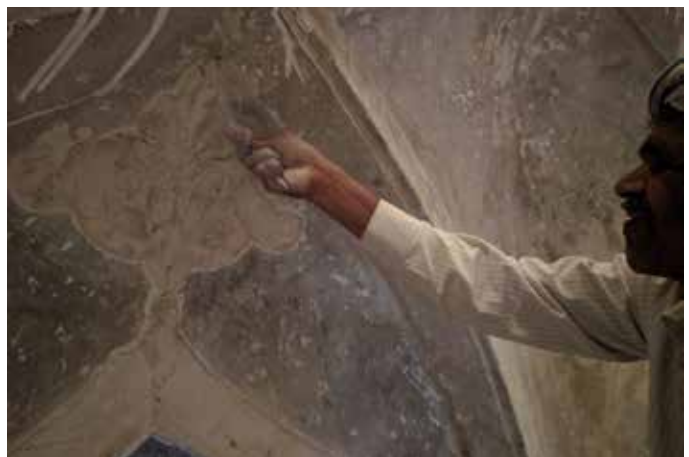
(Left) Final lime punning of the ornamental detail on the internal surface below the dome; (Top Right) The internal dome surface and the ornamental details were carefully cleaned of modern layers and repaired and finished with lime; (Bottom Right) Outline of the original detail found on dismantling of modern plaster layers on internal surfaces

- The internal dome surface and the ornamental details were carefully cleaned of modern layers and repaired and finished with lime.
- 6 missing wooden pendants of the central medallion at the dome ceiling were reinstated as per evidence on the ceiling medallion. 12 pendentives were damaged and repaired using lime traditional lime mortar matching in detail and design with the existing.

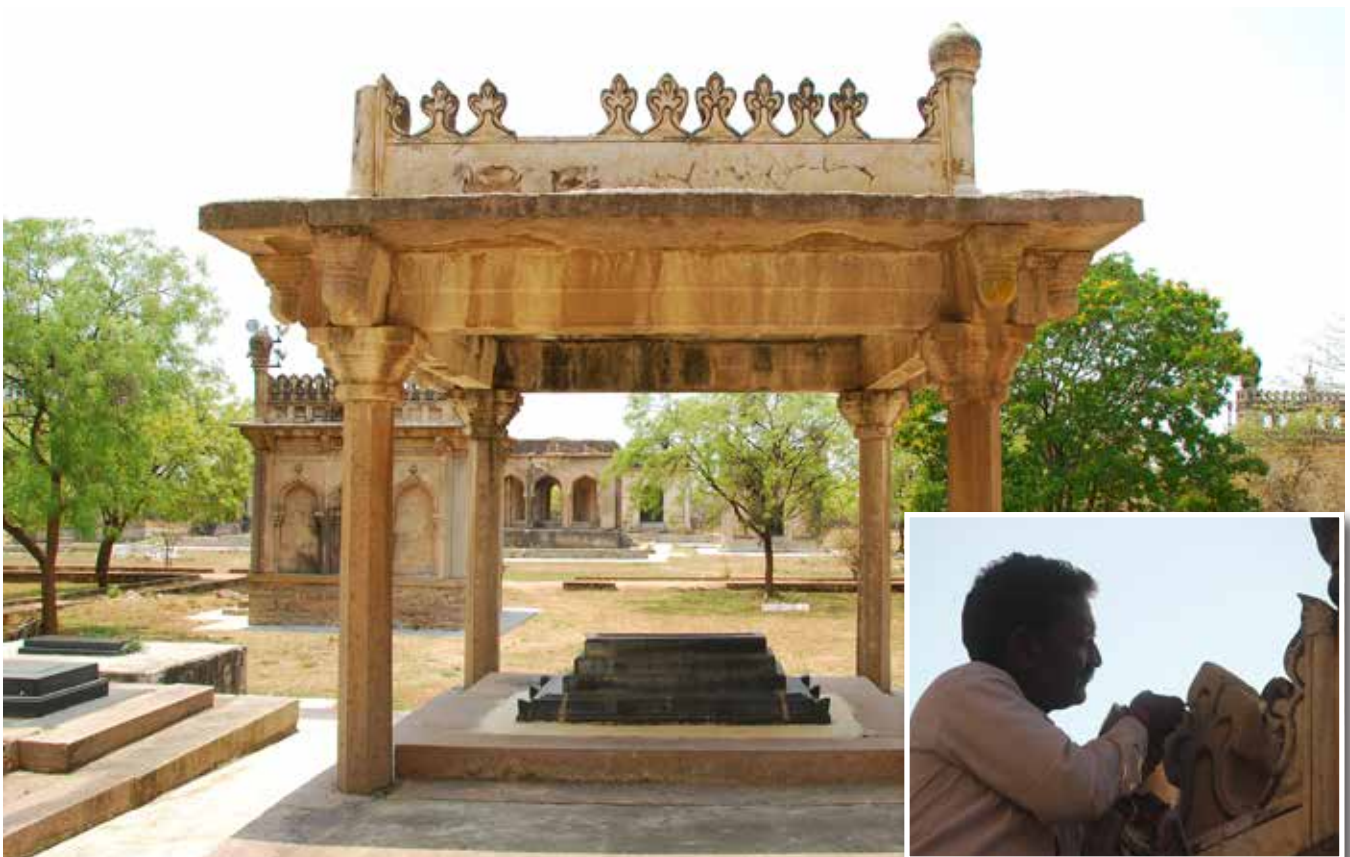
*The missing battlements of the chaukhandi were restored by master craftsmen along with the corner minars*

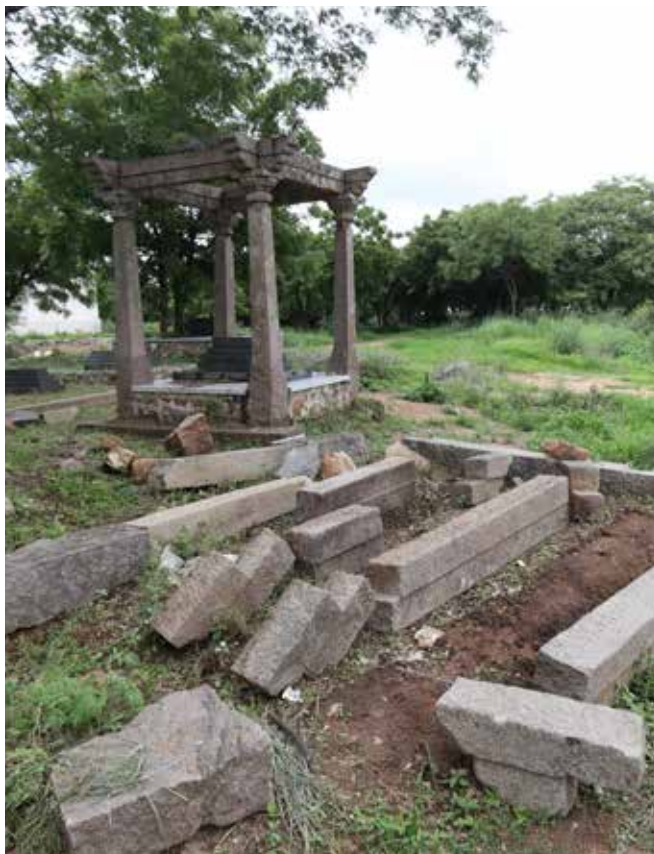
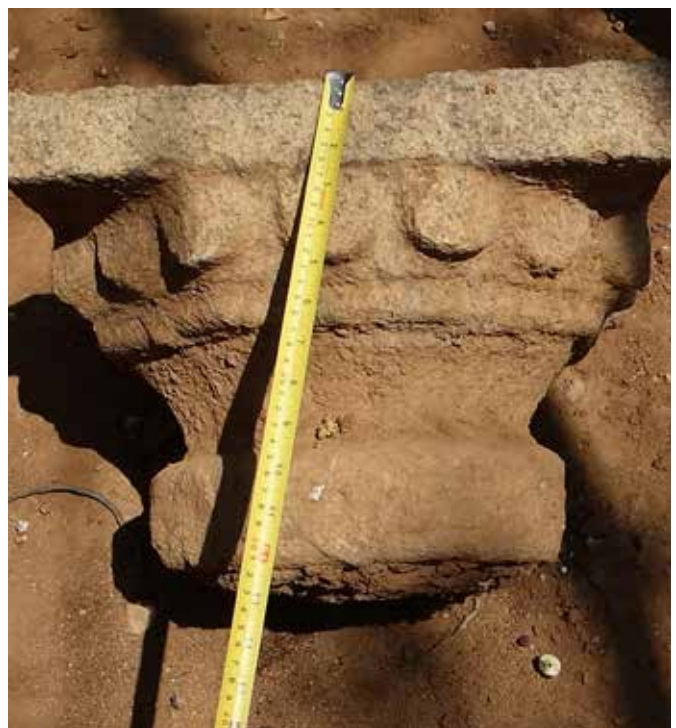
*(Left) Stone elements found on the ground belonging to the Qutb Shahi period Chaukhandi*

*(Below) Stone capital found near mosque no. 11*

In view of the partly missing column piece, it was found advisable to reconstruct the missing portion of one of the broken column. These disjointed pieces need to be attached using an appropriate anchoring system. Further research needs to be carried out on the appropriate anchoring of the broken pieces.

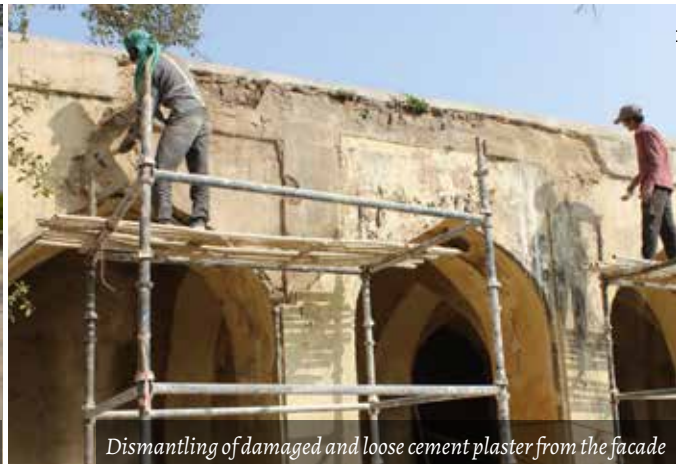
*Dismantling of damaged and loose cement plaster from the facade*

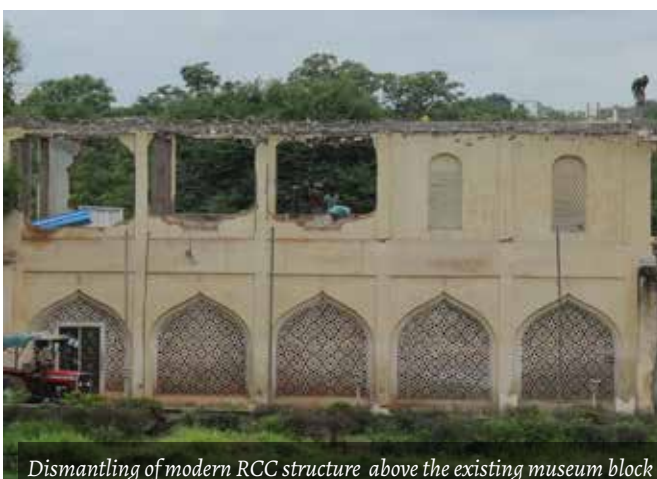
*Dismantling of modern RCC structure above the existing museum block*

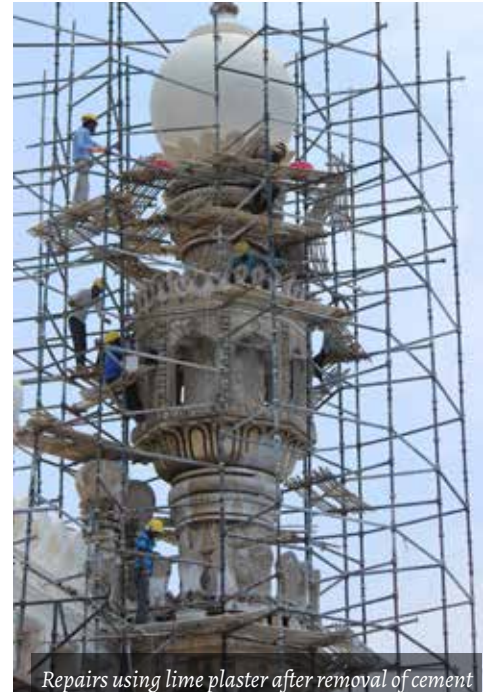
*Repairs using lime plaster after removal of cement*

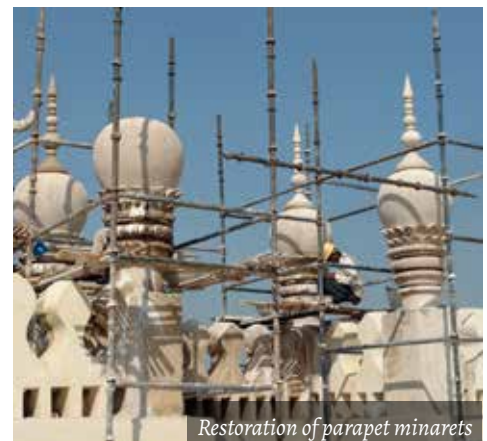
*Restoration of parapet minarets*

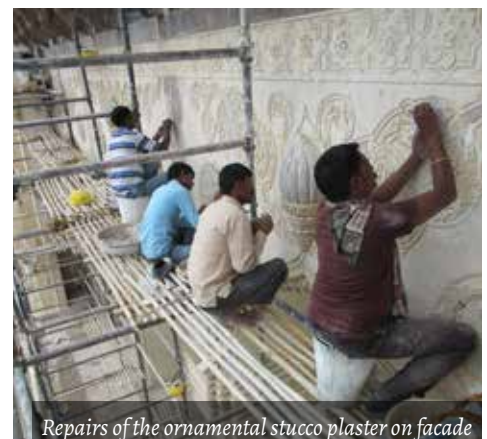
*Repairs of the ornamental stucco plaster on facade*

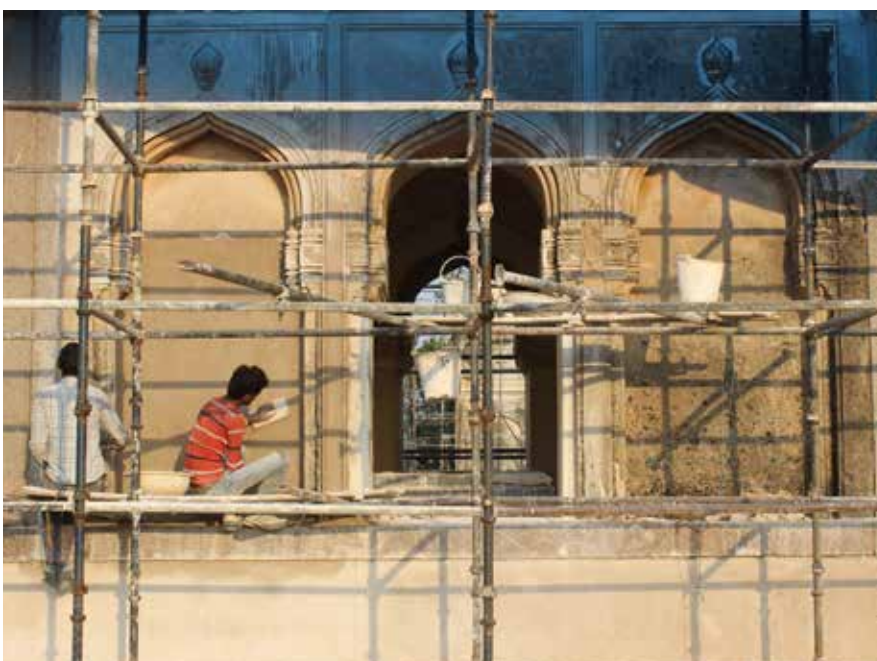
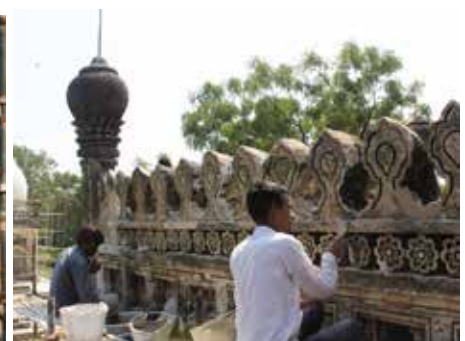
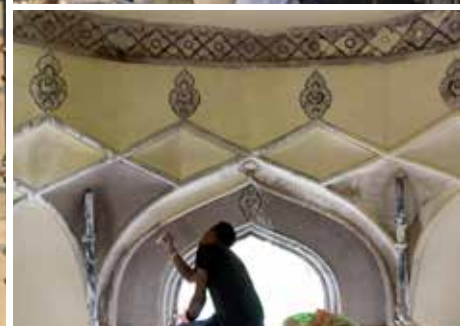
*(Left) Restoration of the facade; (Top Right) Plaster repairs at the parapet details;  
(Bottom Right) Final finish with lime punning at the internal portion after repairs*

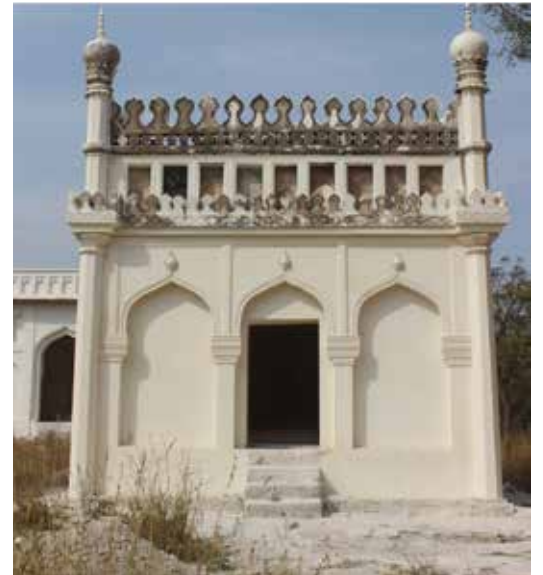
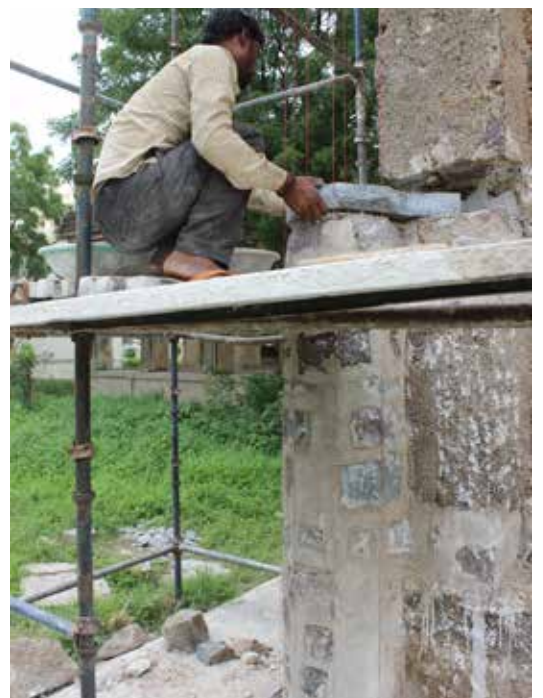
(Middle ) Restored facade of the mausoleum; (Bottom) Reconstruction of the octagonal profile corner pier

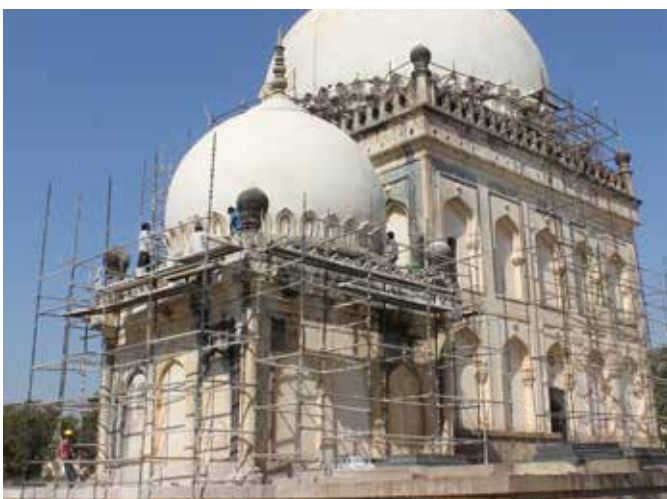
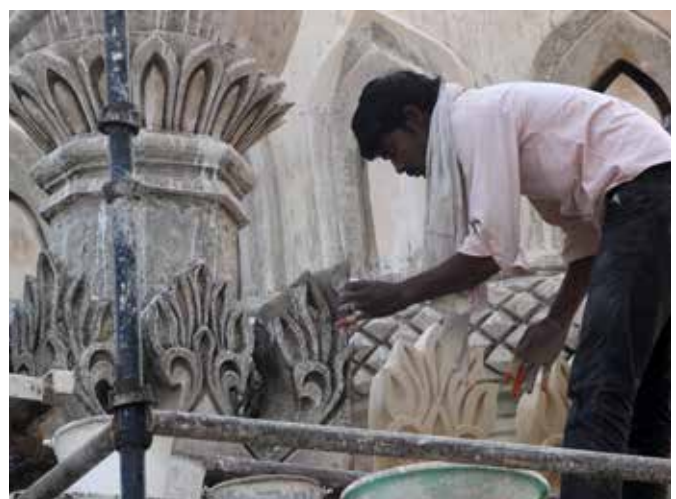
(Left) Mausoleum of Muhammad Amin: during conservation; (Right) Restoration of damaged and missing battlements on the parapet was carried out

- Finials of approved detail and design were installed on the four corner minarets.

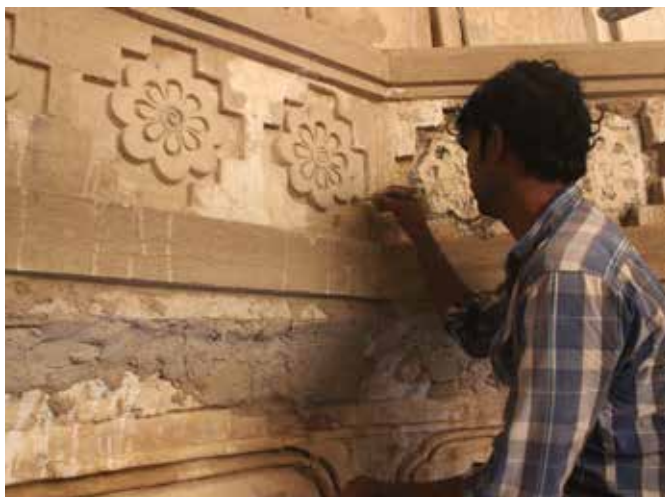
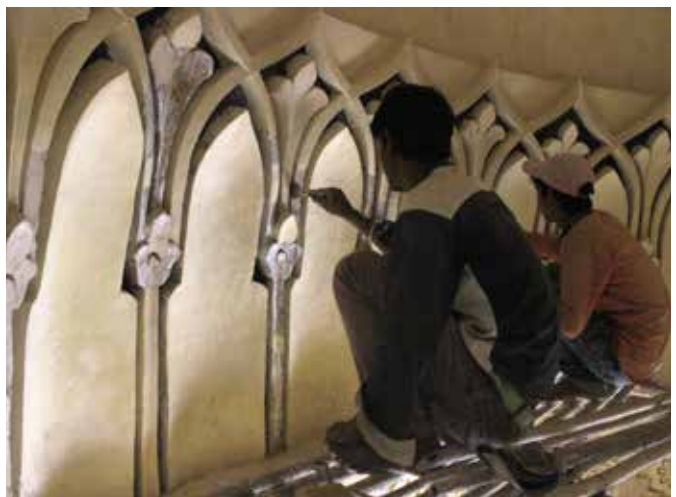
*(Left) Restoration of incised lime plaster details on the internal surface; (Right) Final finish with lime punning at the internal portion of the mausoleum*

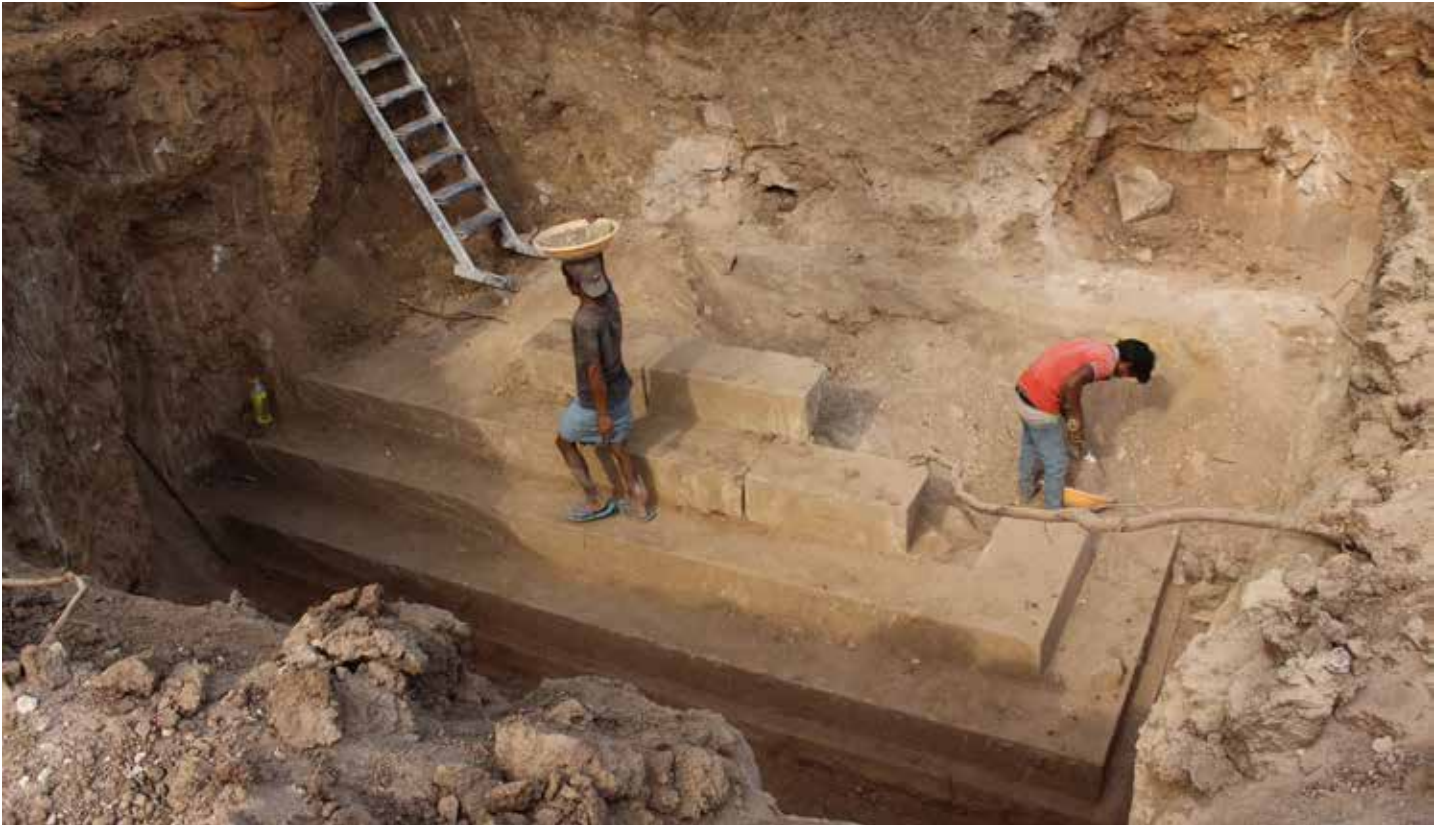
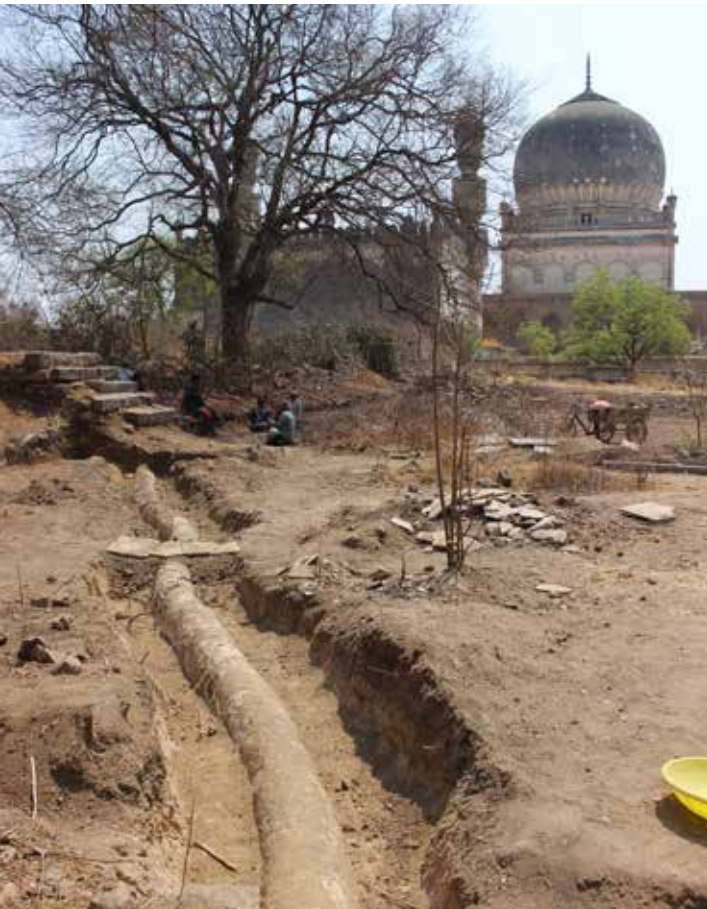
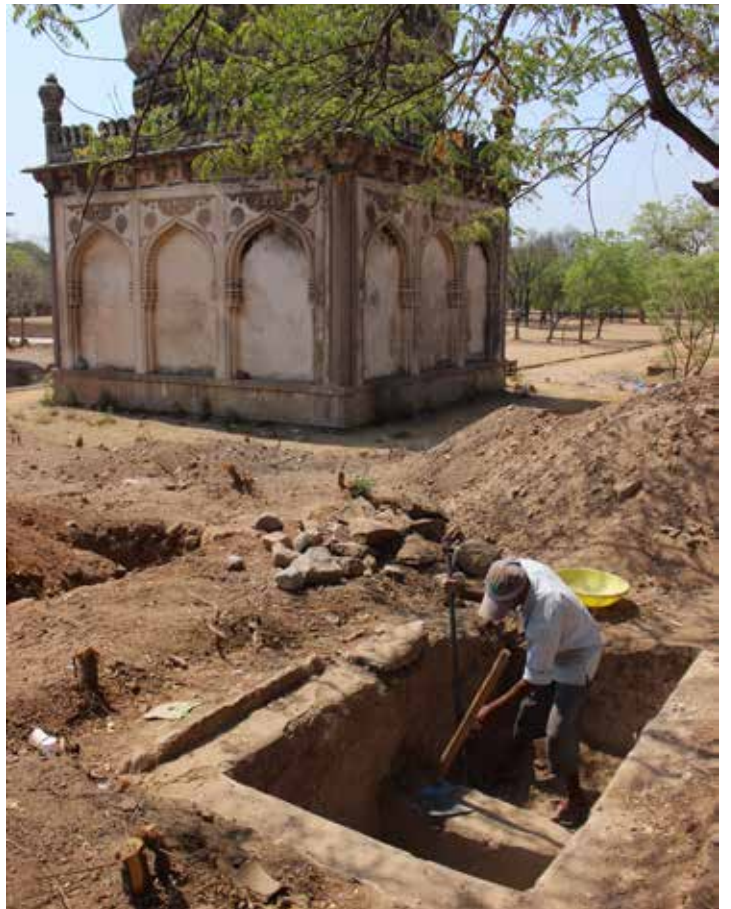
(Top) Remains of steps found aligned to the main 'qibla' of the Idgah; (Bottom left) Over 80 meters long, 30 cm diameter terracotta water channel was discovered at the area north east of the mausoleums of Taramati and Premamati; (Bottom right) Water tank found in the area north of the mausoleums of Taramati and Premamati

The underlying archaeology discovered will provide valuable inputs for an appropriate landscape development in the second phase. The final proposed earth levels and the orientation of the pathways will be determined by these underlying archaeology. It is also imperative that all the discovered archaeological remains may not necessarily be exposed due to issues of water stagnation and safety.
