AGA KHAN DEVELOPMENT NETWORK  
QUTB SHAHI HERITAGE PARK  
CONSERVATION & LANDSCAPE RESTORATION

2017-18  
ANNUAL REPORT

## Conservation & Landscape Restoration

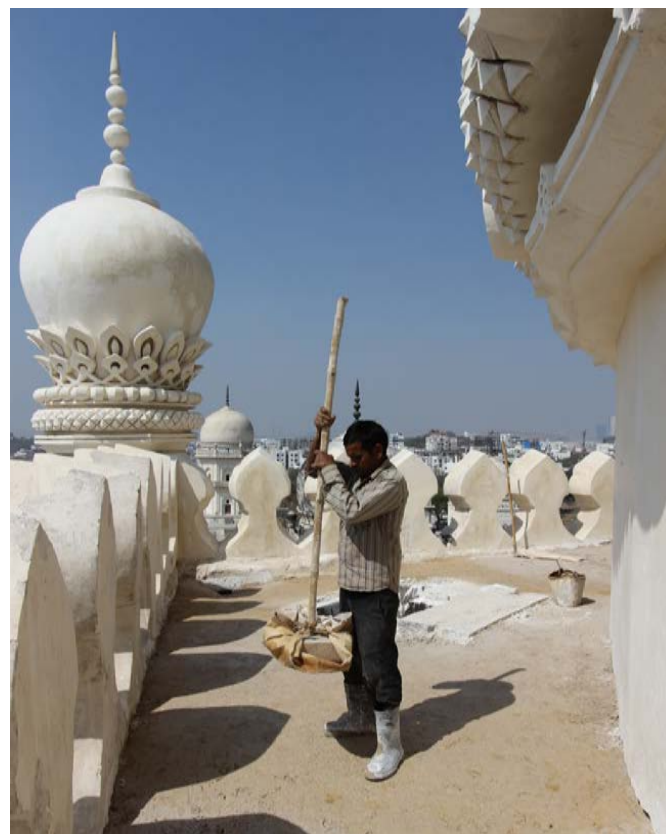
*The cement from the roof was replaced with traditional lime mortar*

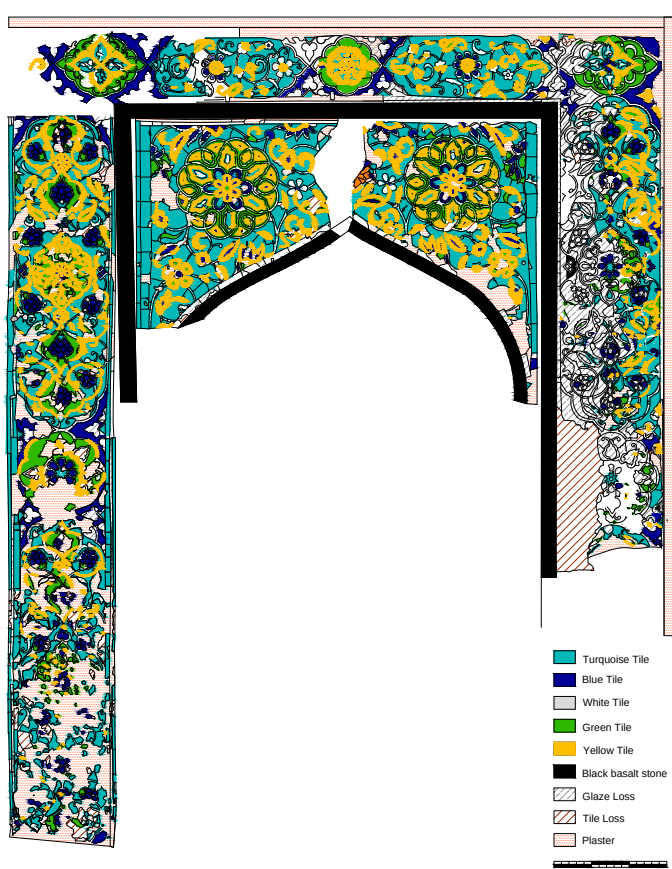
*Architectural documentation of the tile work on the southern facade of the Ibrahim Quli Qutb Shah's Mausoleum*

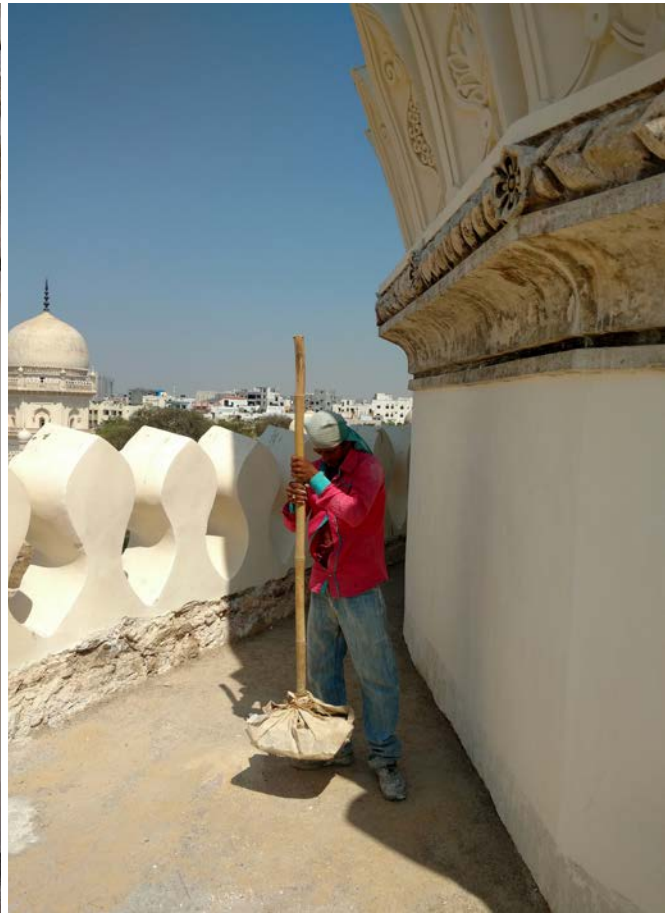
*The cement from the terrace was replaced with traditional lime concrete*

The terrace of the terrace was found covered with vegetation growth causing ingress of water into the monument and resulting in seepage inside the internal dome.

- On inspection, the terrace was found to be covered with a thick layer of 20th-century cement concrete and dilapidated lime concrete found below had developed cracks at multiple spots with rainwater seeping through.

- At the onset, vegetation was scientifically removed from the terrace cracks.
- The excess layer of cement concrete, which weighed around 30 tonnes was dismantled and debris cleared from the site.

- Base masonry of parapet walls on all four sides was repaired using rich lime mortar.
- 4 inch thick layer of traditional lime concrete was laid in appropriate slope, followed by continuous compaction and curing using traditional construction technology and techniques.

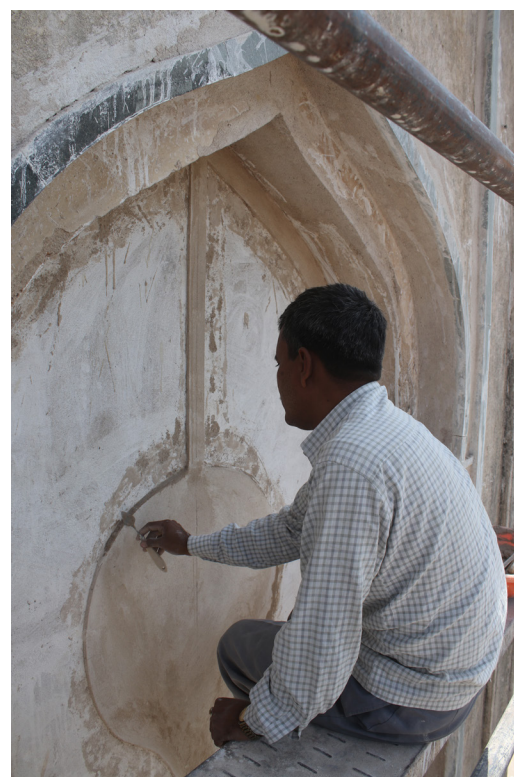
(Top) Outline of the missing detail on the facade were restored; (Middle) Missing stone elements added to the external blind arches on the facade; (Bottom) Physical documentation of existing tiles by architects

- Based on careful investigations and comparative analysis with the archival images, the outline of the missing patterns in the recessed portions of the arches at upper and lower tier were restored in rich lime mortar and finished with lime punning.

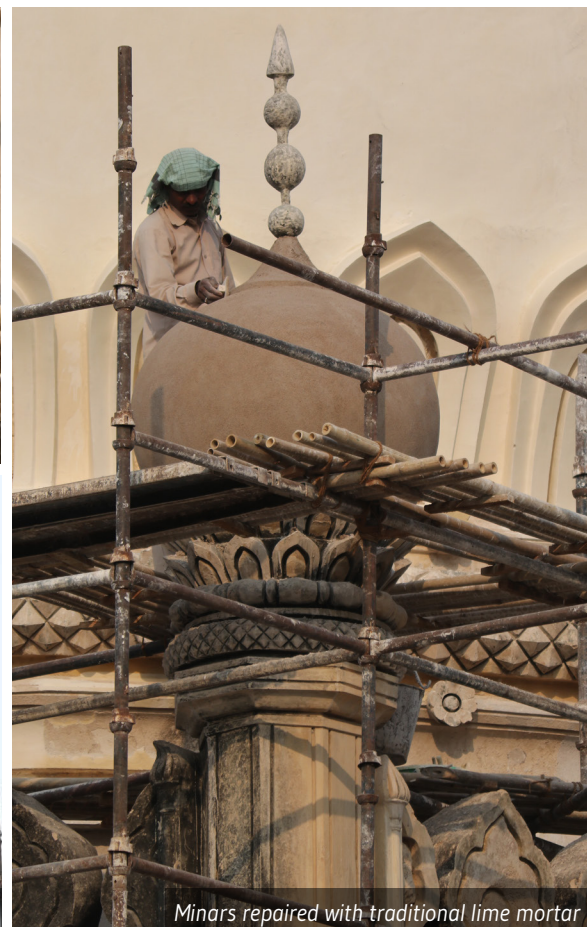
*Minars repaired with traditional lime mortar*

- Corner minarets were repaired and ornamental details were restored using rich lime mortar. Missing finials were prepared as per existing evidence and installed on the minarets.

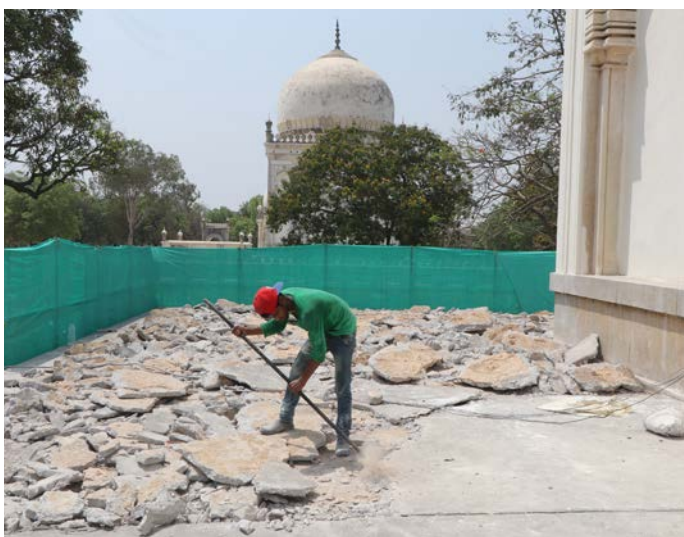
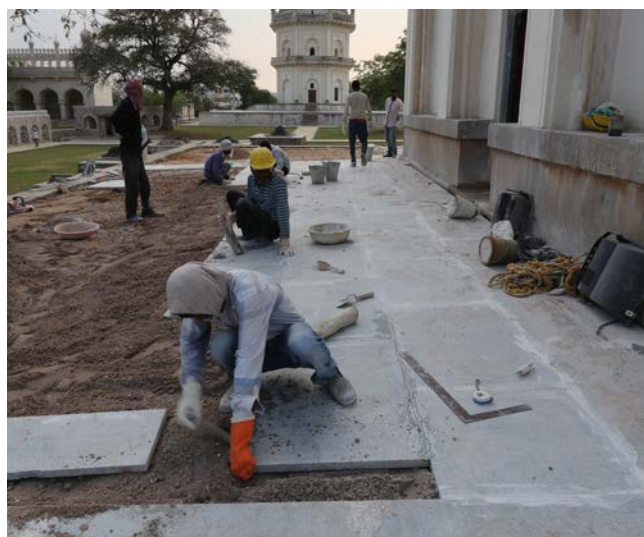
Removal of cement concrete from the plinth to halt further deterioration    Laying of stone slabs on a layer of lime mortar to replace the cement

- Multiple edge stones lining the accentuated plinth were dislocated and re-instated to their original position.
- The plinth was found to be covered with a 20th century layer of 2-inch thick cement concrete. This layer was dismantled and the site cleared of debris.
- Installation of over 4000 square feet of 30 mm thick granite stone slabs in approved layout and appropriate slope was carried out to channel rainwater away from the mausoleum.

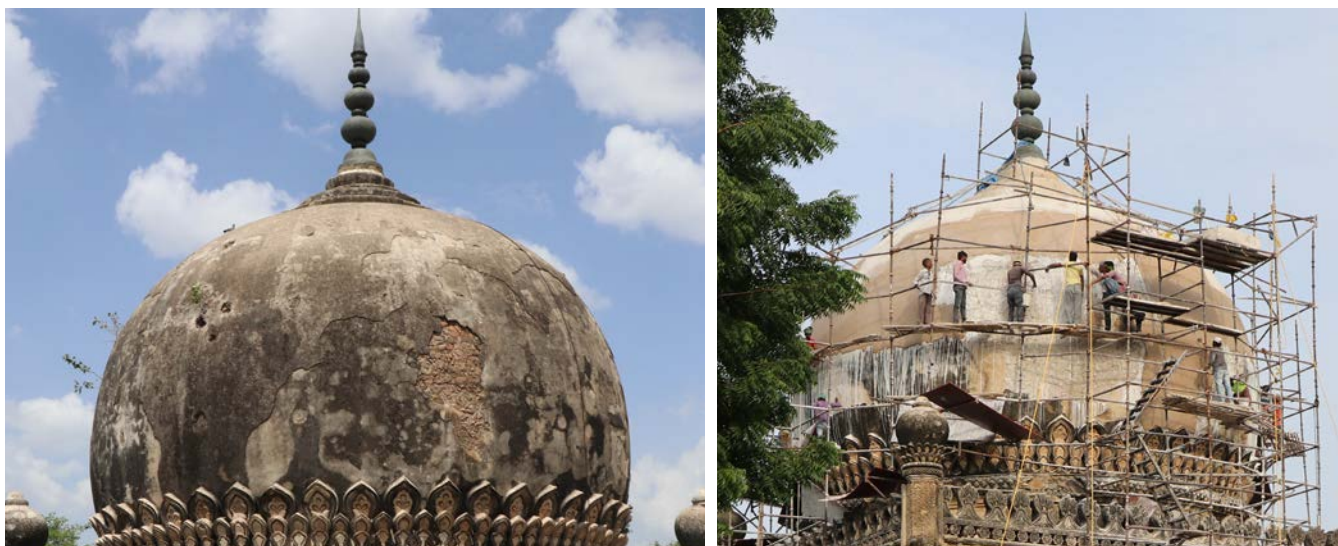
(Left) The dome of the mausoleum of Commander was covered with 20<sup>th</sup> century cement plaster which was causing damage; (Right) After careful removal of the cement layers, lime plaster was applied on the dome.

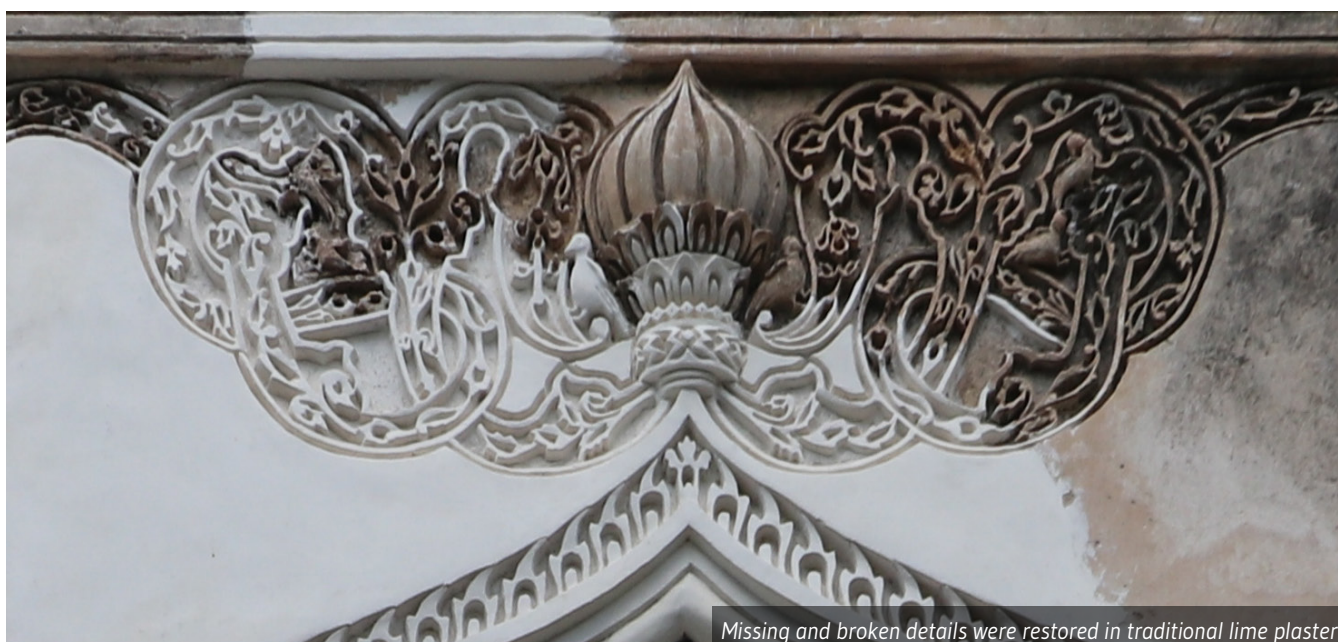
Missing and broken details were restored in traditional lime plaster

- The highly ornate stucco on the external surface of mausoleum, below the parapet, has been carefully repaired and restored by master lime craftsmen after adequate documentation.
- Over 500 man-days of work by master craftsmen was required to restore the lime stucco ornamentation on the external facade.
- During scientific removal of 20<sup>th</sup> century cement layers from stucco, old historic stucco layers with distinct floral medallions were discovered on the southern and eastern facades. These have been consolidated and retained for enhanced understanding of history.
- A number of original details were covered by the addition of modern cement plaster. These have been carefully removed in order to mitigate any unintended damage to the original details. The missing portions were restored based upon the existing site evidence.

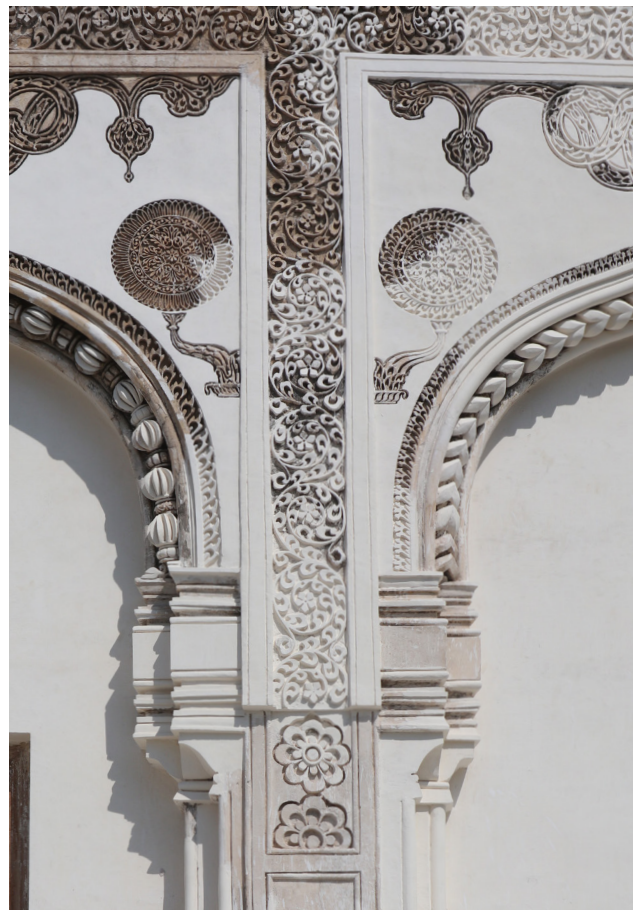
Missing or broken plasterwork on the facade were restored by mastercraftsmen. Original details hidden under the modern cement plaster were restored based on existing evidence.

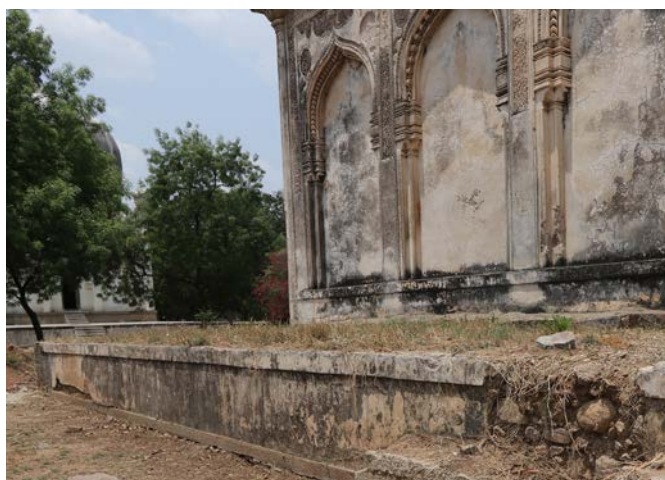
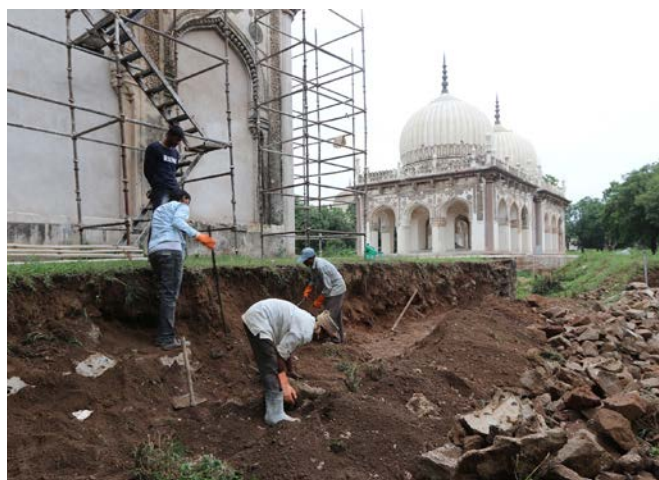
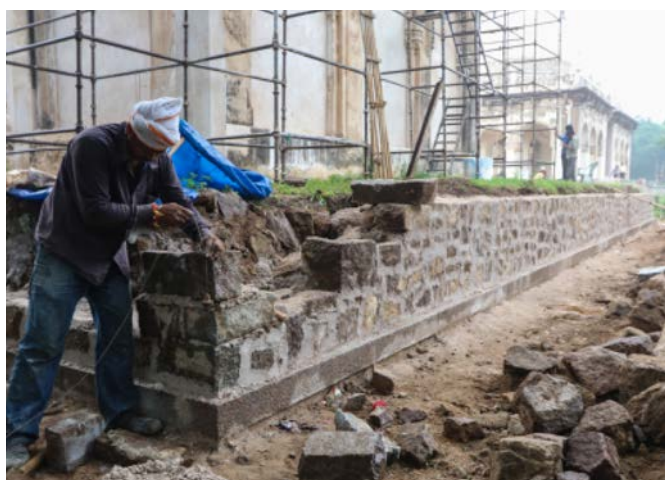
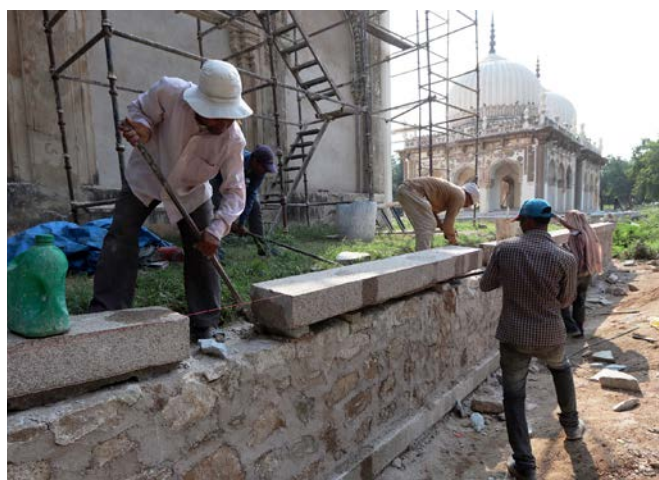
*The plinth wall at Commander's mausoleum was bulging due to water ingress, was hence dismantled and followed by reconstruction with stone and lime mortar and installation of hand-chiseled stone coping*

- 10 cm thick layer including the top cement concrete was removed from the plinth surface and replaced with a traditional lime concrete base.
- 30 mm thick granite stone slabs were laid atop the lime concrete in the lime mortar to provide a water-tight permanent surface, and to withstand the visitor footfall.
- Hand chiseled granite edging stone was used to line the edge of the plinth at two tiers on all the four sides to match the historical evidence revealed after clearance of earth near the north-west corner.
- Over 50 meters of plinth wall made in stone masonry was bulging as a result of water ingress. The bulged portions were carefully dismantled and reconstructed appropriately using over 1700 cubic feet of stone rubble masonry and lime.
- Steps made in hand-chiseled granite were installed on the southern facade to facilitate visitor access.

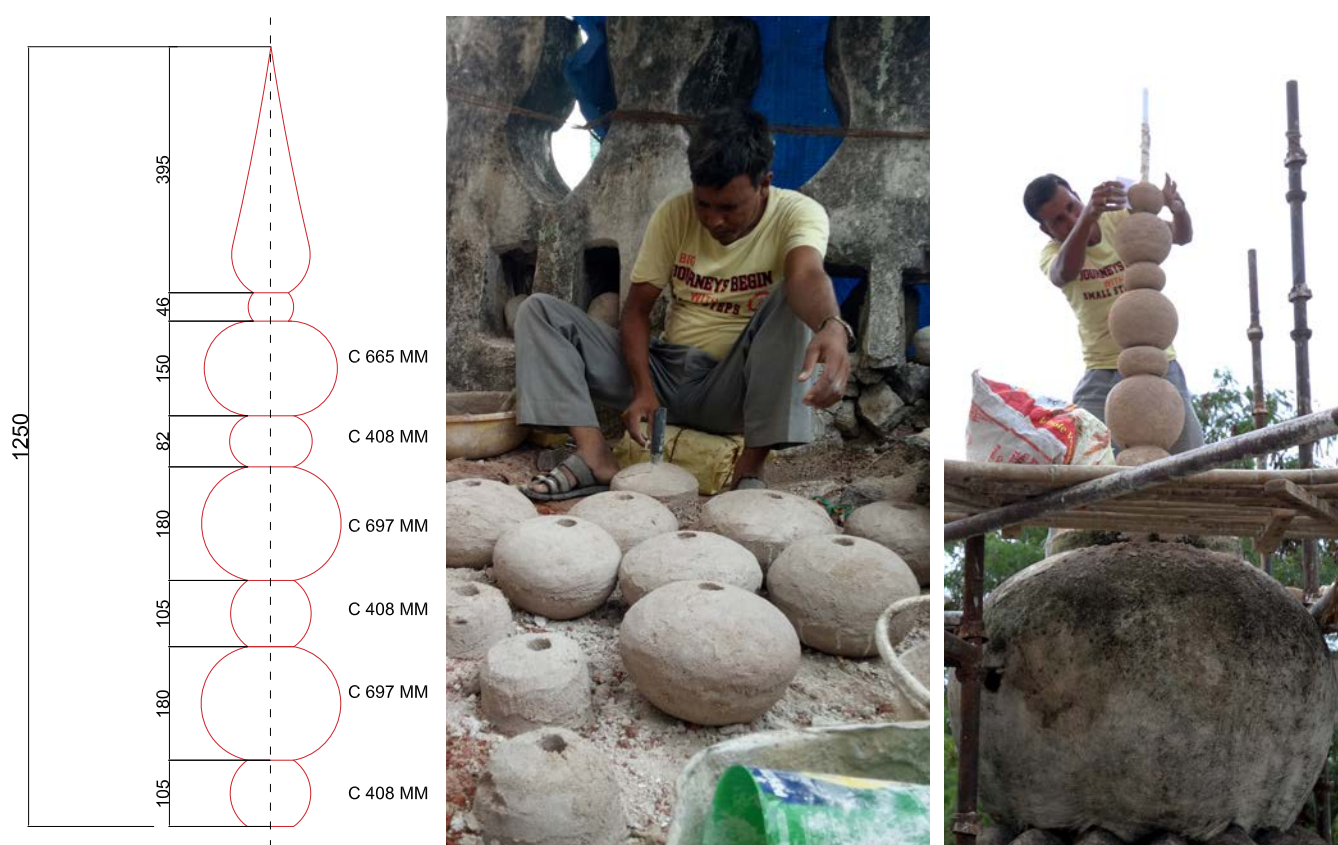
Missing finials on corner minarets were cast in lime mortar and installed in plumb matching the historic evidence.

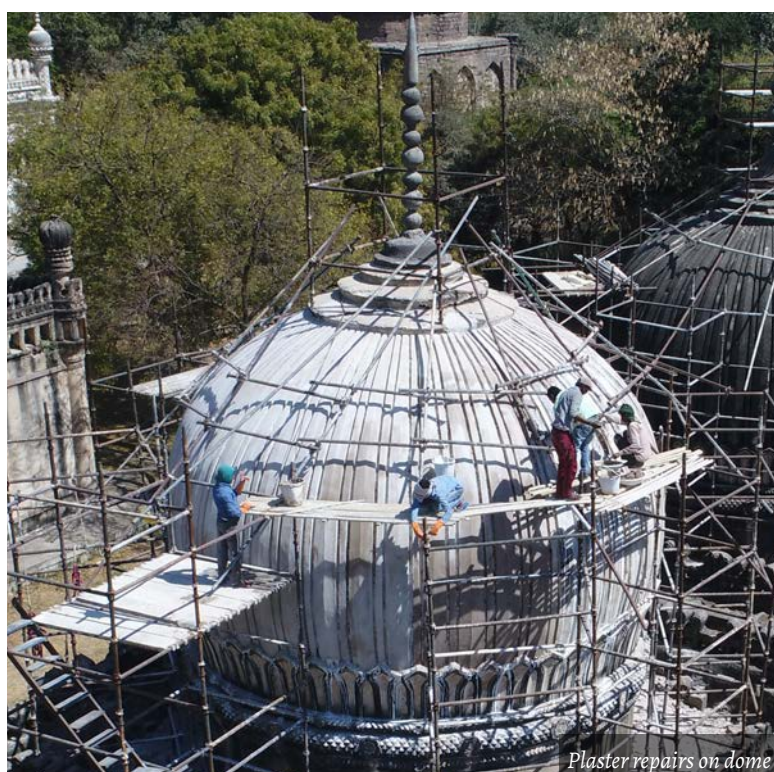
*Plaster repairs on dome*

- Cement plaster from the octagonal profile drum supporting the dome was removed and repaired with traditional lime mortar.

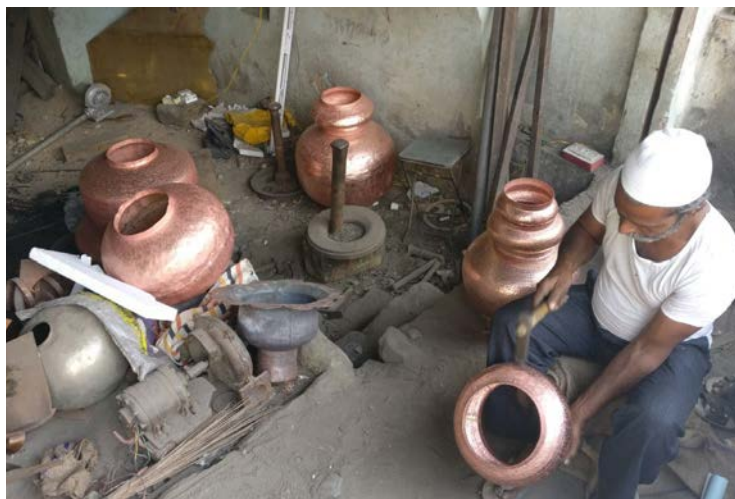
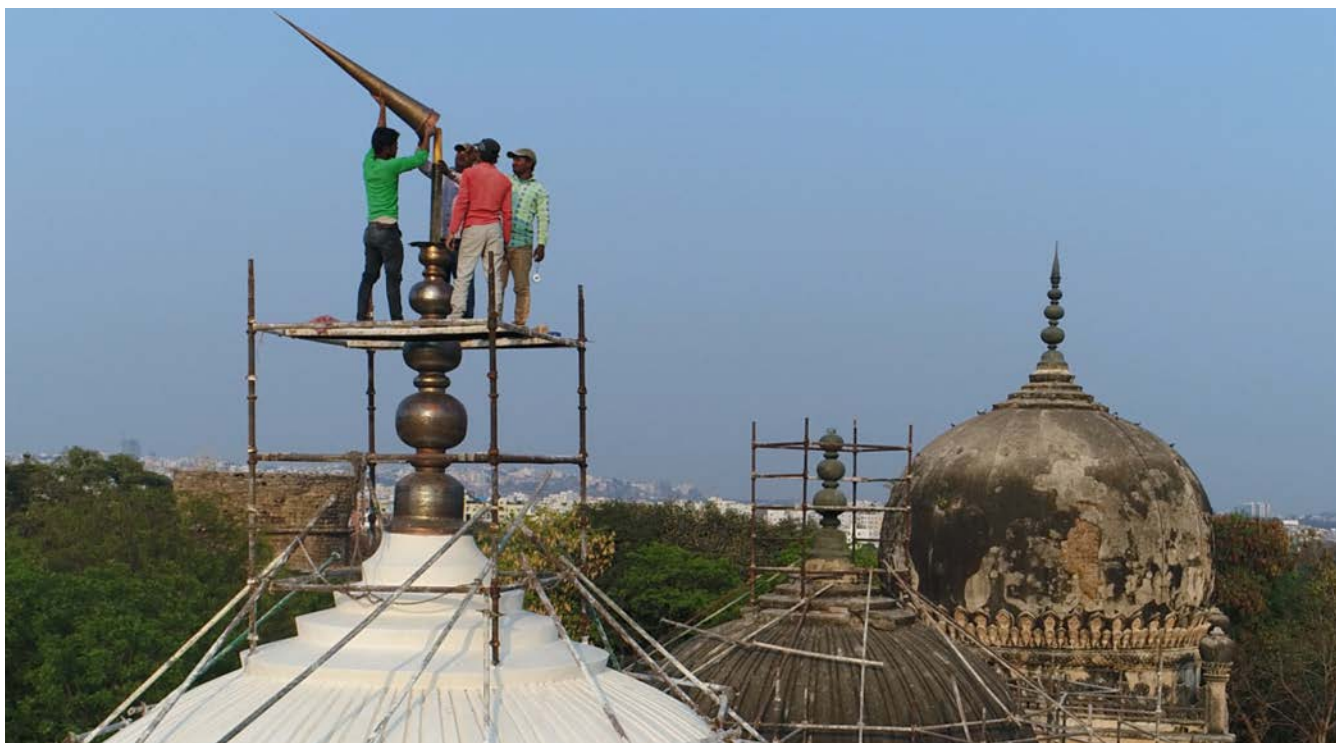
*Installation of finial on the western dome of the twin mausoleums of Hakims'. (Top Left) Cement finial on the mausoleum to the west ; (Top Right) Local coppersmith fabricating components of copper finial; (Below) Installation of the finial on the dome*

(Left) Detailed documentation of the existing finial of the Hakim's mausoleum to the east before installation of the missing topmost cone was carried out

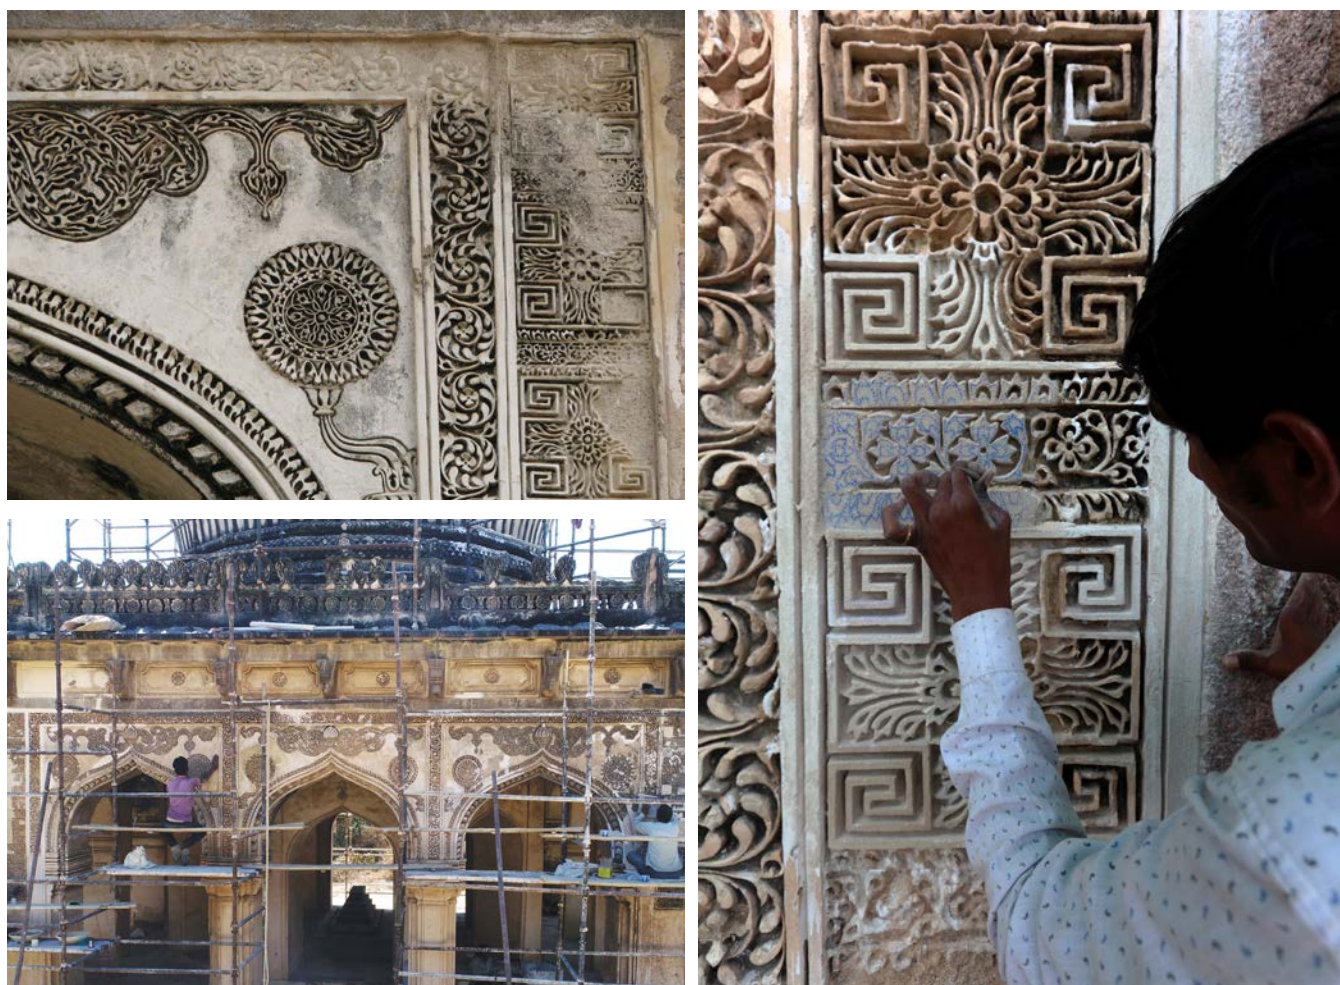
*Missing and damaged ornate stucco patterns on the external facade of the twin mausoleums of Hakims' were carefully restored by craftsmen*

- The facade on all the four sides of twin mausoleums was restored with highly ornate stucco plaster in form of floral-geometric and animate objects, medallions in the spandrels of the arches, arch crowns and moulding bands based on existing evidence, impressions that could be discerned by referring to archival images.

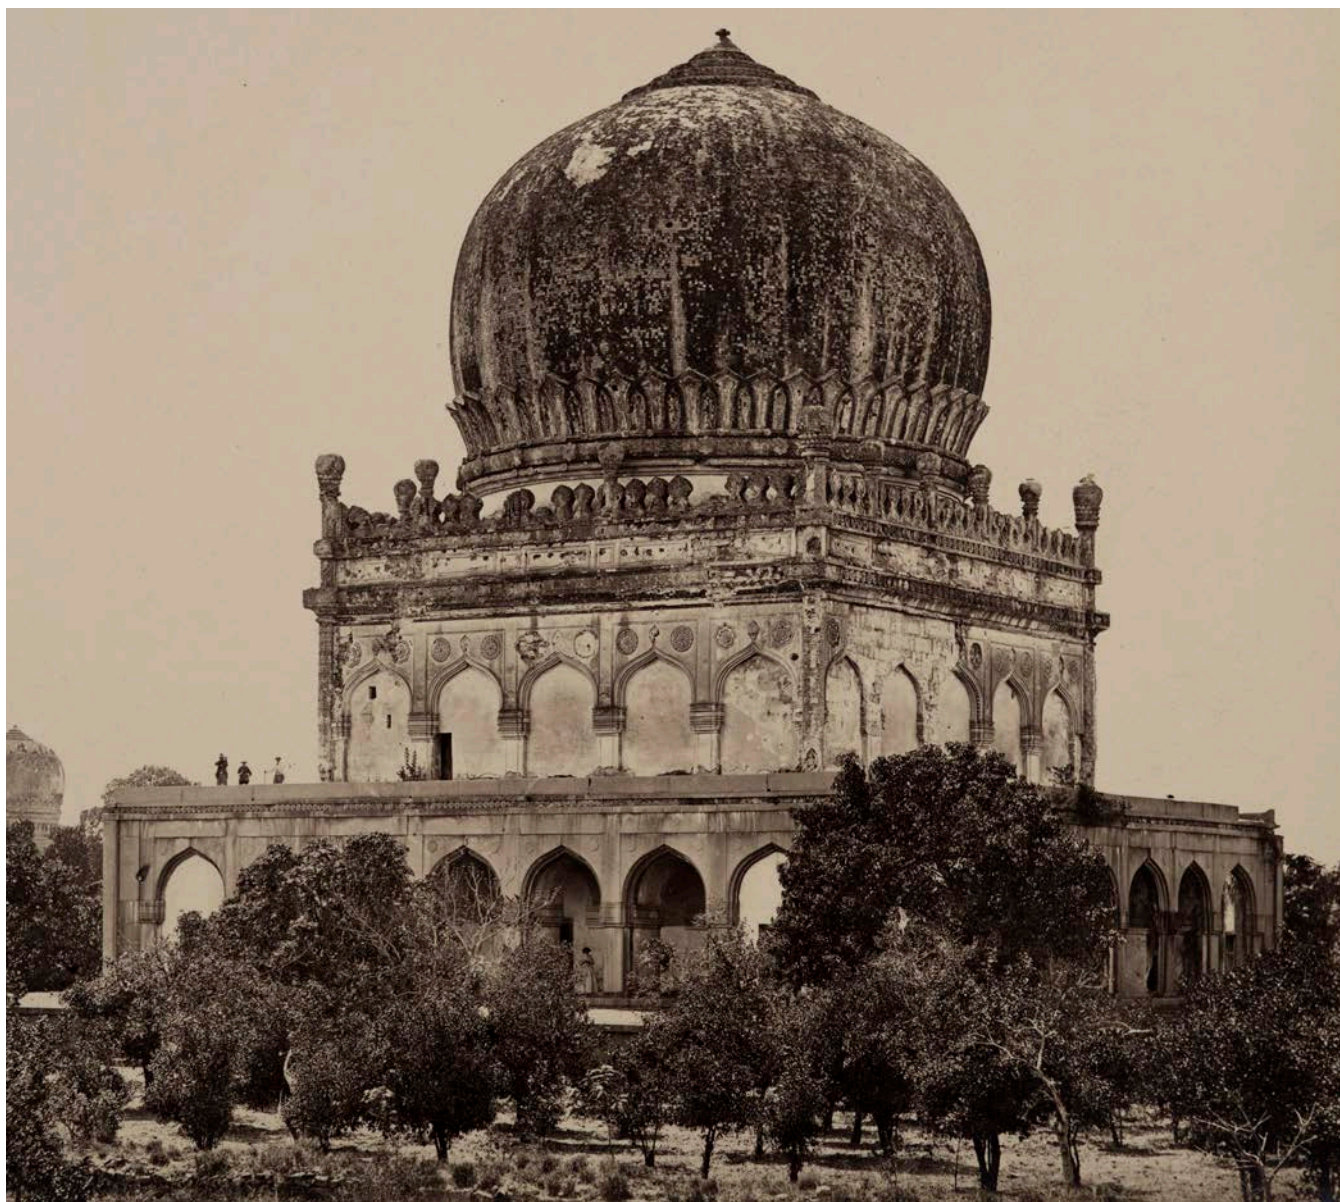
*Archival image from the 1860s showing evidence of original tile patterns on the dome, merlons at the base of the dome, horizontal bands on the facade and the corner minarets. (Image source: Alkazi Foundation)*

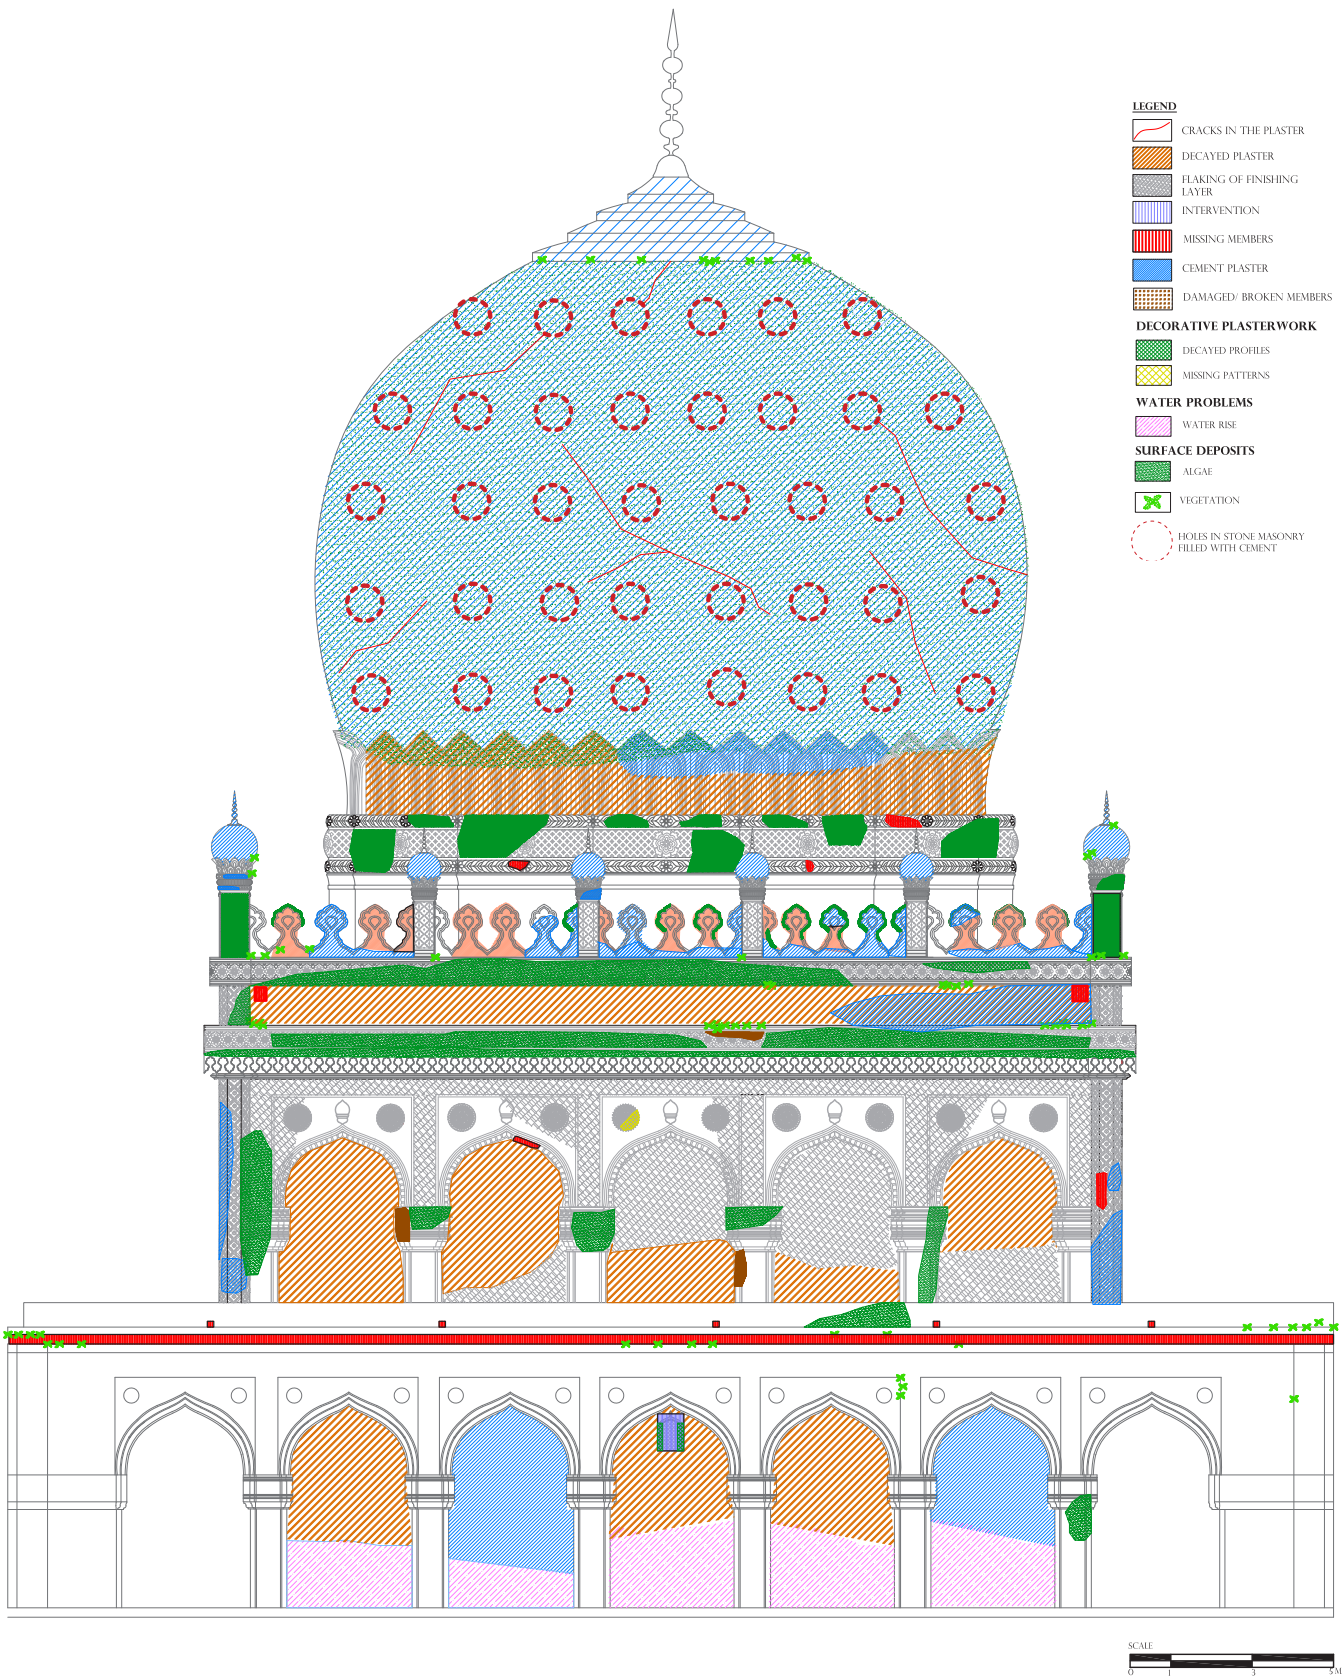
Conidition assesmment of northern elevation of Hayat Bakshi Begum's mausoleum

Her mausoleum is a replica of the mausoleum built for her husband, both in terms of scale and size. In late 2018, removal of later added cement plaster layers was commenced on the dome surface. The dome was covered with a 2 inch thick layer of cement plaster and showed signs of deterioration permitting ingress of water and vegetation growth.

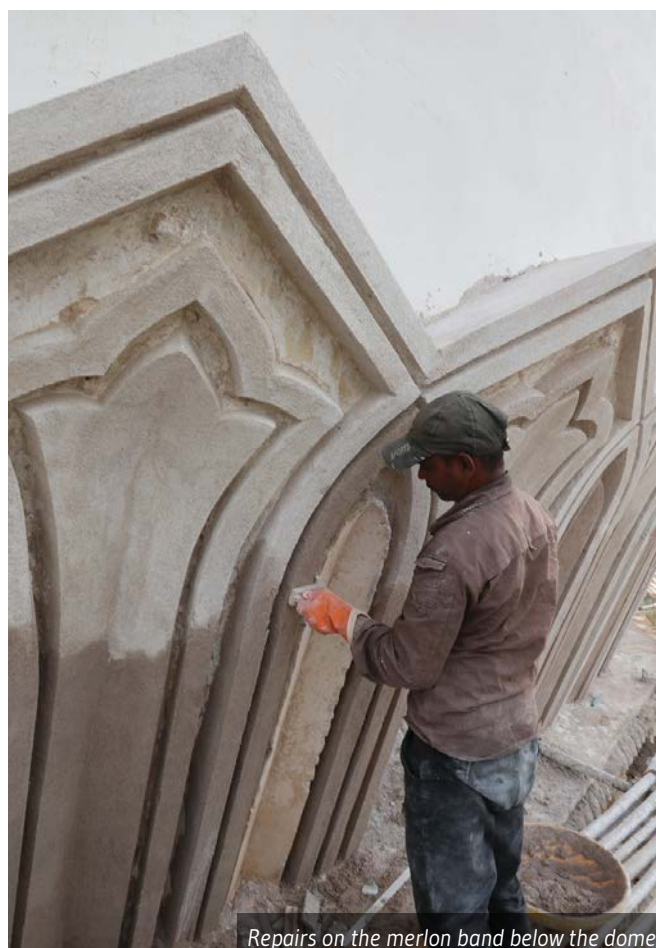
Repairs on the merlon band below the dome

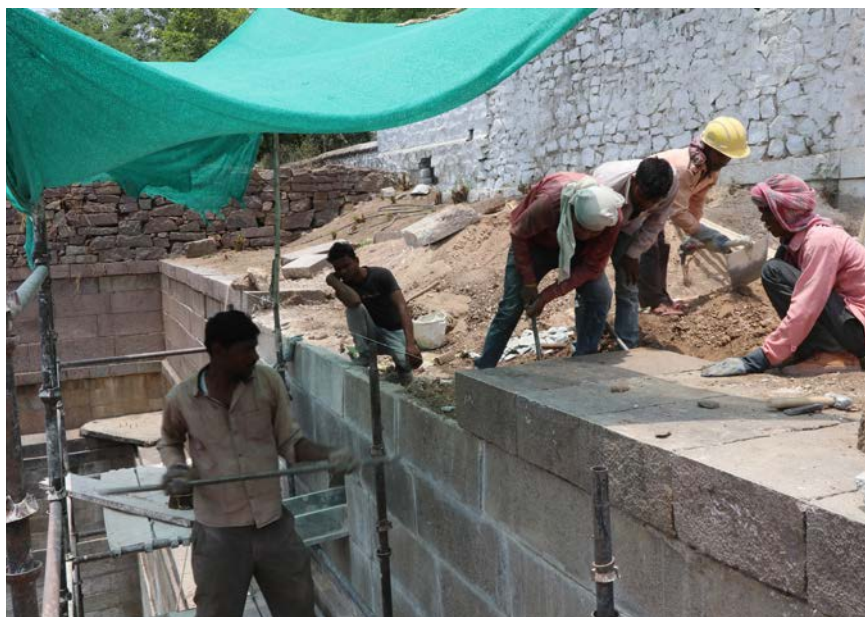
Due to lack of upkeep and periodic maintenance, baoli was in a dilapidated condition and number of stones were bulging from the wall line.

*All the displaced dressed stones were realigned into place using the existing stones as reference*

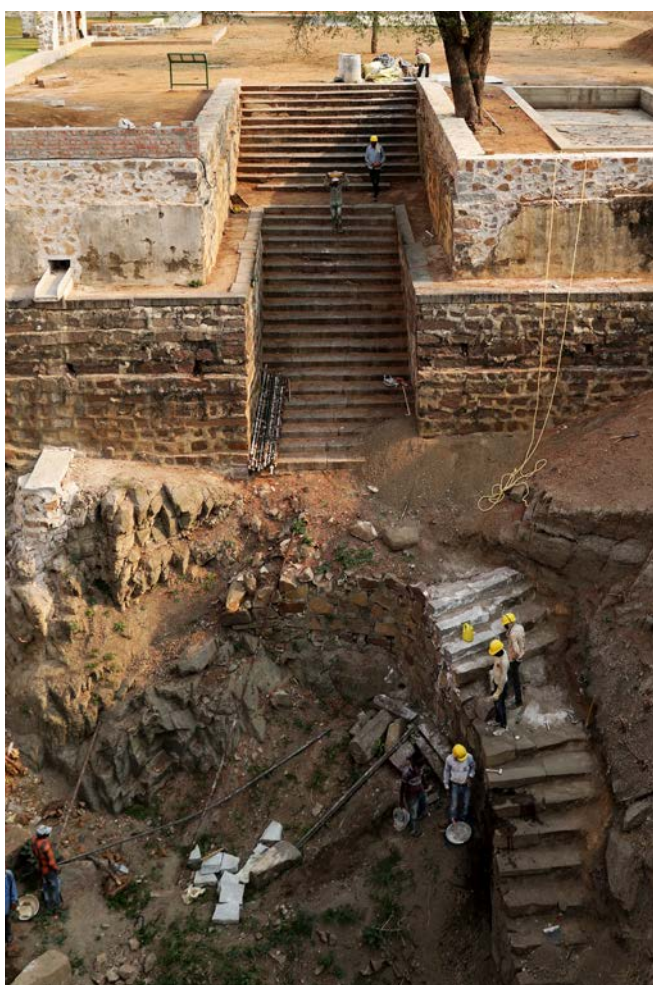
*Repairs of the steps carried out, missing steps were reinstated*

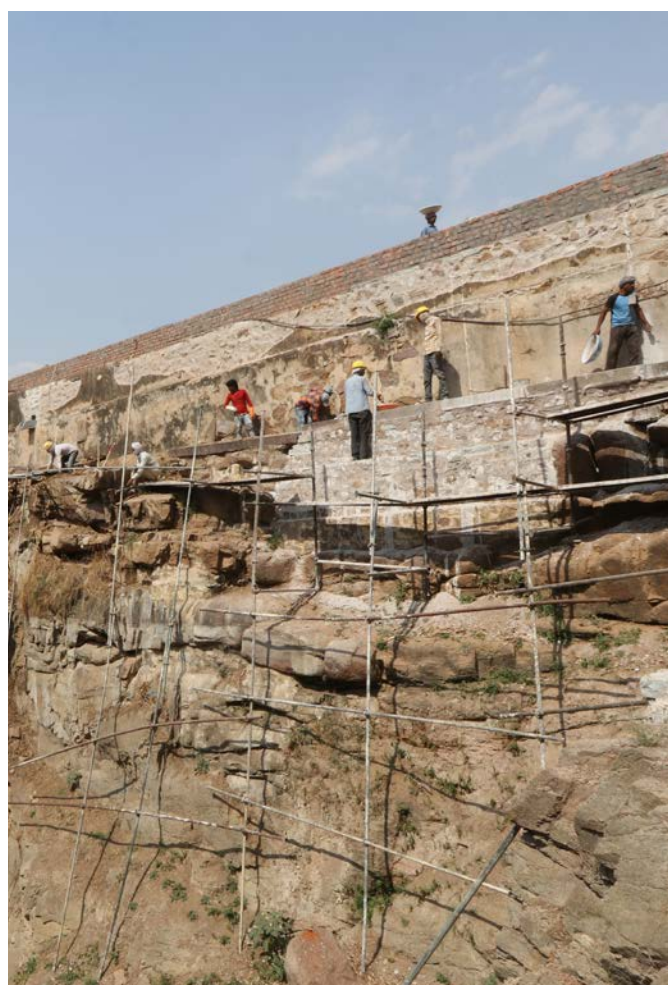
*Missing hand dressed edging stones on the western and southern ledge of the baoli were installed*

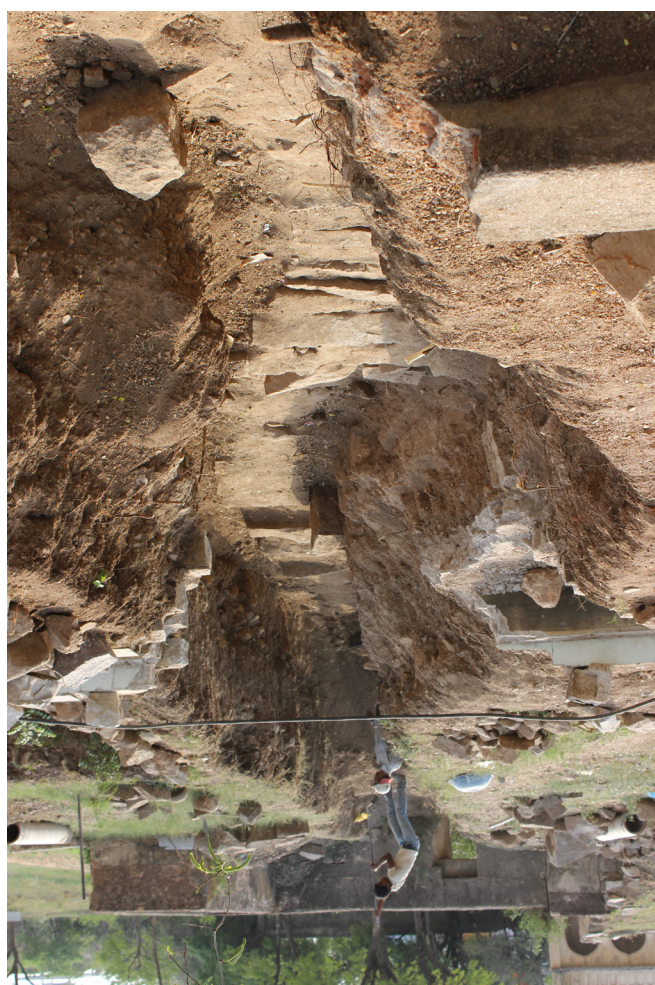
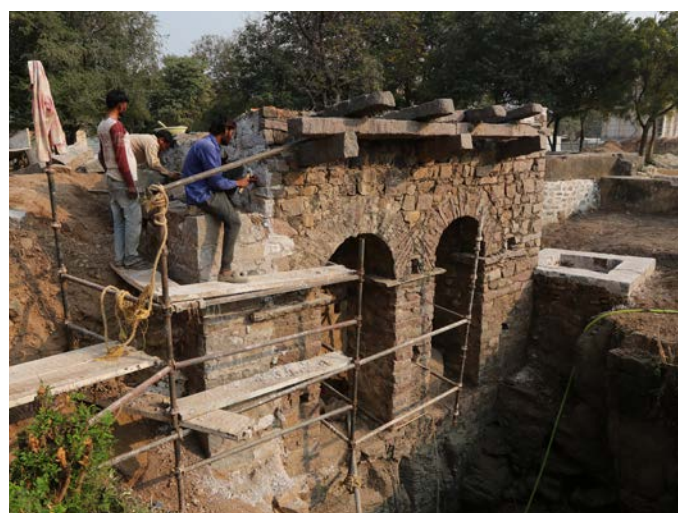
*(Left) Aqueduct to the east of baoli; (Top right) Missing hand dressed edging stones on the western and southern ledge of the baoli were installed; (Bottom right) Low height brick parapet installed to prevent visitors from tripping inside the baoli*

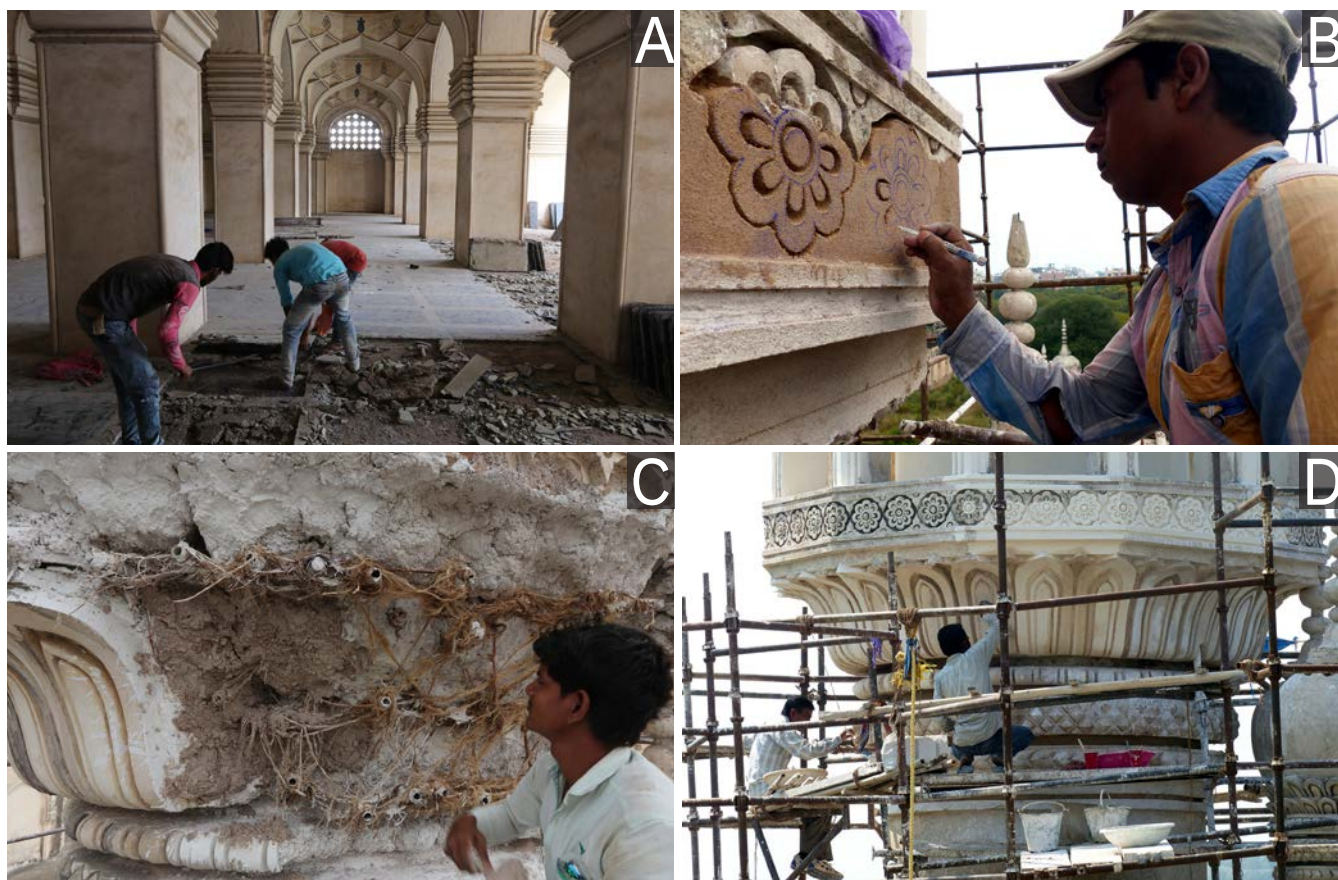
A: Dismantling of inappropriate 20<sup>th</sup> century stone flooring; B: Carving of floral medallions by lime craftsman ; C: Reinforcing damaged portion of minarets with jute fiber and lime mortar; D: Finishing of restored floral brackets supporting the arch gallery

- Dismantling of inappropriate late-20th century stone flooring was carried out to reveal the original floor levels.

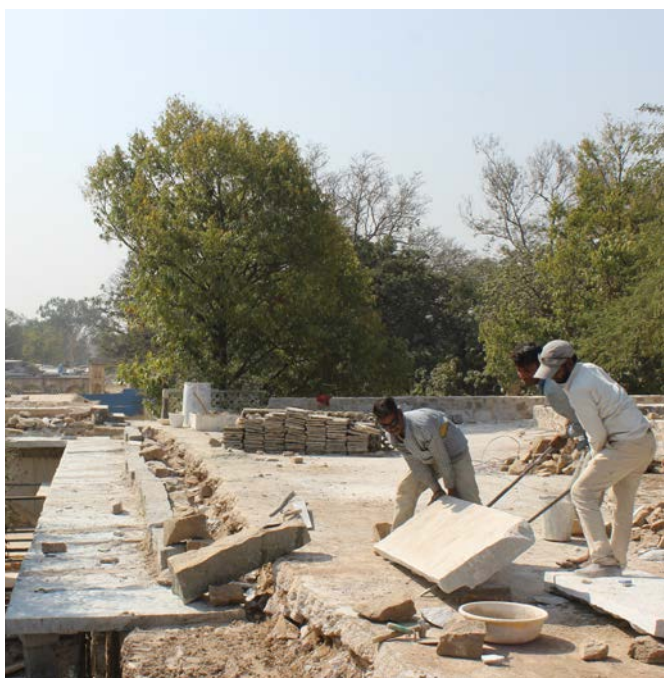
*Stone eaves installed on the facade of serai*

- Projected stone eaves were installed on the southern and northern facade of the main structure based on physical evidence. Final plaster on the southern facade below the chajja was applied using lime mortar and finished with a coat of lime punning after the restoration of the missing details. All the chajja stones were installed in position on the east, south arm of the sarai and the southern external facade based on the archival evidences.
- 0.75 meter high random rubble masonry parapet wall was built over these chajjas matching the evidence depicted in archival photographs from 1870's.
- Upon removal of cement concrete from the roof, lime concrete beneath was found damaged at many portions. The lime concrete was dismantled and a fresh coat of traditional lime concrete was laid on the roof to adequate slope and proper treatment.

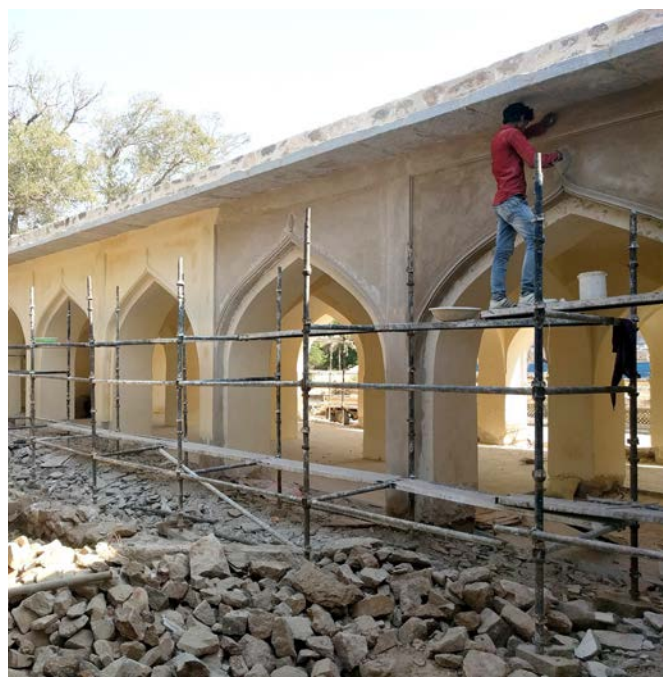
*Repairs on the facade in lime after removal of 20<sup>th</sup> century cement layers*
