AGA KHAN DEVELOPMENT NETWORK  
QUTB SHAHI HERITAGE PARK  
CONSERVATION & LANDSCAPE RESTORATION

2017-18  
ANNUAL REPORT

## Conservation & Landscape Restoration

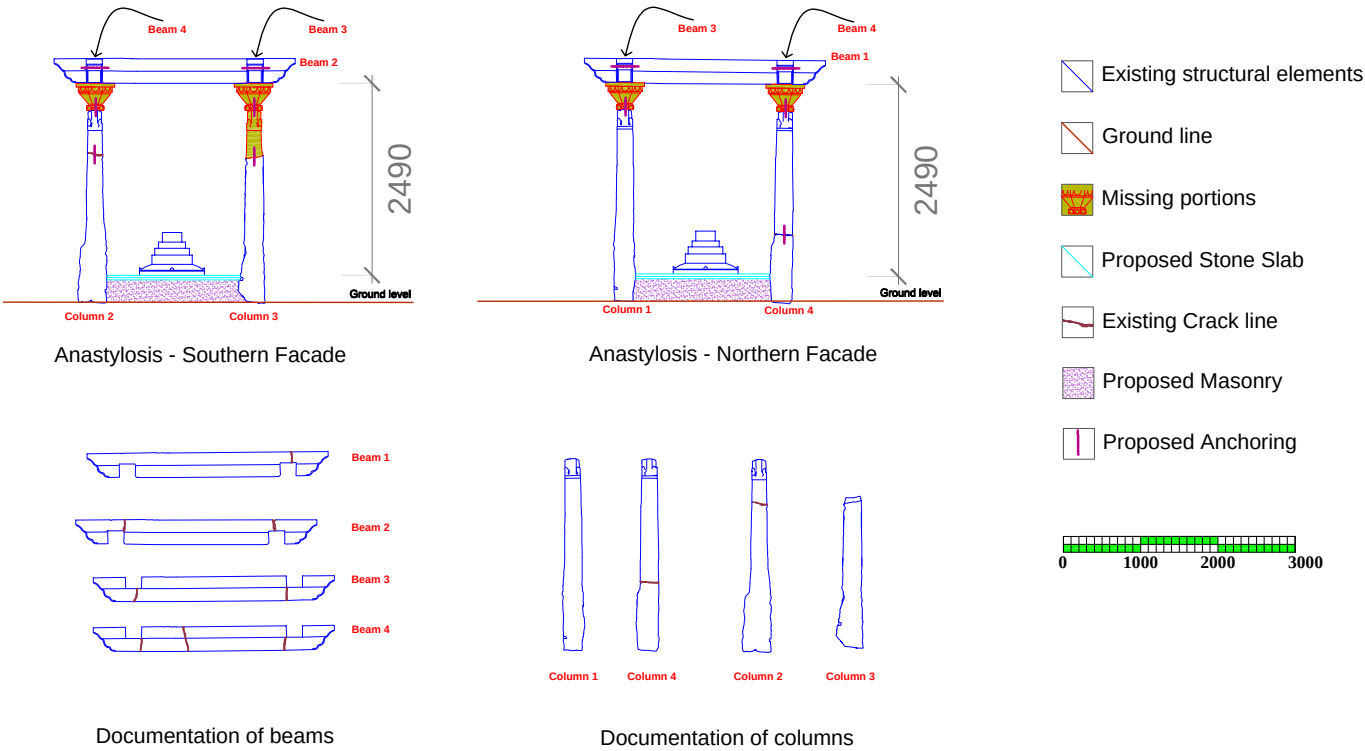
Detailed documentation of individual beams and columns marking the cracks for installation of stainless steel dowels for retrofitting

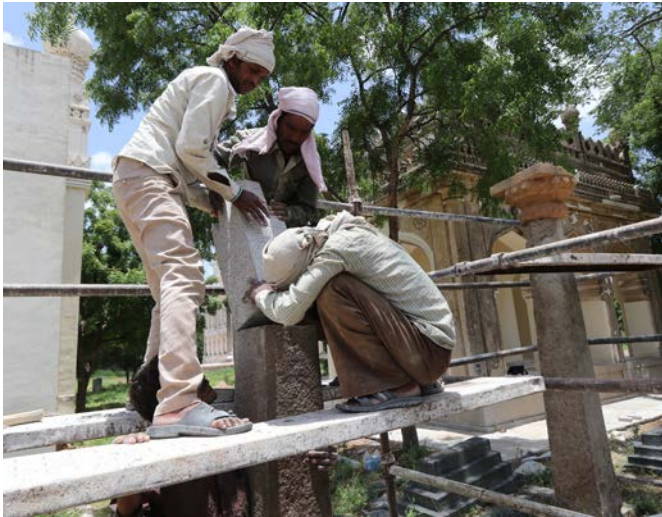
A hand carved stone piece of matching profile was retrofitted with stainless steel dowels along with epoxy resin

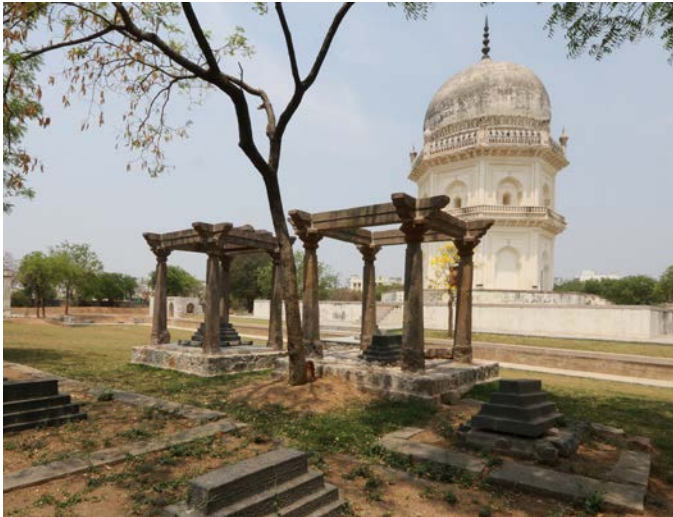
The collapsed pieces were reinstated in their original position

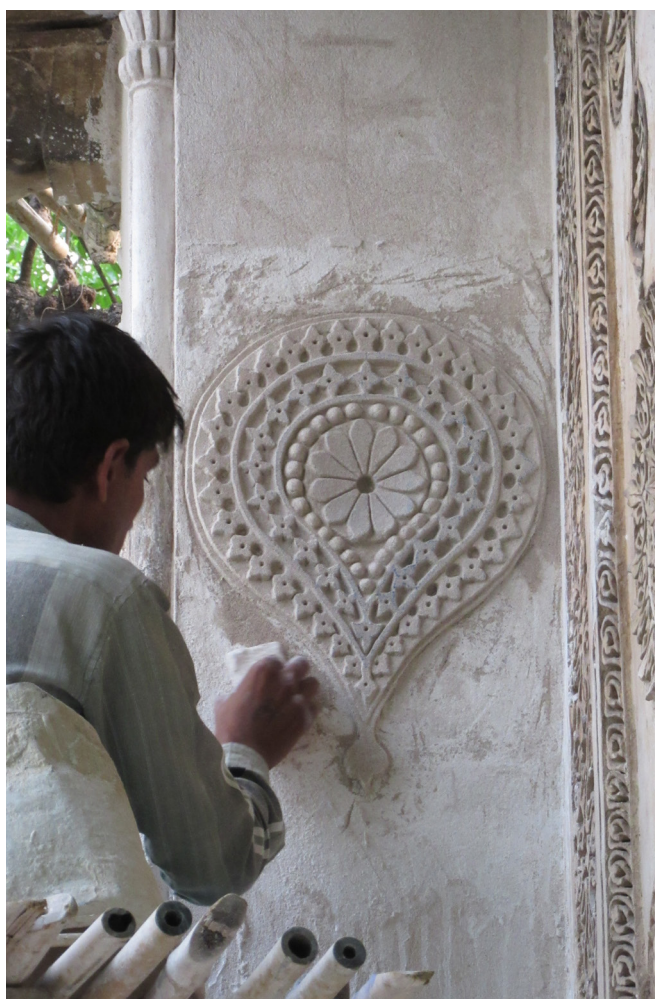
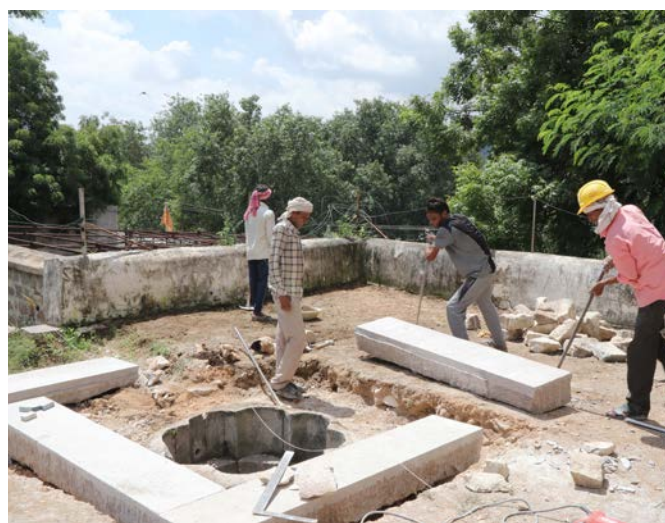
*(Left) Restoration of lime stucco details on the facade; (Top Right) Installation of granite stone edging around the 'wazu'tank; (Bottom Right) Installation of hand chiseled dressed stone steps*

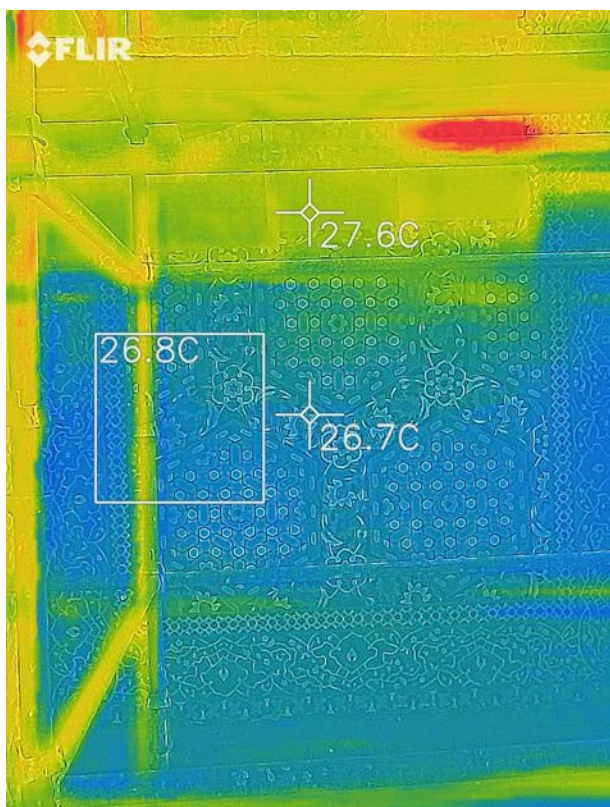
Thermal imaging using a thermal sensing camera, which helps detect areas of moisture. These readings will be taken over a course of a year at different seasons to understand impact of moisture/dampness on the tiles.

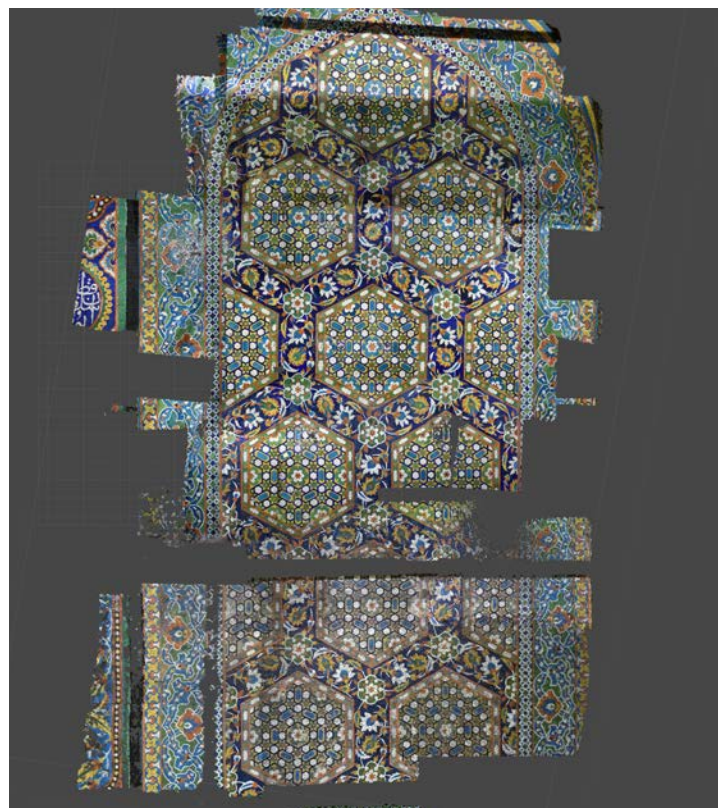
Photogrammetry is a scientific process documenting and taking measurements using a series of photographs. This helps build 3-d Models, 3 D point clouds and accurate measuring. The series of photos have been stitched together using a special software.
