AGA KHAN TRUST FOR CULTURE

# QUTB SHAHI HERITAGE PARK

ANNUAL REPORT 2019

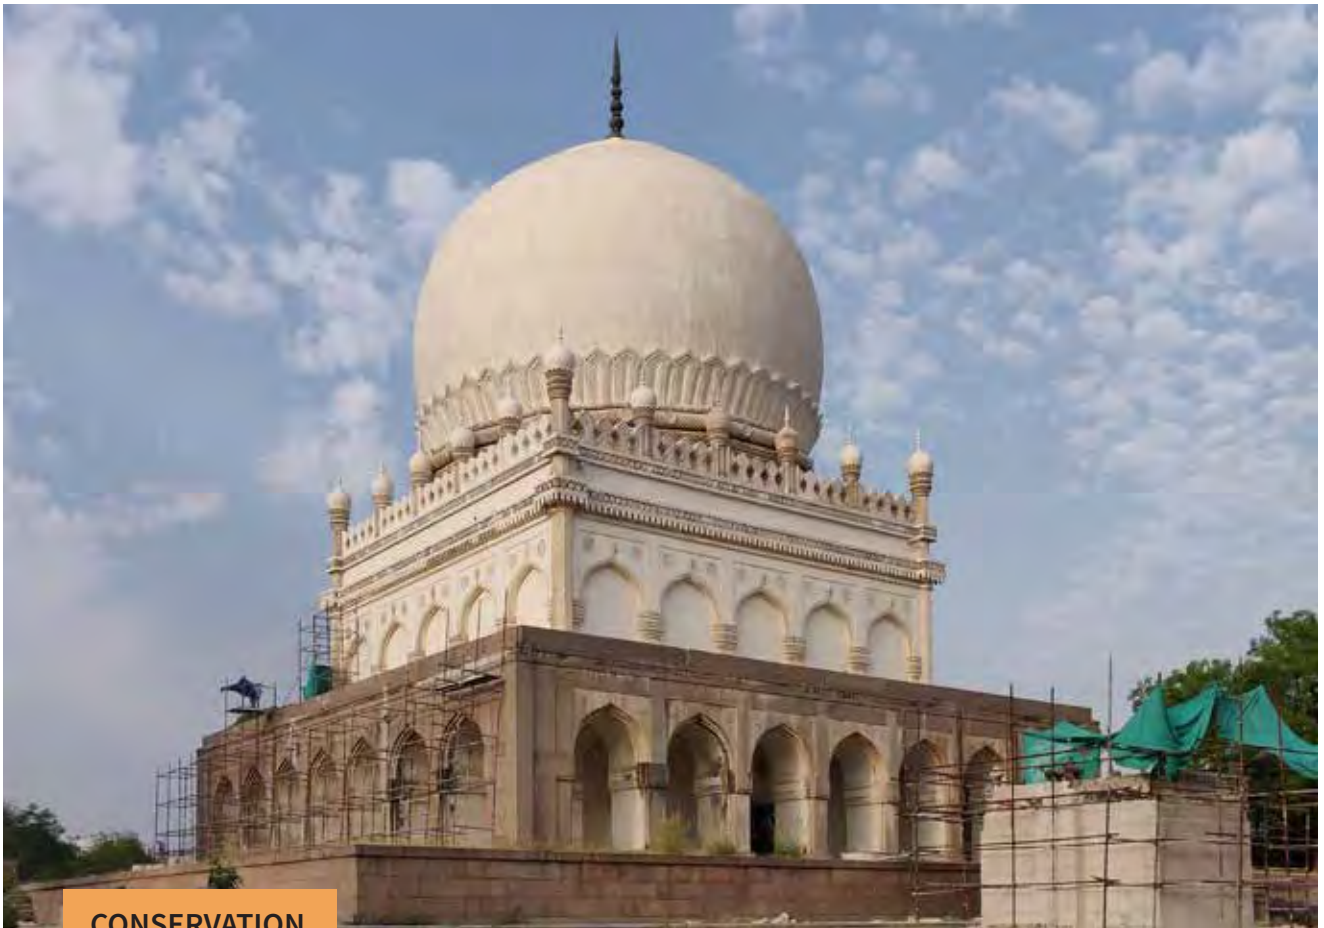
*(Above) The conservation works were preceded by high level of documentation and followed by removal of 20th-century cement mortar and concrete. Repairs were done using traditional lime mortar and reinstatement of ornamental stucco embellished on the principal facades.*

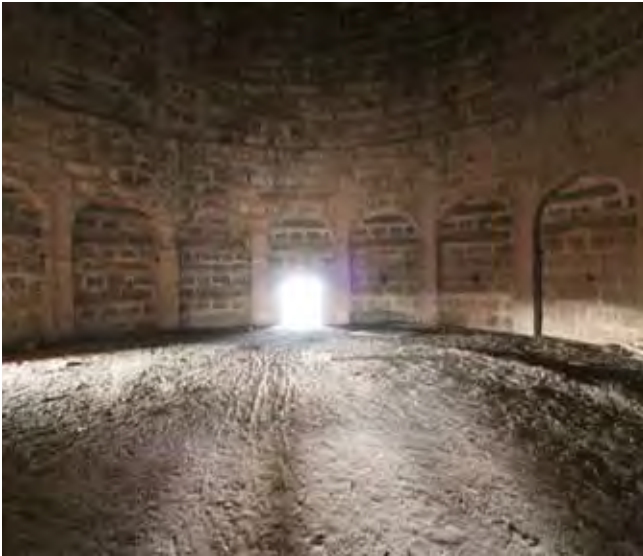
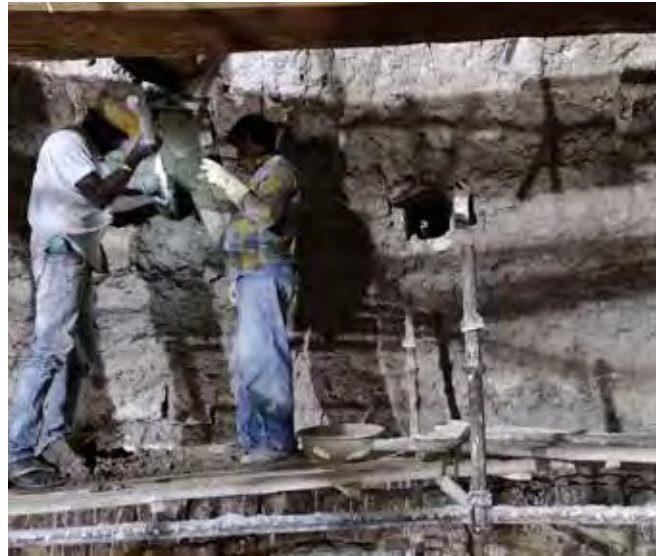
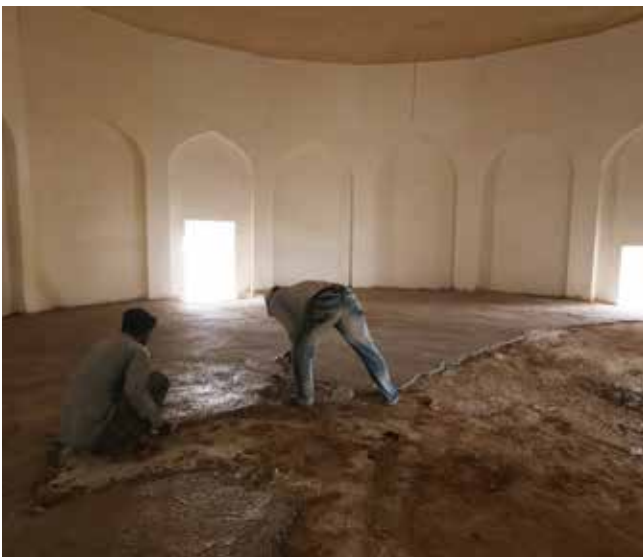
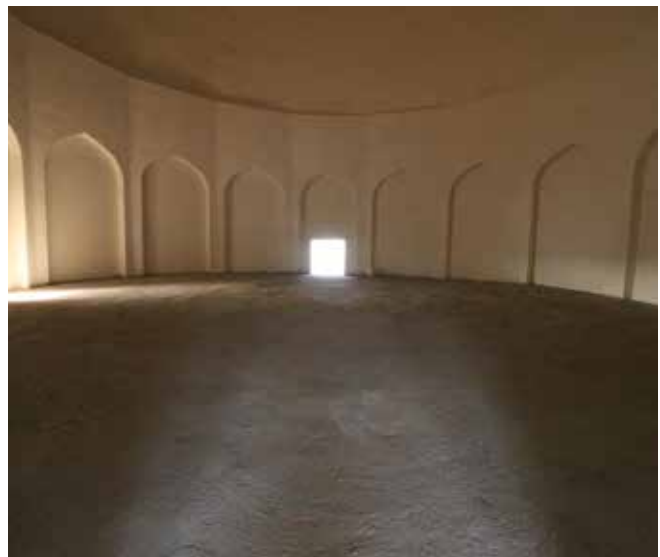
(Clockwise from left) The internal dome before conservation; Up to 4 feet deep holes that were found on the internal dome surface were filled with stones and lime plaster; the flooring was found damaged in portions and was hence, laid with lime concrete

- Plaster on the internal dome was found damaged due to prolonged seepage of rainwater. Repairs were carried out using traditional lime mortar.
- Holes up to 11 feet deep were found on the internal dome and were subsequently filled with rubble and traditional lime plaster.
- 20<sup>th</sup> century cement plaster layer was dismantled on the internal shallow dome, ceiling medallion and lower portions.
- Base plaster on the internal shallow dome was carried out using rich lime mortar by master craftsmen.

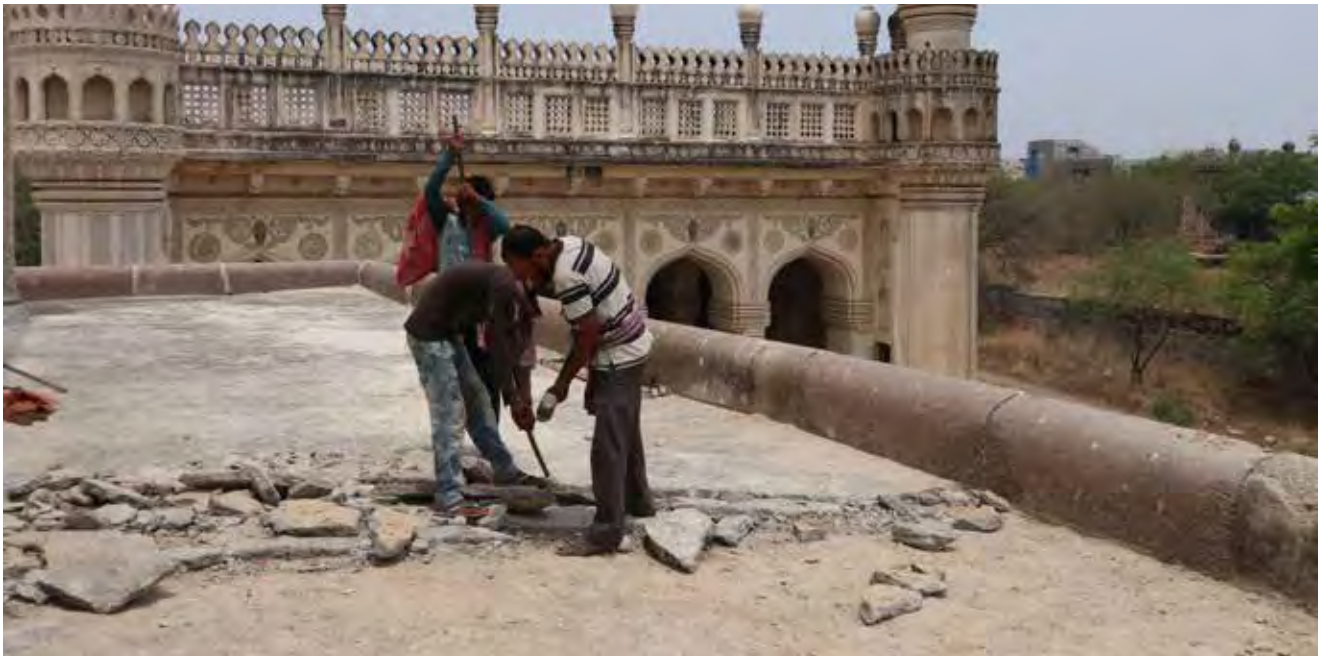
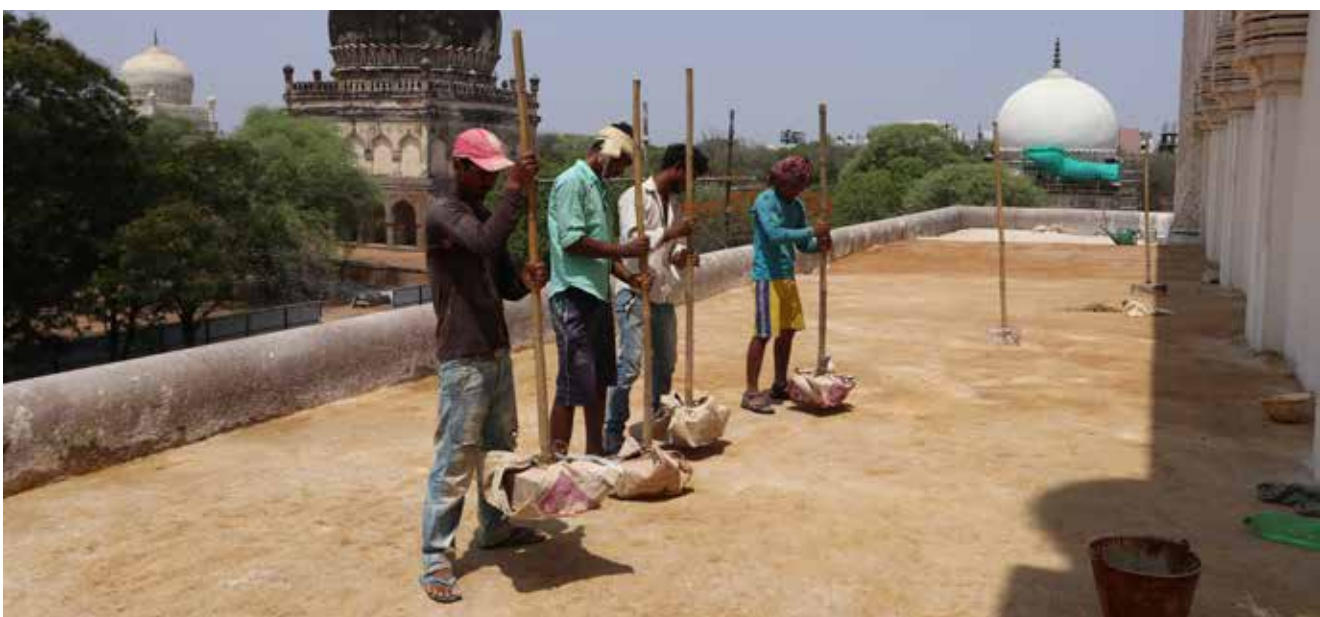
The terrace of Begum Hayat Bakshi's Mausoleum had a 20<sup>th</sup> century cement plaster layer added during the later repairs. On close inspection it was observed that this was leading to the rainwater seeping into the lower arcade.

(Above) Dismantling of 20th century cement concrete on the middle terrace; (Below) Traditional lime concrete was laid in appropriate slope

- 20th century cement concrete was dismantled on the middle terrace as it was leading to seepage of rainwater into the lower arcade and adding excess load on the structure.
- Traditional lime concrete was laid in appropriate slope to drain out rainwater away from the structure. Ramming and curing were carried out continuously for a week to achieve smooth finish which would help rainwater drain away.
- Cleaning of terraces and existing rainwater spouts on both the upper and middle terrace were carried out before the monsoons.
- Cleaning of rainwater spouts on both the upper and middle terrace coupled with removal of plants roots was repeatedly carried out throughout the monsoons as a part of the preventive maintenance.

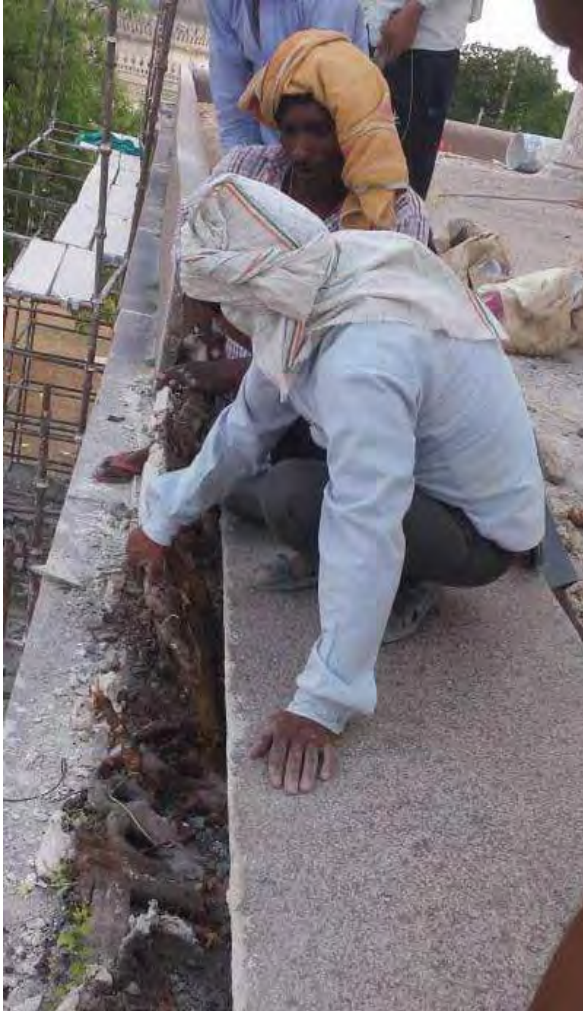
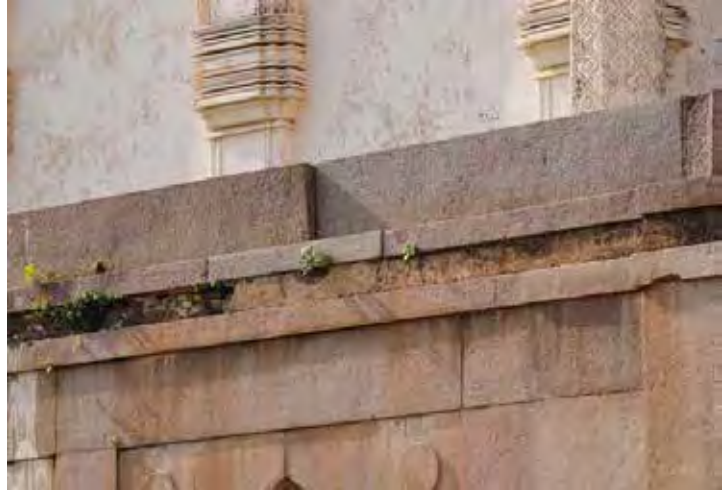
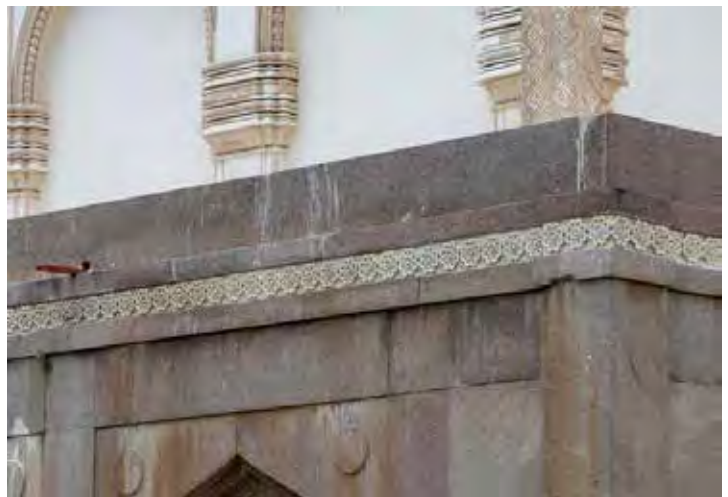
Middle level parapet of Hayat Bakshi Begum's tomb is made of thick hand chiseled granite blocks covering a length of 135 m. Over time, the stone joints developed gaps and had vegetation growth within the joints. All the stone blocks were manually realigned after removal of thick plants roots growing underneath by stone craftsmen.

*(Above) Stone parapet realigned on the middle terrace, and  
(Below) Metal water spouts installed in existing openings for a proper drainage of the rainwater.*

- Stone parapet on the middle terrace was realigned after removing the interspersed plant roots growing beneath.
- 17 metal waterspouts of approved design were installed in the existing openings of stone parapet to drain rainwater away from the structure.

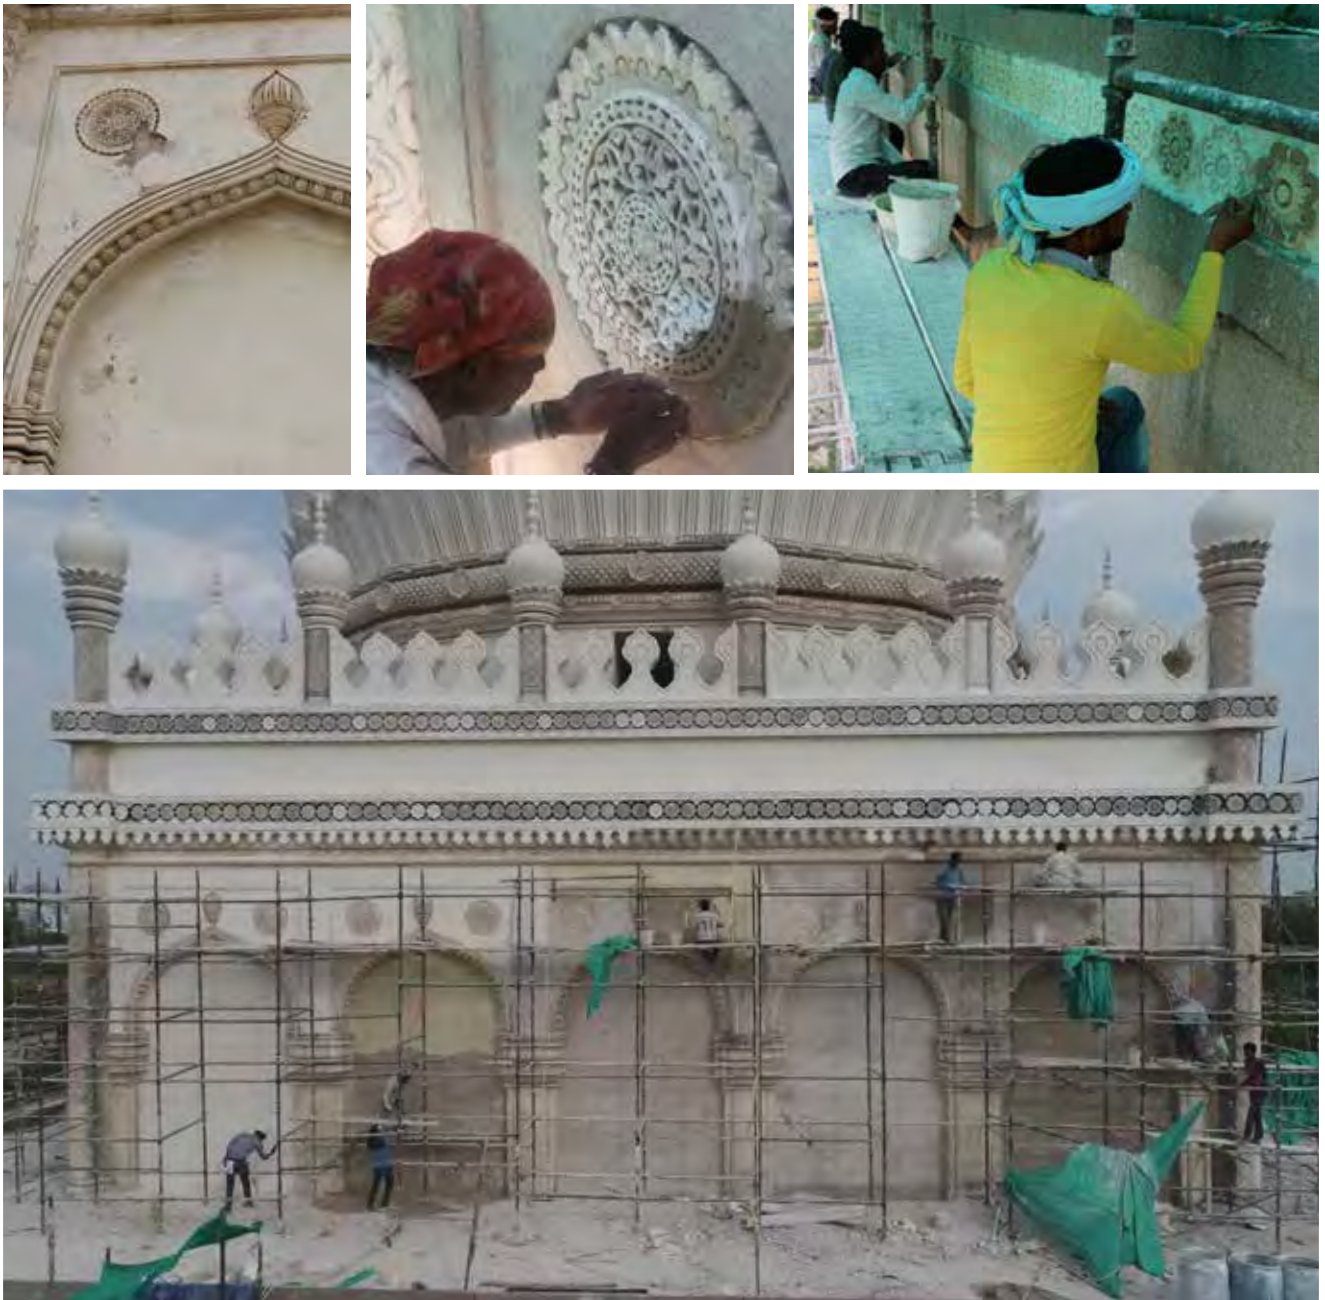
The details on the external surface below the parapet on principal facades of the mausoleum such as merlons, medallions and the flower band were found to be damaged or missing.

*(Above) On the external facade, the broken and damaged ornamental details and architectural elements were repaired and restored using traditional lime plaster and finished with a coat of lime punning based on existing evidence.*

- Repairs and restoration works were carried out on the upper portion of the external façade of the mausoleum where broken, damaged or missing stucco details, merlons, medallions and floral bands were restored using traditional lime plaster and finished with a coat of lime punning based on the existing in-situ evidence.
- The floral band running along the lower terrace was restored using traditional lime mortar and finished using lime punning based on the existing in-situ evidence.

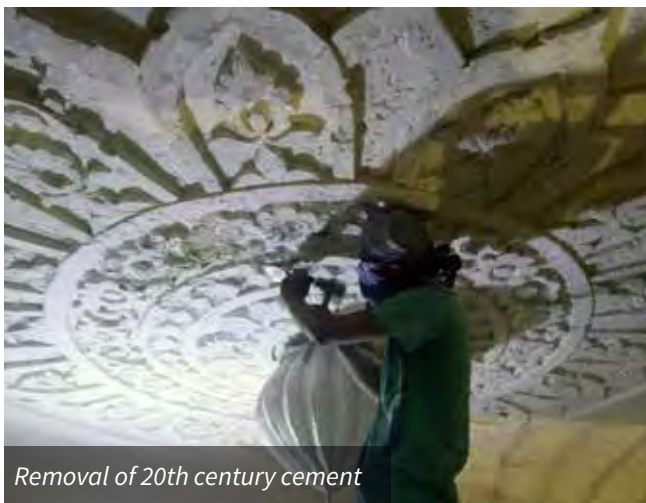
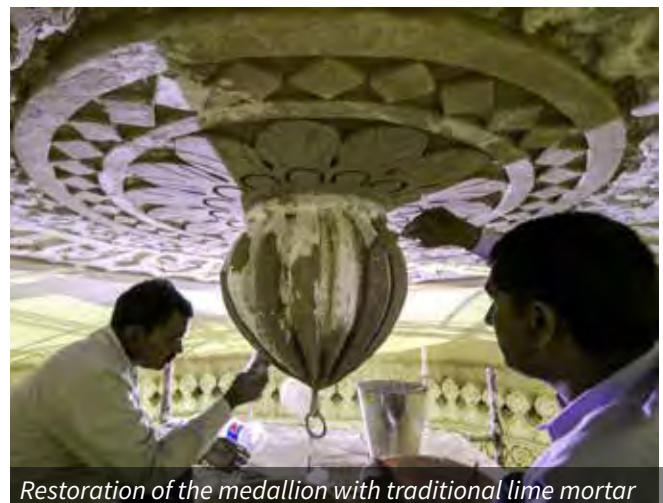
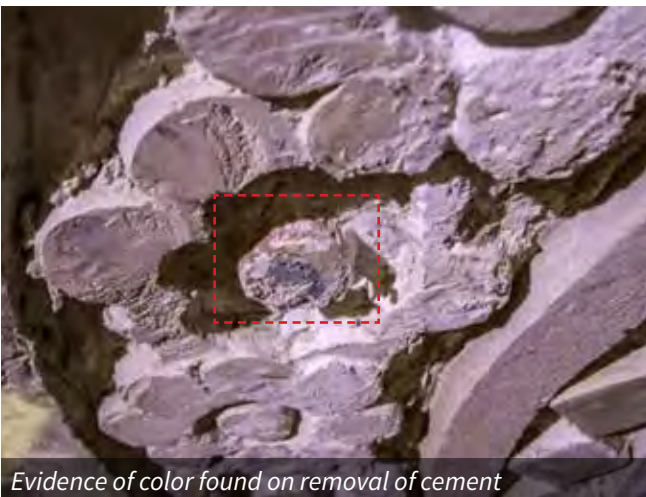
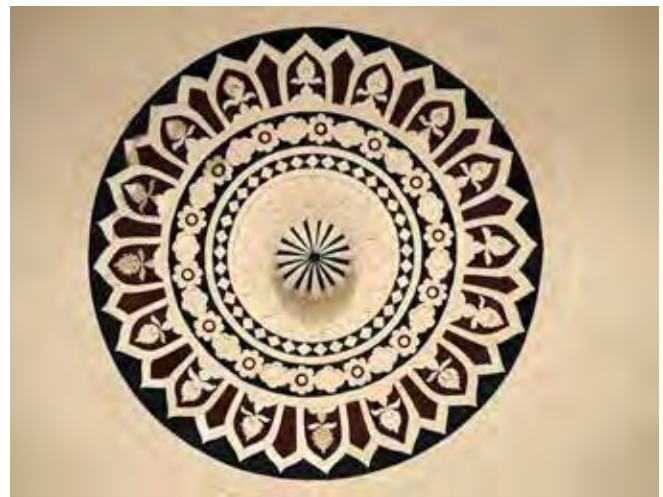
Traces of original color were revealed on the ceiling medallion and missing paint was restored based on the existing site evidence. These conservation efforts have, in turn, helped reveal the character of the structure as intended by the original builders.

*Traces of original color were revealed on the ceiling medallion and missing paint was restored based on the existing site evidence. These conservation efforts have, in turn, helped reveal the character of the structure as intended by the original builders.*

- Ceiling medallion were documented along with removal of 20th-century cement plaster. Ornamental stucco details were restored by master craftsmen using rich traditional lime mortar to conserve the ornamental ceiling medallion.

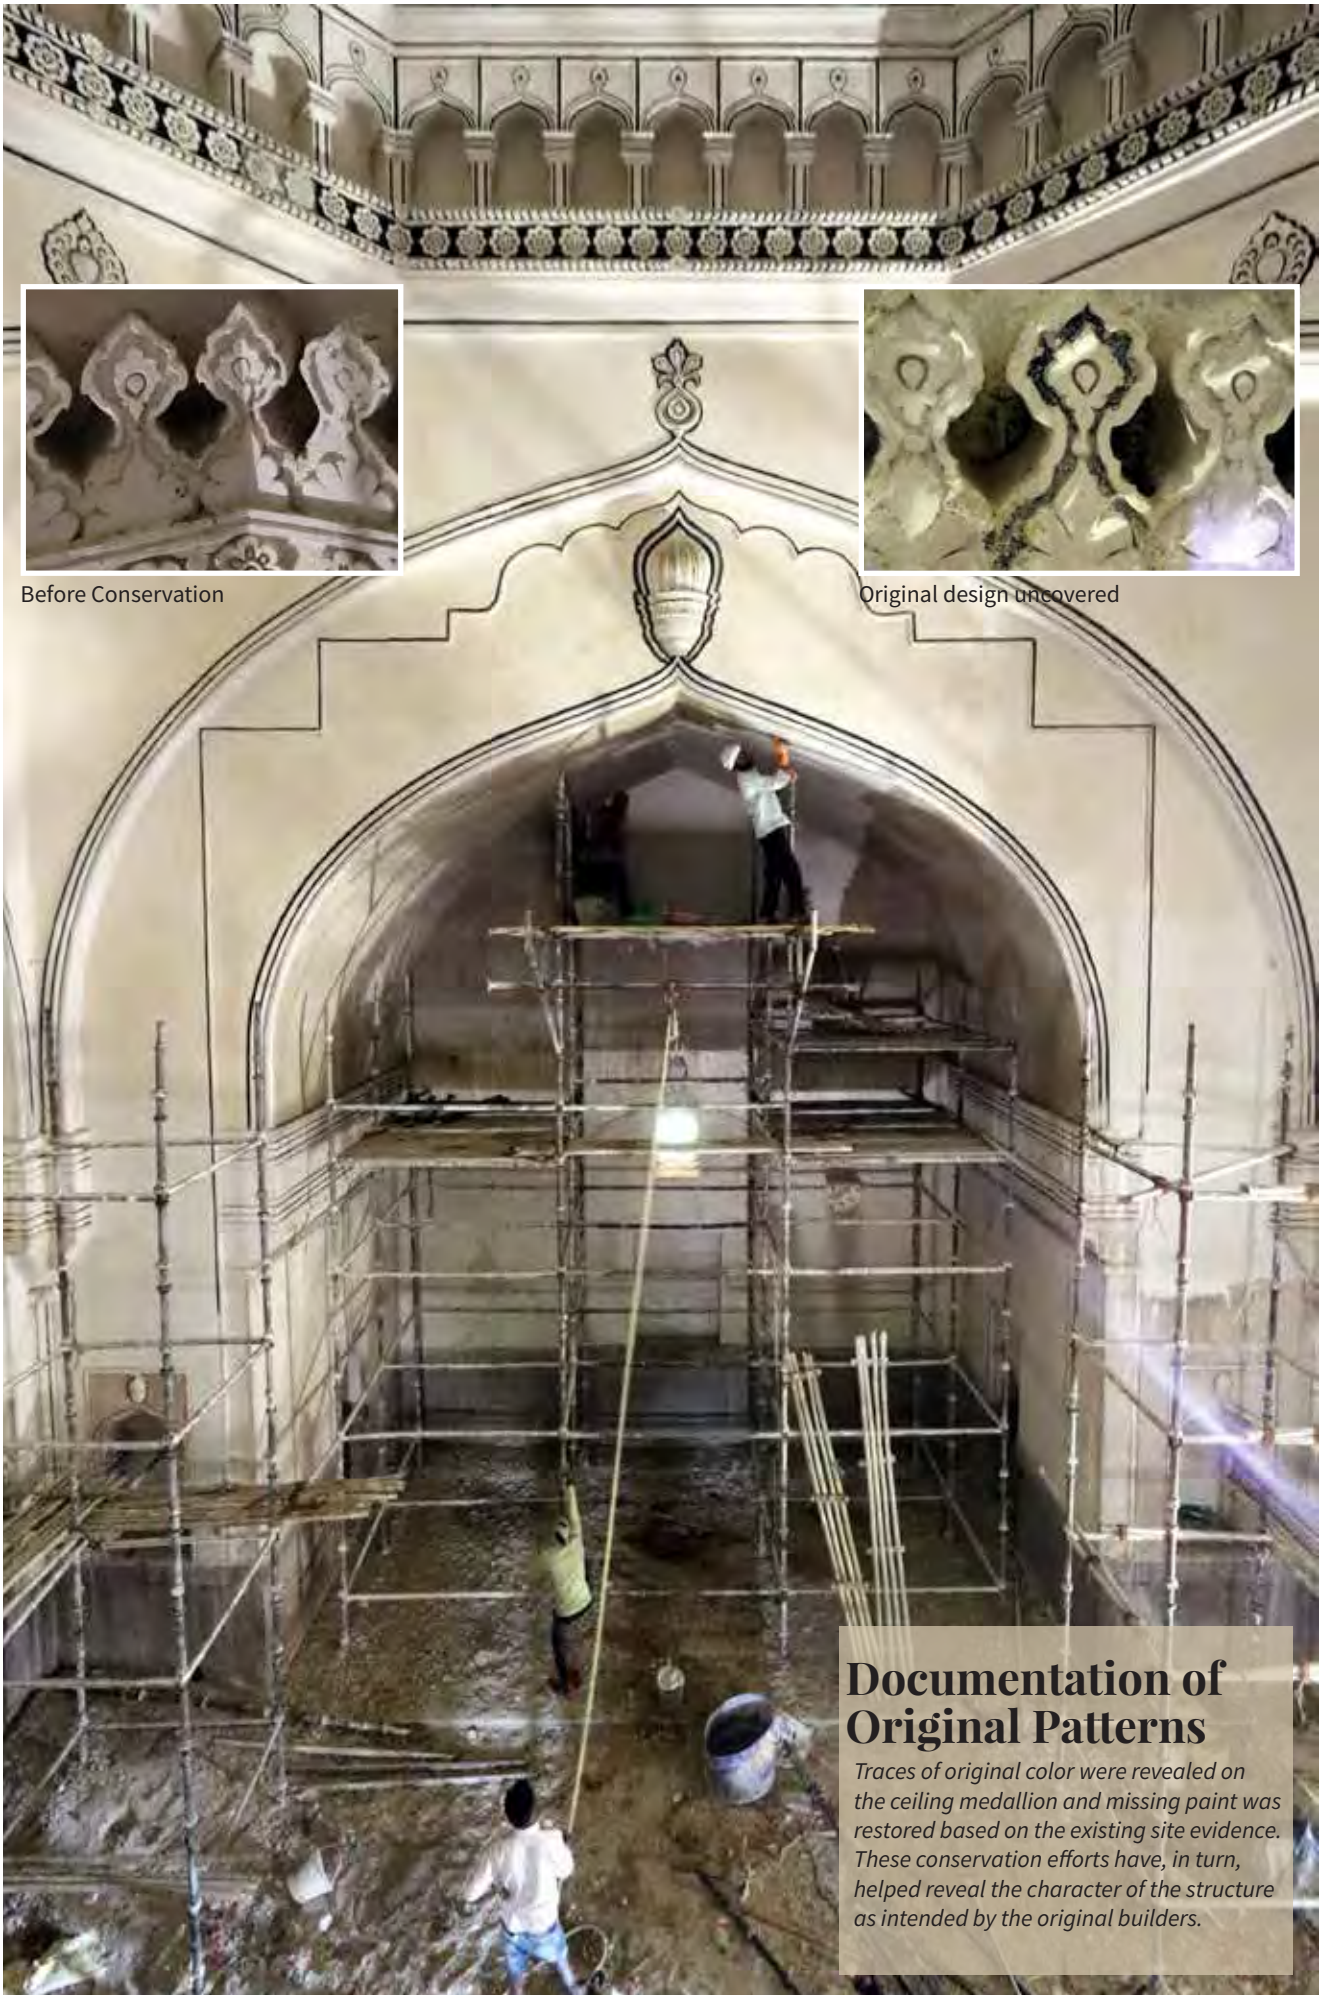
Before Conservation

Original design uncovered

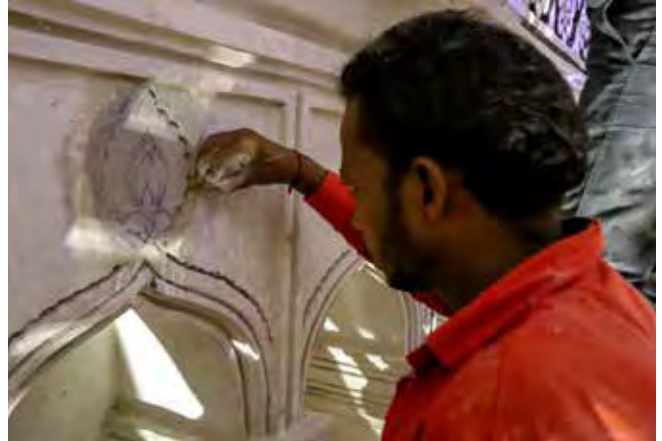
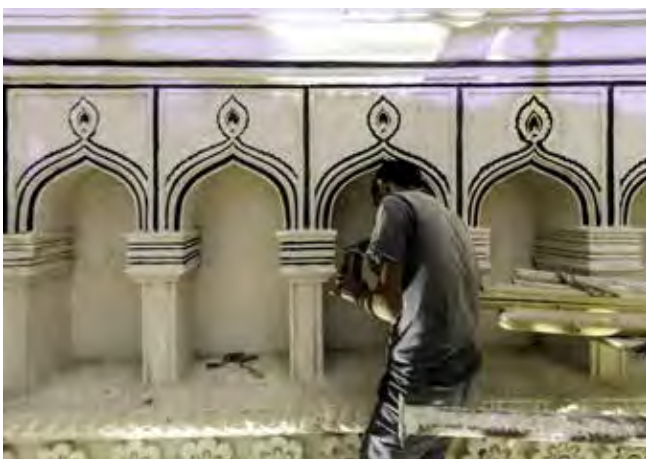
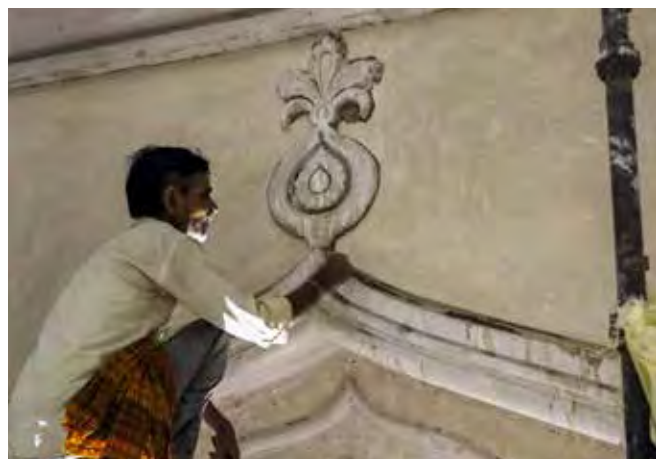
The internal surface below the dome had visible signs of deterioration augmented by 20<sup>th</sup> century repairs carried out using cement. The details on the internal surface below the parapet on principal facades of the mausoleum such as merlons, medallions and the flower band were found to be damaged or missing.

*(Below) Conservation works at the main tomb chamber of have included careful removal of 20<sup>th</sup>-century cement, restoration of lime plaster and missing stucco patterns. Plaster repairs were followed by finishing with a thin 1 mm layer of punning. Traces of original colour were revealed, and missing paint was restored based on the existing site evidence.*

- 50 feet tall scaffolding were erected inside the internal mausoleum.
- Repairs on the blind arches situated below the internal dome were carried out using traditional lime mortar. 20th century cement and white-wash layers were carefully removed to reveal the original appearance of gallery. Plaster repairs were followed by finishing with a thin 1 mm layer of punning, which consists of lime putty mixed with organic additives. Evidences of black colour in grooves of arches were revealed and missing paint was restored based on the existing site evidence.

- Moulding bands surrounding the blind arch gallery were
- scraped to remove cement patches and were subsequently repaired with lime mortar by craftsmen.

- Cement plaster was carefully removed from the recessed arched bays and low heights vaults situated on all four sides inside the mausoleum. Ornamental details, moulding bands, arch crowns and original lattice screens were repaired by master craftsmen. Final finish on plaster repairs was done using a 1 mm thin smooth layer of slaked lime putty mixed with organic additives.

- Traces of black colour were revealed in the moulding bands and ornamental architectural elements inside the mausoleum.

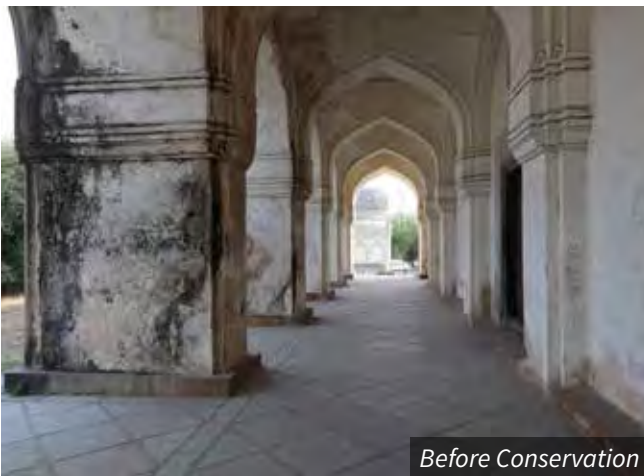
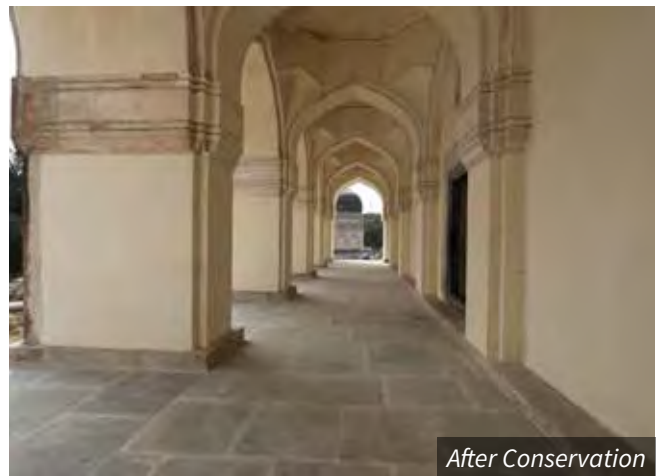
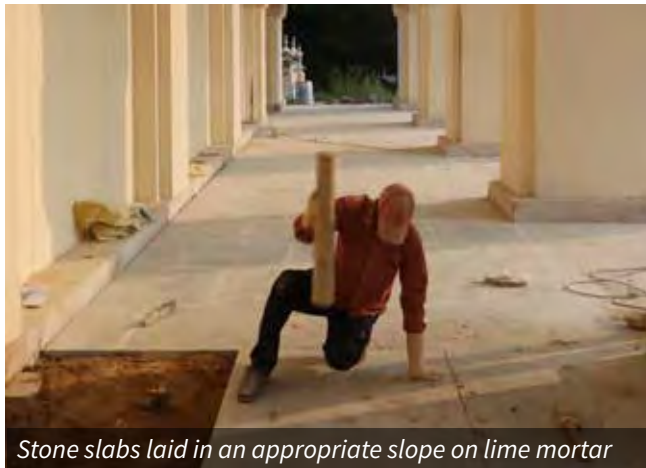
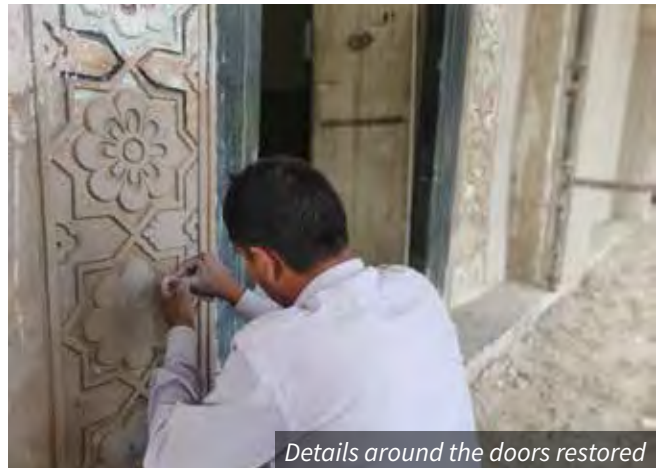
The existing flooring before conservation was 20th century cement concrete.

- 20th century stone flooring laid in contextually inappropriate layout with cement mortar was dismantled in the arcade surrounding the mausoleum. 30 mm thick granite stone slabs were laid in approved layout and appropriate slope in lime mortar.
- Plaster repairs inside the arcade on all four sides was carried out using rich lime mortar by master craftsmen.

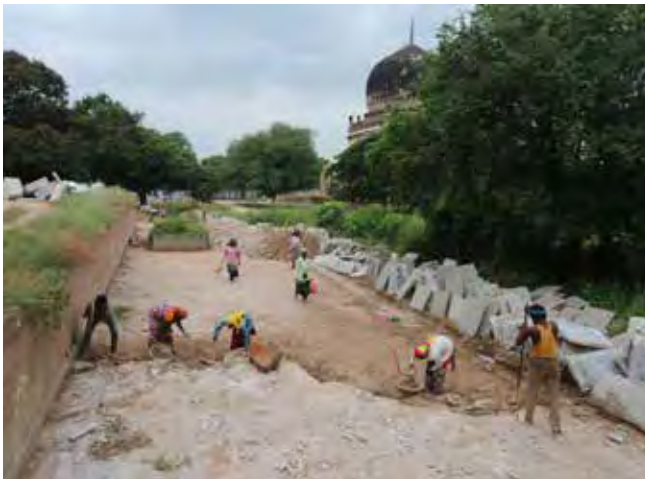
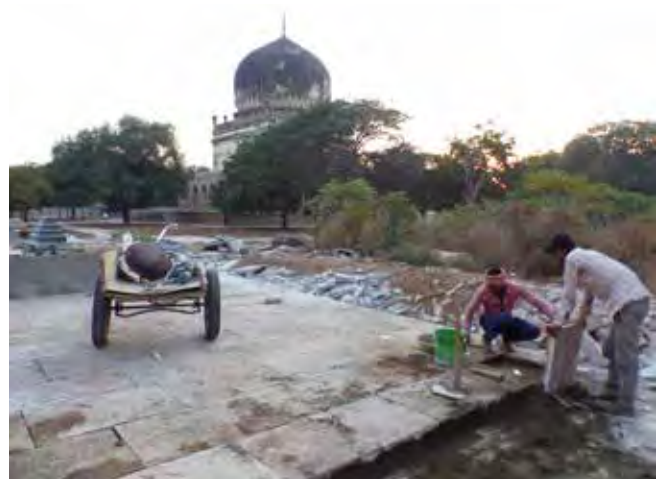
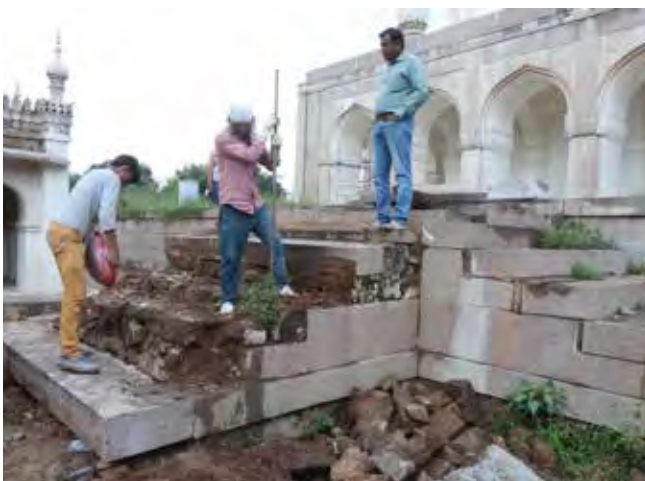
*(Above) Damaged stone steps were reset matching the alignment of steps on the eastern side by stone craftsmen*

- Construction of a 5 feet wide plinth protection was carried out along the perimeter of the lower arcade situated on the projected plinth. The plinth protection was lined with brick walls and base lime concrete for the flooring was laid. 100 mm thick granite stones slabs and edging stone were installed and laid in accordance to the approved layout and in an appropriate slope.
- Plinth protection around the perimeter of mausoleum of Hayat Bakshi Begum has commenced with work being carried out on the eastern side.
- Base work for the pathway on the lower edge of the retaining wall to the south side is being carried out.

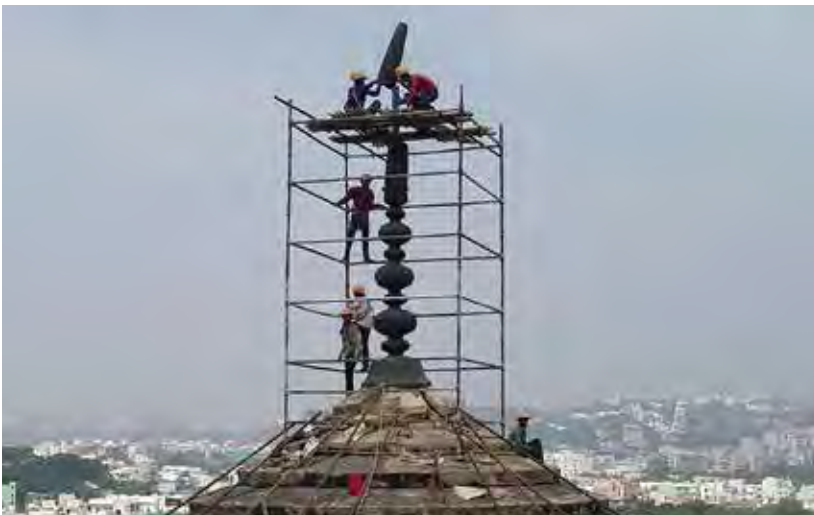
The dome of the mausoleum is dotted with over 300 patches made for supporting the wooden scaffolding erected during 20<sup>th</sup> century repairs. On inspection, the dome was found to be covered with a 4-inch-thick layer cement mortar thereby causing the original lime plaster and prominent ribs below to disintegrate. The petal band along the base of the dome was also found in a dilapidated condition before conservation.

- Dome of this mausoleum was dotted with over 300 patches made for supporting the wooden scaffolding erected during repairs undertaken in the 20<sup>th</sup> century and were covered up with a thick layer of cement plaster.
- Steel scaffolding has been erected around the dome and the terrace of the mausoleum to commence the dismantling of 20<sup>th</sup> century cement plaster.
- It was observed the top conical piece of the copper finial was skewed and appeared disjointed. The top three pieces of the copper finial were carefully removed and a traditional copper smith will be repairing the damaged portions to correct the alignment and stitch the holes made by hammering of iron nails on the conical portion to attach it to the internal wooden piece.

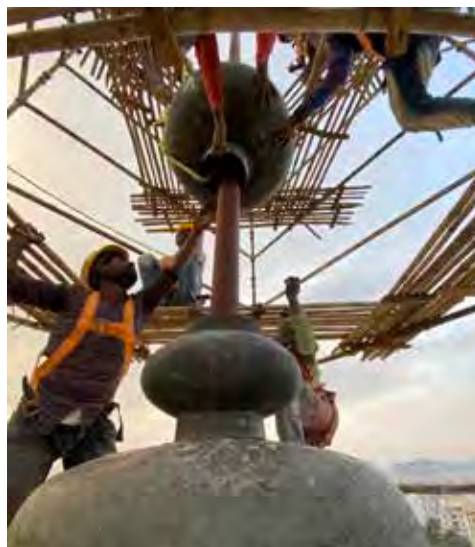
Amongst the significant architectural elements on the mausoleum, is the 25-feet high copper finial standing atop the dome. This required specialised repairs by a traditional coppersmith, as it was found much damaged. The individual hollow copper pieces were carefully removed from the dome for repair, and have now been reinstated in their original position.

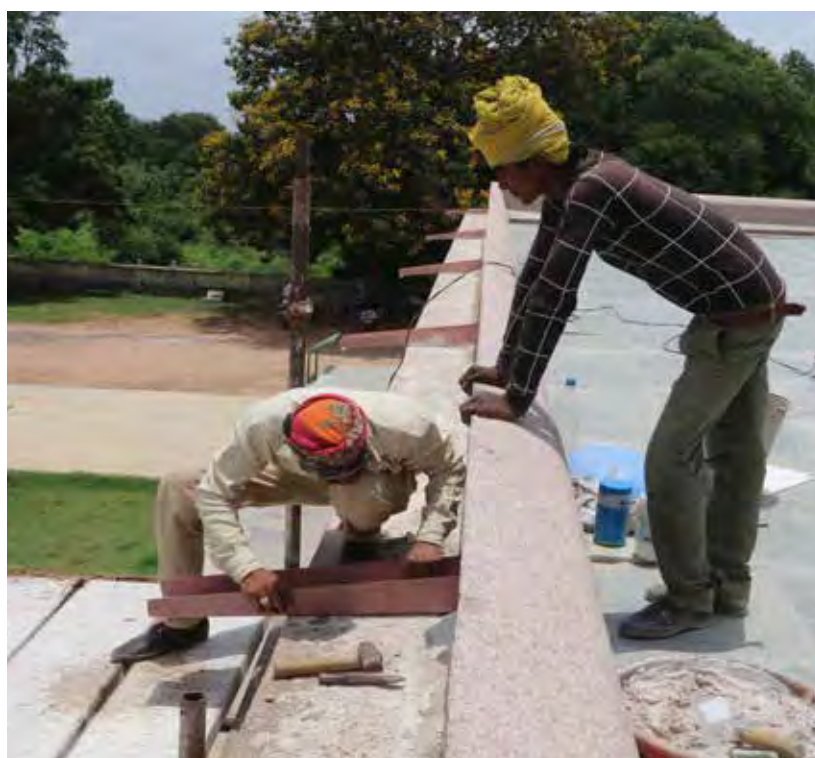
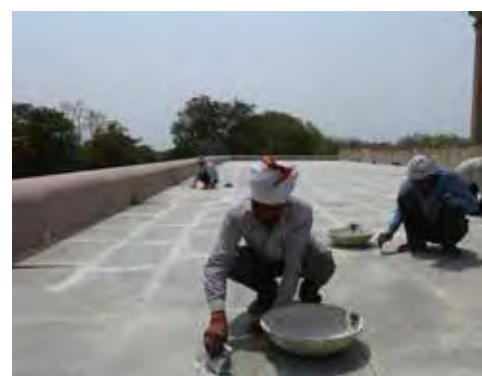
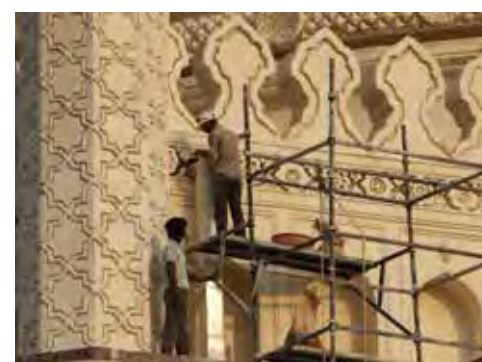
(Clockwise from left) Installation of metal waterspout on the parapet at upper plinth; Grouting and pointing with lime mortar on all the joints at the upper plinth level; Cleaning of existing rainwater spouts

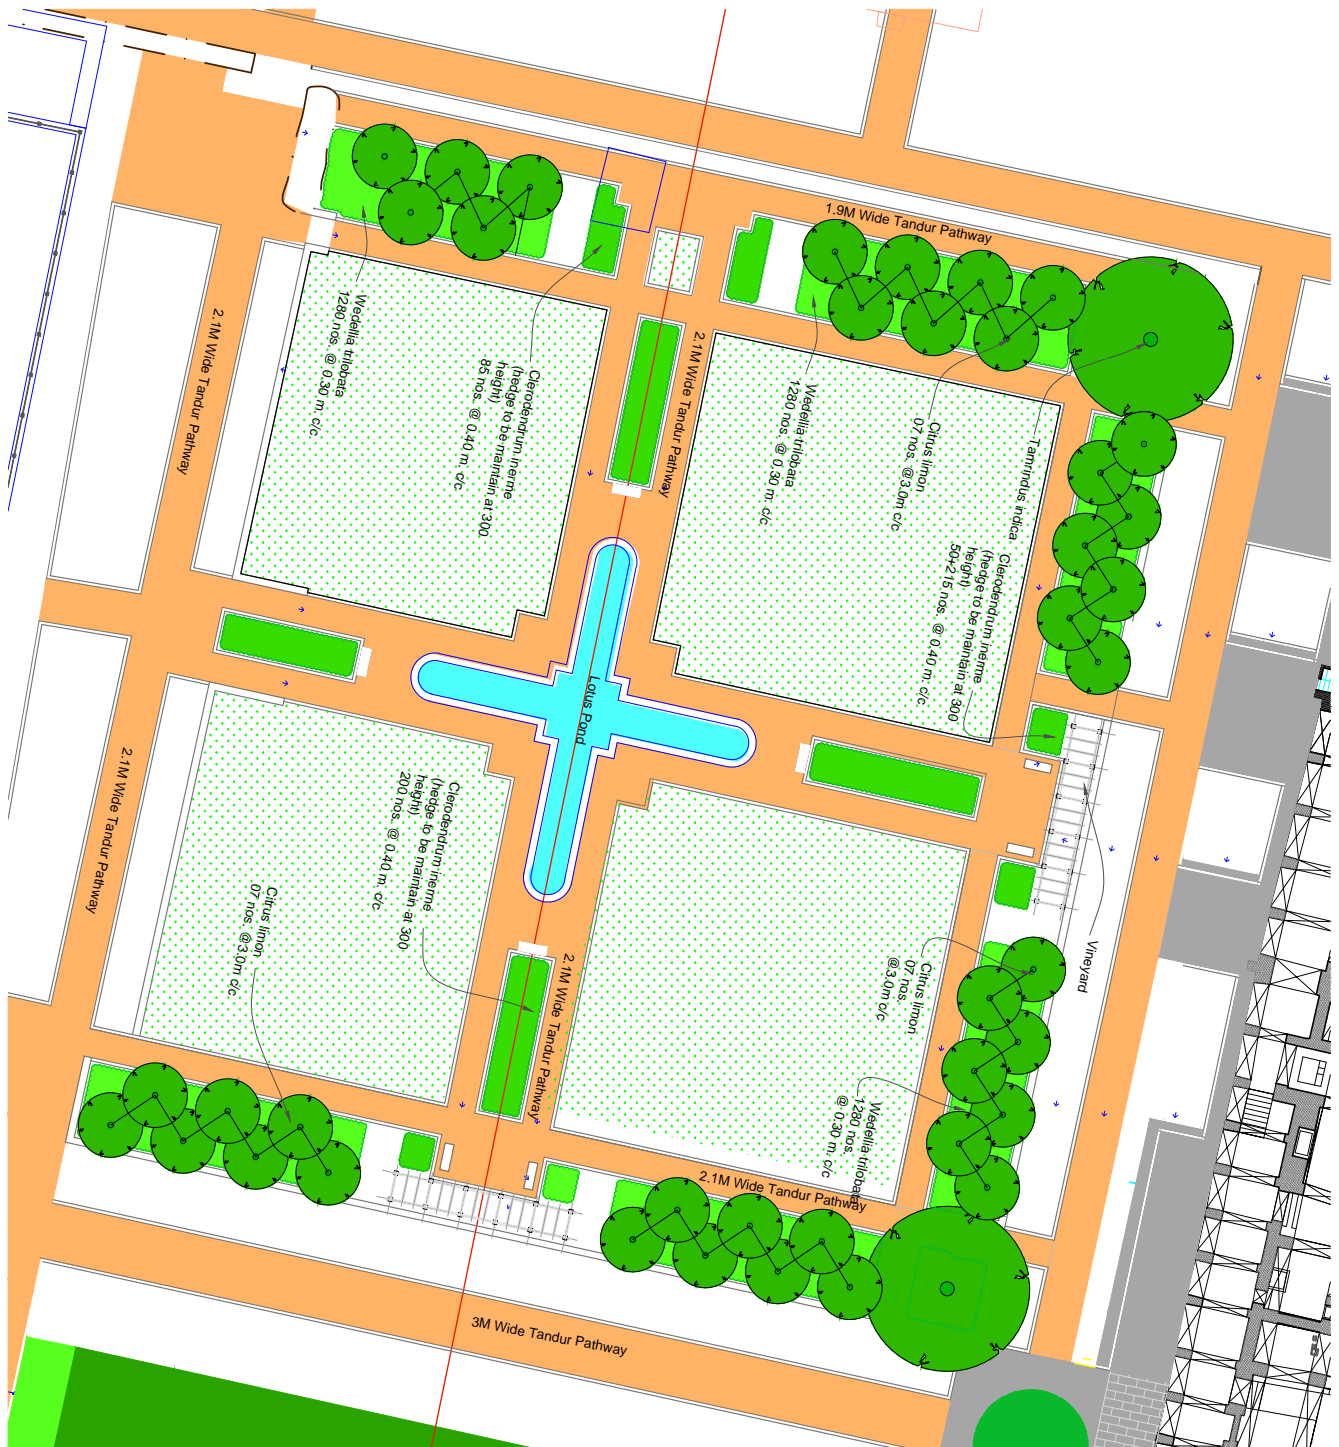
(Above) Landscape scheme for the forecourt of Muhammad Quli Qutb Shah's mausoleum.

- Pathways along with connecting steps were laid in appropriate gradient as per the plan. 3.0-metre-wide pathways were laid on the north - south and east - west directions along the periphery of the garden. The pathways were finished with 50mm thick Tandur stones.

- Grading was completed in the forecourt for planting of local grass.
- Citrus saplings were planted on the periphery of the central pathways in a manner so as to not obstruct the view of the Hamam.

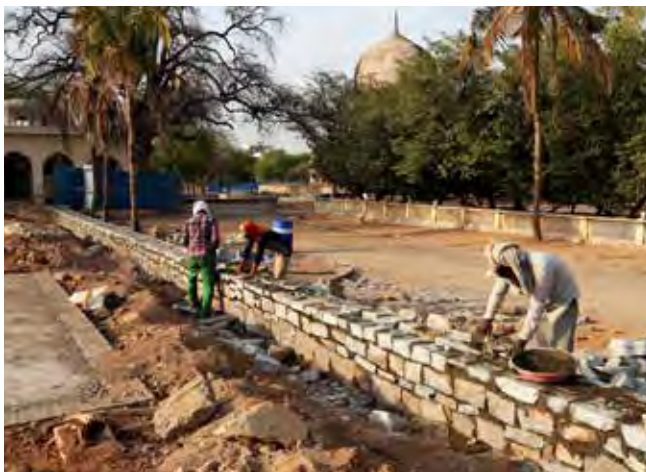
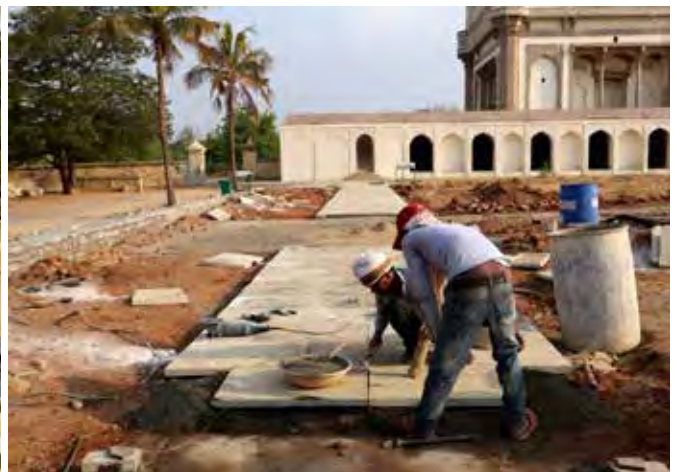
*(Left) Construction of plinth wall along the raised forecourt; (Right) Installation of paving stone on the pathways constructed as a part of the landscape master plan*

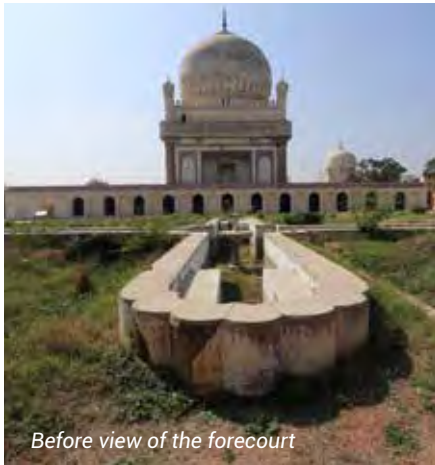
*Before view of the forecourt*
