AGA KHAN TRUST FOR CULTURE

# QUTB SHAHI HERITAGE PARK

ANNUAL REPORT 2019

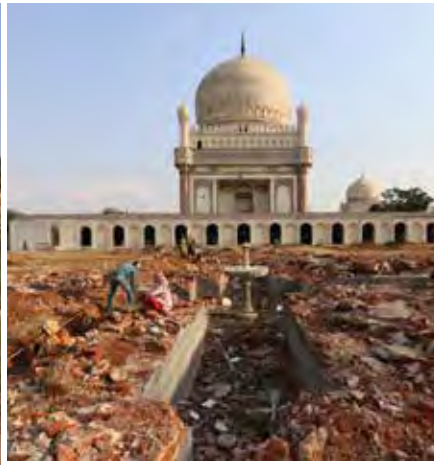
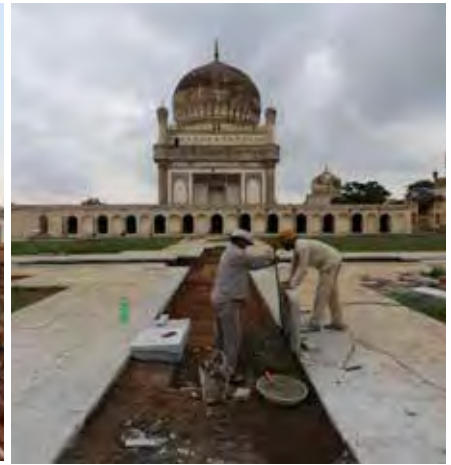
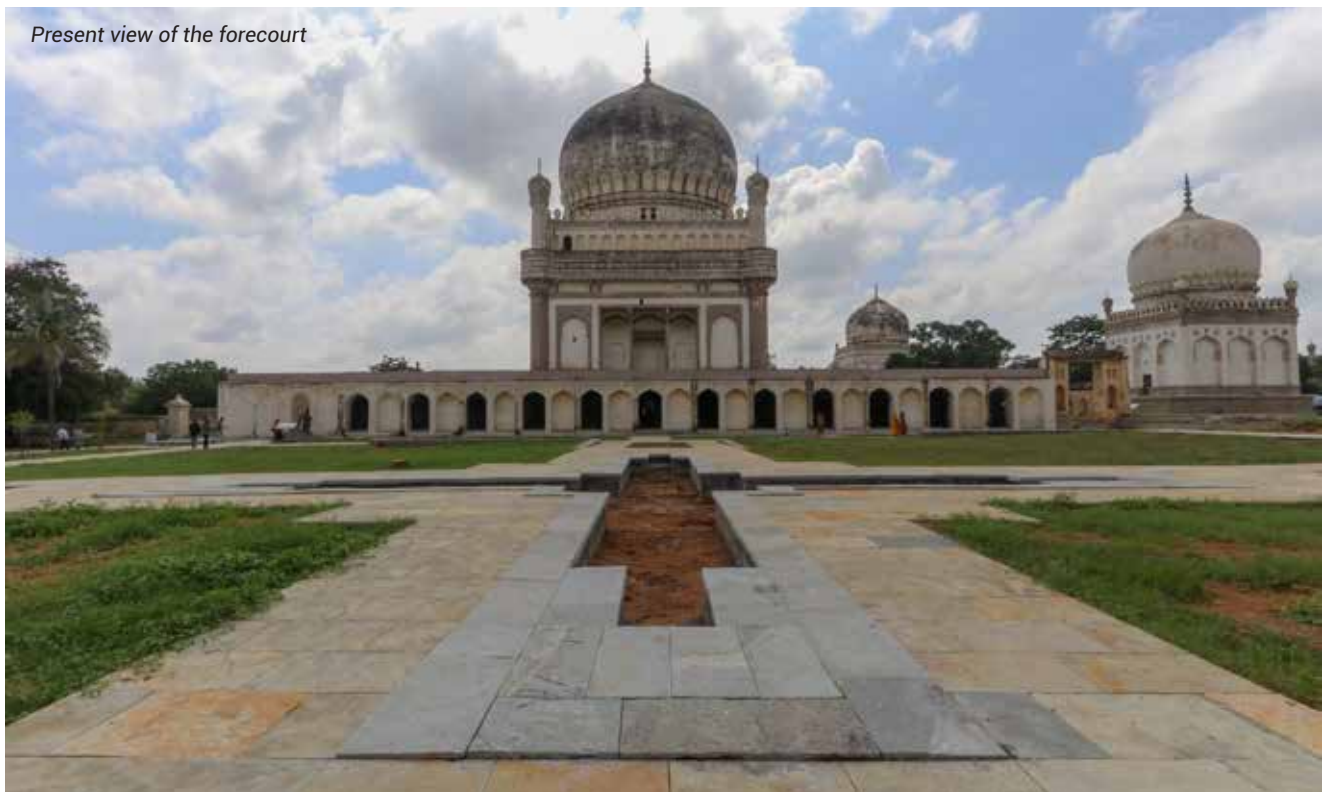
*Present view of the forecourt*

*(Above) Photographs showing the various stages of paving of pathways inside the forecourt of Muhammad Quli Qutb Shah. Installation of paving stone slabs and granite edging lining the cruciform shaped depressed lotus pond was carried out by stone craftsmen as per the landscape masterplan*

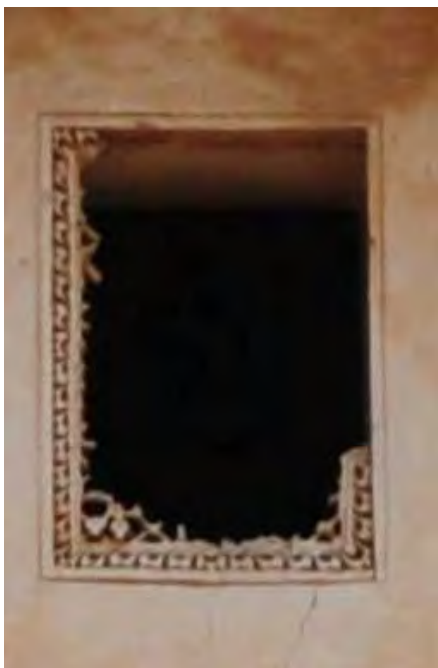
- Vegetation and algae growth could be seen on the dome and facade
- Small structural cracks visible on the corner minarets.
- Ornamental details are damaged or missing on various parts of the facade.
- No water outlets
- External surfaces had a new finish, and had been plastered with cement in portions.
- External plaster was flaking in portions and the lime lattice screen were missing on the east and south sides.
- Internal surfaces were covered with lime wash.
- The plinth wall was missing in portions.

Before Conservation

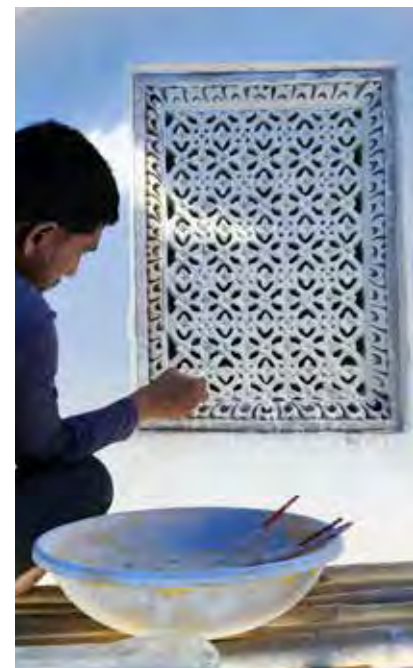
Craftsman restoring the lattice screen with lime mortar

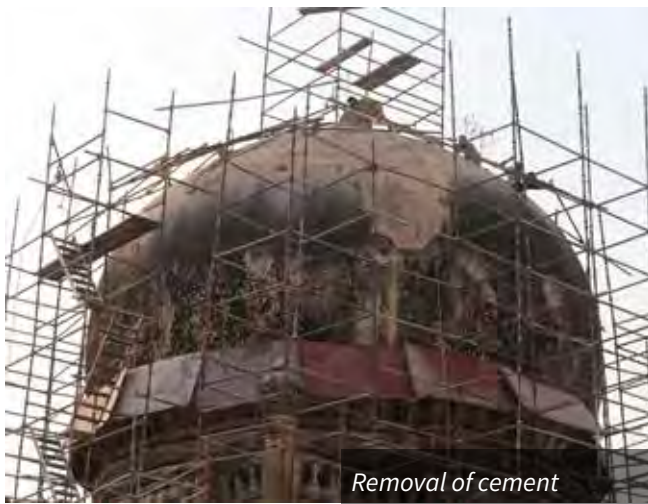
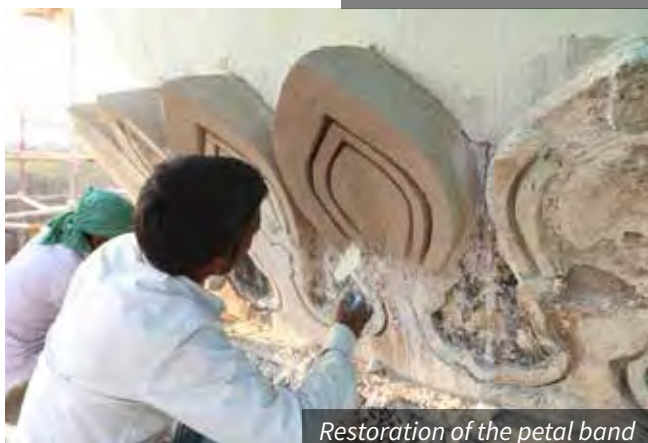
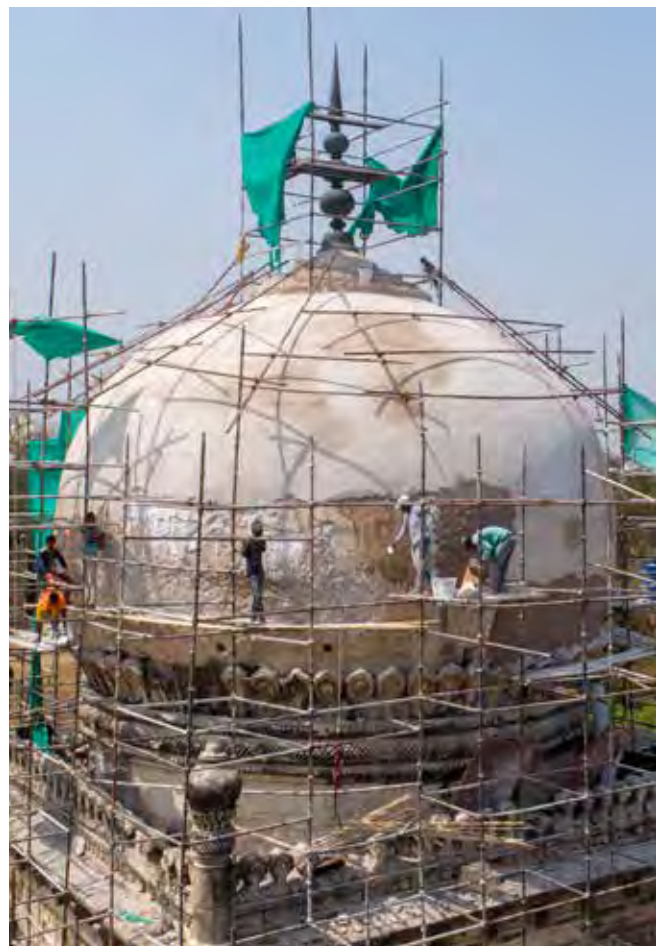
The dome of the mausoleum was dotted with patches made for supporting the wooden scaffolding erected during 20<sup>th</sup> century repairs. On inspection, the dome was found to be covered with a 4-6-inch-thick layer cement mortar thereby causing the original lime plaster below to disintegrate.

The petal band below the dome were damaged in portions and the drum below was also finished with cement mortar and showed visible signs of deterioration.

- Dome of this tomb was dotted with over 30 patches made for supporting the wooden scaffolding erected during repairs undertaken in the 20<sup>th</sup> century and were covered up with cement mortar. After on-site investigations, all the holes were filled with rubble and lime mortar to prevent rainwater ingress.

- Dilapidated lime plaster layer on the 16-sided drum
- supporting the dome was dismantled.
- Repairs on the drum were done using traditional lime mortar.

- The petal band along the base of the dome was restored using rich traditional lime mortar and finished with a final coat of lime punning.
- 20th century cement plaster and whitewash were dismantled from the internal dome. Plaster repairs on the dome were completed and finished with a 1 mm thin layer of lime putty mixed with organic additives.

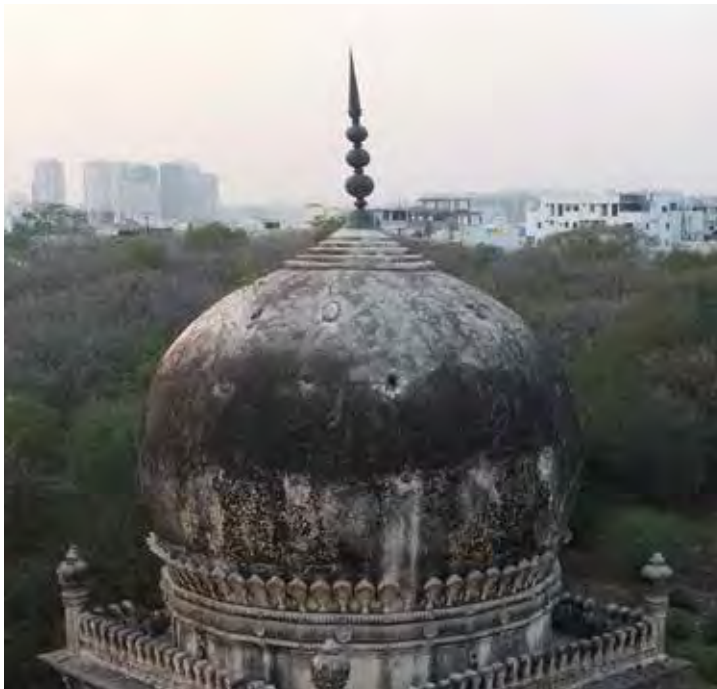
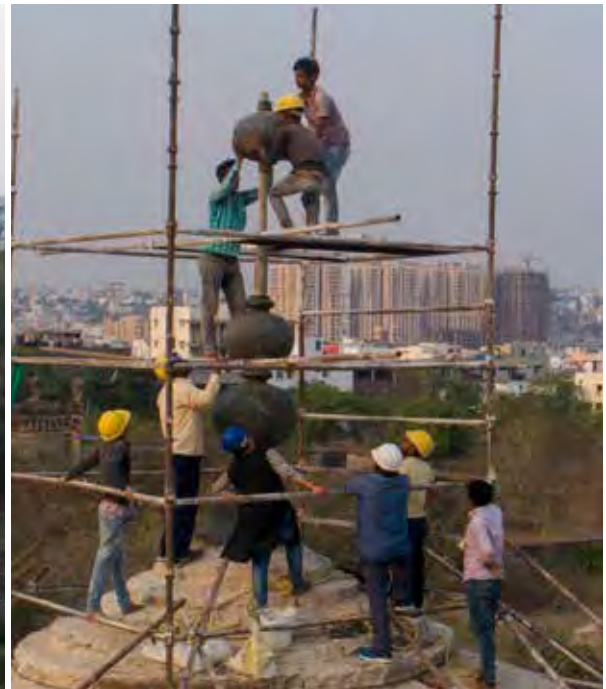
The copper finial of the dome of the mausoleum was found to be damaged and the internal support made of wood had started to disintegrate over time.

*(Left) Before final installation, pieces of the copper finial were assembled on the ground to ensure that the GI pipe inserted in the center fits appropriately;  
(Right) Installation of the repaired pieces of copper finial atop the dome*

- The copper finial of the dome on investigation found to be in poor shape with the internal wooden support within the finial having deteriorated over time. The various copper vessels that made up the finial also had 4-5 holes in them.
- The finial was disassembled and brought down from the dome and carefully documented.
- The damaged copper vessels were repaired by a local coppersmith.
- The repaired copper finial was carefully re-installed on the top of the mausoleum and the wooden skeleton inside the finial was replaced with a GI pipe having 80mm to 100mm diameter to withstand strong winds and rain.

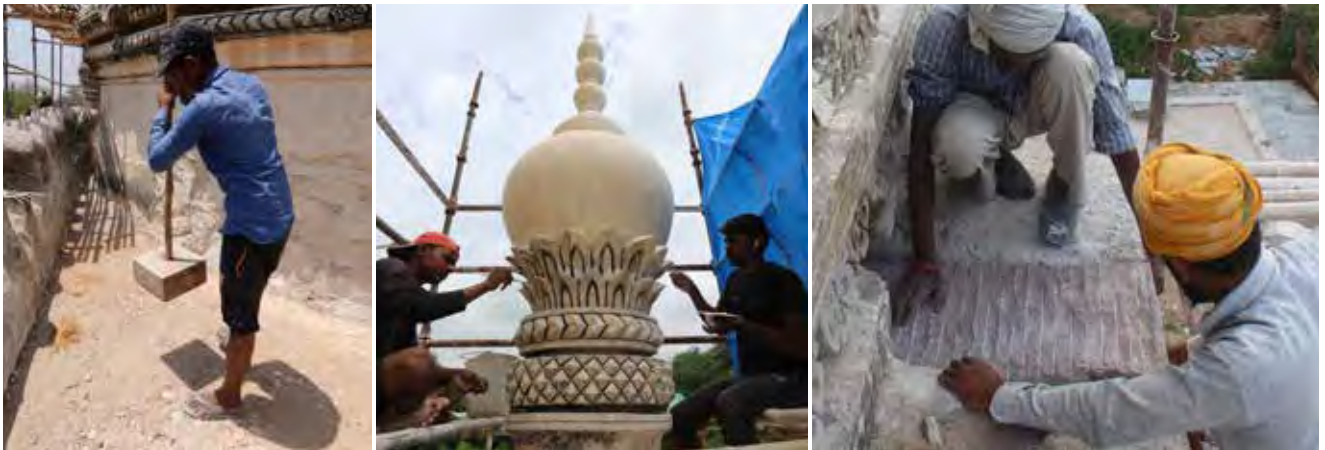
The terrace was covered with a layer of 20<sup>th</sup> century cement concrete and this aggravated the water seepage inside the mausoleum. Multiple stone eaves situated below the battlements were found to be damaged or missing.

*Left - Cement from the terrace was removed and replaced with traditional lime concrete in an appropriate slope*

*Middle - Minarets on the external parapet repaired with traditional lime plaster*

*Right - Missing stone eaves were replaced with hand dressed stone sections of matching size and colour*

- 20<sup>th</sup> century cement concrete was dismantled from the terrace.
- Traditional lime concrete was laid on the terrace to appropriate slope to drain rainwater away from the monument. Ramming and curing were carried out continuously for a week to achieve smooth finish.
- Thick plant roots on the rainwater outlets below the battlements were carefully removed and deep holes were repaired with rubble masonry and rich traditional lime mortar.
- The terrace and existing rainwater spouts on terrace were cleaned before the monsoons.

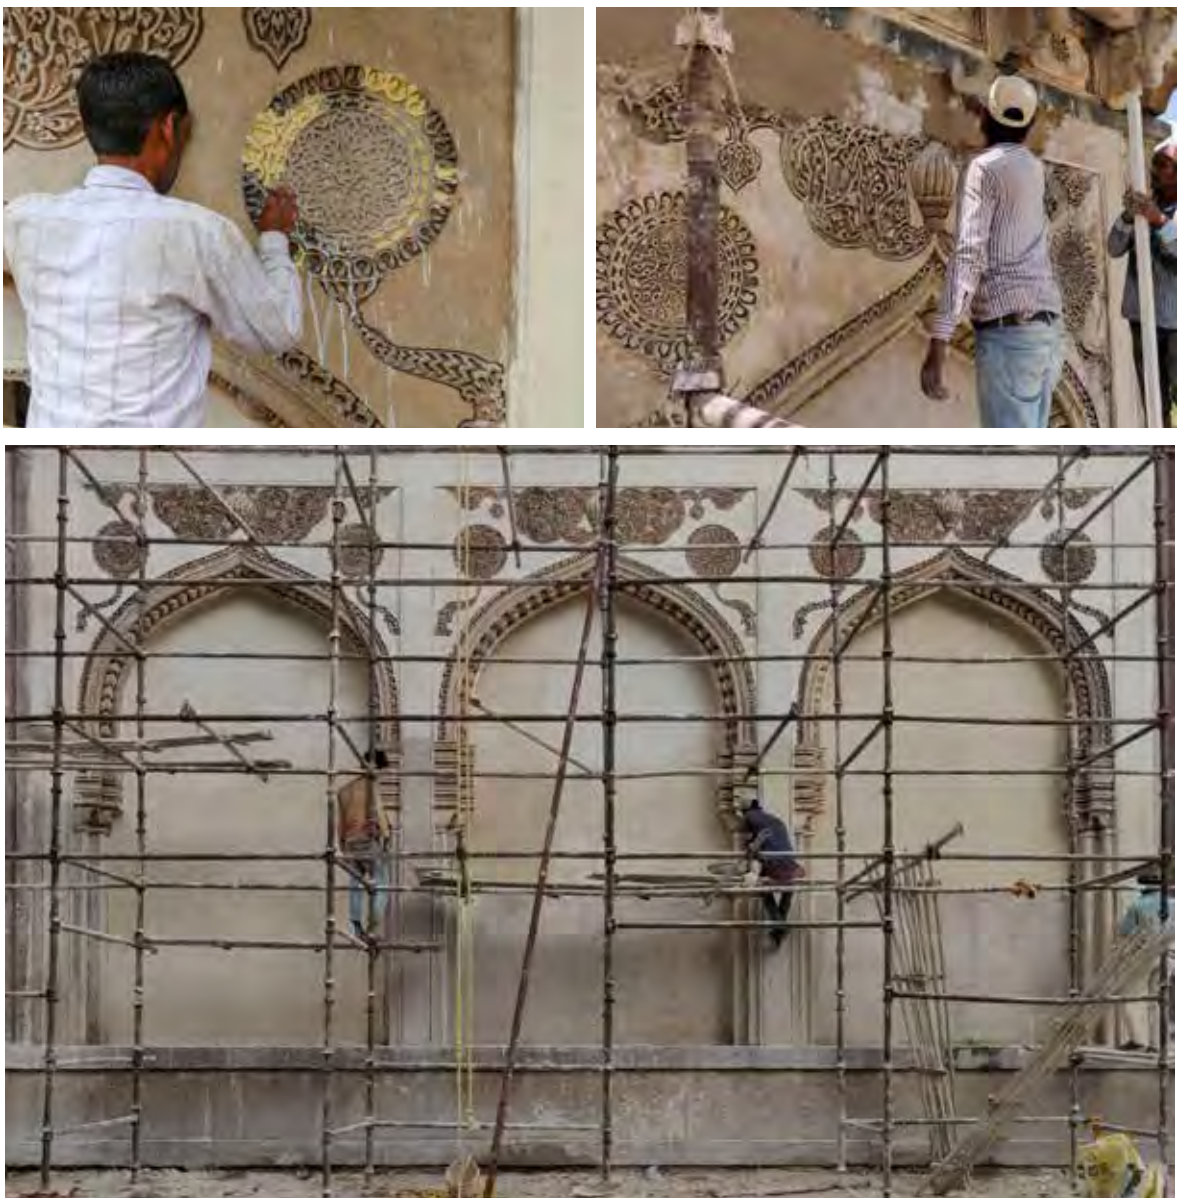
The external surface below the projected stone eaves on principal facades of the mausoleum is embellished with highly ornate lime stucco including highly intricate floral medallions. Major portions of the medallions, arch mouldings, and stucco ornamentation were obfuscated with later added layers of cement. The wooden door shutters leading into the monument were found to be in a dilapidated condition.

*Missing and damaged ornate stucco patterns on the external facade of the mausoleum were carefully restored by craftsmen*

- Damaged medallions ornamental stucco around the arch crowns, and lattice screens above the doors were restored using the existing design by master craftsmen.
- Repairs were carried out on the mouldings and capital bands of the external facades using rich traditional lime mortar.
- Plastering with rich lime mortar was carried out on the blind arches situated at the base of the principal facade on all four sides.
- Stone lintels were installed on the southern and eastern doorways after replacing the 20<sup>th</sup> century cracked wooden planks situated above the doorways.
- Wooden doors matching the historic designs were fabricated by the carpenter and were installed in the southern and eastern doorways.

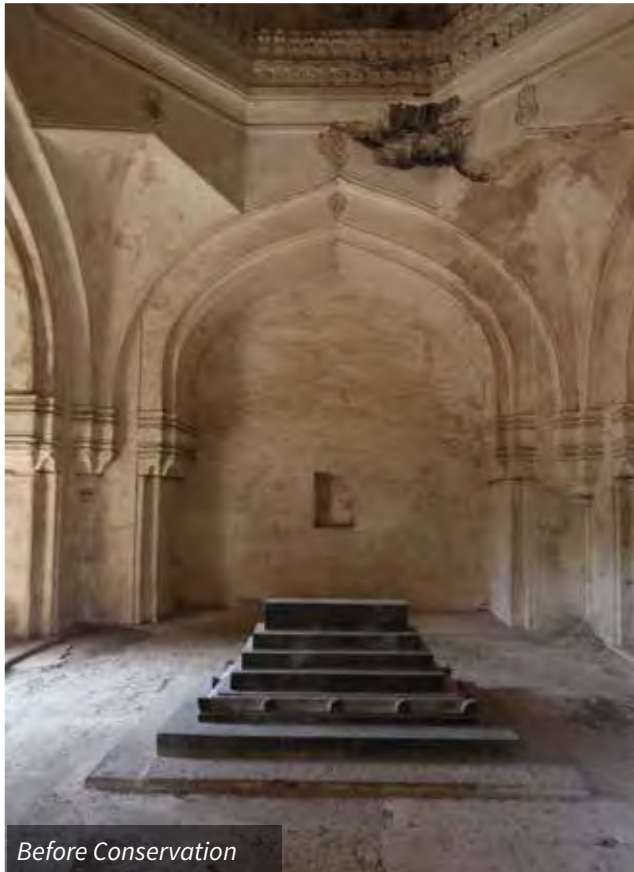
*Before Conservation*

The internal surface below the internal dome on principal internal facades of the mausoleum is embellished with ornate lime stucco. Major portions of the battlements were missing, and floral medallions arch mouldings, and other stucco ornamentation were obfuscated with later added layers of cement. The internal surfaces also showed signs of seepage and visible signs of deterioration.

- Repairs on broken portions of the battlements situated at the bottom of the internal dome has been finished by master craftsmen using traditional lime mortar. A total of 62 missing battlements were reconstructed in brick masonry, covered with lime plaster and finished with a layer of 1 mm thick lime punning layer.
- Repairs on the lower projected blind arch galleries were carried out using rich lime mortar and patination was gently scraped off using water and soft bristle brushes.
- 28 floral medallions were restored on the band situated above the spandrel of lower recessed arch bays.
- 20<sup>th</sup> century cement plaster and whitewash layers were removed from the spandrel, squinches, columns and the recessed arched bays present inside the internal mausoleum. Repairs have been carried out using traditional lime plaster and finished with a 1 mm thin layer of lime punning.

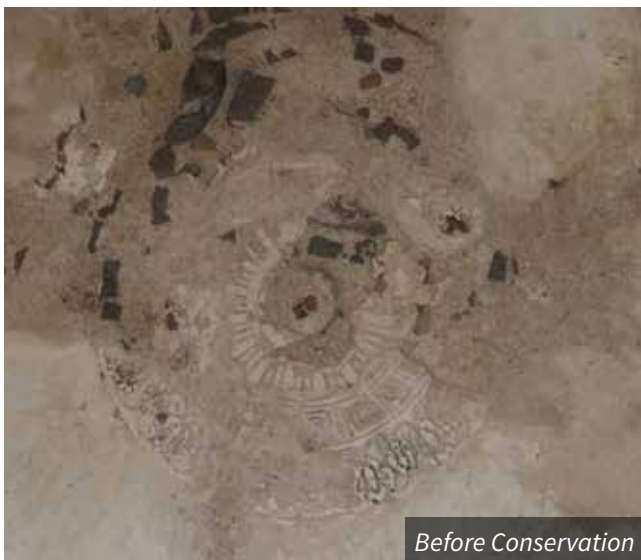
*Before Conservation*

The ceiling medallion of the dome of the mausoleum was found to be partially damaged and the stucco ornamentation in several sections of the ceiling medallion were missing.

- Pulverized lime plaster from the internal ceiling medallion was carefully removed and missing ornamental stucco was restored matching the existing evidence at site by master craftsmen using rich traditional lime mortar and finished with a 1 mm thin layer of lime punning. A total of 56 missing floral leaf patterns were restored based on the existing evidence at site.
- Restored stucco patterns were finished with a 1 mm thin layer of matured lime mixed with organic additives

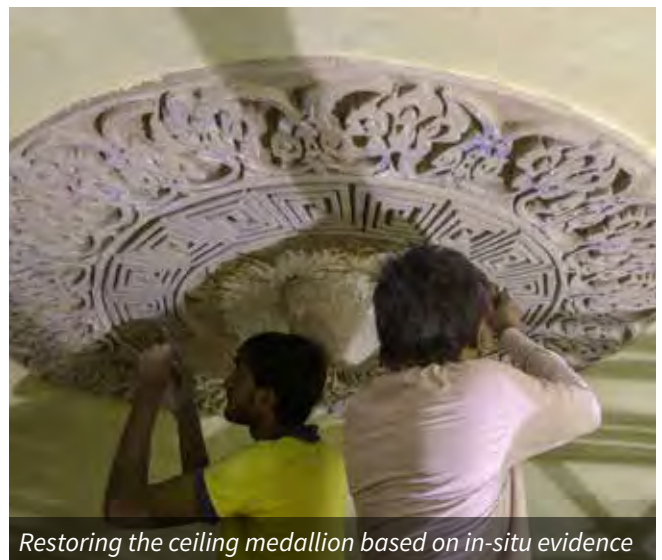
*Restoring the ceiling medallion based on in-situ evidence*

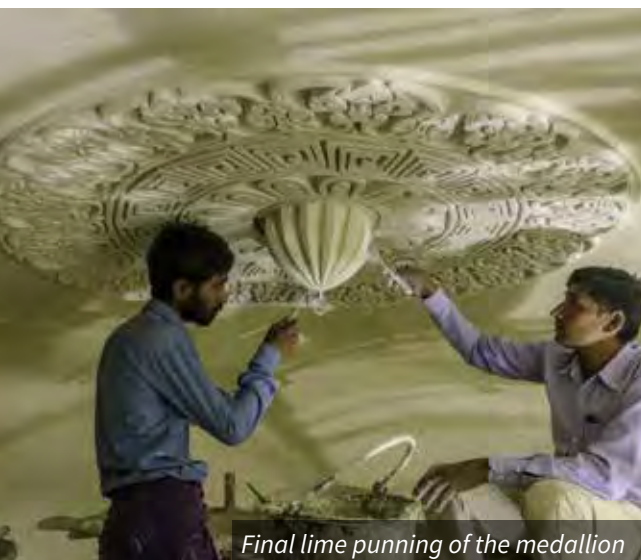
*Final lime punning of the medallion*

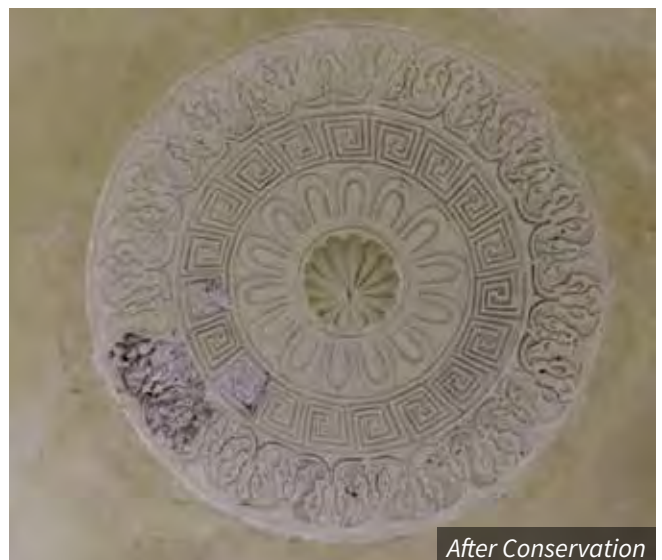
*After Conservation*

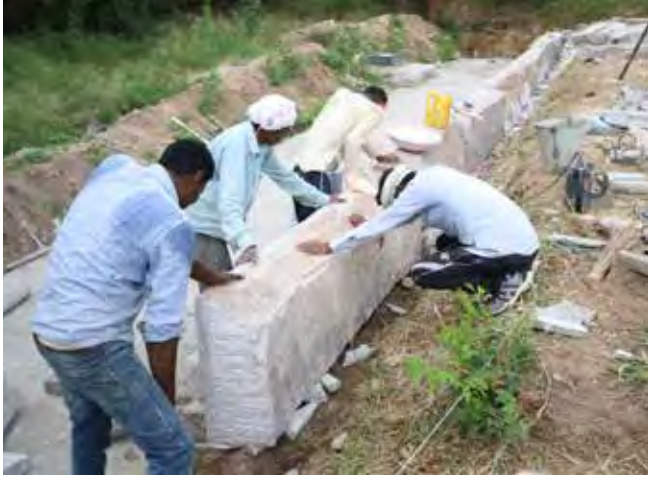
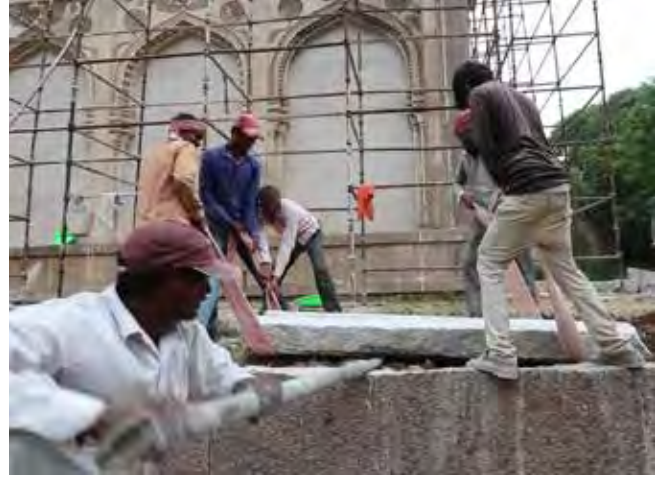
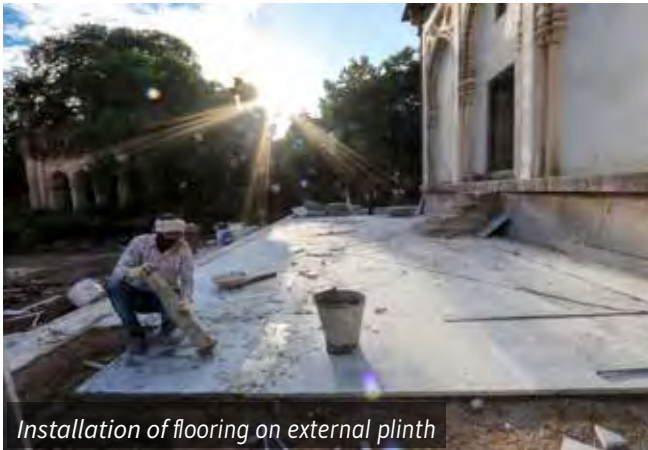
Prior to conservation the existing vertical façade stones of the plinth were missing on three sides. The existing flooring on the plinth was non-existent and covered with plant overgrowth.

*Installation of flooring on external plinth*

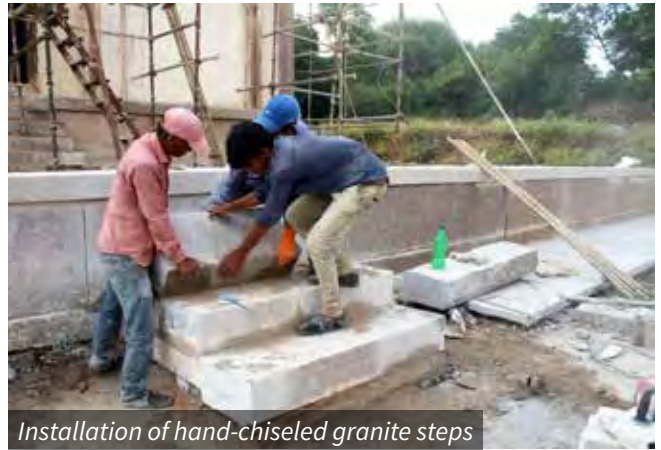
*Installation of hand-chiseled granite steps*

*Missing and collapsed vertical stone band along with the granite edging lining the top edge of the projected plinth were reinstated*

- Vertical facade stones of the plinth were found missing or collapsed on three sides.
- These missing and collapsed vertical stones of specified size and similar texture were prepared by stone master craftsmen and reinstated on the plinth.
- Hand chiseled stones of specified size and similar texture were prepared by stone craftsmen and installed as edging stones on the plinth of the mausoleum.
- Six inches thick band of dressed granite edging lining the top edge of the projected plinth was installed on all four sides of the plinth.
- 30 mm thick granite stone flooring in approved layout and appropriate gradient was laid on all four sides of the external plinth.
- Hand chiseled steps were installed below the eastern side of plinth to make the mausoleum accessible for visitors.

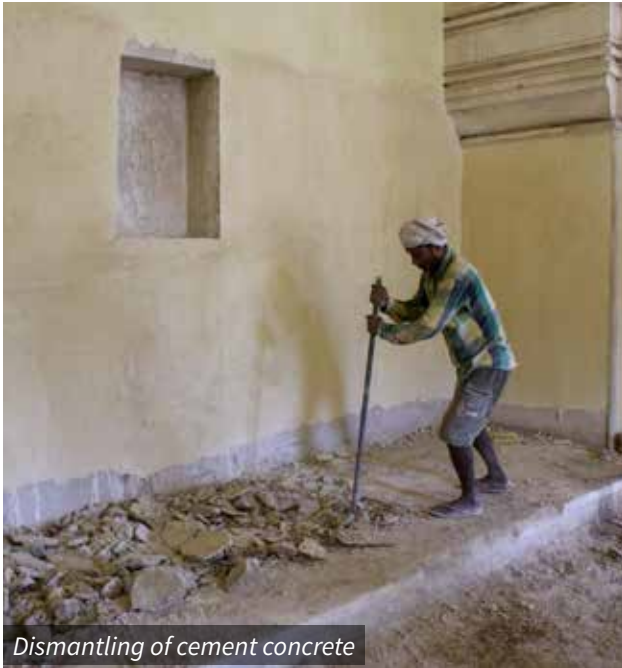
*Dismantling of cement concrete*

- Dismantling of cement concrete laid inside the mausoleum was carried out to reveal the original floor levels and site cleared of debris.
- 30 mm thick granite stone flooring in approved layout

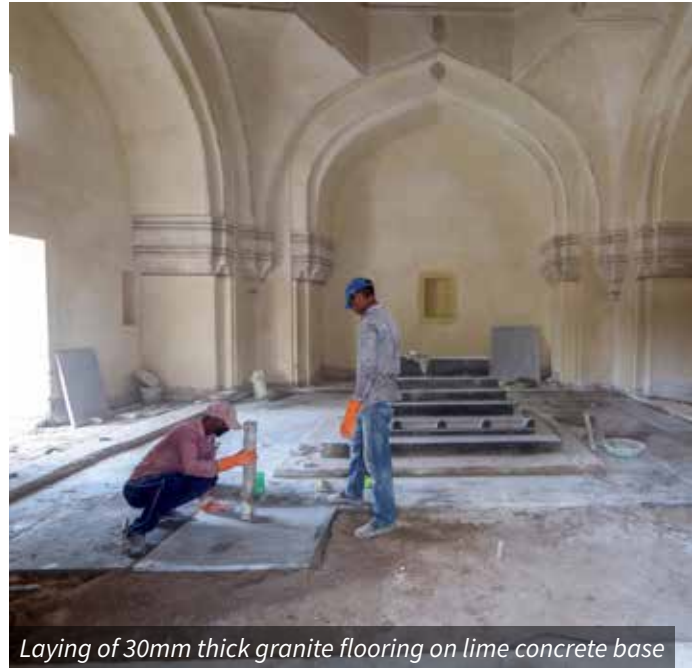
*Laying of 30mm thick granite flooring on lime concrete base*

and appropriate gradient was installed inside the internal mausoleum. A three-inch-thick layer of lime concrete was laid to serve as a sturdy base to support the stone flooring to be installed above.

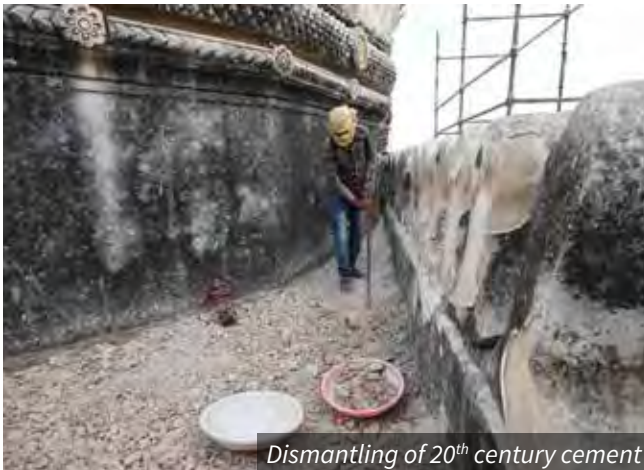
The terrace was covered with a layer of 20<sup>th</sup> century cement concrete and this aggravated the water seepage inside the mausoleum. Multiple stone eaves situated below the battlements were found to be damaged or missing.

*Dismantling of 20<sup>th</sup> century cement*

- 20<sup>th</sup> century cement concrete was dismantled from the terrace.
- Traditional lime concrete was laid on the terrace to appropriate slope to drain rainwater away from the monument. Ramming and curing were carried out continuously for a week to achieve smooth finish.
- Thick plant roots on the rainwater outlets below the battlements were carefully removed and deep holes were repaired with rubble masonry and rich traditional lime mortar.
- The terrace and existing rainwater spouts on terrace were cleaned before the monsoons.
- Missing and damaged granite stone eaves were replaced with matching granite stone eaves that were prepared and installed on the eastern and northern parapet by stone craftsmen.

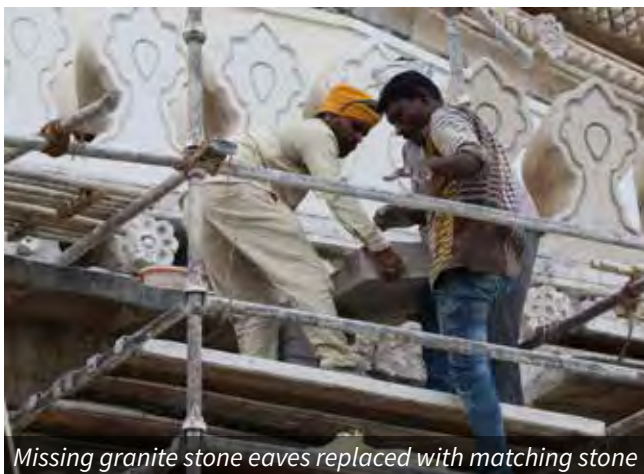
*Missing granite stone eaves replaced with matching stone*

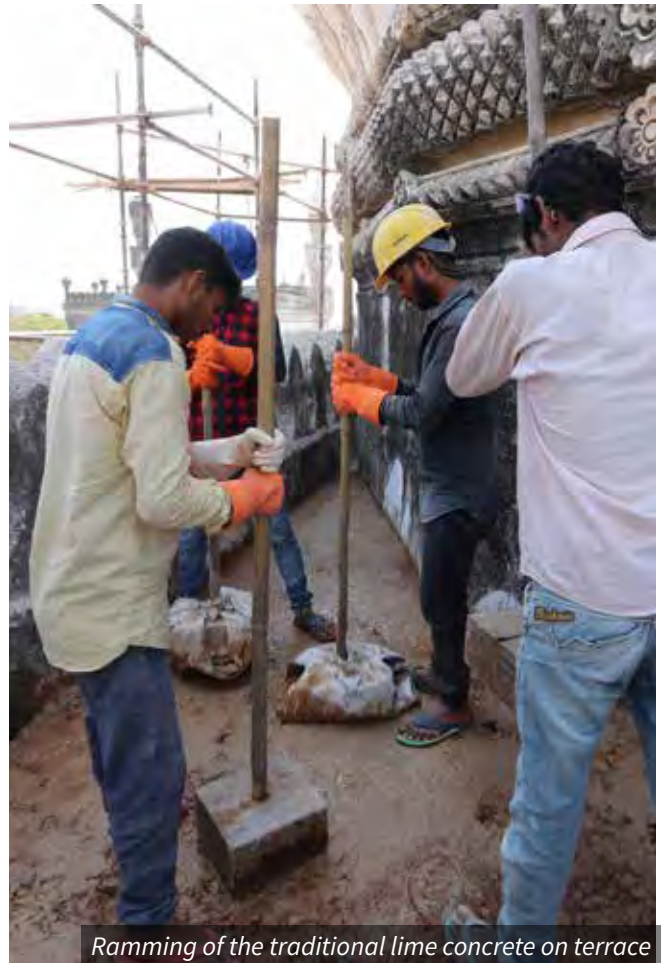
*Ramming of the traditional lime concrete on terrace*

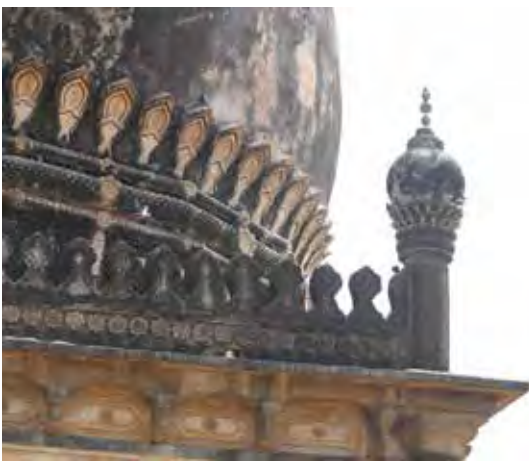
Battlements on the parapet above the eaves were severely damaged and partly broken in many portions. Minarets on the parapet above the eaves were severely damaged and partly broken in many portions, with original finials missing on all the corner minarets.

*Installation of missing finial atop the minars and final lime punning of the battlements*

- Damaged battlements were restored on the parapets using lime mortar and finished with lime punning.
- Damaged floral medallions situated immediately above the stone's eaves were repaired and restored using rich traditional lime mortar and finished with a thin layer of lime punning on all four sides of the parapet.
- Minarets on the external parapet were repaired and ornamental stucco patterns in the shaft of minarets were restored. Missing finials were fabricated based on the archival evidence were installed by master craftsmen.

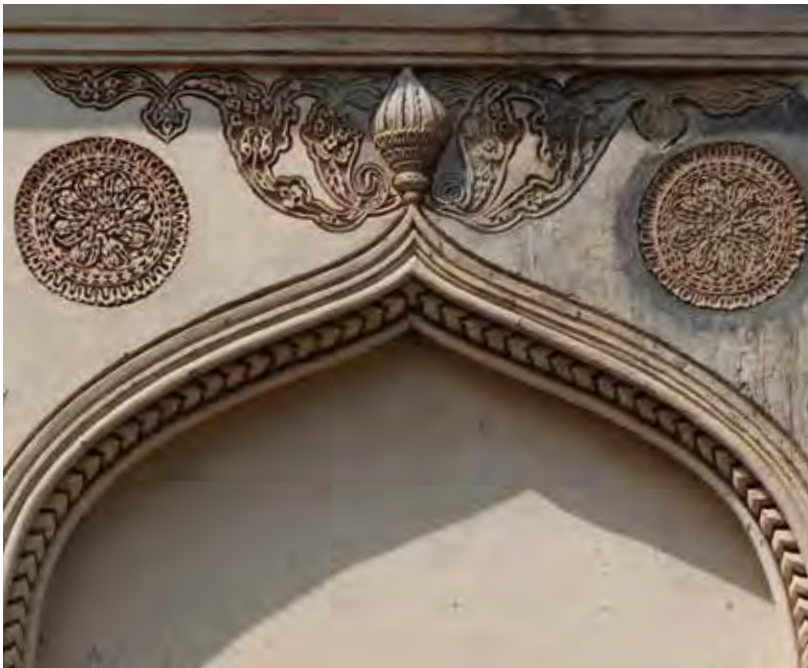
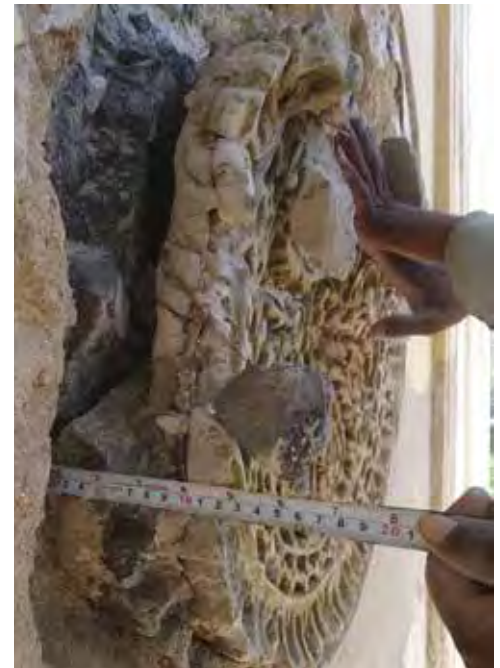
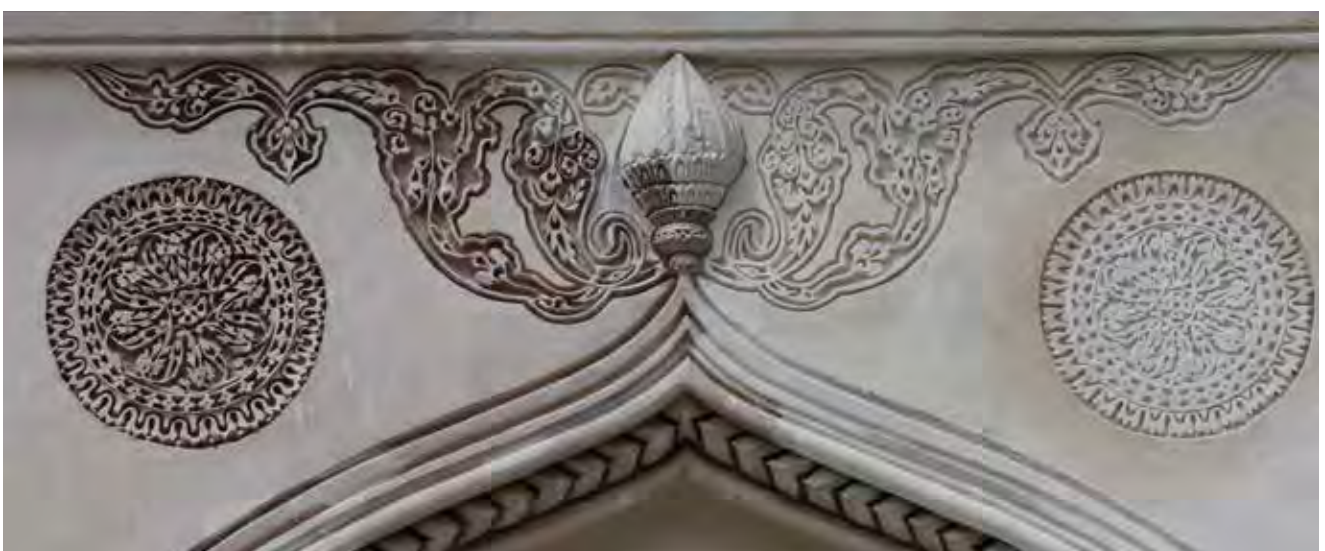
*20<sup>th</sup> century cement repairs on the decorative elements on the spandrel were carefully dismantled, and restored in traditional lime mortar as per site evidence*

- Plastering with rich lime mortar was carried out on the blind arches situated at the base of the principal facade on all four sides.
- Damaged medallions and ornamental stucco around the arch crowns were restored using the existing design by master craftsmen.
- Repairs were carried out on the mouldings and capital bands of the external facades using rich traditional lime mortar.
- Stone lintels were installed on the southern and eastern doorways after replacing the 20th century cracked wooden planks situated above the doorways.
- Wooden doors matching the historic designs were fabricated by the carpenter and installed in the southern and eastern doorways.

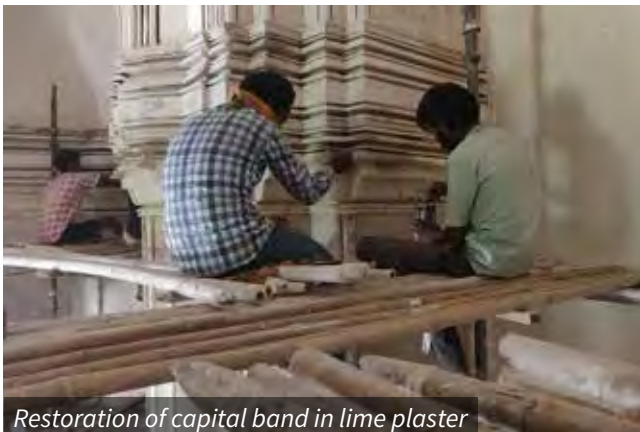
The internal surface below the internal dome on principal internal facades of the mausoleum is embellished with ornate lime stucco. Major portions of the battlements below the dome were missing, and arch mouldings, were obfuscated with later added layers of cement. The existing flooring before conservation was 20<sup>th</sup> century cement concrete.

*Restoration of capital band in lime plaster*

- Repairs on broken portions of the battlements situated at the bottom of the internal dome has been finished by master craftsmen using traditional lime mortar.
- 20<sup>th</sup> century cement plaster and whitewash layers were removed from the spandrel, squinches, columns and the recessed arched bays present inside the internal mausoleum.
- Repairs were carried out using traditional lime plaster and finished with a 1 mm thin layer of lime punning.
- 30 mm thick granite stone flooring was installed inside the mausoleum in accordance to an approved layout and appropriate gradient on the external plinth is ongoing.

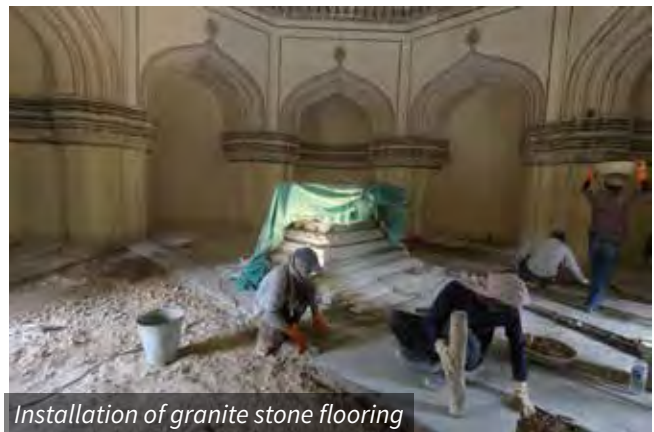
*Installation of granite stone flooring*

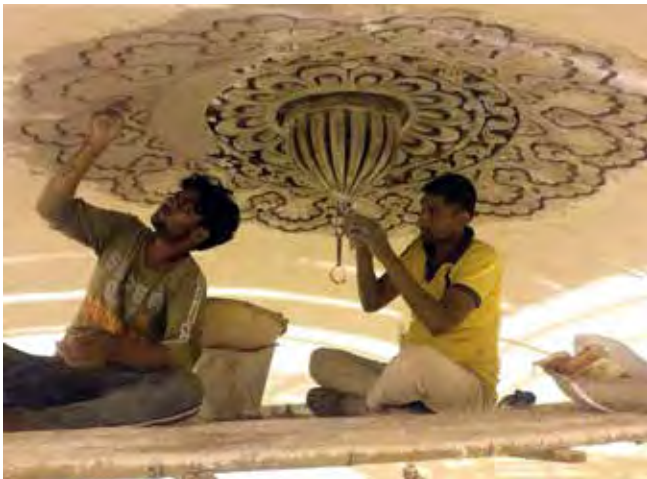
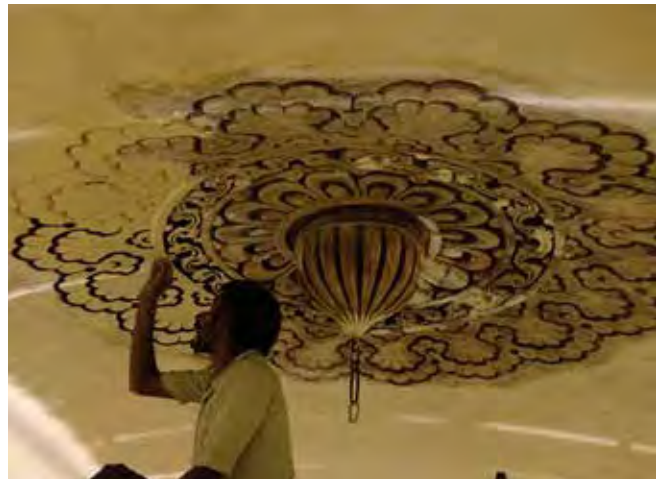
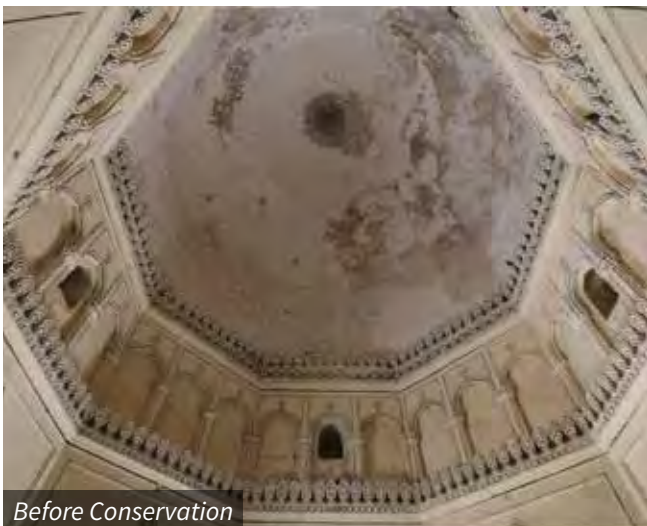
The ceiling medallion of the dome of the mausoleum was found to be partially damaged and the stucco ornamentation in several sections of the ceiling medallion were missing.

*Before Conservation*

- Pulverized lime plaster from the ceiling medallion was carefully removed and missing ornamental stucco was restored matching the existing evidence at site.
- Traces of black colour were revealed in groves and recessed portions of the ceiling medallion, moulding bands and ornamental architectural elements inside the mausoleum and a matching natural colourant was applied in the missing portions.
- Ceiling plaster of internal dome was found to be in a dilapidated condition due to water seepage and had to be removed.
- Repairs were carried out using traditional lime mortar and finished with 1 mm thin layer of matured lime putty applied by lime craftsmen.

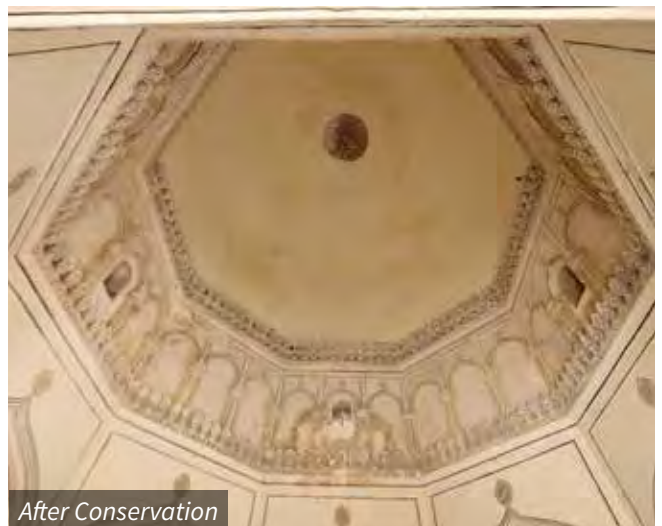
*After Conservation*

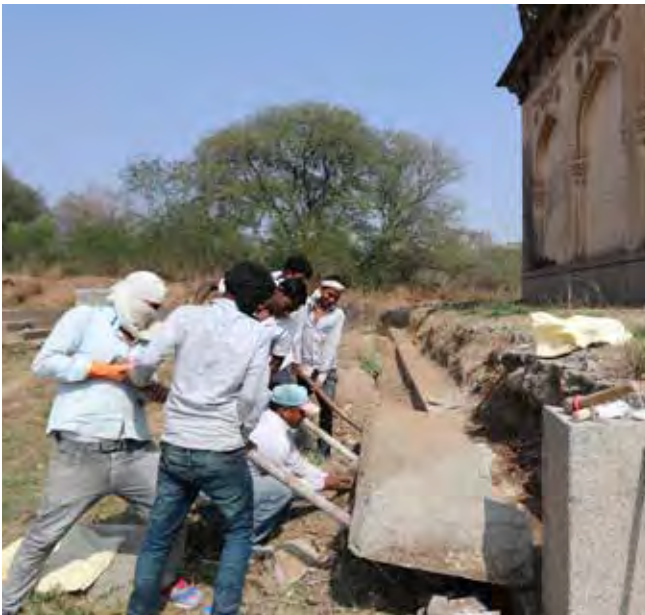
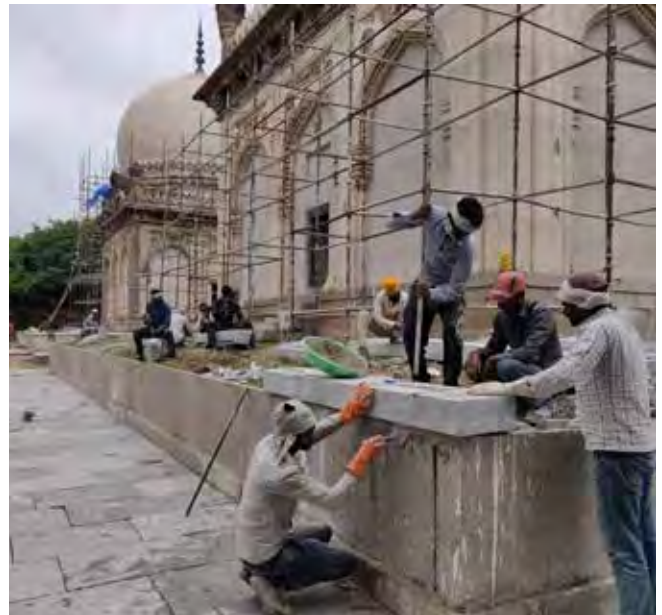
Stone craftsmen fixing the hand chiselled granite blocks lining the plinth of Premamati's mausoleum.

- Vertical façade stones of the plinth were found missing or collapsed.
- The missing and collapsed vertical stones on the plinth were reinstated.
- Six inches thick band of dressed granite edging lining the top edge of the projected were installed on all four sides.
- Missing hand chiselled steps were installed below the eastern side of plinth to make the mausoleum accessible for visitors.

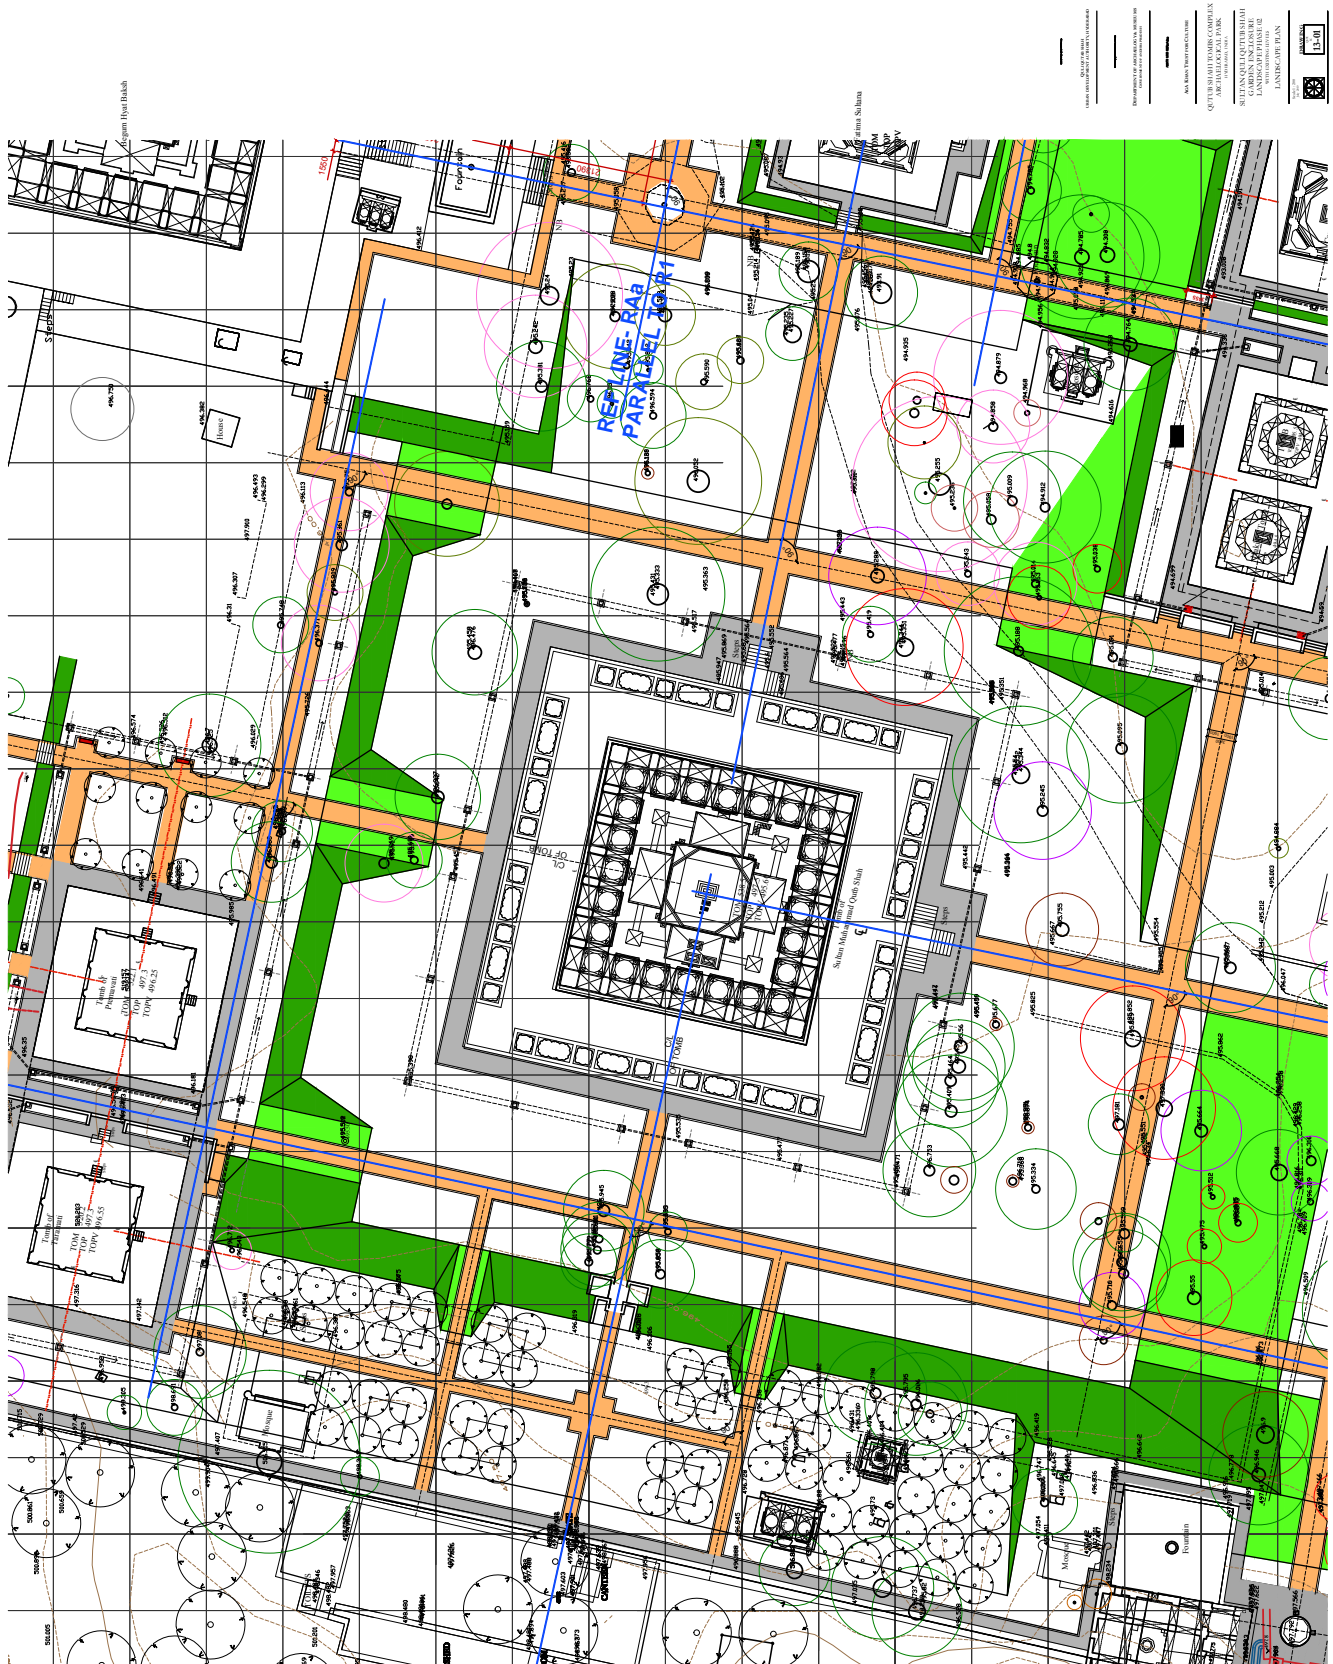
*Landscape scheme around the mausoleum of Mohd. Qutb Shah. Enclosing pathway around the mausoleum is built incorporating the earth level differences on north and west side.*

- Grading of earth as per the landscape masterplan has been carried out on the western side of the mausoleum of Muhammad Qutb Shah.
- Pathways enclosing the mausoleum of Muhammad Qutb Shah are being constructed as per the landscape masterplan on the east, north and south sides.
