AGA KHAN TRUST FOR CULTURE

# QUTB SHAHI HERITAGE PARK

ANNUAL REPORT 2019

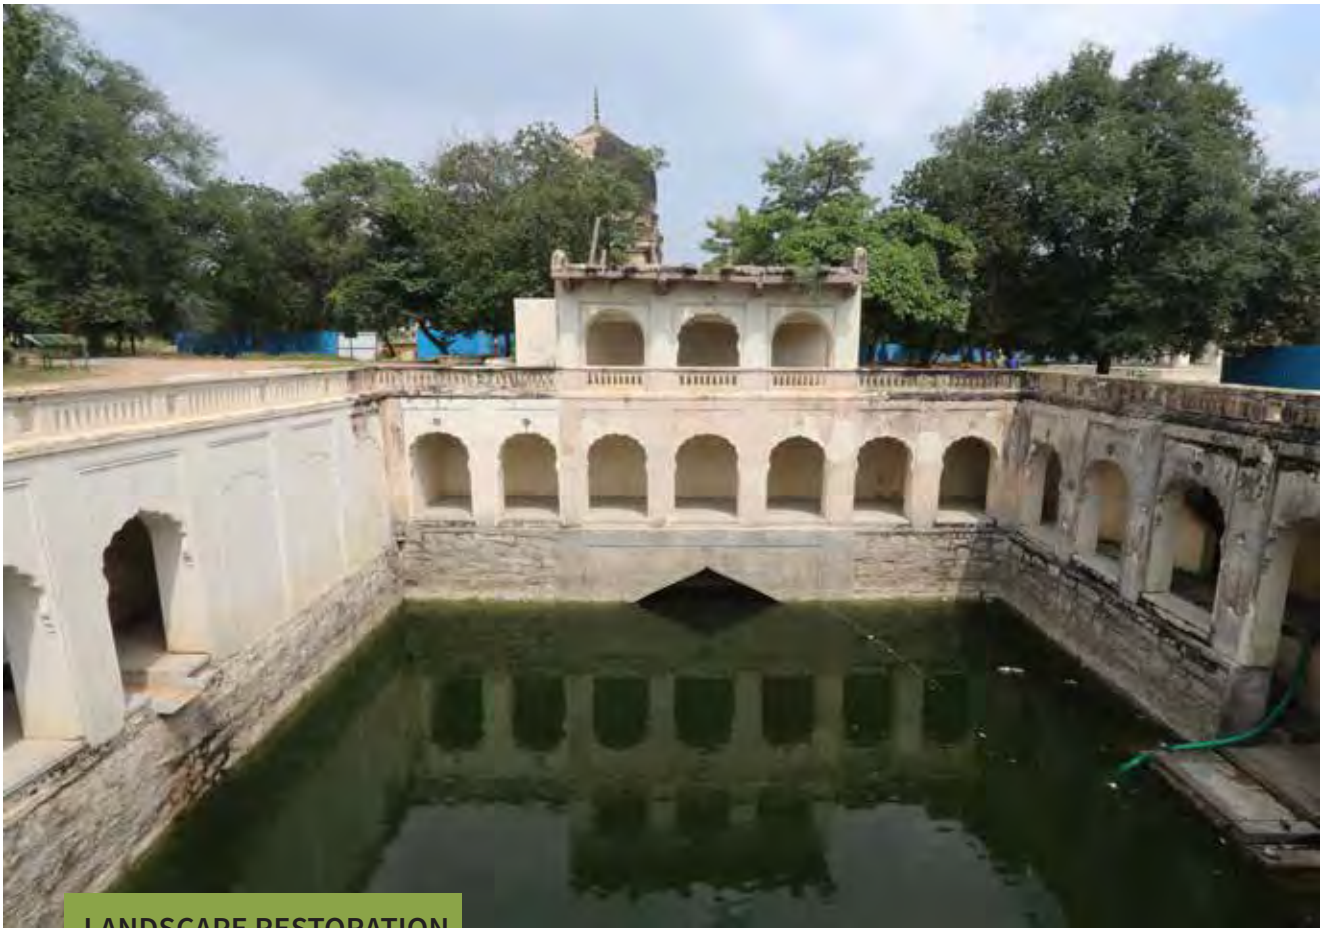
*(Above) Conservation of the Badi Baoli, after its collapse in 2013, required over 4000 mandays of work required to clear the Baoli of collapsed masonry, under extremely dangerous conditions but the reconstruction of 600 cu.m. of stone masonry has led to an annual collection of 3 million litres of water - now used for irrigation and conservation works.*

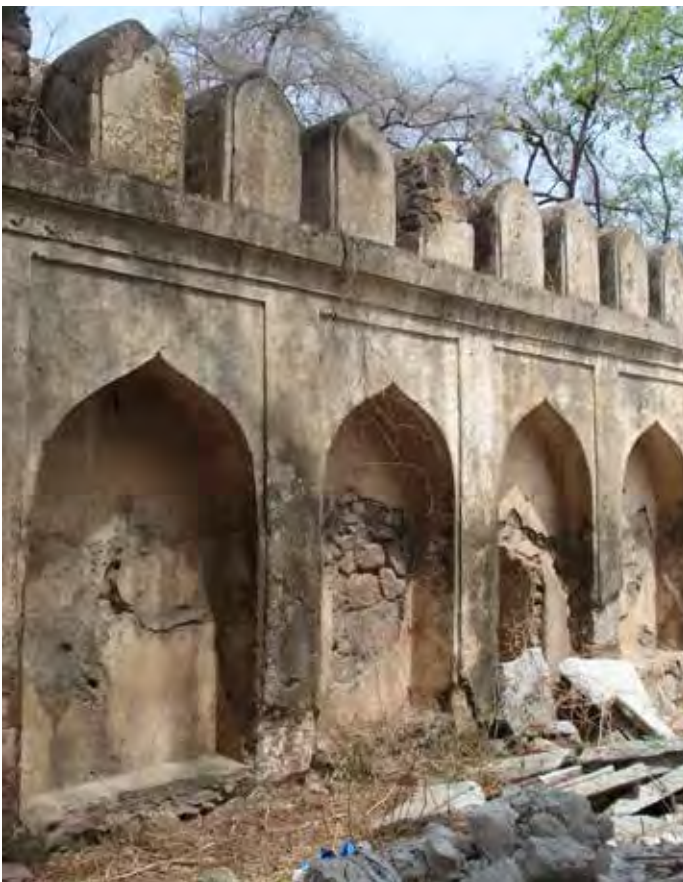
*Replastering of the wall surface and repairs on the arches using traditional lime mortar*

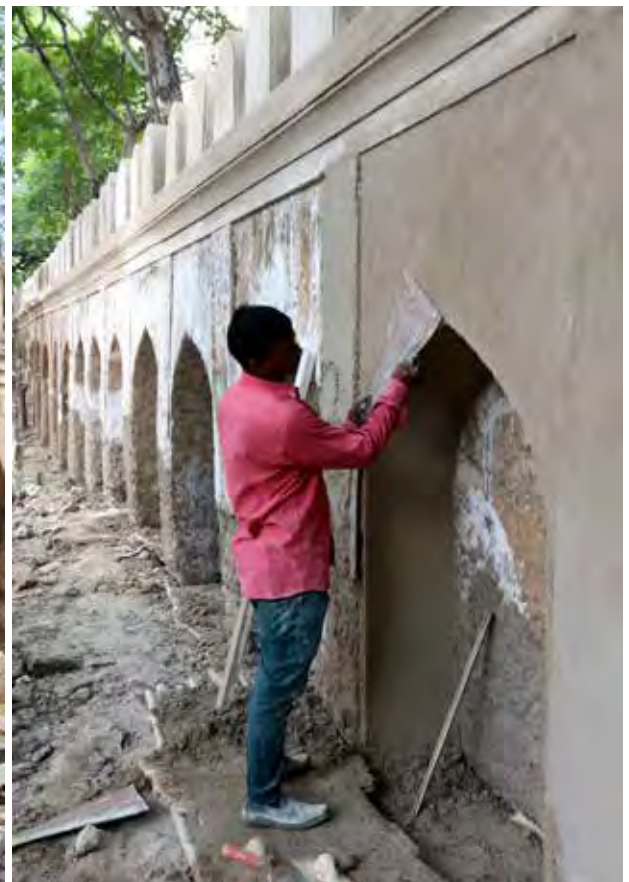
*Repairs on the arches using traditional lime mortar; Repair and reconstruction of battlements was carried out*

- Extensive plant roots and vegetation was removed from the wall surface and voids filled with rubble masonry and rich lime mortar.
- Excavations were carefully carried out to trace the original portions of the historic stone wall.
- Re-plastering of damaged wall surfaces was carried out by craftsmen in traditional lime mortar and finished with a 1 mm thin layer of slaked lime added with organic additives.
- Missing battlements in stone masonry walls were raised in portions where original battlements were found to be missing.
- Plinth protection was installed along the length of the restored enclosure wall as per the landscape masterplan. Four arches were reconstructed in on the north-west corner matching the existing in-situ evidence.

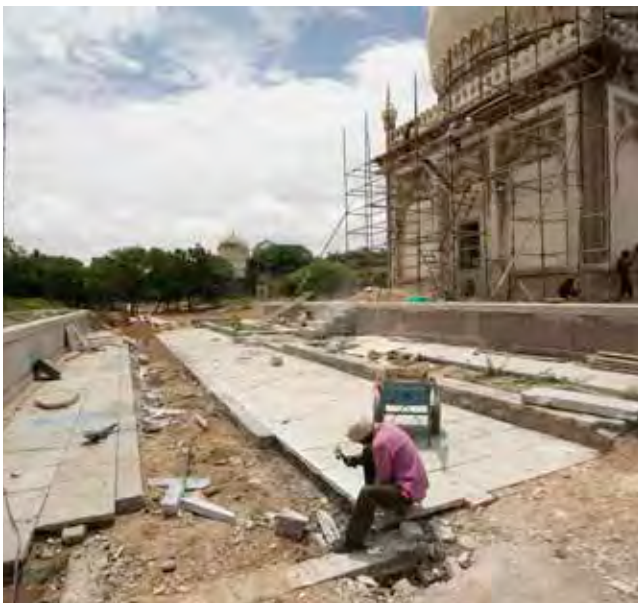
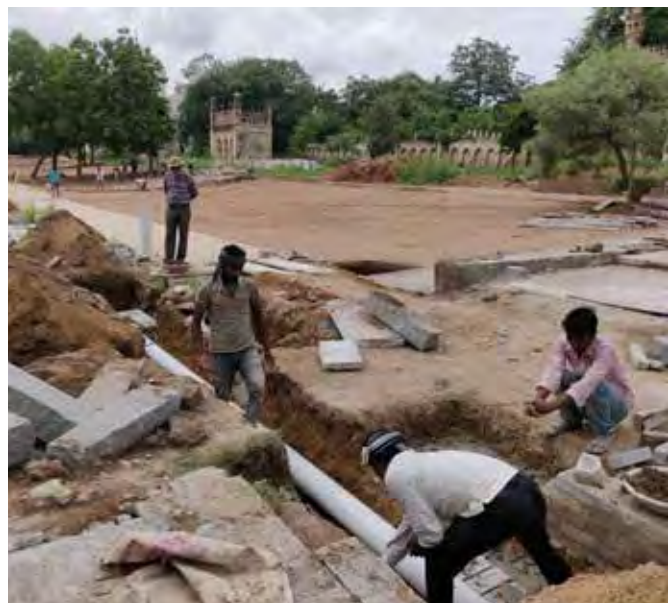
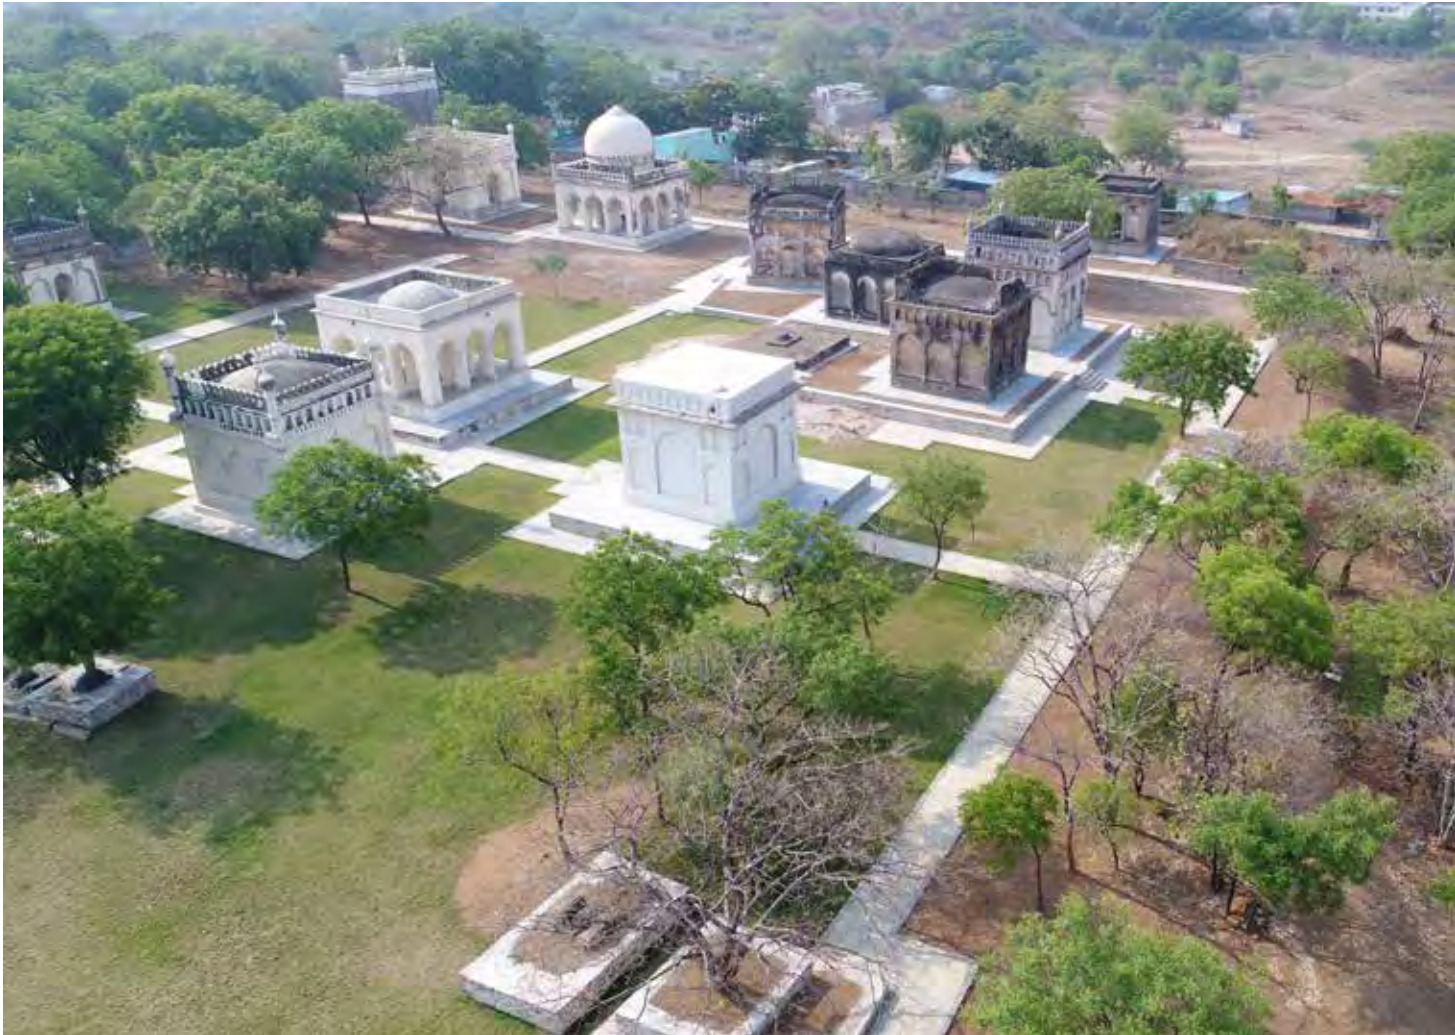
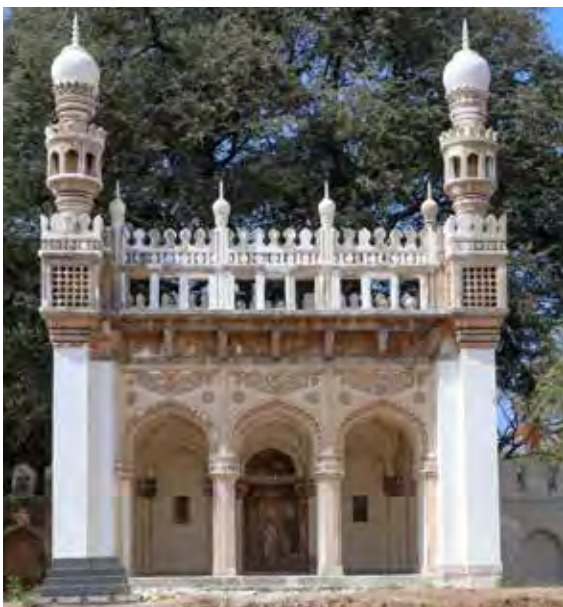
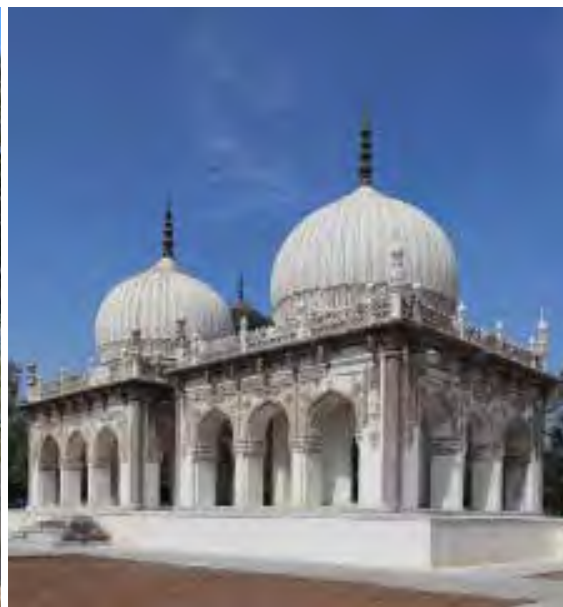
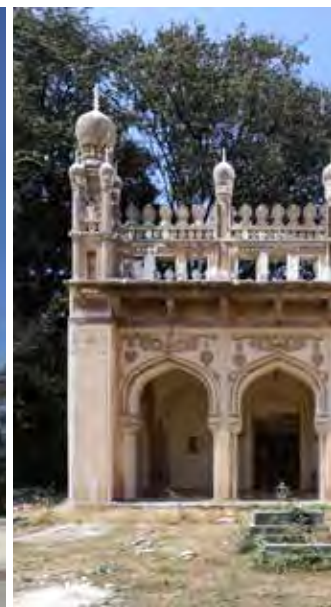
*(Below) Installation of edging stones along the recently constructed pathways being carried out along with the channelizing of rainwater for landscaping*

- Base work for the plinth protection around the mausoleums of Taramati and Premamati were completed. 100 mm thick granite stones labs were installed around the mausoleums.
- Rubble masonry steps on the eastern edge of the mausoleum of Taramati were constructed as per the design specified in the landscape masterplan.
- Several interconnected manholes were constructed to channel rainwater from the upper terrain behind Taramati's mausoleum to the nearest baoli.
- Edging stone along the plinth protection for the mausoleum of Taramati was installed.

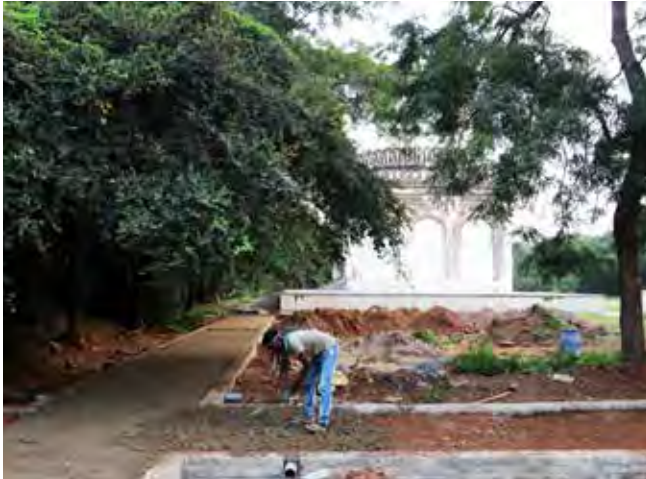
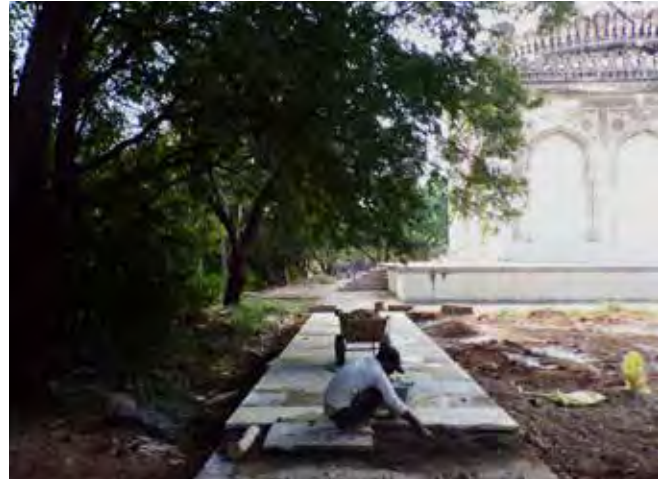
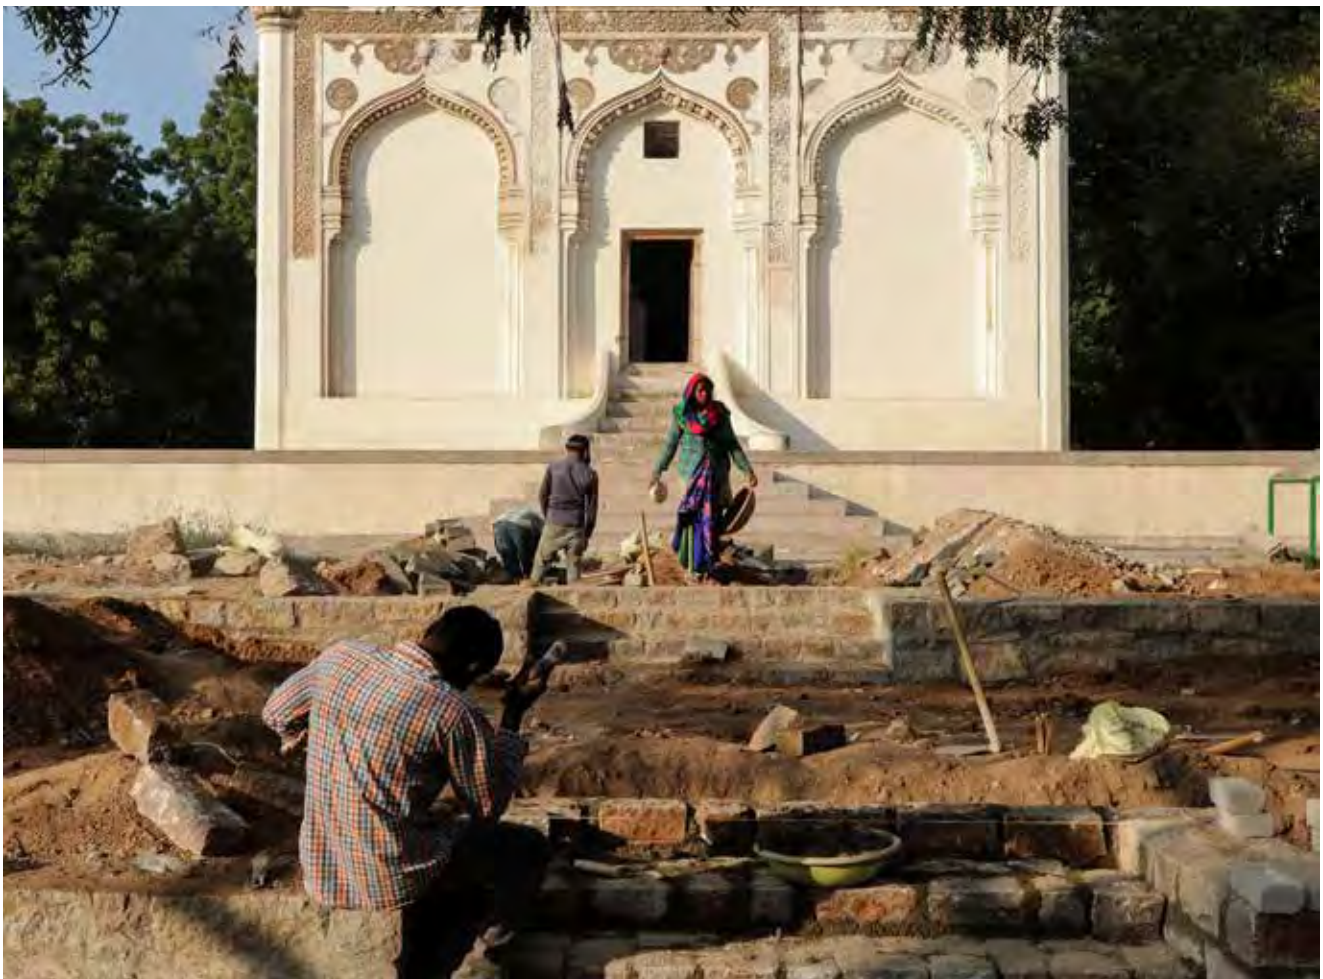
(Top) Pathways were built connecting Fatima's mausoleum to Commander's mausoleum; (Bottom) Construction of steps as part of the plaza south of Commander's mausoleum

- Stone masonry walls are being built on the south side as per the landscape proposal with ramp access on the south east to accommodate the varying levels.
- Layout of the main plaza to the south was carried out and excavation works and the construction of brick retaining walls are being undertaken.
- PCC for the base of pathways of plaza is being laid.
- On the north side, pathways connecting to the mausoleums of Fatima Sultana and Hayat Bakshi Begum were laid on the eastern and western edge as per landscape proposal. They were finished with 50 mm thick Tandur stones as per approved pattern.
- Earth grading on the north side of the mausoleums is being carried out for laying of local grass.

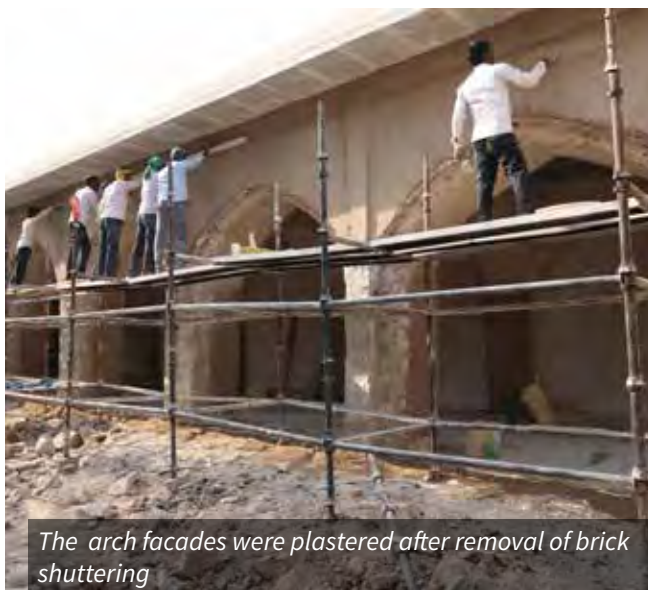
*The arch facades were plastered after removal of brick shuttering*

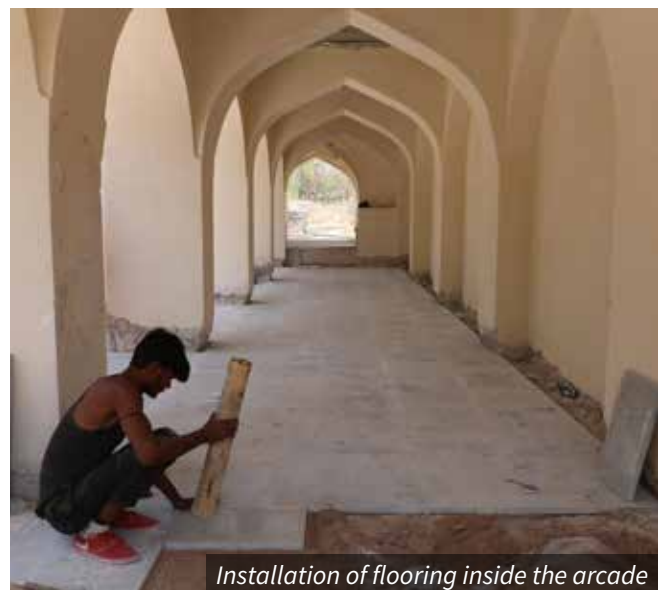
*Installation of flooring inside the arcade*

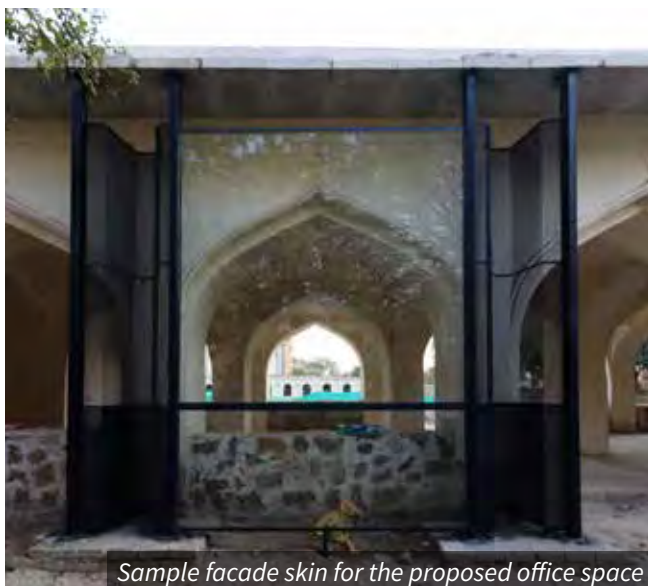
*Sample facade skin for the proposed office space*

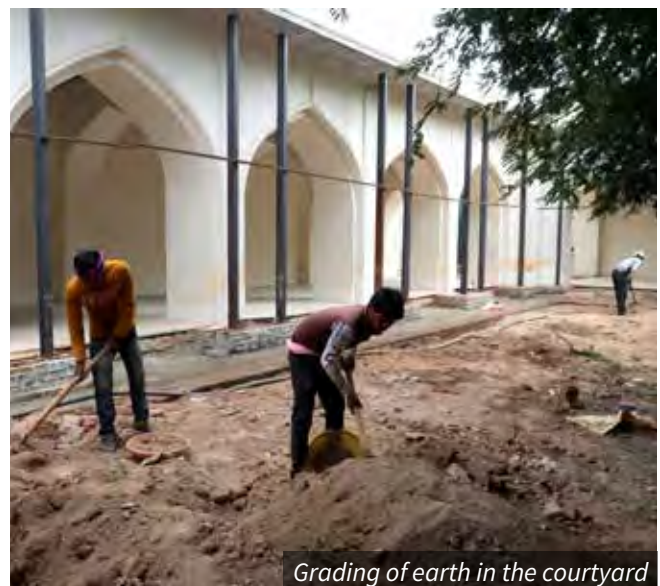
*Grading of earth in the courtyard*

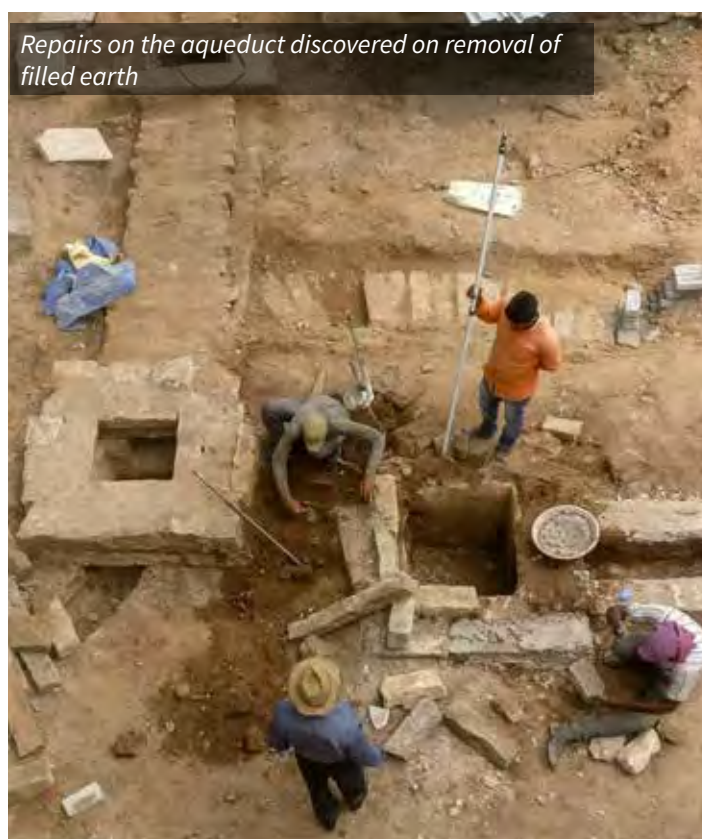
*Repairs on the aqueduct discovered on removal of filled earth*

- Grading of earth along the pathway and plinth protection were carried out as per the landscape proposal.

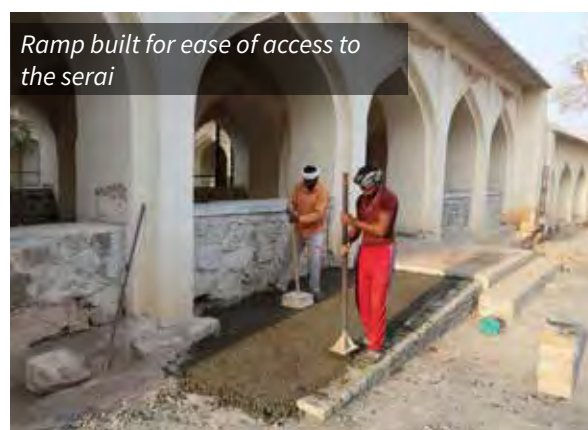
*Ramp built for ease of access to the serai*

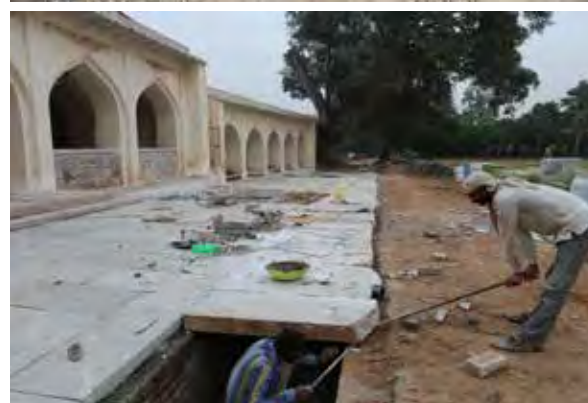
*6.4 meters wide plinth protection was finished with 100 mm thick natural rough granite stones with the grading towards the aqueduct. Care was taken that the historic water channel running at the south of Hamam is not affected and is being covered with granite stone slabs*

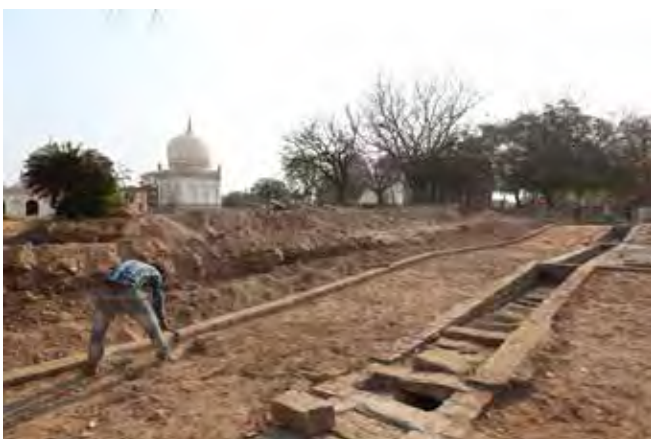
A portion of an aqueduct was exposed south of Hamam as a part of the landscape masterplan

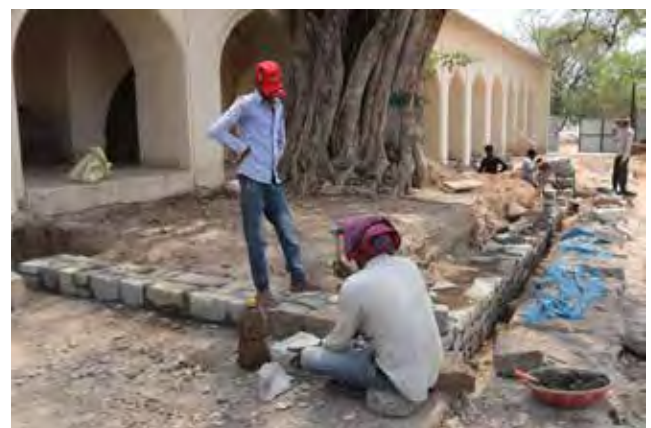
Retaining walls were built around the holding earth of the Peepal tree abutting the monument

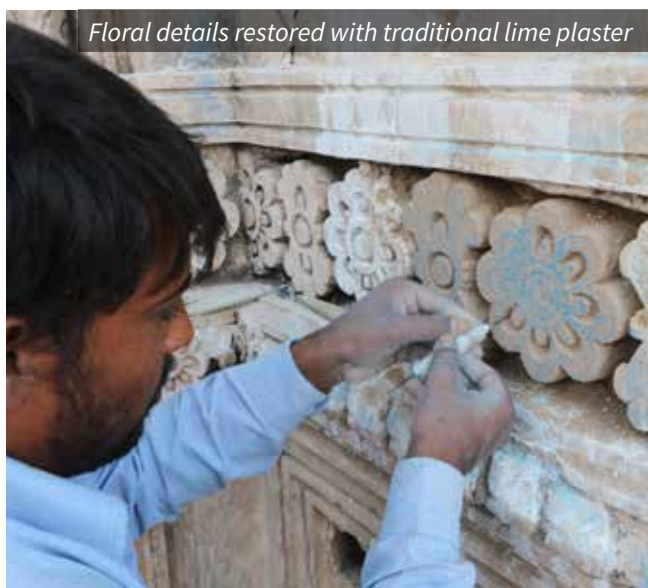
*Floral details restored with traditional lime plaster*

- Scaffolding has been erected around the perimeter of the structure on northern, western and southern sides.
- 20<sup>th</sup>-century cement and white-wash layers are being carefully removed to reveal the original appearance of the structure.
- Plaster repairs are being carried out on the northern, western and southern walls by master craftsmen using traditional lime mortar.
- Repairs with traditional lime mortar followed by lime punning have been finished on the internal and internal surfaces.

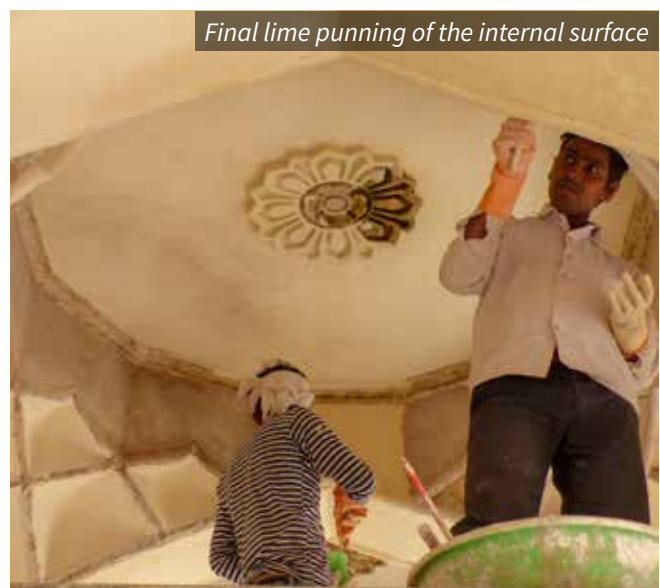
*Final lime punning of the internal surface*

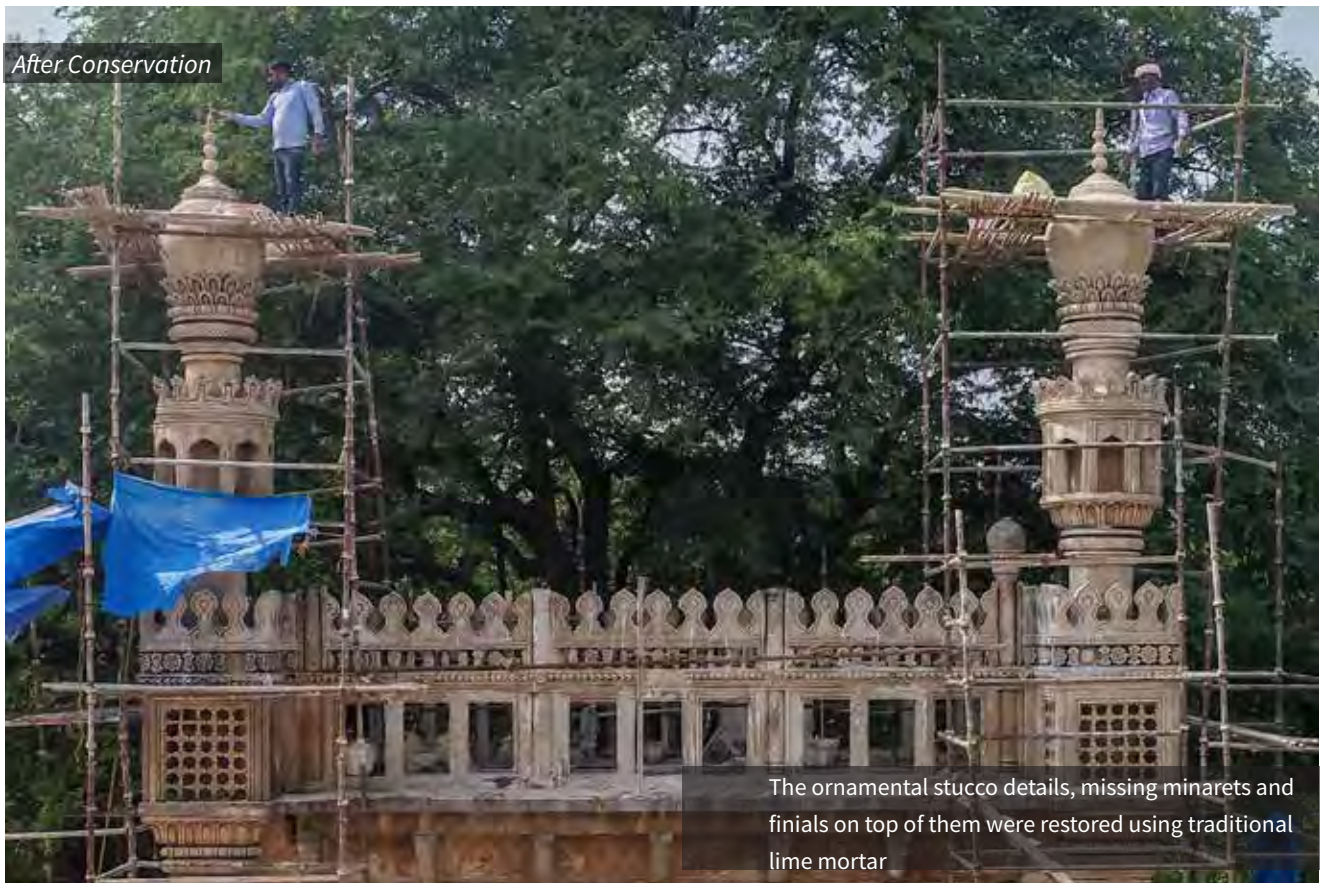
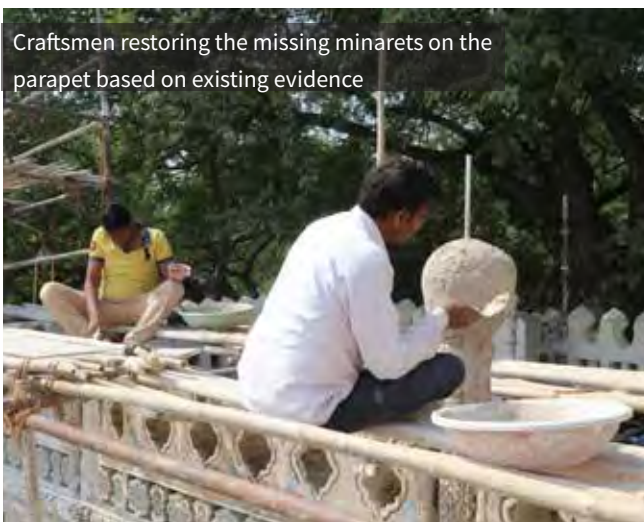
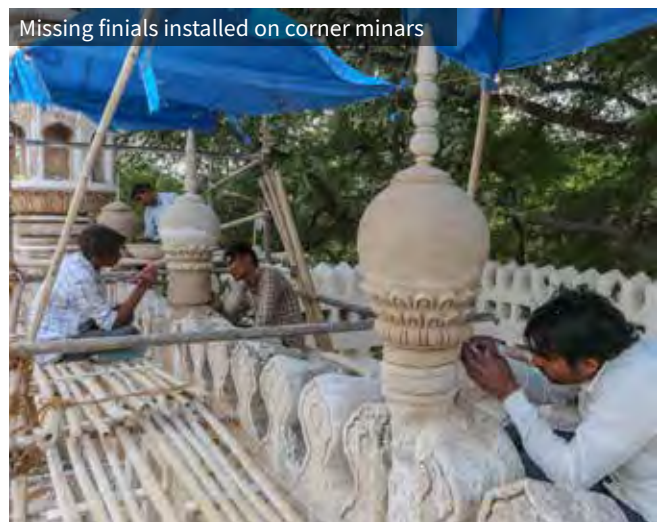
Sections of the corner minaret had collapsed before conservation.

- Collapsed portions of corner minarets at the parapet level were reinstated.
- Reconstruction of missing and restoration of partially damaged minarets has been carried out by master craftsmen using traditional lime mortar.

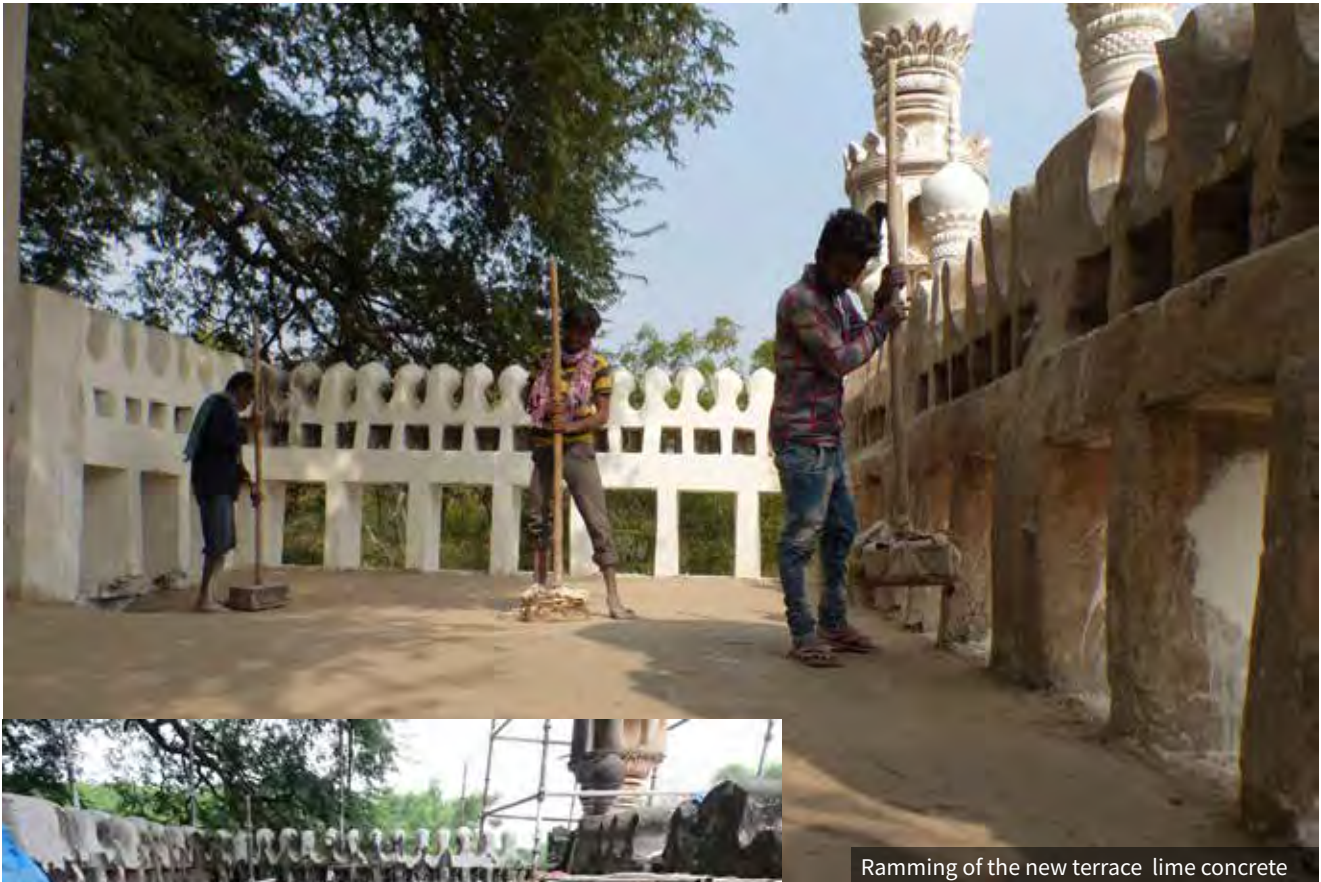
The terrace showed visible signs of water seepage inside the mausoleum.

Ramming of the new terrace lime concrete

- There were evident signs of water seepage from the terrace inside the structure. Repairs on terrace concrete were undertaken and new terrace lime concrete was laid to appropriate slope.
- Dilapidated terrace layer leading to seepage of water was carefully dismantled and traditional lime concrete was laid coupled with installation of projected waterspouts on the western edge to channel rainwater away from the structure.

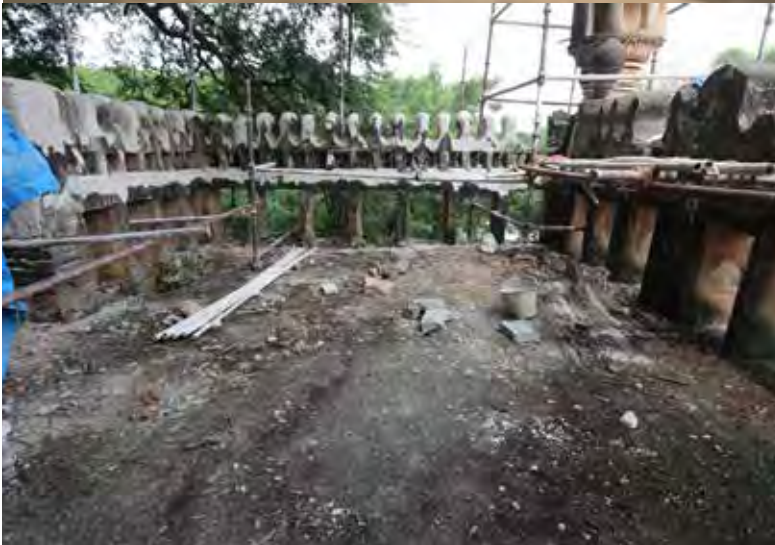
(Left) Existing terrace in a dilapidated condition

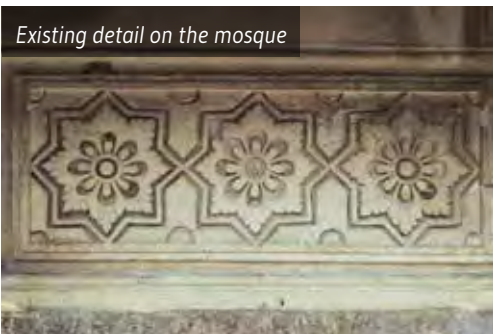
Traces of original detail found

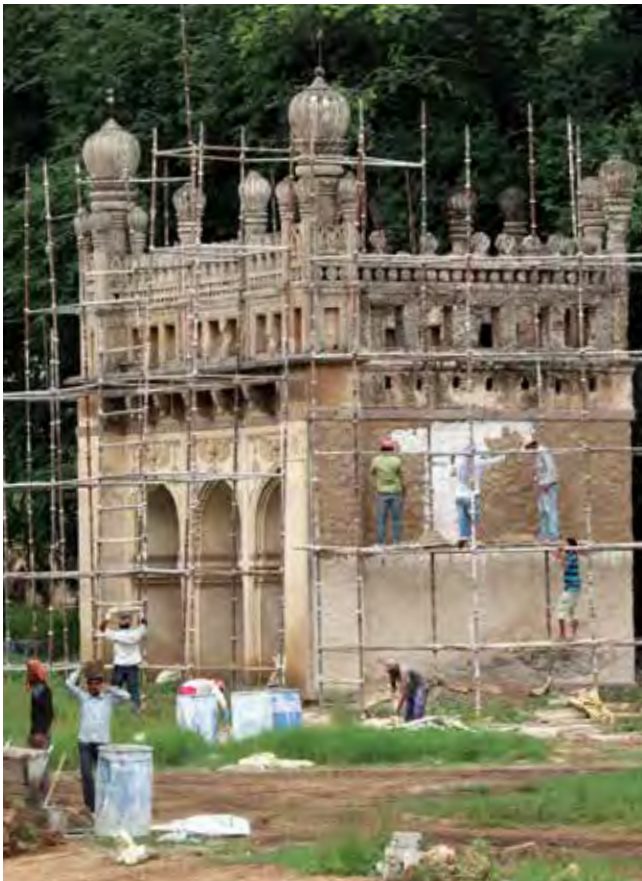
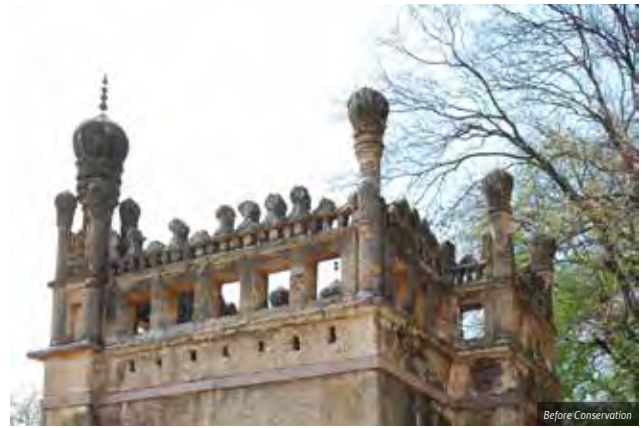
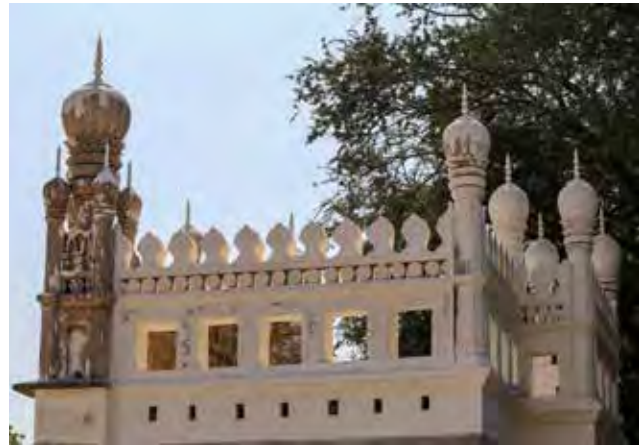
(Clockwise from left) The external facade of the mosque was repaired with lime mortar after removal of 20th century cement and white wash layers; Restoration of decorative plasterwork on parapet; Craftsmen repairing and restoring the battlements

The external façades of the mosque were covered with 20th century cement, multiple layers of limewash and several portions of decorative plasterwork and minarets situated on the parapet were found in a damaged state. Six minarets on the western parapet were found in a damaged state and had to be reconstructed matching the existing evidence at site. Archival evidence of ornamental medallions was revealed after removal of twentieth century plaster layers.

- Scaffolding has been erected around the perimeter of the structure on northern, western and southern sides.
- 20<sup>th</sup> century cement and white-wash layers are being carefully removed to reveal the original appearance of the structure.
- Plaster repairs are being carried out on the northern, western and southern walls by master craftsmen using traditional lime mortar.
- Repairs with traditional lime mortar followed by lime punning have been finished on the internal and internal surfaces.

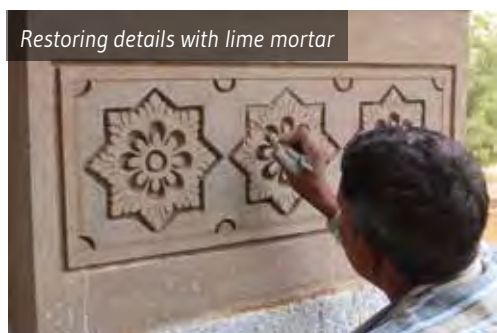
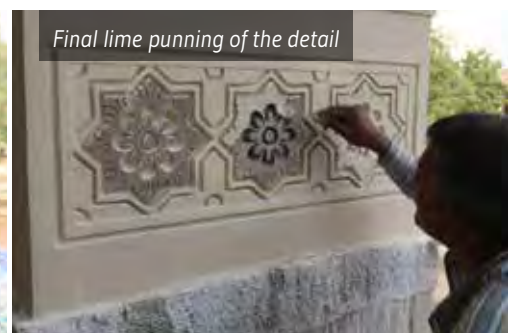
*(Top) Restoration of details and minarets on the parapet; (Bottom Left) Repairs on the collapsed portions of a minaret and installation of missing finial on top; (Bottom Right) Missing minarets were restored using traditional lime mortar*

- Collapsed portions of corner minarets at the parapet level were reinstated.
- Reconstruction of missing and restoration of partially damaged minarets has been carried out by master craftsmen using traditional lime mortar.

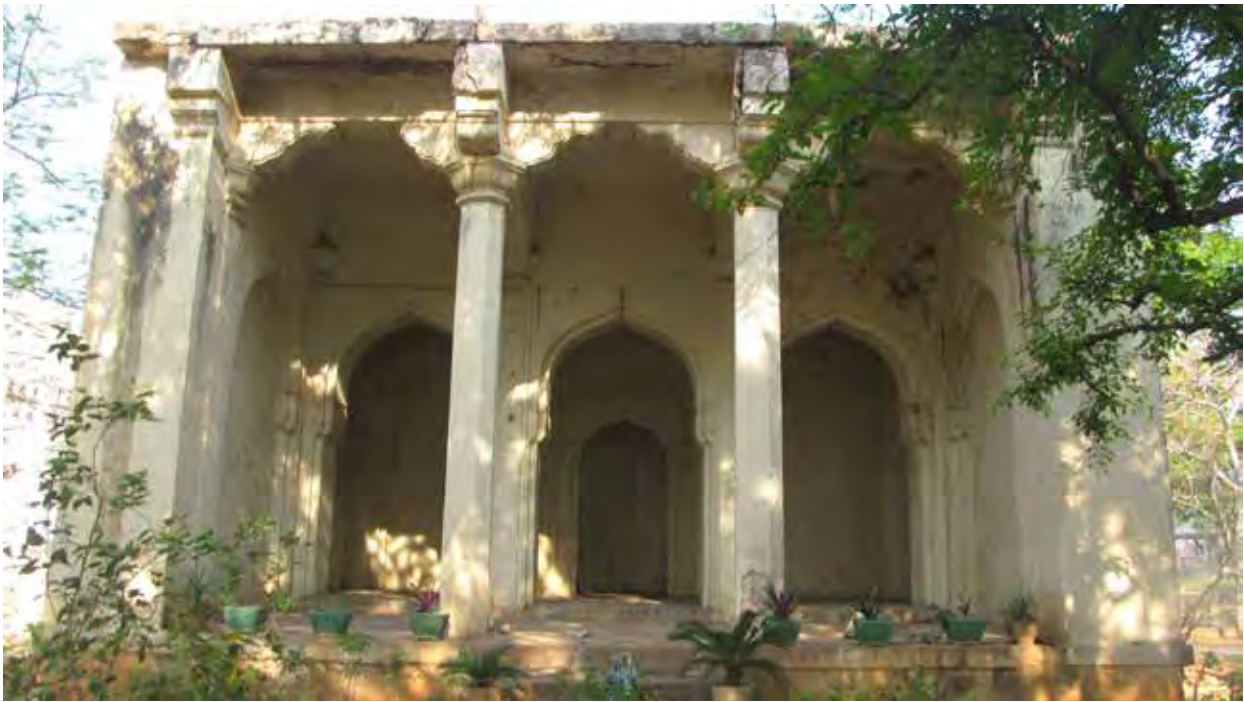
EAST ELEVATION - CONDITIONAL ASSESSMENT

The terrace showed visible signs of water seepage inside the mausoleum. The external façades of the mosque were covered with 20<sup>th</sup> century cement, multiple layers of lime wash and several portions of the recessed blind arches were found missing on the western and northern facades damaged state. Deep plant roots were visible on the internal facades and layers of cement plaster was covering the wall surfaces. Terrace was leaking with large tree roots visible on the surface and waterspouts were found missing on the western parapet.

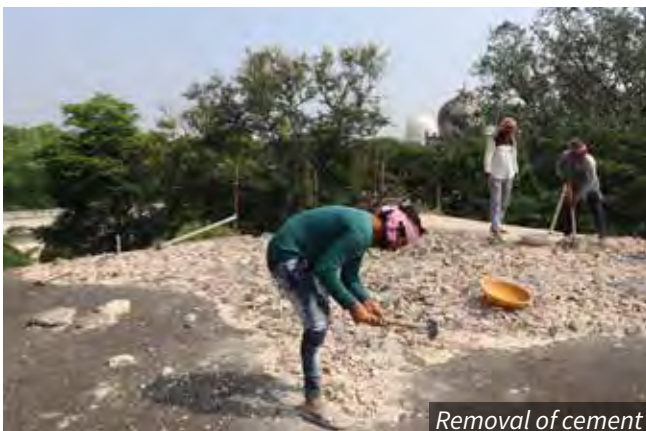
*Removal of cement*

- 20<sup>th</sup>-century cement and white-wash layers were carefully removed to reveal the original appearance of the structure.
- Plaster repairs are being carried out on the northern, western and southern walls by master craftsmen using traditional lime mortar.

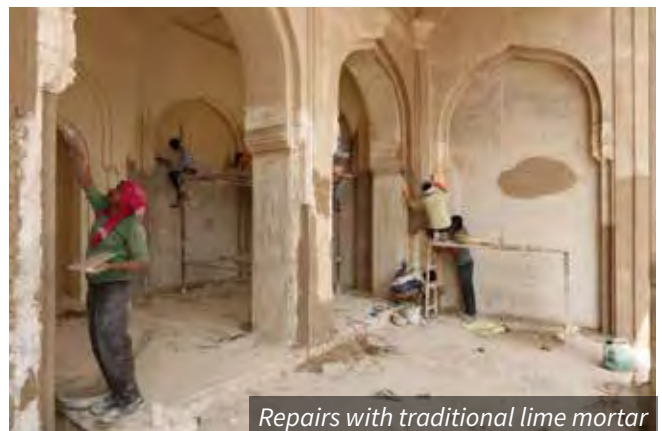
*Repairs with traditional lime mortar*

- Repairs with traditional lime mortar followed by lime punning have been finished on the external and internal surfaces.
- Missing blind arches on the northern and western external facades were reconstructed using honey comb brick shuttering and allowed to set for a period of 30 days.

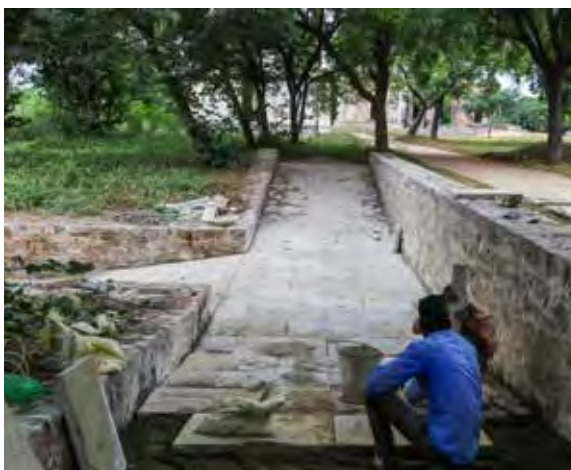
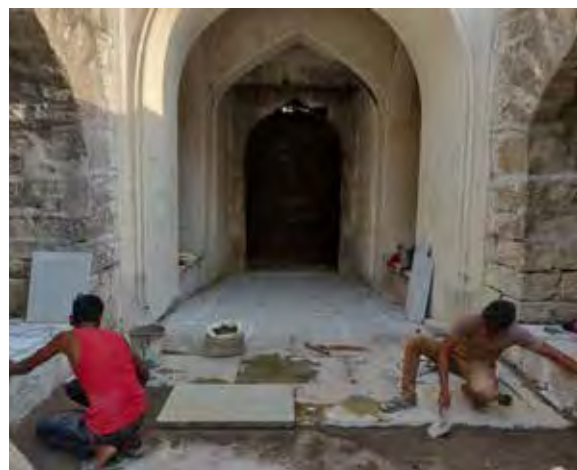
The Southern gate original levels were revealed during the archaeological investigations carried out in 2014-15. Since this formed a critical connection between the Golconda and the Tomb complex, it was necessary to provide an adequate connection from the existing ground. Thus ramped pathway connecting the main network of paths around the mausoleum of Ibrahim Quli was designed accommodating the old wall and developing new retaining walls.

- The work on the pathways connecting the Southern Gateway to the tombs and the unknown tombs in the South West quadrant have been completed including preparation of base, brickwork retaining walls (near mosque above the southern gateway) and 50 mm thick Tandur stones that are laid in accordance to the landscape proposal.
- Tandur stones were laid on the ramp joining the western peripheral pathway in the south-west quadrant to the South Gate, which is linked with the historic pedestrian linkage to Golconda Forts outer fortification.

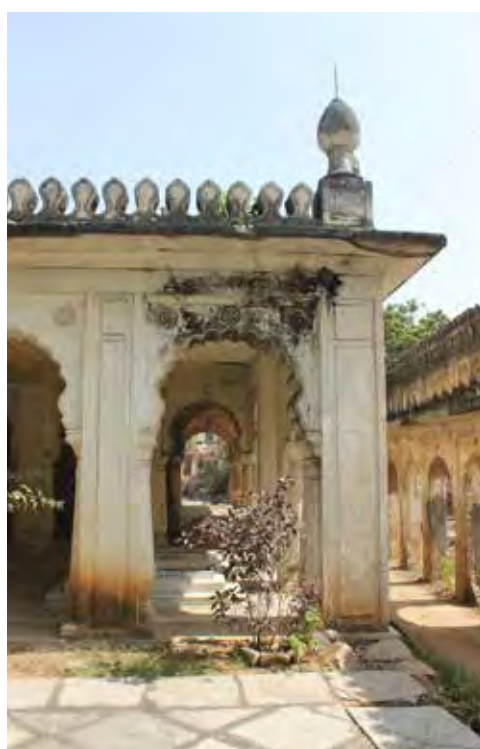
*Images indicating the current conditions of the mausoleum of Khair Nawaz Jung.*

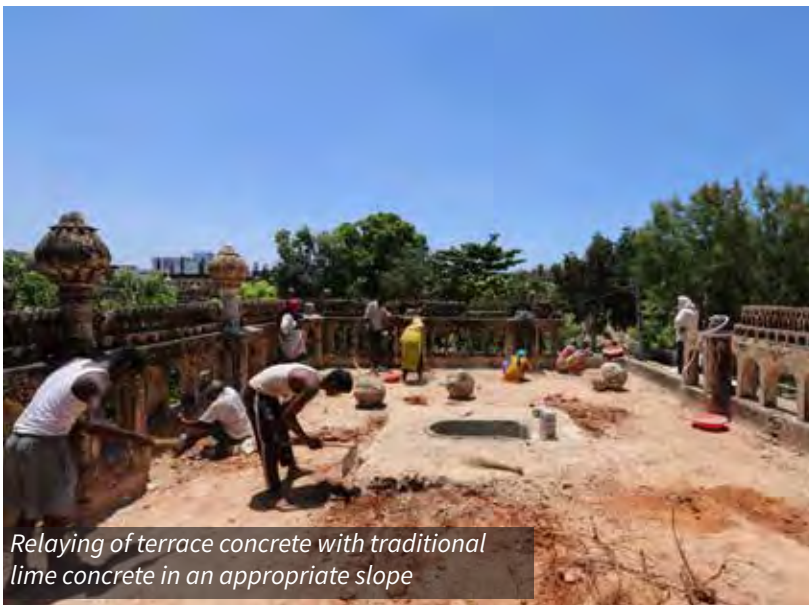
*Relaying of terrace concrete with traditional lime concrete in an appropriate slope*

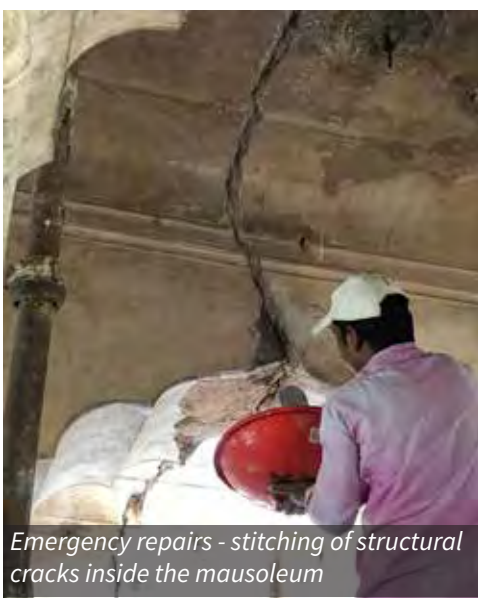
*Emergency repairs - stitching of structural cracks inside the mausoleum*

- Structural cracks on the ceiling and terrace of Ghansimiyan Tomb were stitched using rich lime mortar injected through injection grout by stone craftsmen.

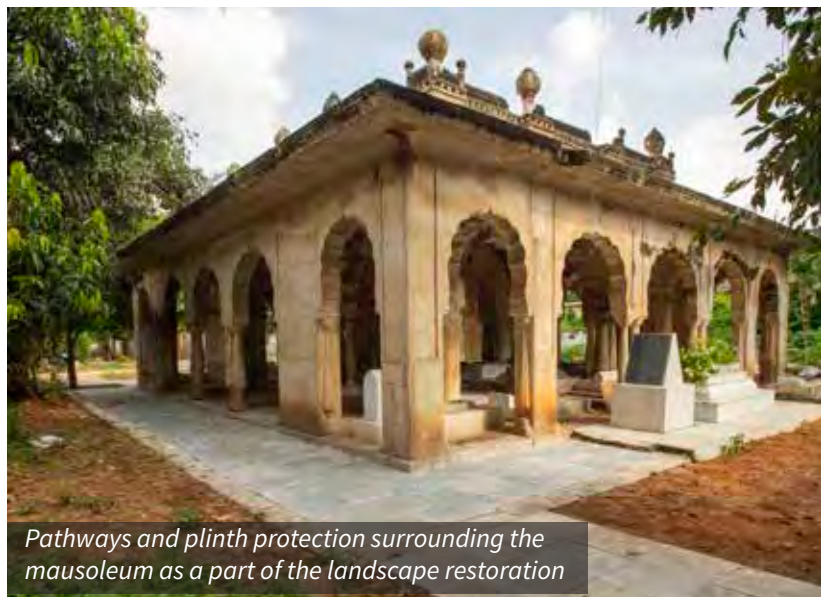
*Pathways and plinth protection surrounding the mausoleum as a part of the landscape restoration*

- Lime concrete was laid in the plinth protections built around the perimeter of the mausoleum.
- 30 mm thick granite stones were laid as plinth protection, laid to appropriate slope and approved layout to channel rainwater away from the foundation of the structure.
