AGA KHAN TRUST FOR CULTURE

# QUTB SHAHI HERITAGE PARK

ANNUAL REPORT 2019

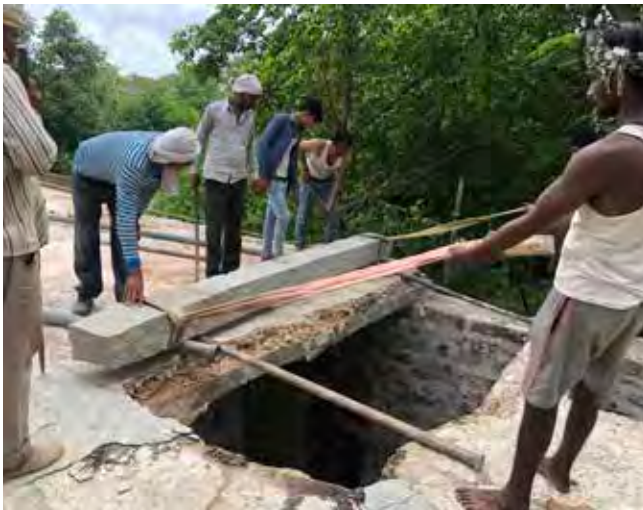
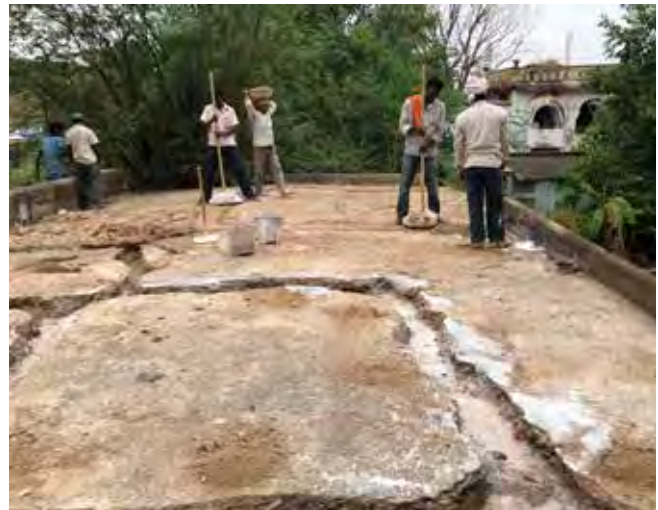
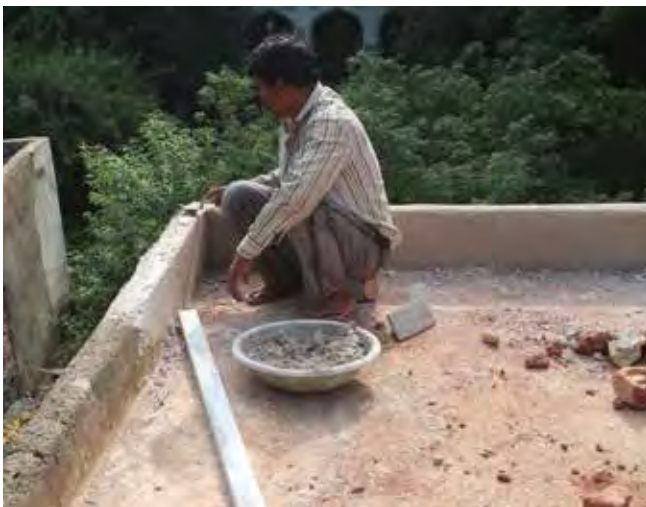
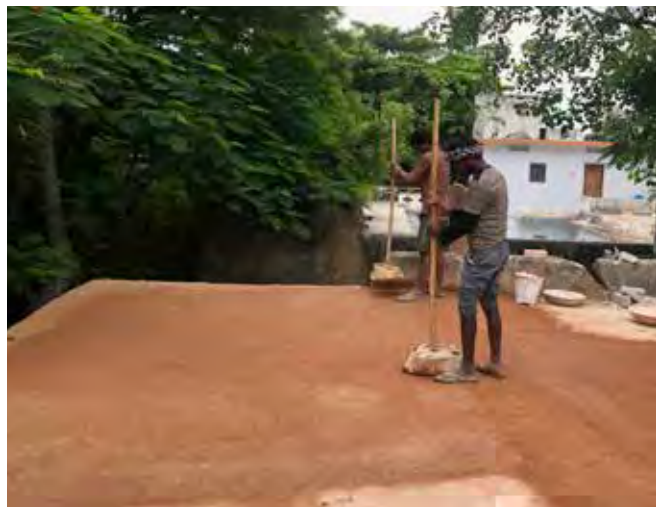
*(Below) Re-installation of missing roof beams and repairing of terrace concrete of the Samakhana with traditional lime concrete in an appropriate slope*

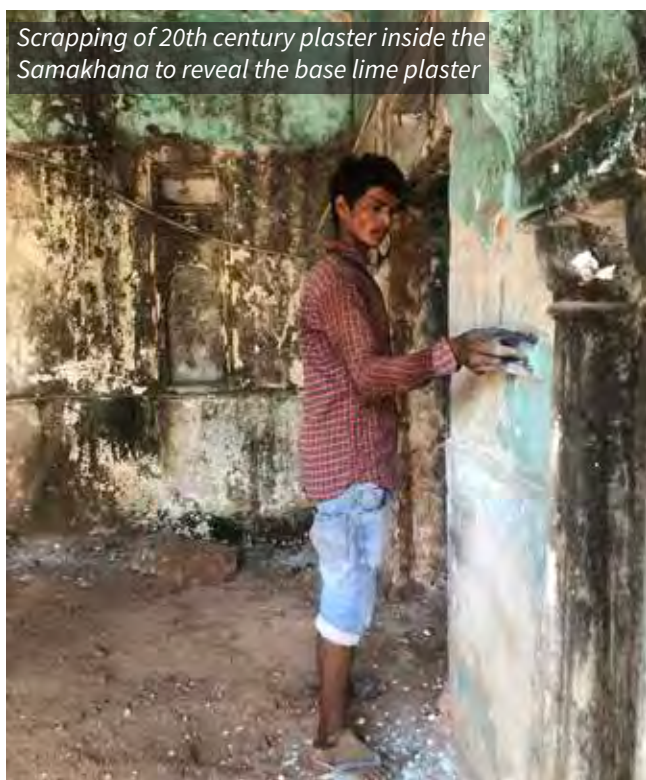
*Scrapping of 20<sup>th</sup> century plaster inside the Samakhana to reveal the base lime plaster*

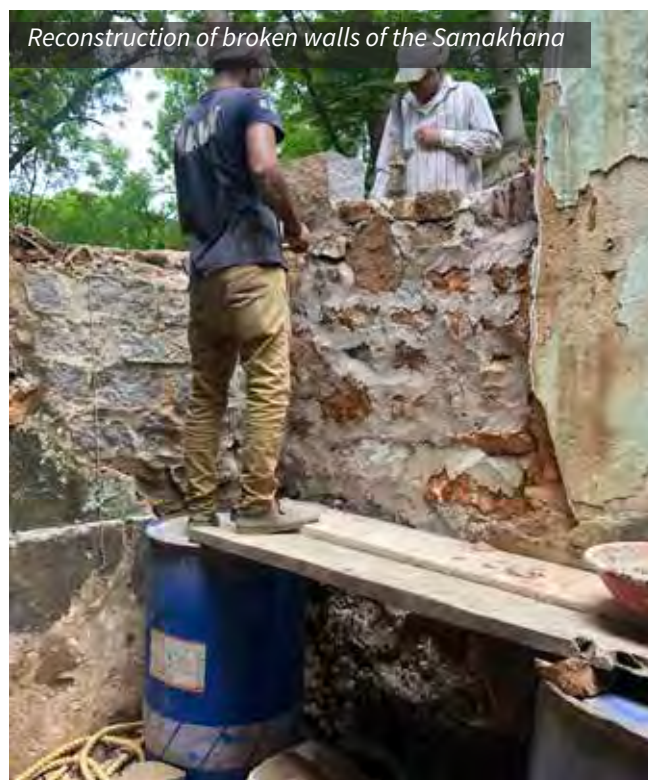
*Reconstruction of broken walls of the Samakhana*

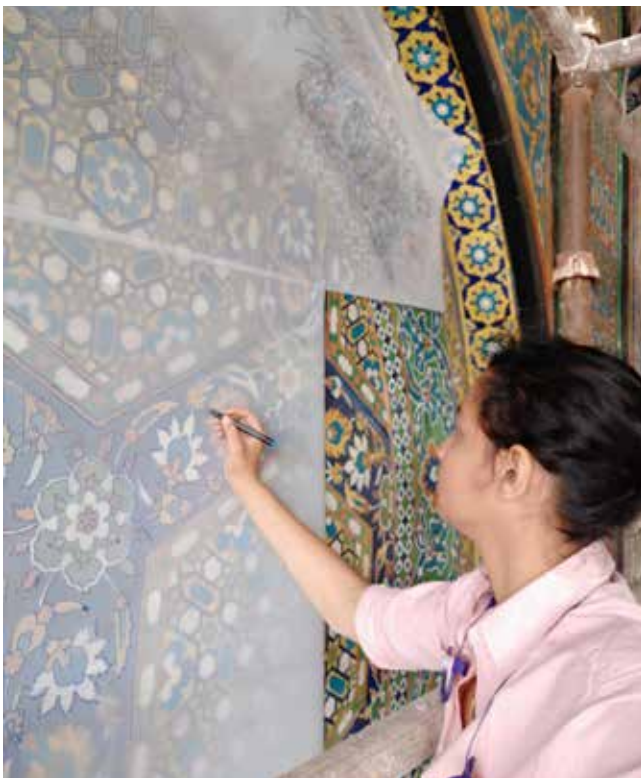
*(Below) True scale detailed documentation of the inlay tiles on the recessed bays inside the structure is being carried out.*

- True scale detailed documentation of the exquisite inlay tiles on the recessed bays inside the structure is being carried out to precisely estimate the extent of damage.
- Layers of 20th century paint obfuscating the underneath tiles are being cleaned to reveal the tiles.
- The tiles are being individually traced and superimposed on AutoCAD drawings, prepared with perspective corrective photogrammetric images created using point cloud data.
- Thermal imaging cameras use infrared radiation to highlight areas beneath the tiles with excessive water seepage in a rainbow coloured palette. This will aid in adopting an appropriate conservation methodology to conserve the tile embellishment on the internal facades.
- Documentation has been completed in four of the five recessed arch bays embellished with tilework inside the structure.
