QUTB SHAHI HERITAGE PARK

CONSERVATION & LANDSCAPE RESTORATION

ANNUAL REPORT –2020

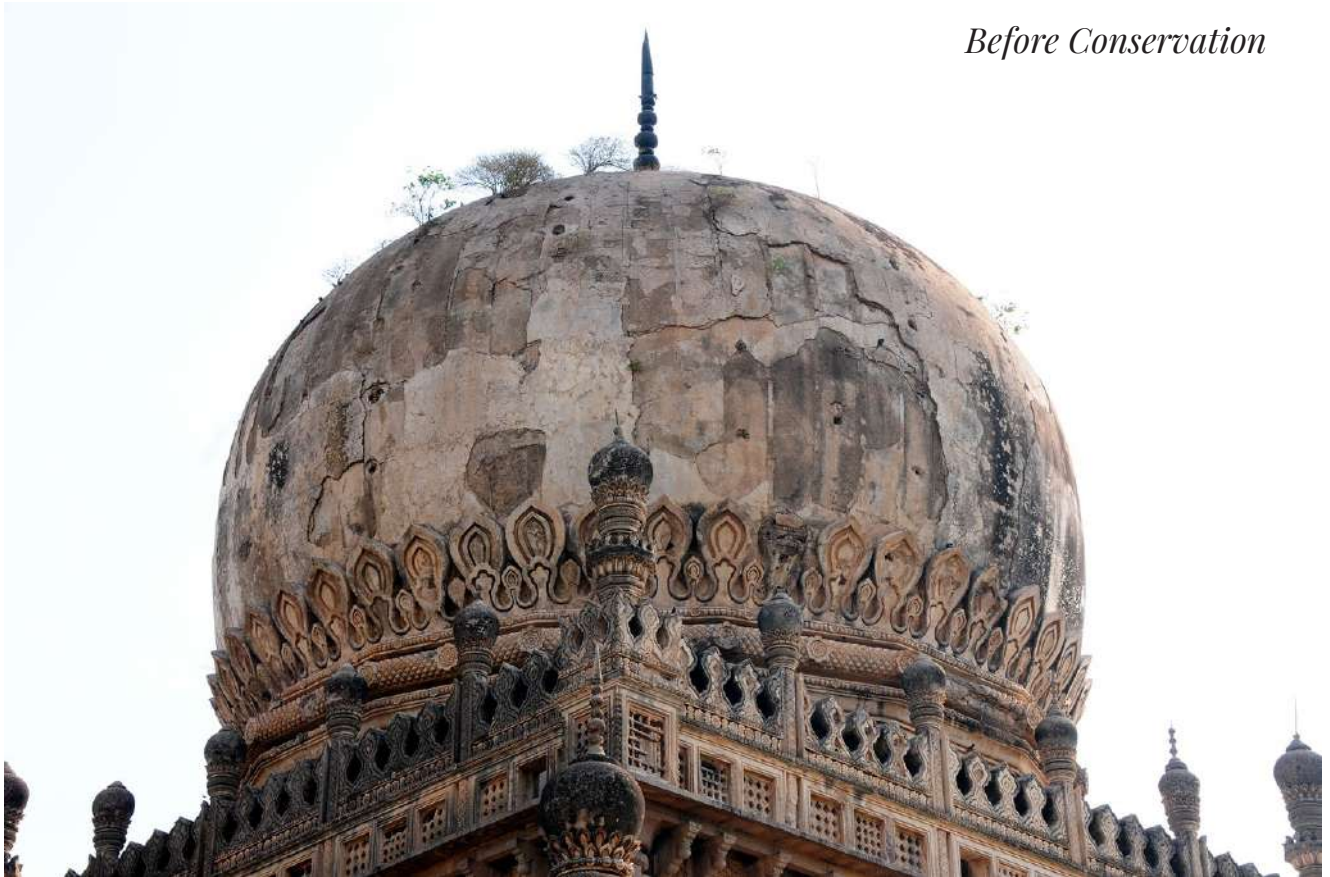
Dome was found covered with a thick layer of cement plaster leading to ingress of rainwater and growth of deep rooted plants on the dome surface. Remnants of the original ribs were visible after removal of cement plaster. Dilapidated lime plaster was found on the 16 sided drum and merlons situated below the dome.

(Top) Illustrative restoration of 56 historic ribs revealed during investigation at dome

- A 3-inch-thick layer of cement plaster was carefully removed from the dome surface exposing the remnants of the original ribs.
- Deeply rooted plants were removed and holes filled with rubble and lime mortar to prevent further ingress of water causing damage to the dome masonry.

(Clockwise from left) Dismantling of 20th-century cement plaster from dome surface to reveal the original ribs underneath; Restoration of missing ribs coupled with plastering of dome surface carried out by master craftsmen; Restoration of merlons situated below dome

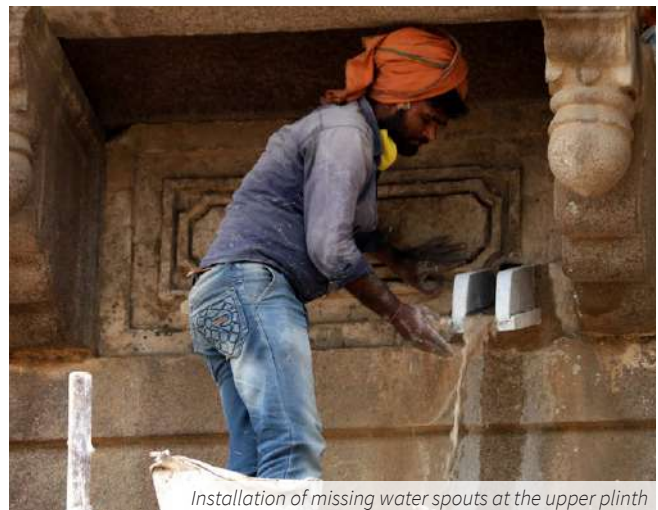
Installation of missing water spouts at the upper plinth

- Cleaning of openings for waterspouts, fabrication in granite and installation of missing rainwater spouts on middle terrace were carried out before the monsoons.

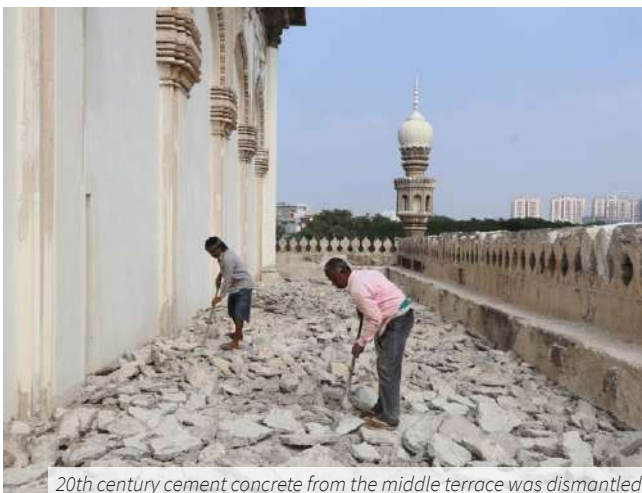
Middle terrace of Abdullah Qutb Shah's Mausoleum had a 20th- century cement concrete layer added during the 20th-century repairs. On close inspection it was observed that later added cement concrete and missing rainwater spouts was leading to the rainwater seeping into the lower arcade.

20th century cement concrete from the middle terrace was dismantled

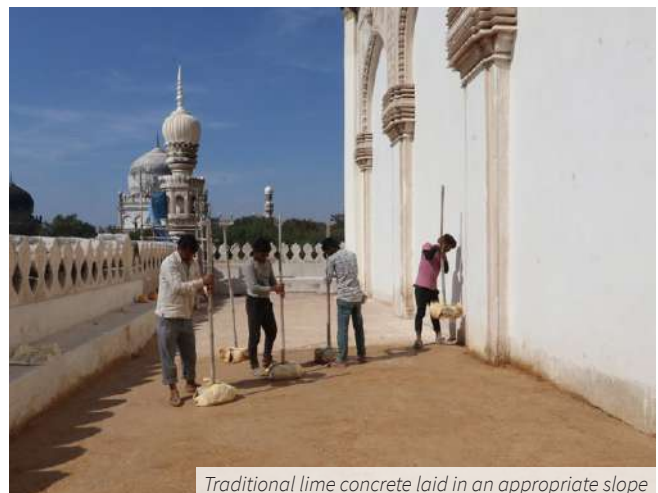
Traditional lime concrete laid in an appropriate slope

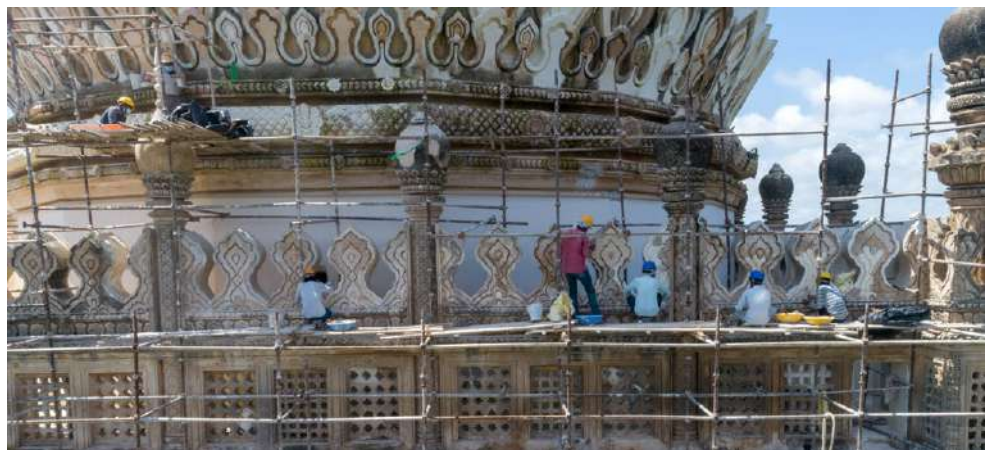
The minarets and the intricate lattice screens on the parapet of the mausoleum were found to be partially damaged or missing. Most of the finials present on top of them were also observed in a dilapidated condition. Covered with layers of cement, these minaret shafts also showed signs of deteriorated stucco.

(Above) Missing or broken portions of the minars, battlements and other details on the parapet were successfully restored by master craftsmen; (Below-left) Reconstruction of missing portions of lattice screens at the parapet level using local stone pieces; (Below-middle) Detailed documentation of the existing evidence; (Below-right) Mastercraftsmen restored the lime stucco details on the reconstructed portions of the lattice screen

- Cement layers from the minars at the mausoleum were removed and replaced with traditional lime plaster.
- Damaged and missing finials atop the minars were reconstructed based on in-situ evidence.
- Missing and broken details on the minars were restored using traditional lime plaster and finished in lime punning by master craftsmen.
- Framework for the missing portions of the lattice screens was constructed using local stone pieces of matching sizes and finished with lime mortar matching the original design and finished with a thin layer of lime putty applied by the lime craftsmen.
- Damaged moulding bands, floral medallions and ornamental stucco details were restored by master craftsmen.

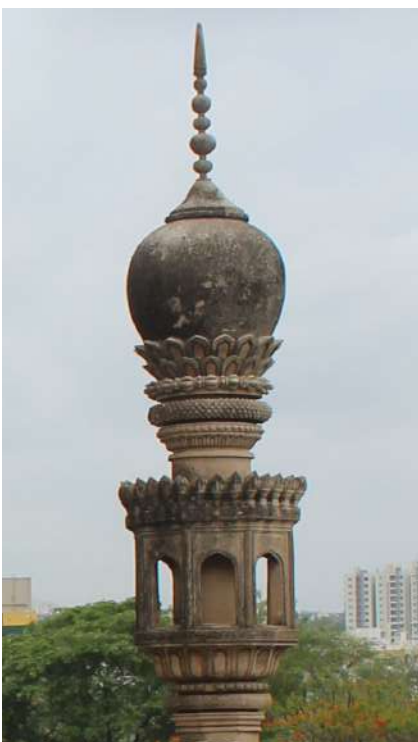
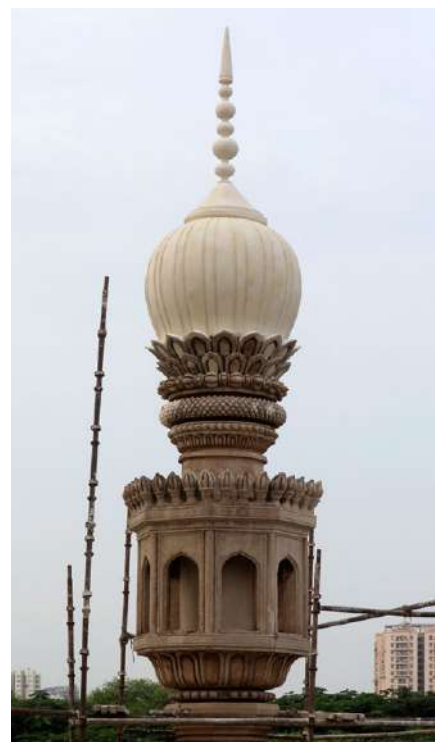
Taking a cue from archival images, 20th-century plaster layers were removed from the bulb of the minar at Abdullah Qutb Shah's mausoleum, to reveal the historic ribs underneath. Mastercraftsmen have repaired the ribs using traditional lime mortar.

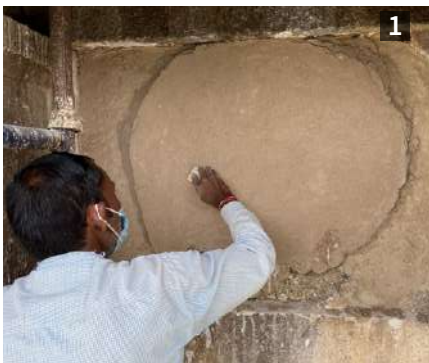
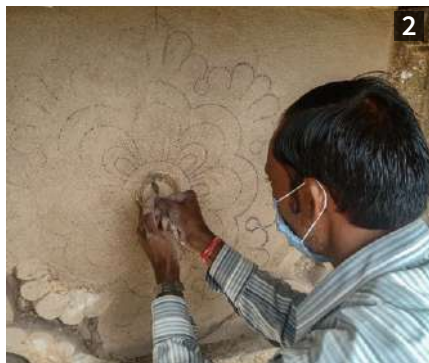
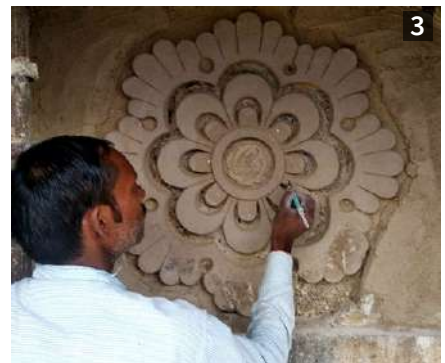
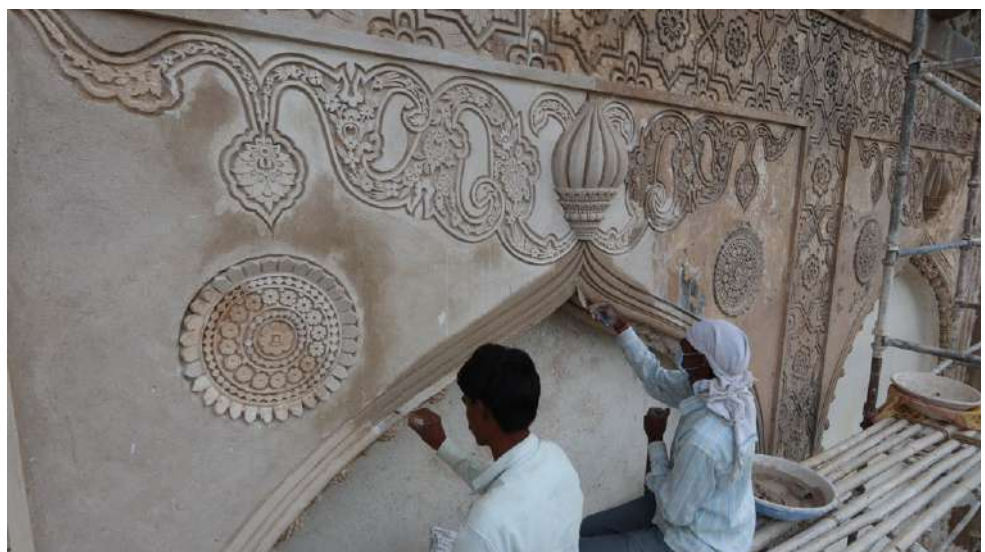
The external surface below the projected stone eaves on principal facades at the upper terrace level of the mausoleum is embellished with highly ornate lime stucco including highly intricate floral medallions. Major portions of the medallions, arch mouldings, and stucco ornamentation were obfuscated with later added layers of cement and multiple portions were found damaged. A number of stone eaves were found damaged on the southern façade.

(Above) Restoration of original ornamental stucco medallions underneath the projected eaves below the terrace carried out by traditional lime craftsmen; (Below) Moulding bands, ornamental stucco and arch crowns restored using traditional lime mortar

- Repairs and restoration works were carried out on the upper portion of the external façade of the mausoleum where broken, damaged or missing stucco details, merlons, medallions and floral bands were restored using traditional lime plaster and finished with a coat of lime punning based on the existing in-situ evidence.
- The floral band running along the lower terrace was restored using traditional lime mortar and finished using lime punning based on the existing in-situ evidence.

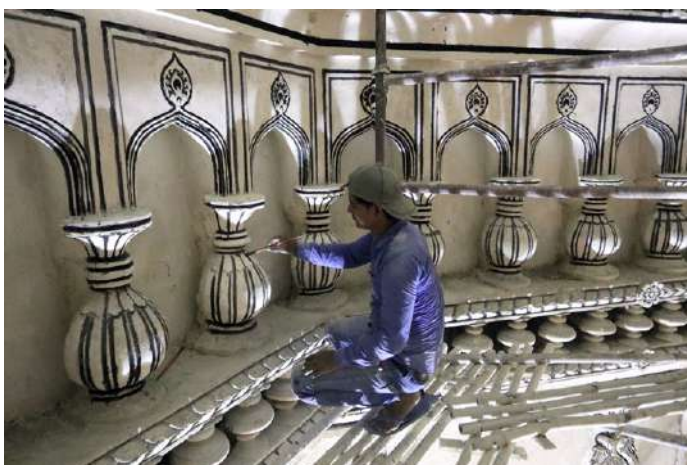
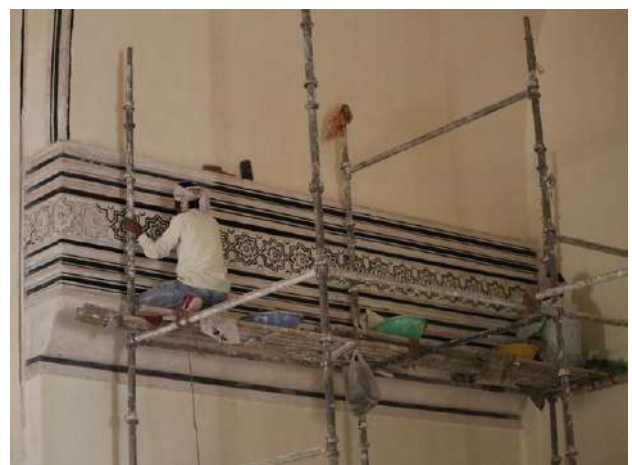
The internal surface below the dome had visible signs of deterioration accentuated by 20th-century repairs carried out using cement. The details on the internal surface below the parapet on principal facades of the mausoleum such as merlons, medallions and the flower band were found to be damaged or missing. Many portions were found covered with cement plaster and multiple layers of lime wash.

Ornamental stucco details and moulding bands were restored inside the internal mausoleum matching the existing evidence

- 60 feet tall scaffolding was erected inside the internal mausoleum.
- Repairs on the blind arches situated below the internal dome were carried out using traditional lime mortar.

- 20th-century cement and white-wash layers were carefully removed to reveal the original appearance of gallery.
- Plaster repairs were followed by finishing with a thin 1 mm layer of punning, which consists of lime putty mixed with organic additives.

- Evidences of black colour in grooves of arches were revealed and missing paint was restored based on the existing site evidence.
- Moulding bands surrounding the blind arch gallery were scraped to remove cement patches and were subsequently repaired with lime mortar by craftsmen.

- Ornamental details, moulding bands, arch crowns and original lattice screens were repaired by master craftsmen using rich lime mortar. Final finish on plaster repairs was done using a 1 mm thin smooth layer of slaked lime putty mixed with organic additives.

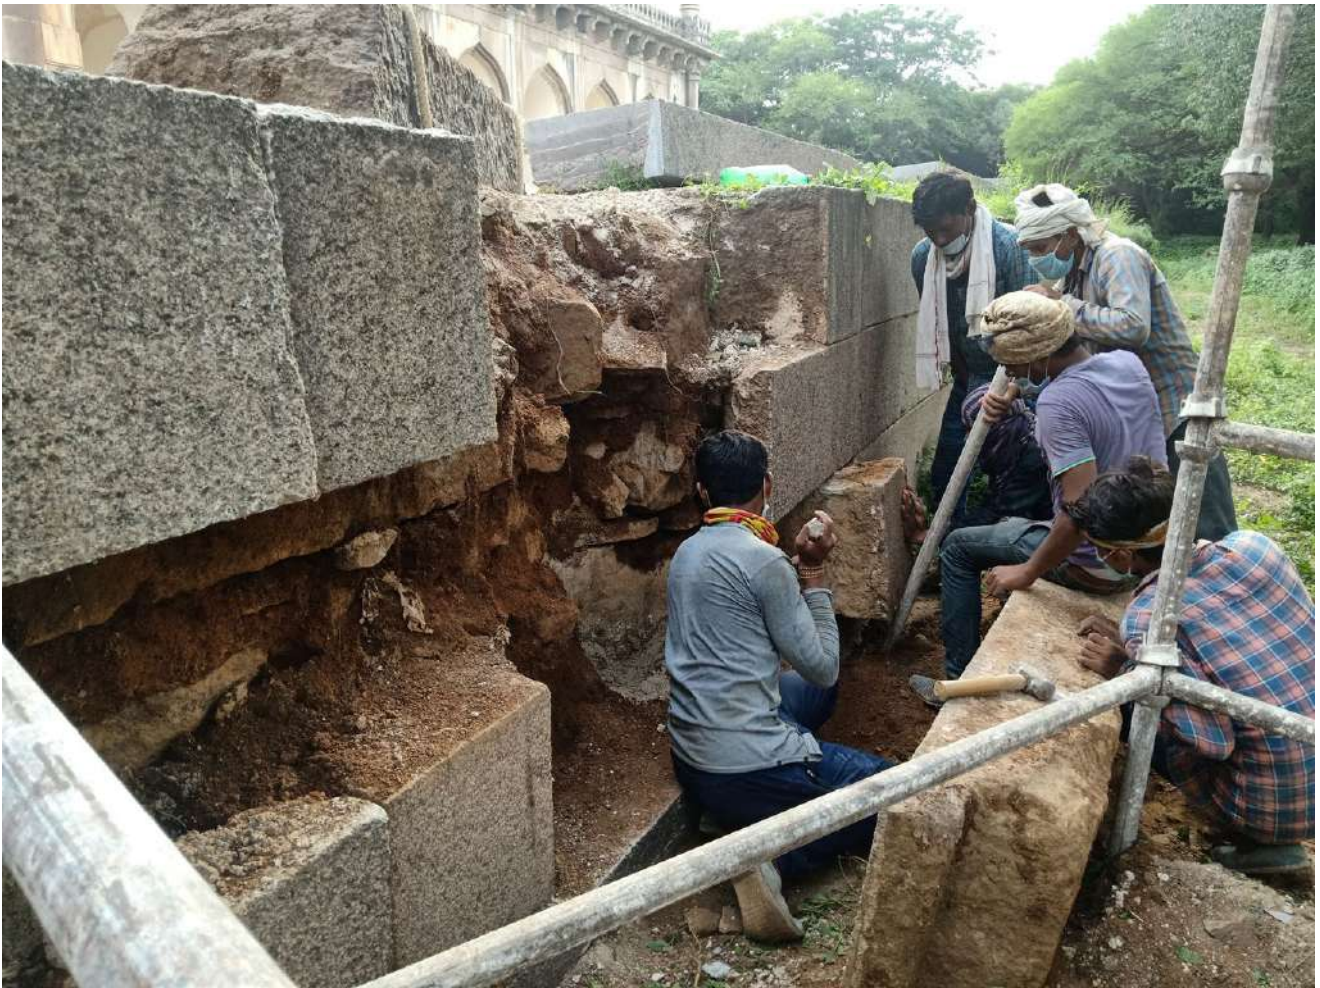
Realignment of the stones lining the plinth wall as per original design

The projected plinth 18 metres away from the main structure comprises of dressed stone wall lining rising upto a height of 2.0 metres. The stone masonry was damaged on the west and north side with stones bulging out. The coping stones were also missing over the vertical wall.

- A total of 145 missing coping stones lining the projected plinth wall were hand dressed and installed by stone craftsmen.
- Over 40000 cubic feet of earth laid in on the projected plinth in appropriate slope to channel rainwater away from the structure.

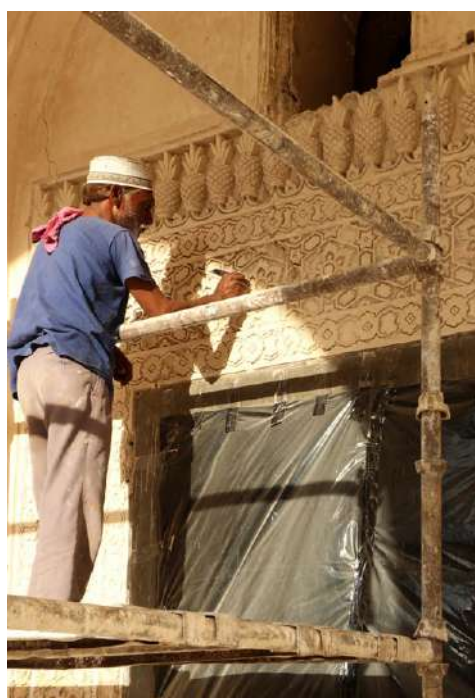
The existing corridor consisted of stone flooring laid on cement mortar. Wall and ceiling surfaces inside the arched corridor were found in a dilapidated condition due to water ingress from terrace above and accentuated by 20th-century repairs using cement.

(Right) Ornamental stucco frieze around the stone doorway jambs were meticulously restored by skilled craftsmen based on original evidence

- Scraping of 20th-century whitewash and enamel paint layers on the Western, Eastern and Southern doorways embellished with stucco patterns has been meticulously carried out.

- Repair of damaged stucco patterns on the doorways was followed by painting of missing portions by an art conservator to restore the original appearance of the principal entrances leading to the internal mausoleum.

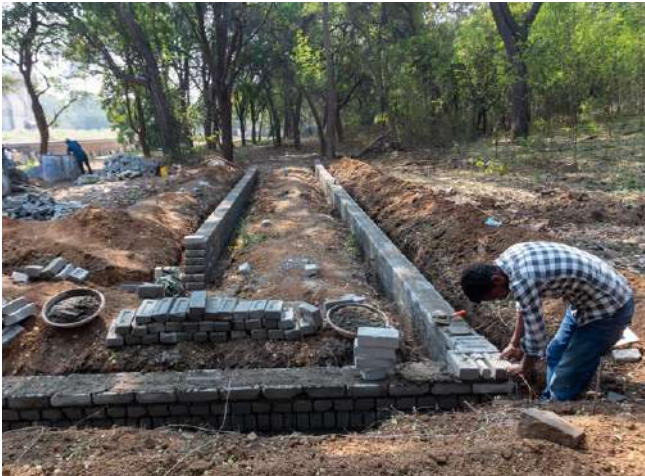
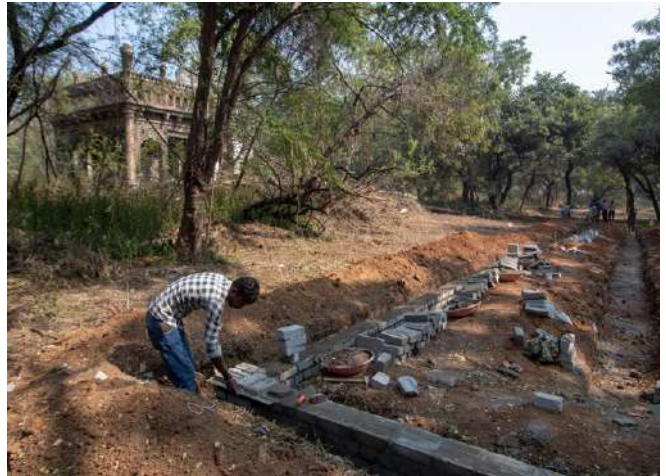
Basework for pathways towards north of Abdullah Qutb Shah's mausoleum

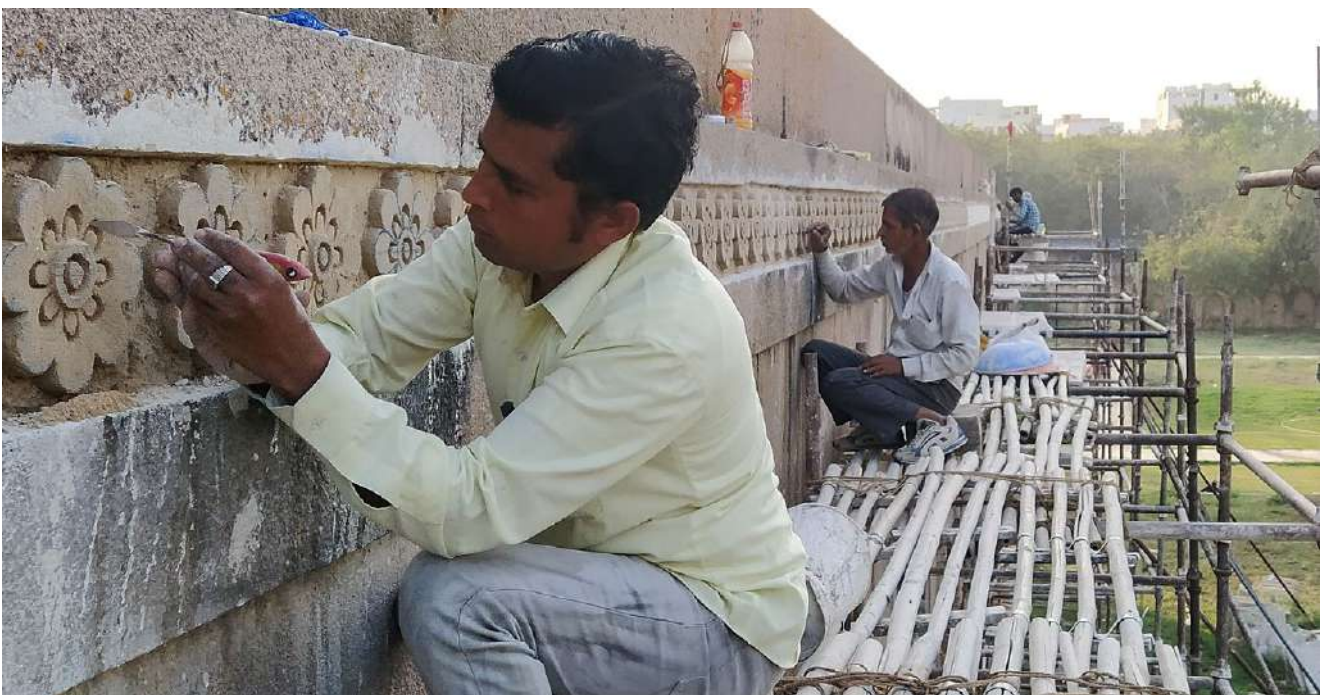
The external surface below stone parapet and above the blind arches is embellished with highly ornate floral stucco medallions. Major portions of the floral medallions below the stone parapet and above the blind arches are damaged and missing. Large portions of the medallions, arch mouldings, and stucco ornamentation were obfuscated with later added layers of cement and multiple portions were found damaged. Stone waterspouts were found missing on the stone parapet.

Restoration of floral medallion band on the facade by skilled craftsmen

- Plaster repairs and restoration of ornamental medallions and stucco will be carried out on the middle façade of the mausoleum. 30 mm thick granite stone slabs were laid in approved layout and appropriate slope in lime mortar. Installation of missing hand dressed stone will be carried out on the western projected plinth. Restoration of damaged floral medallions situated below the eastern external façade will be completed. Multiple layers of 20th-century paint will be meticulously removed from the lower dressed stone plinth situated above the historic granite flooring.

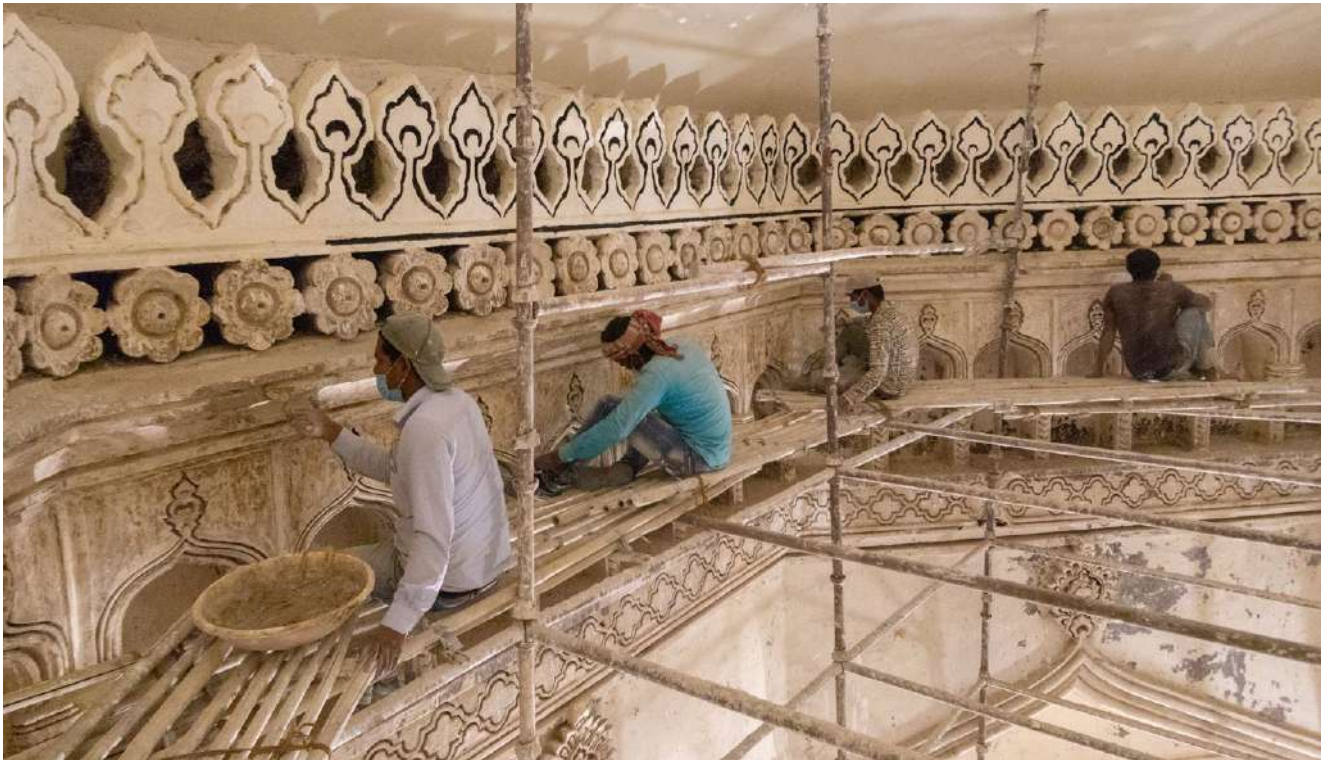
(Above) Ornamental moulding bands situated above the projected arch gallery were restored using lime mortar

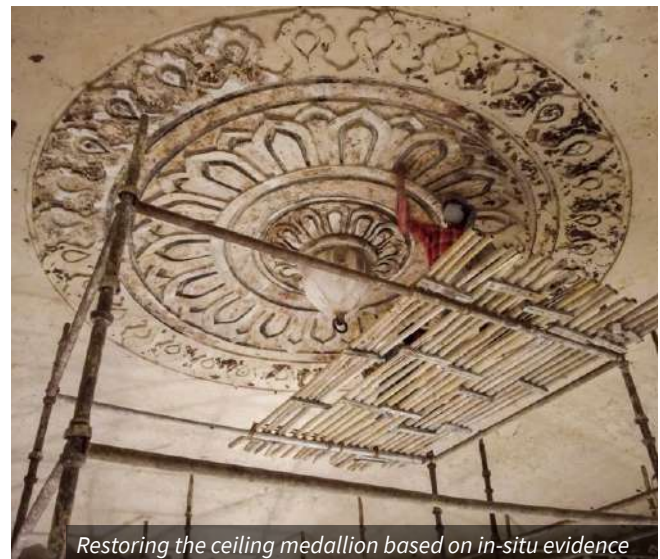
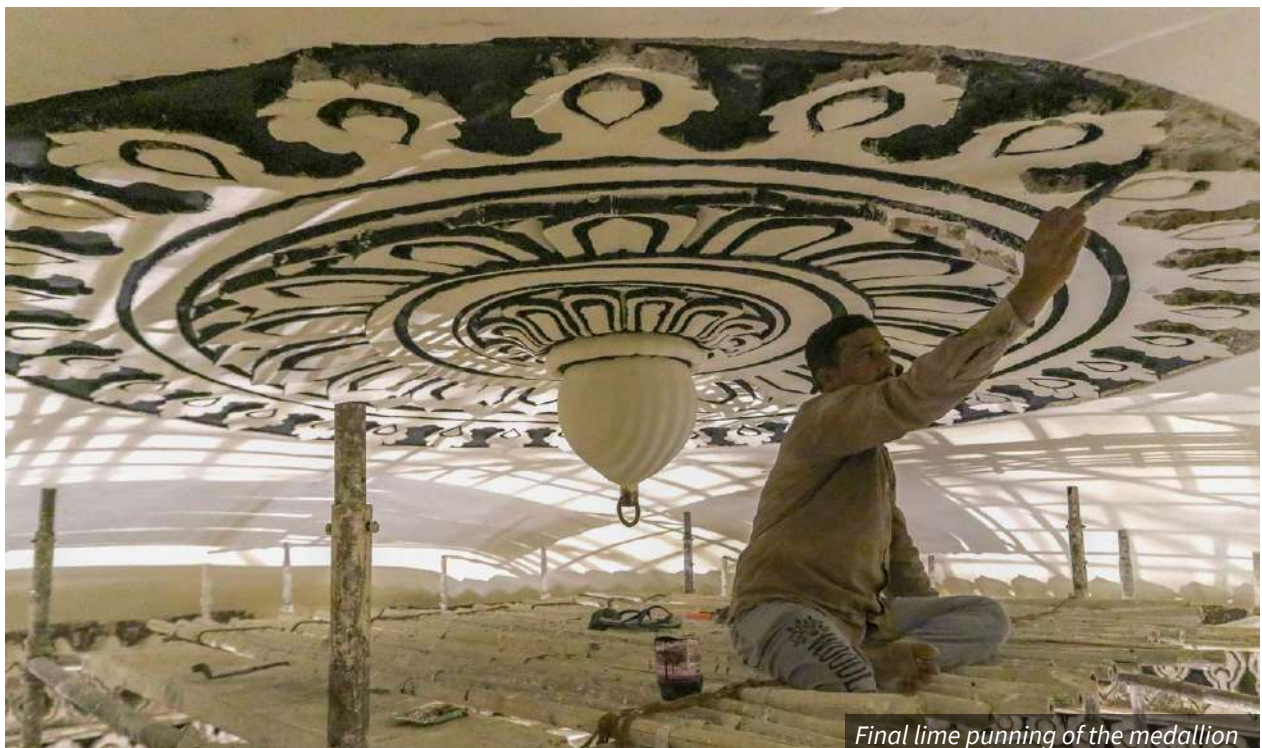
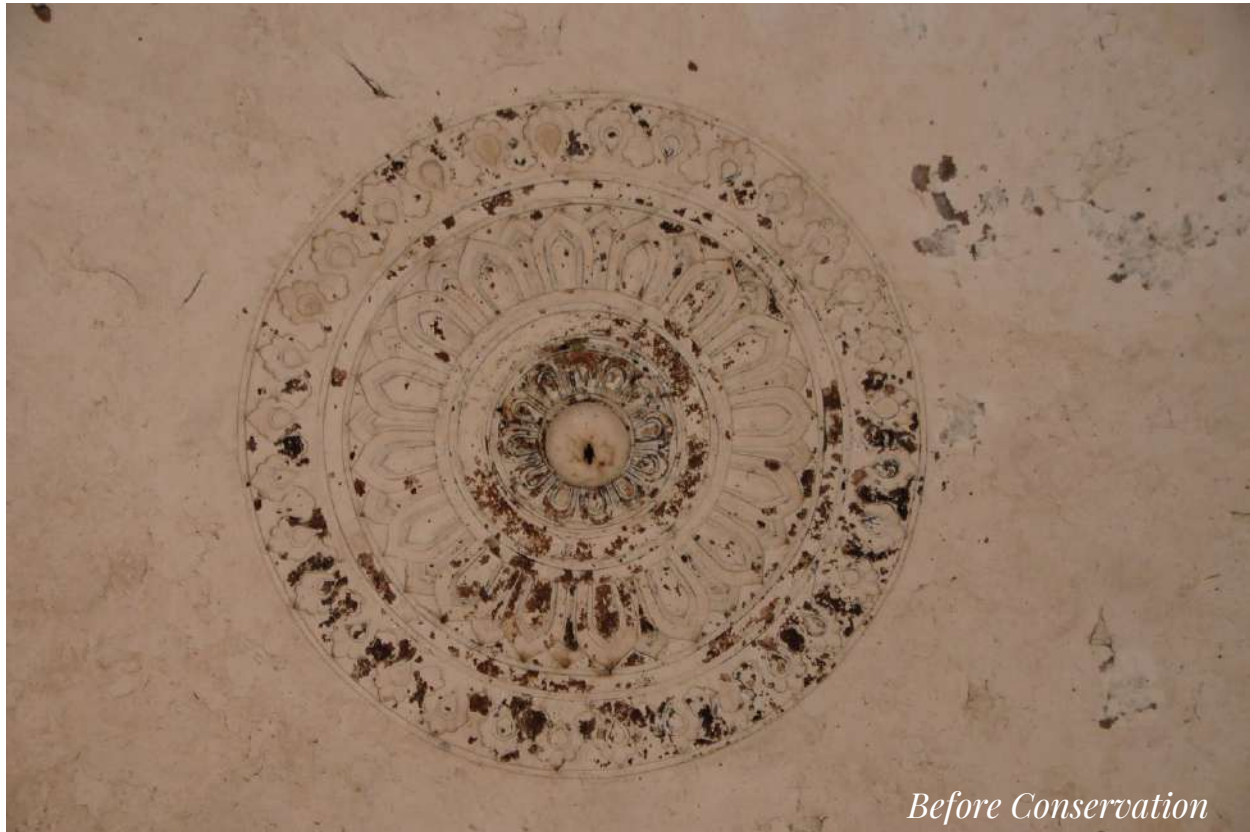
Internal ceiling was found covered with multiple layers of lime wash. Major portions of ornamental ceiling medallion were found covered with cement. Traces of original color were revealed on the ceiling medallion and missing paint was restored based on the existing site evidence.

- Pulverized lime plaster from the internal ceiling medallion was carefully removed and missing ornamental stucco was restored matching the existing evidence at site by master craftsmen using rich traditional lime mortar and finished with a 1 mm thin layer of lime punning. A total of 56 missing floral leaf patterns were restored based on the existing evidence at site.
- Restored stucco patterns were finished with a 1 mm thin layer of matured lime mixed with organic additives

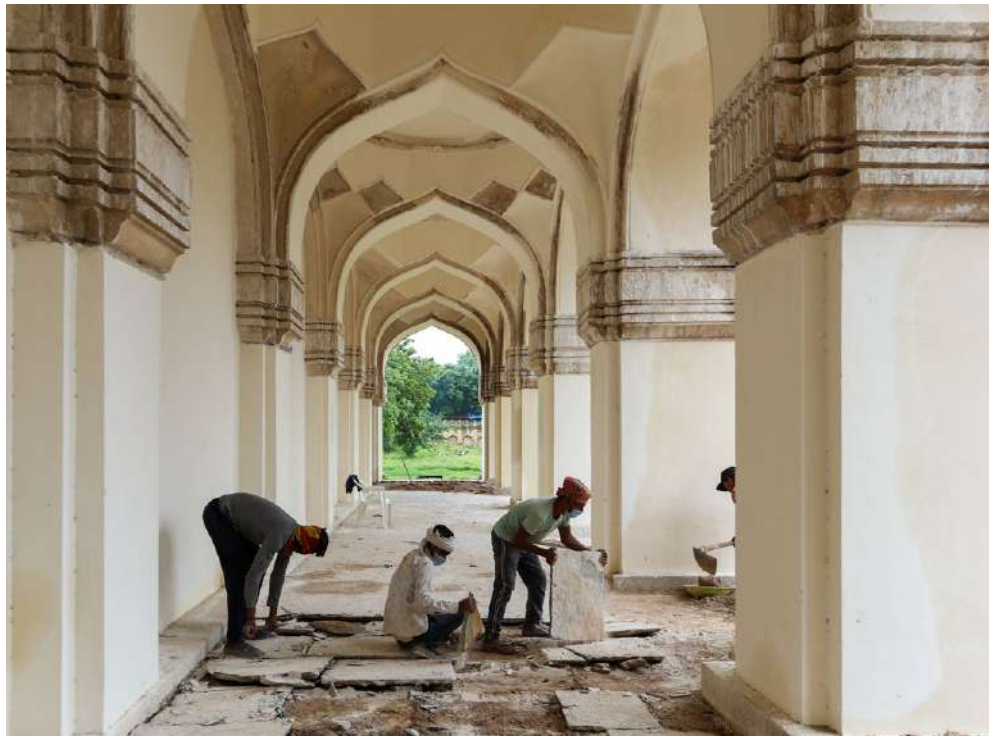
The existing flooring before conservation was 20th-century stone flooring installed in cement mortar. Wall and ceiling surfaces inside the arched corridor were found in a dilapidated condition due to water ingress from terrace above and accentuated by 20th-century repairs using cement.

(Right) 20th century inappropriate stone flooring being dismantled by craftsmen

- Dismantling of 20th-century stone flooring laid in cement inside the corridor was carried out.
- Ornamental ceiling medallions on the ceiling of arched bays in the corridor were found to be pulverized, dismantling of the same was carried out carefully and re-plastering in traditional lime mortar and finished with lime putty to match the original design by traditional lime craftsmen. Over 24 of these large sized ceiling medallions were restored.

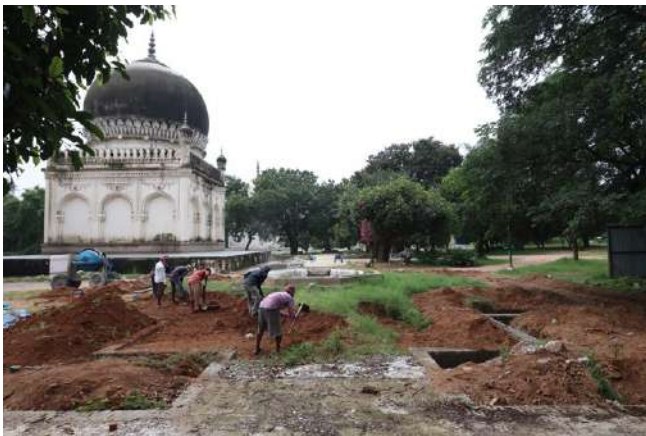
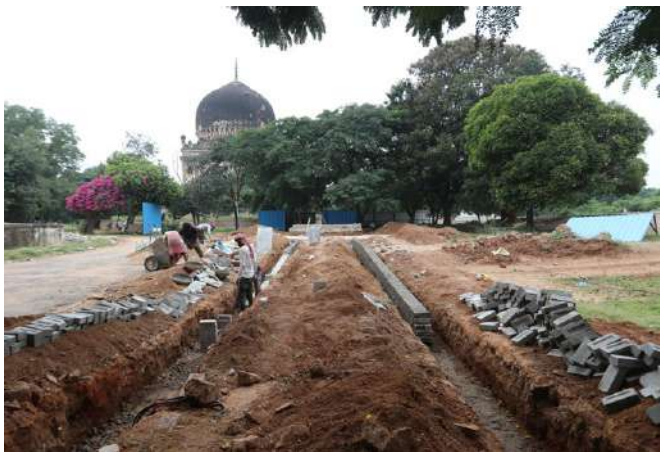
Pathways and plazas being developed as part of the landscape masterplan near the Mausoleum of Hayat Bakshi Begum

- A plaza has been developed on the south side of the mausoleum with tandur stone flooring around the existing ashlar masonry tank.

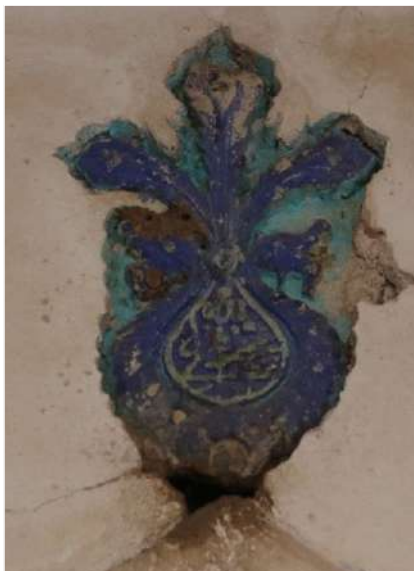
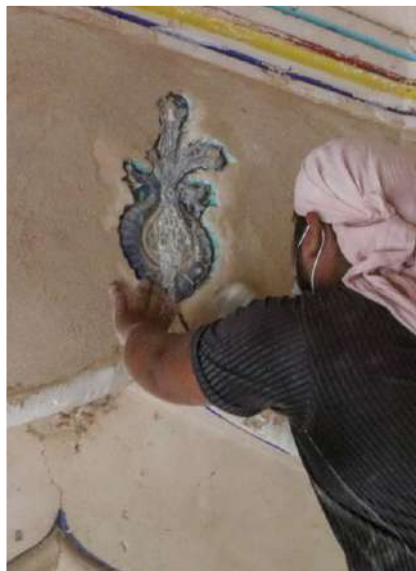
Process of removal of 20th century paint layers from the basalt stone arch crown

- 20th century enamel paint was meticulously removed from the mouldings, stone and stucco arch crowns.
- Removal of paint from stone arch crowns revealed the original appearance.
- Original moulding details were revealed on internal arched niches during removal of 20th-century plaster layers and were restored using rich lime mortar by traditional craftsmen.
- Missing stucco embellishment inside the mihrab on western wall was reinstated by traditional lime craftsmen.
- Repairs on the blind arches situated below the internal dome were carried out using traditional lime mortar.
- 20th century cement and white-wash layers were carefully removed to reveal the original appearance of gallery.
- Plaster repairs were followed by finishing with a thin 1 mm layer of punning, which consists of lime putty mixed with organic additives.

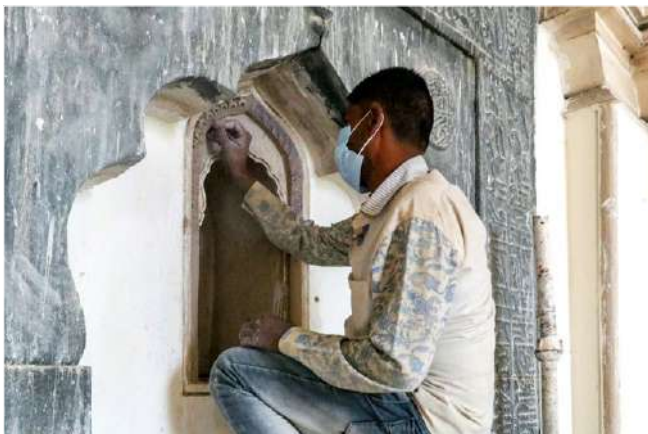
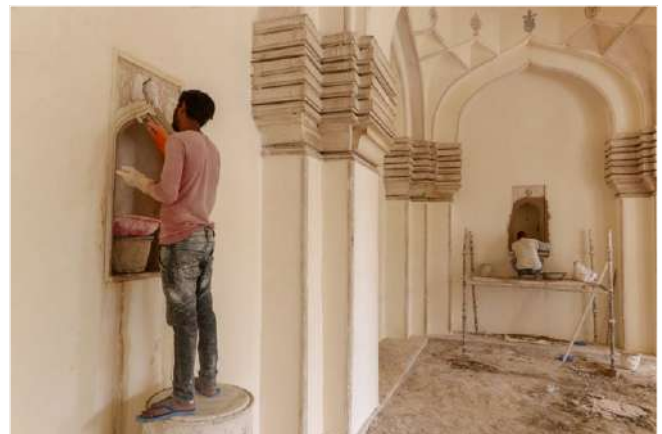
The internal wall and ceiling surfaces depicted visible signs of deterioration caused by perennial seepage of rainwater from terrace above. The details on the internal domes and squinches were found to be damaged or missing. Many portions were found covered with cement plaster and multiple layers of lime wash. Moulding bands on masonry columns were majorly damaged. Stucco moulding details on the niches of internal walls have been obfuscated with later added plaster layers. 20th-century stone flooring laid in cement mortar was removed to reveal the original levels of the dressed stone skirting lining the internal walls.

Ornamental stucco details were restored on the internal wall surfaces

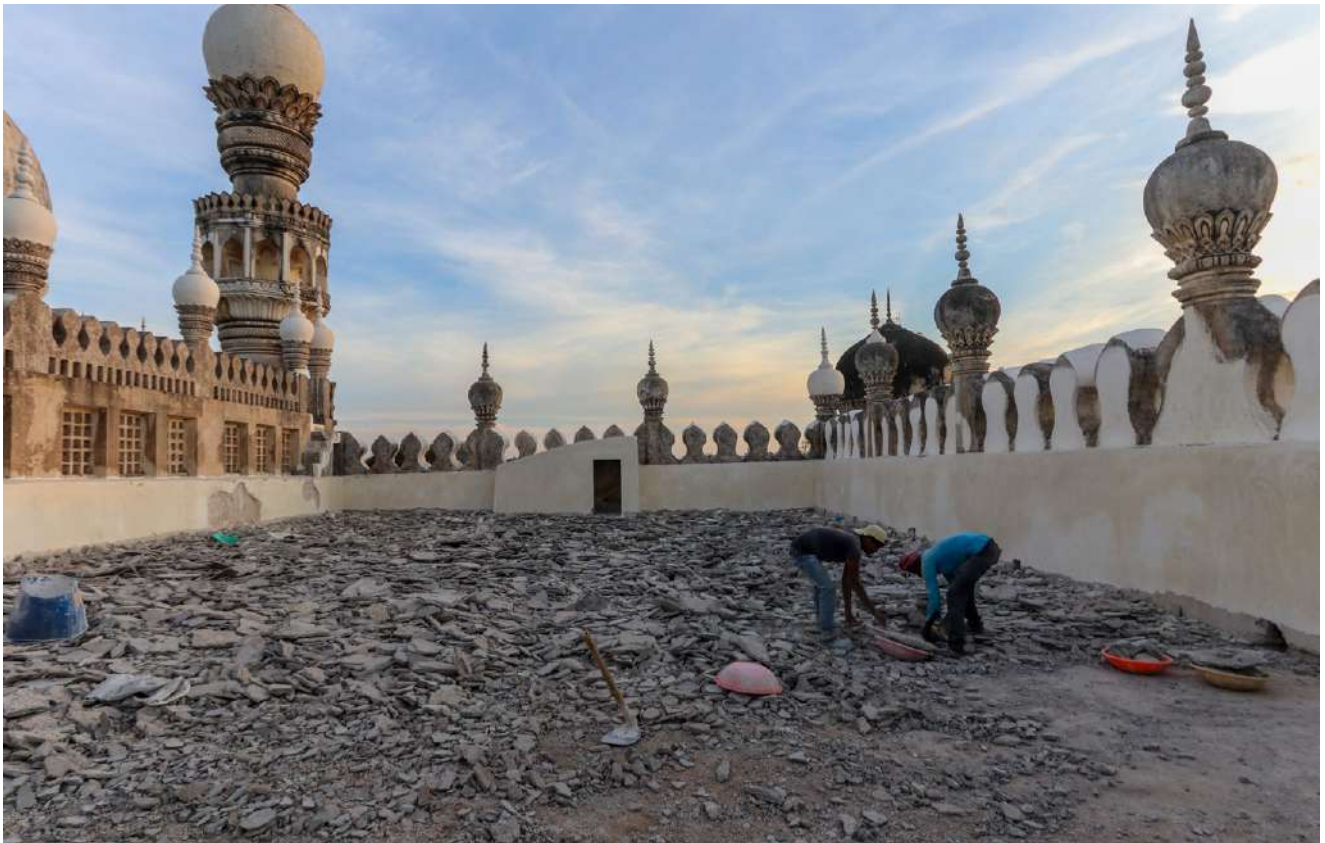
(Above) Dismantling of 20th century cement concrete on the middle terrace;
(Below) Traditional lime concrete was laid in appropriate slope

Terrace was covered with a 20th- century cement concrete layer added during the modern repairs. On close inspection, it was observed that later added cement concrete and missing rainwater spouts was leading to the rainwater seeping into the structure below.

- 20th century cement concrete was dismantled on the terrace as it was leading to seepage of rainwater into the lower arcade and adding excess load on the structure.
- Traditional lime concrete was laid in an appropriate slope to drain out rainwater away from the structure. Ramming and curing were carried out continuously for a week to achieve smooth finish which would help rainwater drain away.
- Cleaning of openings for projected waterspouts, fabrication in granite and installation of missing seven rainwater spouts were carried to channel rainwater away from the structure.

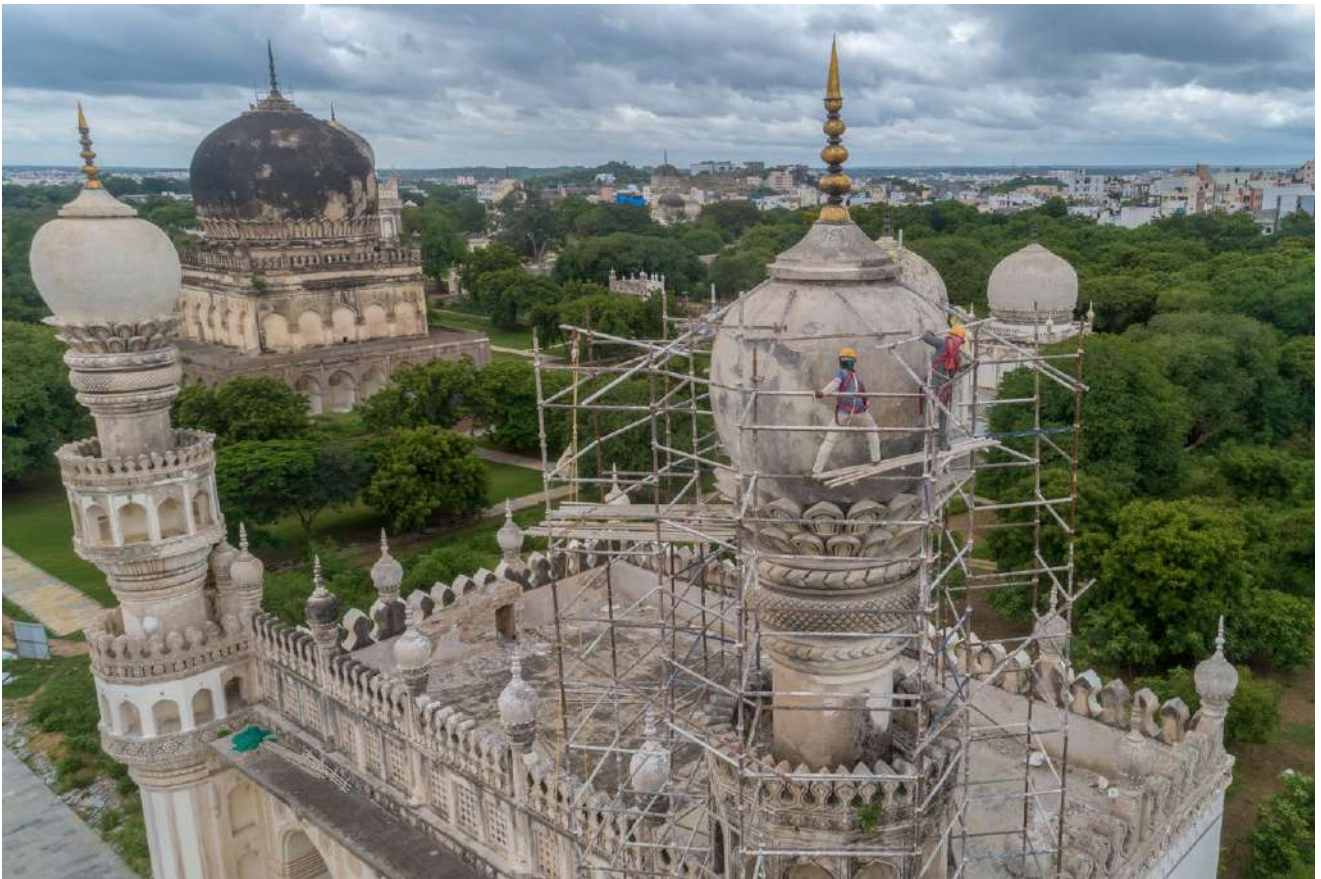
(Above) North-West corner minaret showed signs of deterioration due to ingress of rainwater and accentuated by usage of cement in later carried out repairs. The plaster on the battlements was flaking and in some portions masonry was visible. Precast cement medallions in floral and geometric patterns were inappropriately added during the 20th century repairs and needed to be replaced. Finials on intermediate minarets on the parapet were damaged and missing in some portions.

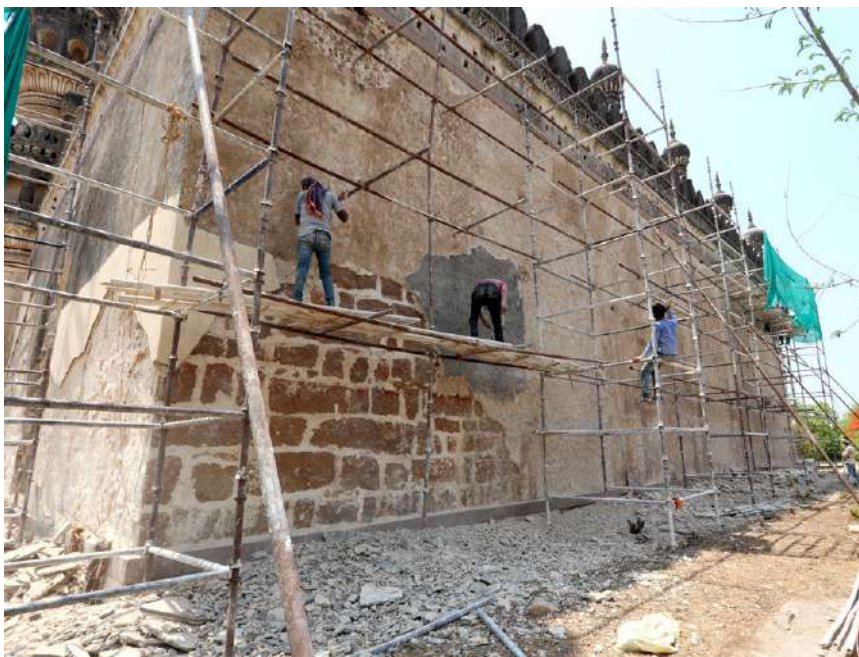
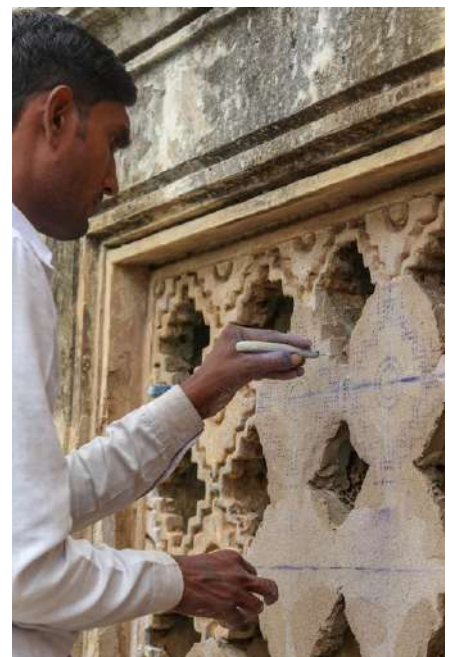
The external wall surfaces were found covered with dilapidated lime plaster and 20th century cement

(Left) Inappropriate 20th century cement was removed from the facade;

(Right) Ornamental stucco lattice screens were restored matching the existing evidence

- 20th-century cement layers were carefully removed from the north, west and south facades and repaired using traditional lime mortar and finished with matured lime putty mixed with organic additives.

- Damaged portions of the eastern chajjas and supporting beam below were repaired in rich lime mortar and finished with lime punning.
- Scraping of 20th-century whitewash was carried out on the principal façade below the eastern chajjas and repairs on moulding and capital bands were carried out.

- Dilapidated plaster has been dismantled from the internal and external facades, replaced with traditional lime mortar along with the application of lime putty mixed with organic additives.

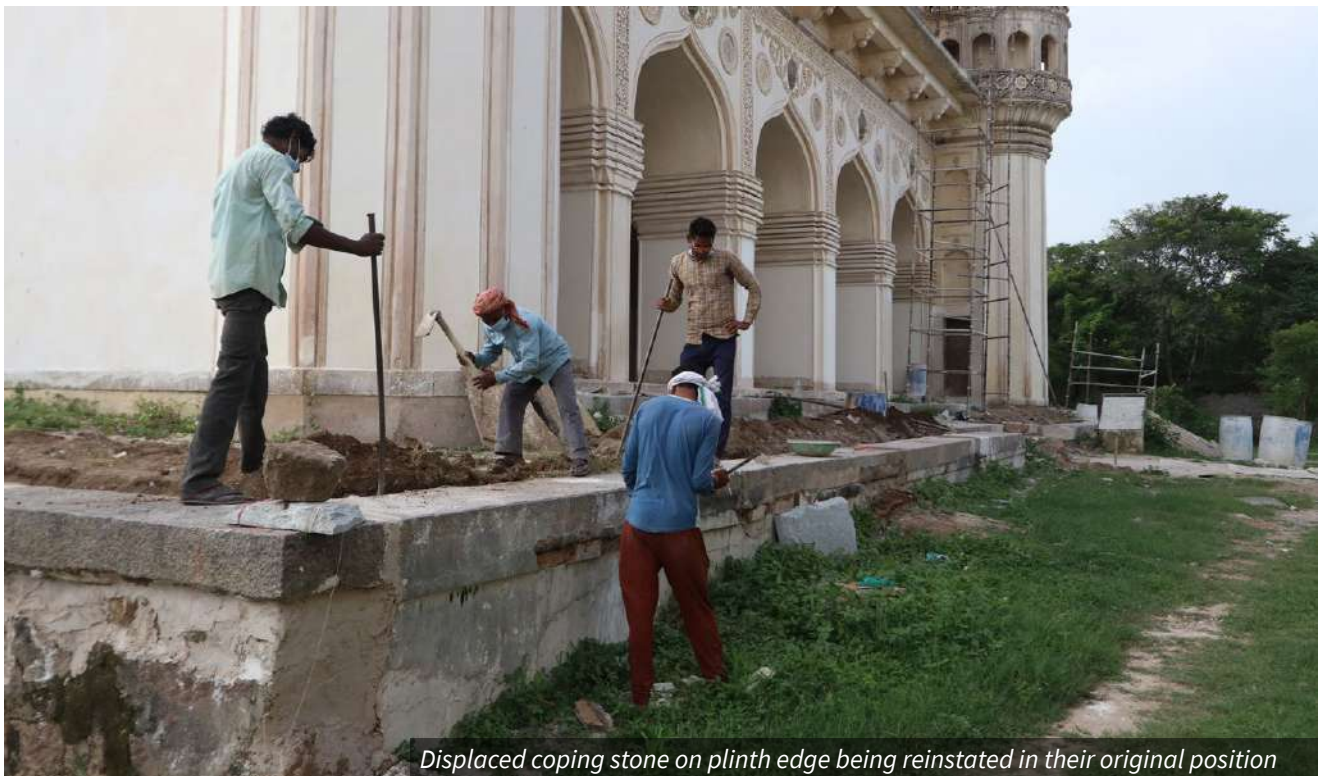
The existing plinth protection abutting the mausoleum before conservation works was covered with 20th century cement concrete and the edging stone lining the plinth was displaced from its original position.

Displaced coping stone on plinth edge being reinstated in their original position

- Existing stones lining the plinth wall on four sides have been realigned as per the original levels. The edging was reset with outward directed slopes and damaged pieces were replaced coupled with reconstruction of base masonry wall in rich lime mortar.
- Plinth protection around the perimeter of projected plinth has been completed.
- Base lime concrete was laid on the projected plinth on all four sides. 30 mm thick slabs of granite will be installed on the projected plinth.
- Installation of over 4000 sq feet of 30 mm thick granite stone slabs has been carried out in approved layout and appropriate slope to channel rainwater away from the structure and withstand the visitor footfall in future.
