QUTB SHAHI HERITAGE PARK

CONSERVATION & LANDSCAPE RESTORATION

ANNUAL REPORT –2020

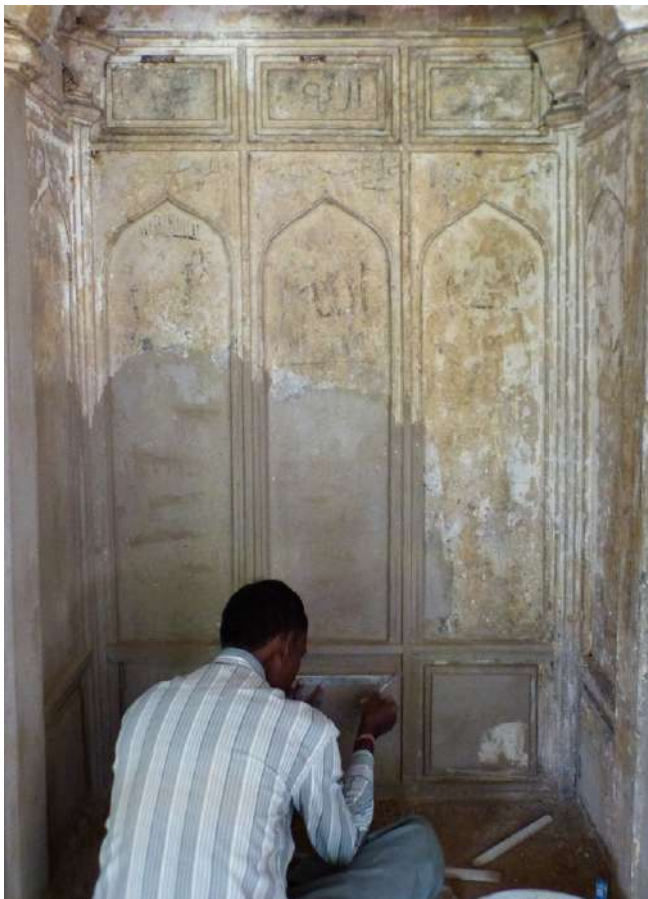
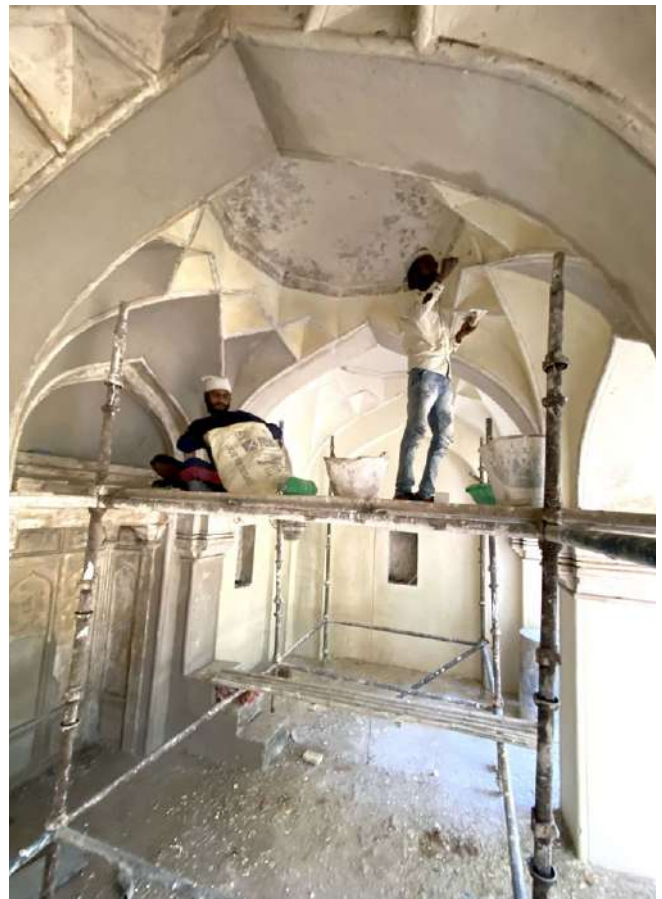
The internal wall and shallow domed ceiling surfaces was found covered with dilapidated lime plaster and 20th-century cement. The external wall surfaces were found covered with dilapidated lime plaster and 20th-century cement.

Craftsmen carried out repairs on the internal surface using traditional lime plaster after removal of inappropriate 20th century cement

- Cement plaster was removed from the internal wall and ceiling surfaces and repaired with traditional lime mortar and finished with lime putty.
- Damaged mouldings and ornamental bands were restored inside the mosque and finished with lime putty mixed with organic additives.
- Dismantling of deteriorated 20th century cement plaster was carried out followed by repairs in traditional rich lime mortar.
- Part of the external southern façade had exposed masonry and lime plaster on the other sides were damaged, therefore dismantling of the damaged plaster along with re-plastering in traditional lime mortar was carried out.
- Finishing of repairs was carried out using a thin layer of matured lime putty mixed with organic additives.

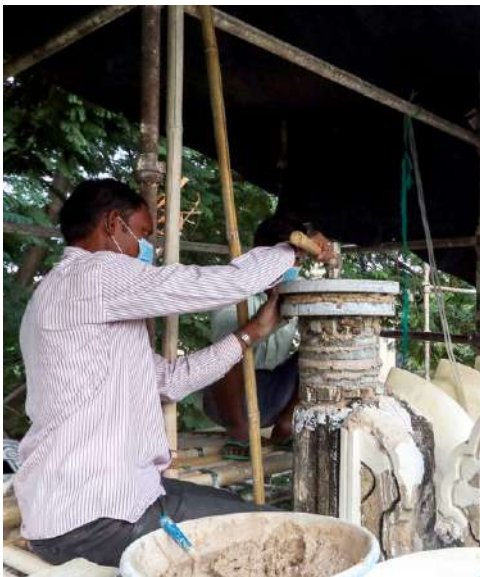
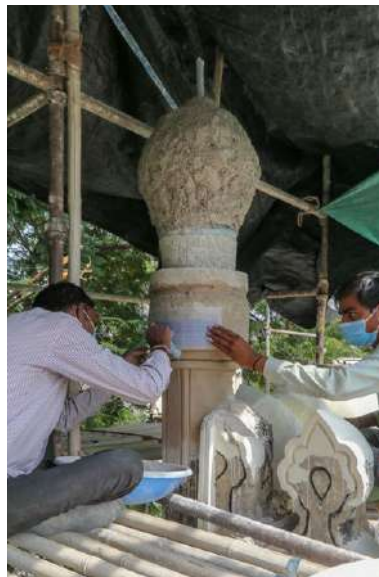
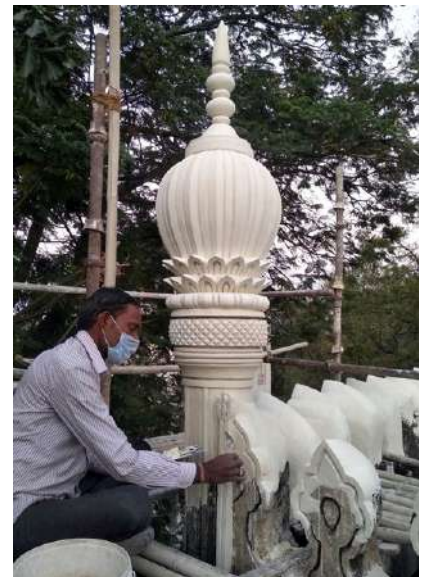
All minarets on the parapet minaret showed signs of deterioration due to usage of cement in later carried out repairs. The plaster on the battlements was flaking and in some portion's battlements were found missing. Finials on intermediate minarets on the parapet were damaged and north-west corner minaret was found missing.

Reconstruction of missing minaret on north-west corner was completed based on the existing evidence. Rubble masonry and lime mortar was used to reconstruct the minaret, and finished with a layer of lime putty mixed with organic additives

- Restoration of ribs on the bulb of the minaret located at the parapet level coupled with repairs of other ornamental details was undertaken by master craftsmen.
- Corner minarets at the parapet level had evidence of an existing finial. Therefore matching finials casted in lime mortar by master craftsmen was installed on all four minarets.
- Missing minaret on the north-west corner was reconstructed matching the existing evidence using rubble masonry and lime mortar and finished with lime putty mixed with organic additives.
- Ornamental battlements were found in damaged condition and repairs were carried out using traditional mortar and finished with a 1 mm thin layer of lime putty mixed with organic additives.
- Damaged ornamental stucco on intermediate minaret shafts was carried out traditional craftsmen.

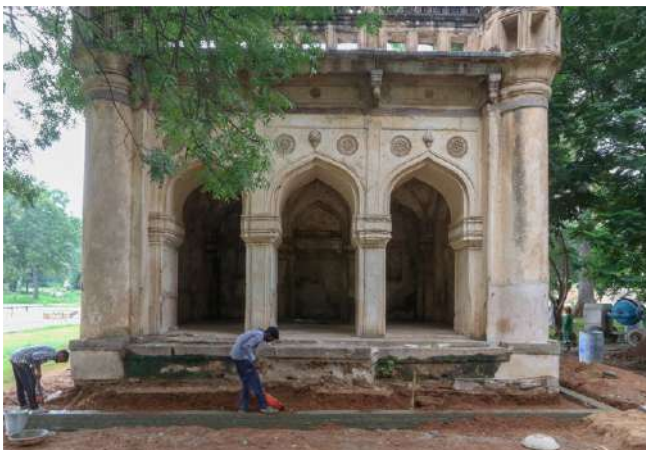
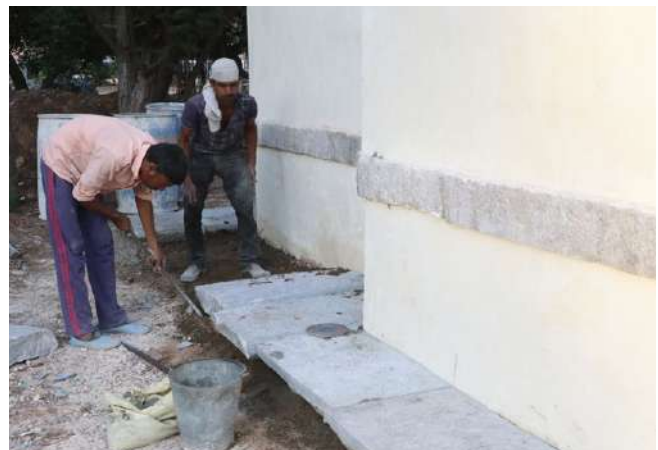
Stone craftsmen installed a plinth protection around the funerary mosque

- The mosque had a later added extended plinth in cement concrete and rough stone which was demolished.
- A 4-inch-thick granite stone flooring of approved layout and appropriate slope was installed on the plinth protection around the monument.
- Thick edging stone in granite was installed around the edge of recently installed plinth protection.

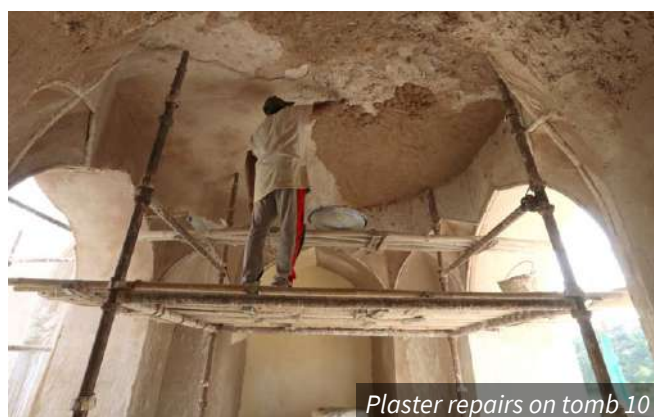
Plaster repairs on tomb 10

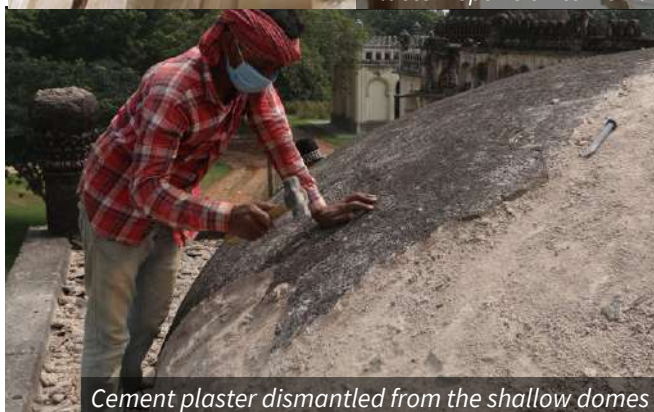
Cement plaster dismantled from the shallow domes

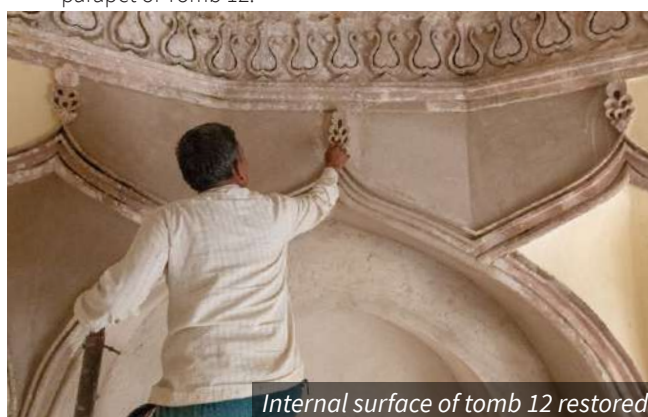
Internal surface of tomb 12 restored

- Dismantling of cement plaster layer on wall surfaces inside Tomb 12 was followed by plaster repairs using rich lime mortar and finishing with lime putty mixed with organic additives.

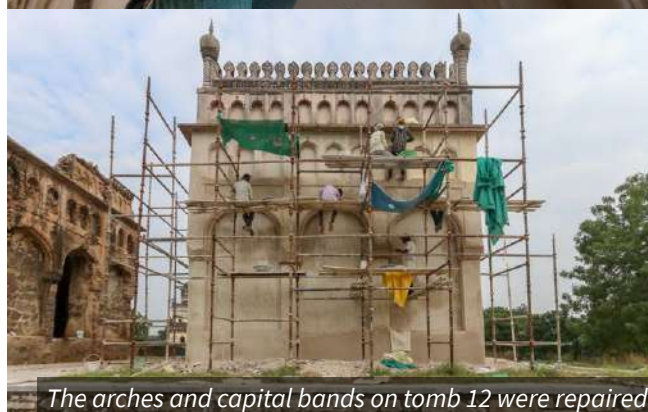
The arches and capital bands on tomb 12 were repaired

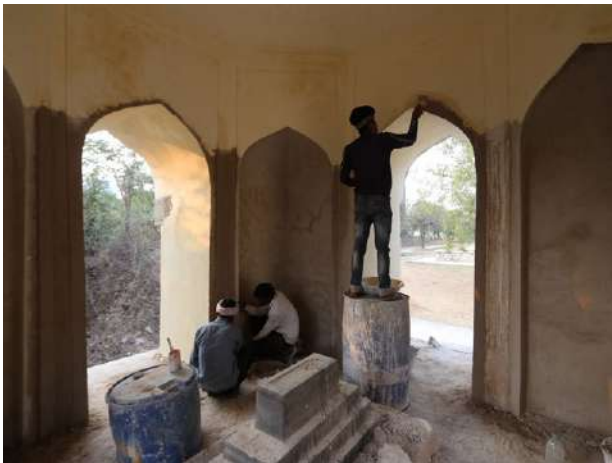
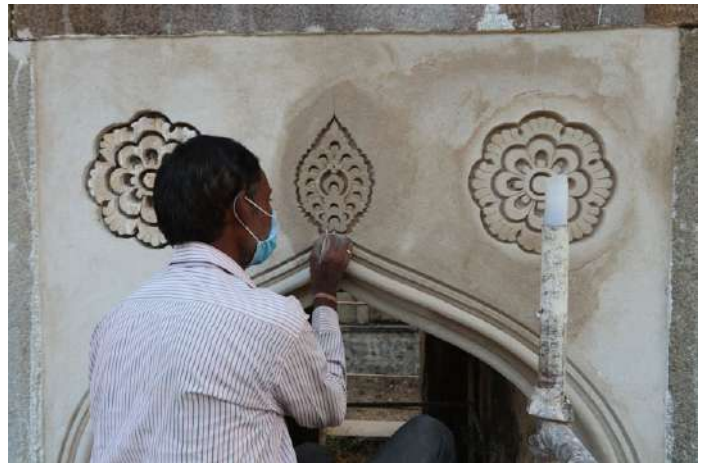
(Left) Plaster repairs were carried out at the internal surface of the tomb; (Right) Missing details on the facade were restored based on in-situ evidence

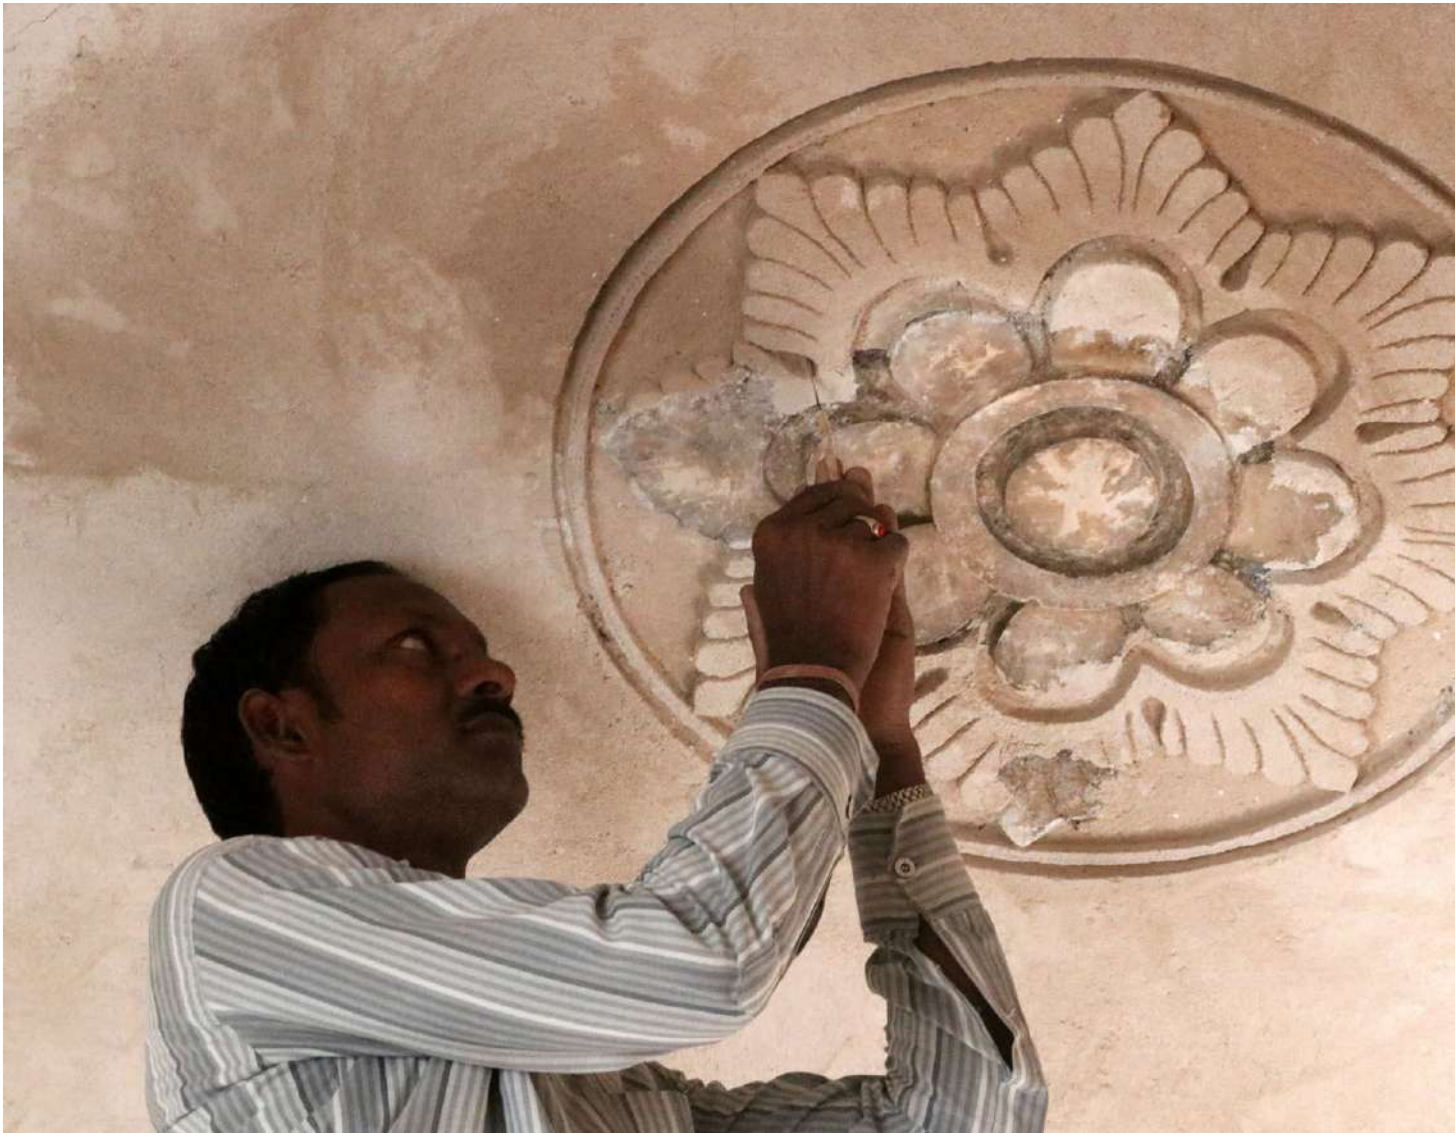
Mastercraftsmen reinstating ornamental stucco ceiling medallion at a tomb using rich lime mortar. A true size stencil was made based on the existing evidence, and the design was transferred onto lime plaster for restoration of damaged portions

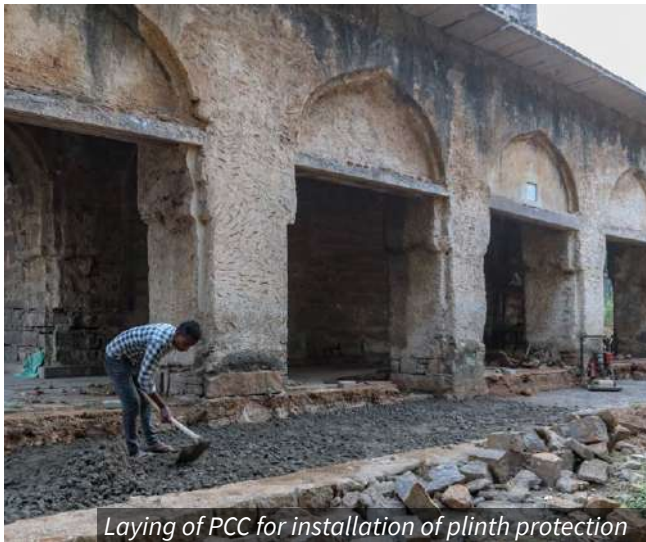
Laying of PCC for installation of plinth protection

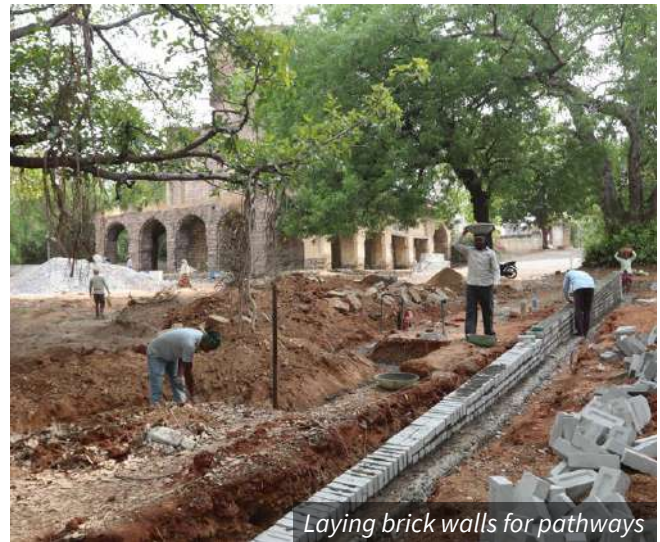
Laying brick walls for pathways

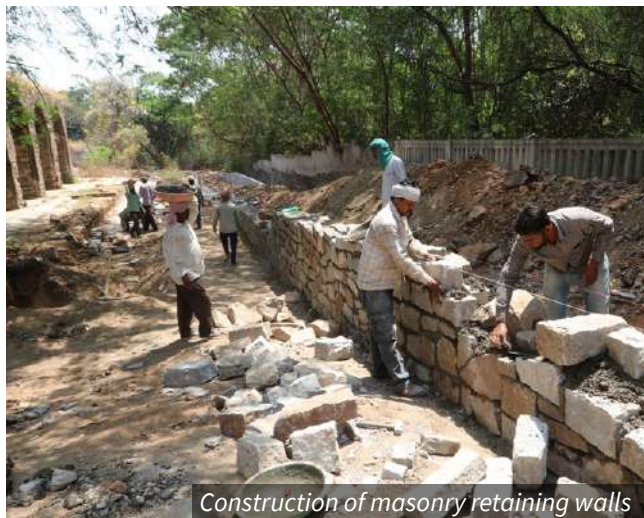
Construction of masonry retaining walls

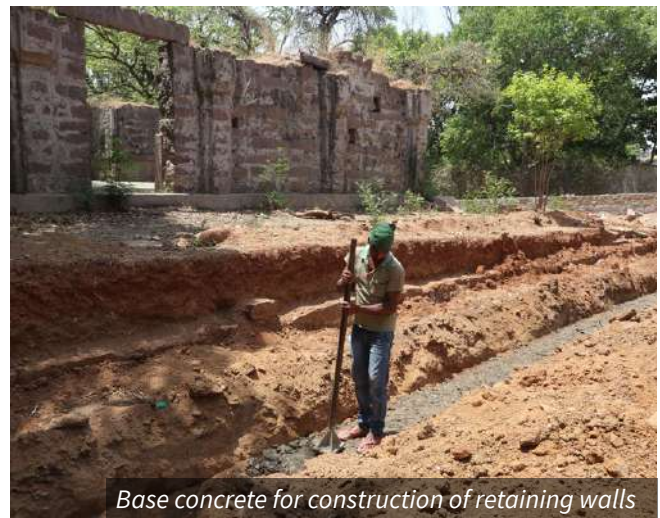
Base concrete for construction of retaining walls

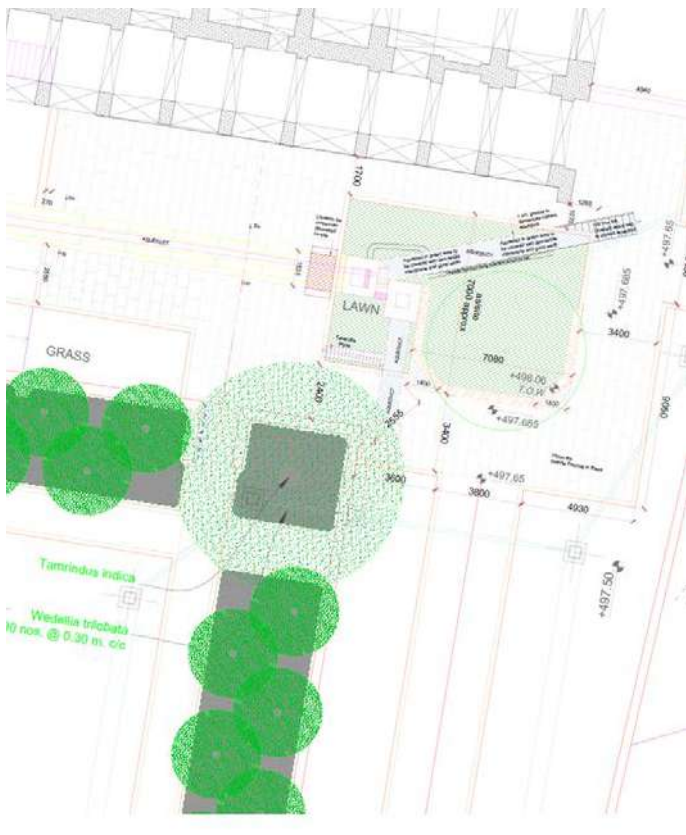
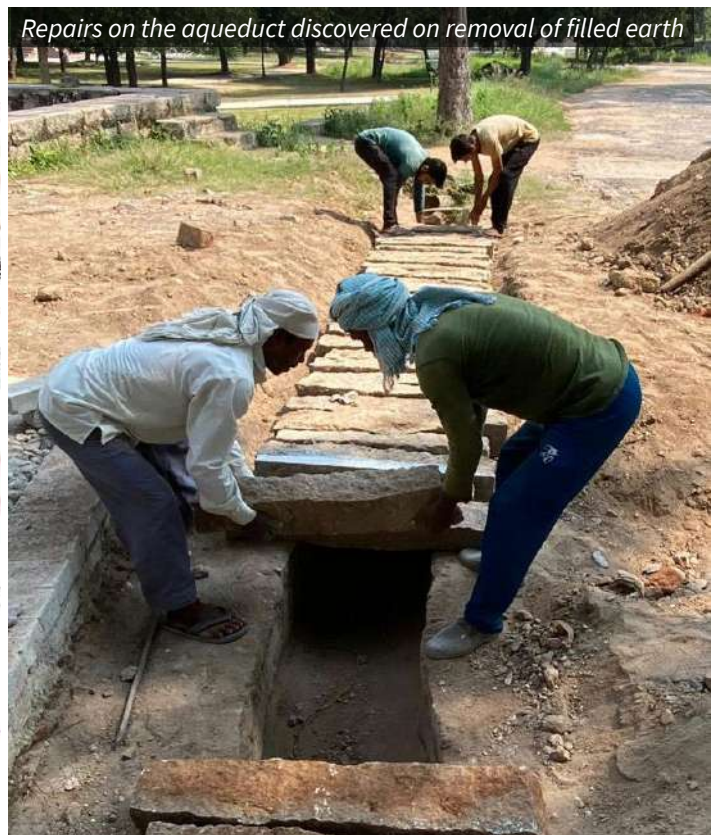
6.4 meters wide plinth protection was finished with 100 mm thick natural rough granite stones with the grading towards the aqueduct. Care was taken that the historic water channel running at the south of Hamam is not affected and is being covered with granite stone slabs

- The aqueduct running along the southern façade of Hamam and the Serai was covered with 100 mm thick- rough granite blocks in portions where the proposed levels of pathway and plinth protection were above the top level of the aqueduct. Portions where the top of the aqueduct was higher than the proposed pathways were exposed for visitor information.

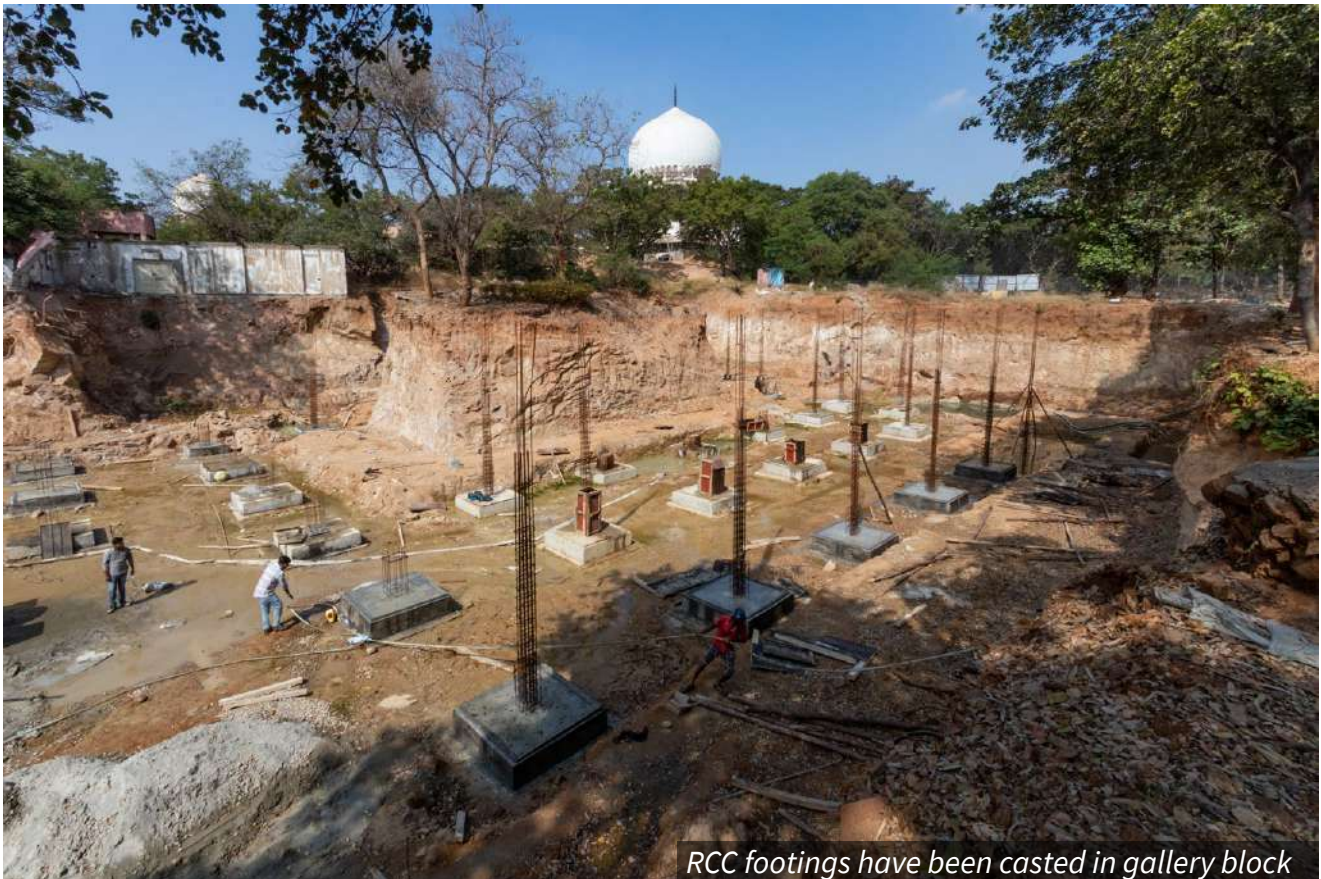
RCC footings have been casted in gallery block

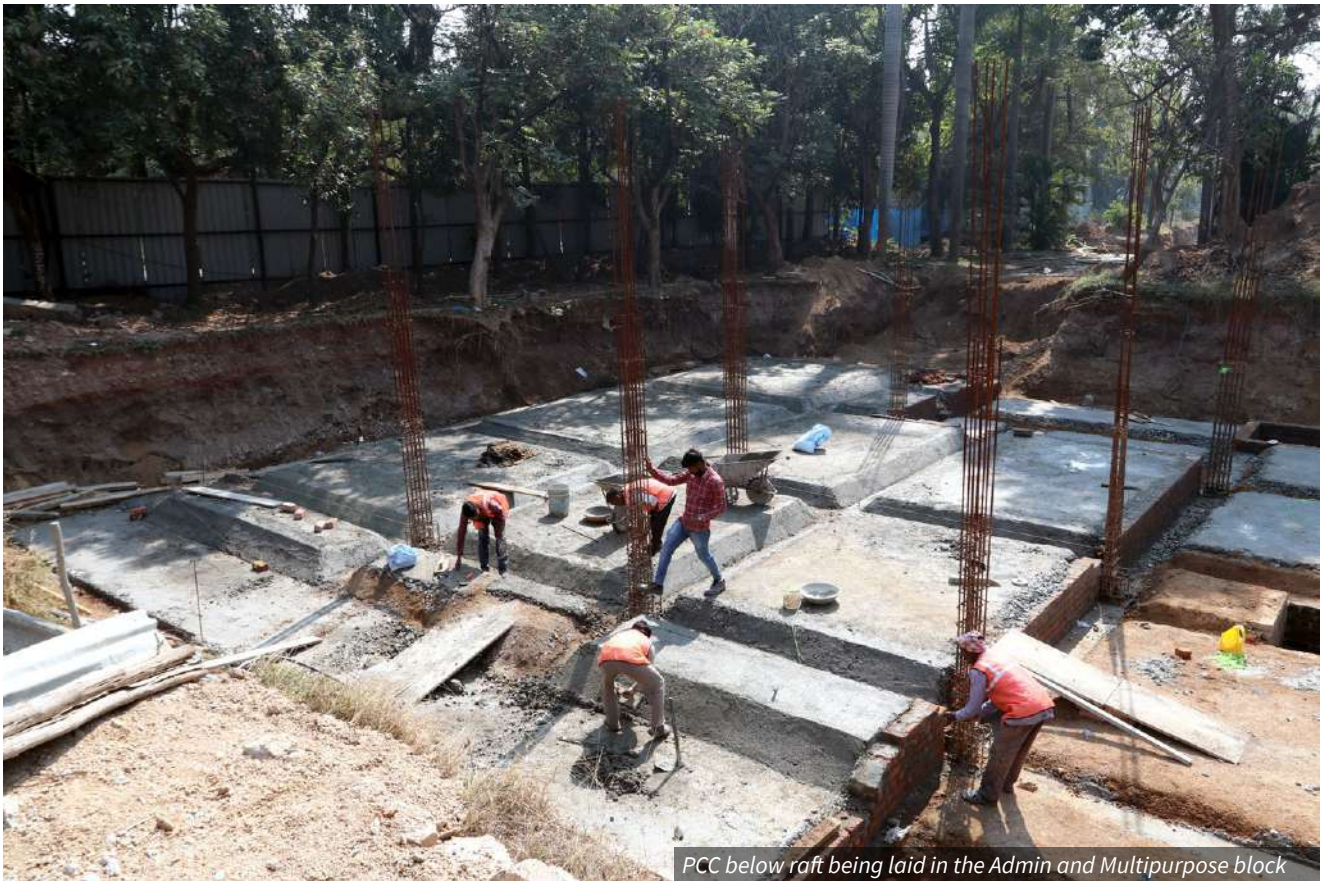
PCC below raft being laid in the Admin and Multipurpose block

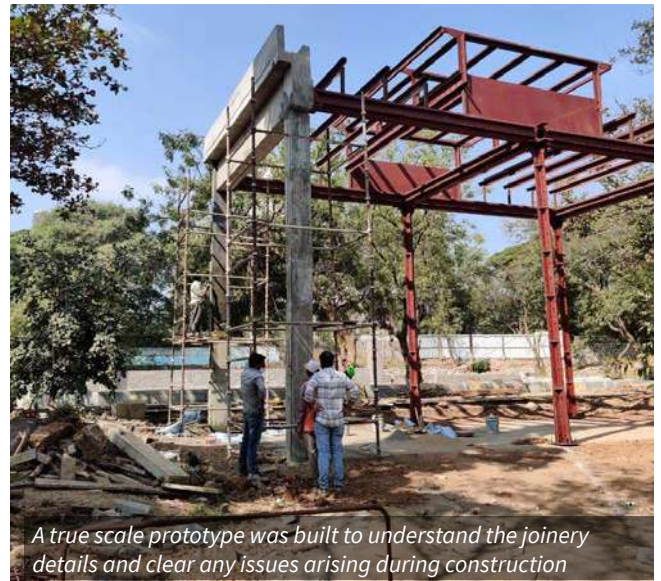
A true scale prototype was built to understand the joinery details and clear any issues arising during construction

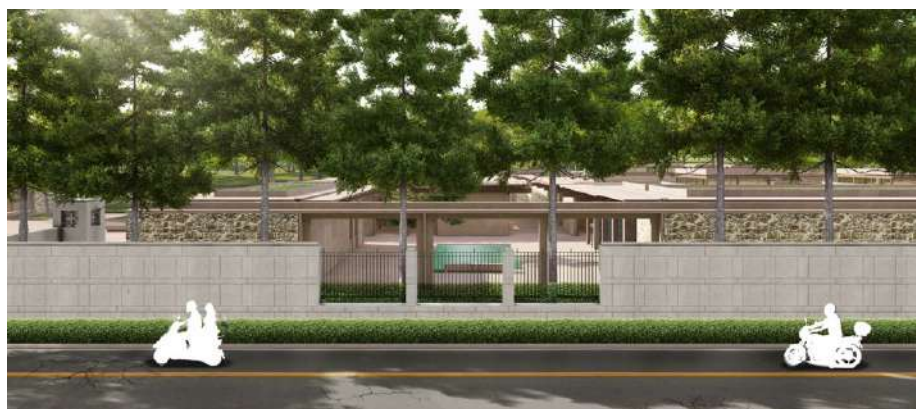
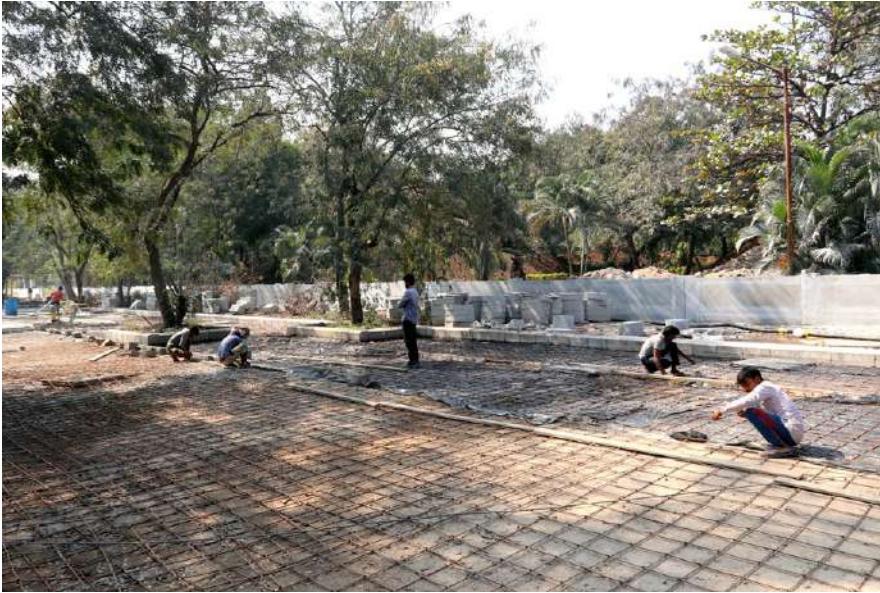
(Left) Tying of Reinforcement mats for the car parking area before laying of final road finish;
(Below) Construction of stone steps and the stage area at the amphitheater

- The final layer of M 30 grade RCC was laid at the parking including the entry, exit and the road leading to service entry.
- All works at the Amphitheater have been completed except for the bounding pathways where the finishing needs to be corrected.
- Finishing Works have commenced for the construction of the front boundary wall which is built using solid granite stone blocks interlocked using stainless steel dowels.

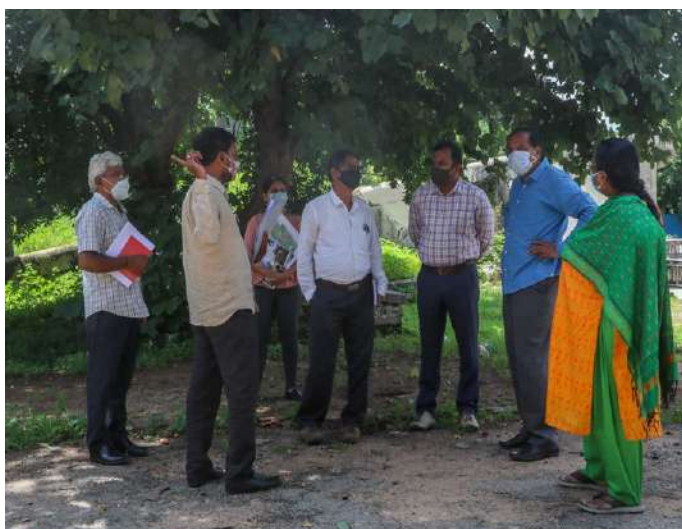
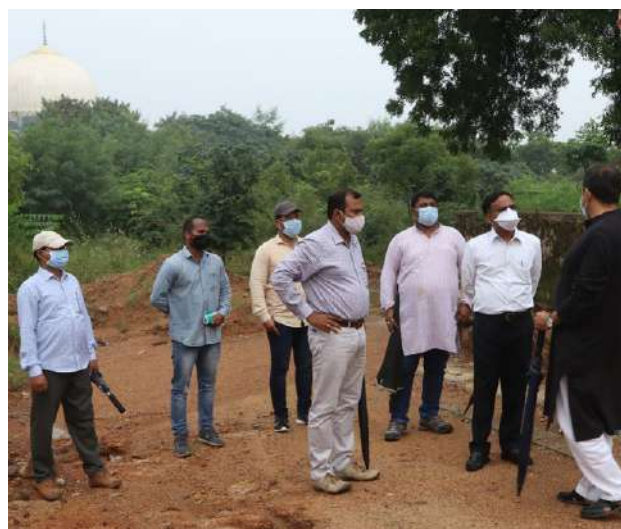
21. Paigah Tombs

- Detailed architectural documentation of the mausoleums followed by condition assessment was carried out by AKTC before commencement of work on-site. Through inspection it was realized that most of the structures are stable in terms of structure, but severe deterioration of built fabric is visible which can soon be aggravated causing major structural damage. Major condition which are the point of concern include extensive water seepage, capillary rise, damaged ornamental lime stucco and broken lattice screen.

- Most unique architectural element on the site are intricate lattice screens casted in terracotta and lime mortar, which are partly damaged or missing. In order to prevent further damage to the lattice screens, a temporary support has been provided.

- Phase I of the project has been commenced with restoration of tomb of Ghansimiyan and Sama Khana located in South-East corner of the site. Conservation works at these monuments aim to restore the missing architectural features and replace inappropriate repairs in cement with traditional materials and techniques, ensuring mitigation of water ingress and prolong the life of the monument.

- Further, proposed works to be undertaken include detailed inspection of the terraces followed by dismantling of 20th century cement terracing along with stitching of structural cracks and laying of lime concrete terracing to appropriate slope, restoration of ornamental stucco and other plaster repairs. Also, completing the remaining conservation works in Sama Khana and Tomb of Ghansimiyan.

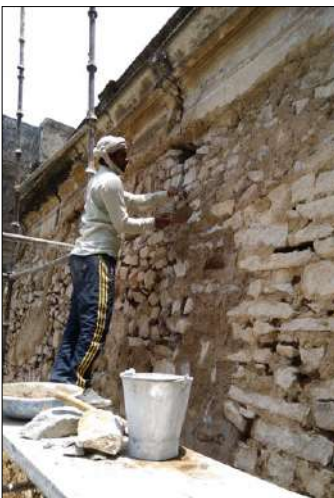
22. Badshahi Ashoorkhana

Badshahi Ashoorkhana is one of the finest buildings of the Qutb Shahi era, its construction was started by Muhammad Quli Qutb Shah in 1592-93 AD and completed in 1596-97 AD and was further embellished by Abdullah Qutb Shah. The original part of the building is the central hall which consisting five blind arches, this portion was built by Muhammad Quli Qutb Shah whereas the extension of the halls and embellishment of the blind arches with tiles in geometric pattern was carried out during Abdullah's Reign. The tile-work consists of highly refined geometric, floral and arabesque designs in a varied colour palette consisting of blue, white, yellow, green and terracotta

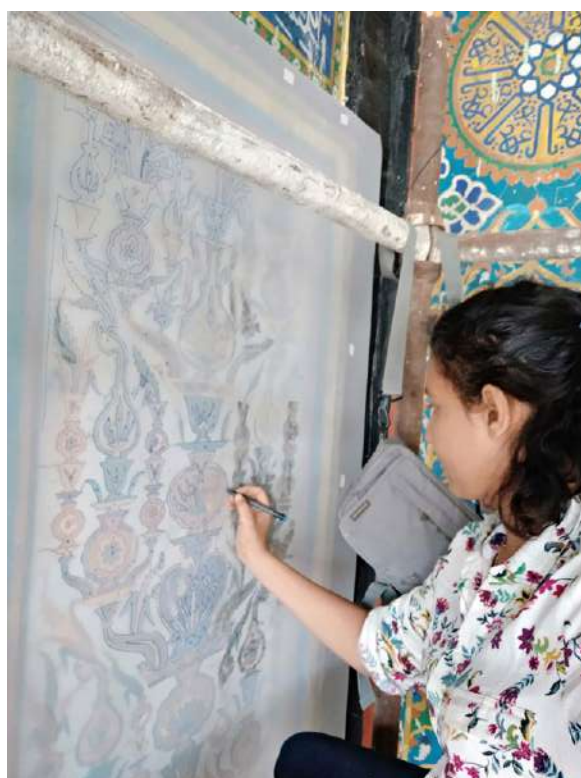
- Persian tiles ornamenting the five blind arches is the most intrinsic architectural element of the complex and was majorly damaged during the floods in 1908. After the floods, synthetic paints were used to fill colours in the missing portions due lack of funds and technical know-how. This addition has defaced the integrity of the original design and needs to be reversed. An extensive exercise of documenting each tile manually along with its condition has been carried out over the period of one year. Thermal imaging cameras have been used to highlight the areas beneath tiles with excessive water seepage in a rainbow-coloured palette. This documentation has been further digitised to create a reference database for adopting an appropriate methodology for restoration work.

- Emergency repairs have been carried out on the structure by AKTC upon request of the Department of Heritage Telangana who had been approached by the members of the community to carry out emergency repairs as the roof was leaking and seepage of water from the western wall was damaging the 400-year-old enamelled tiles. The roof and external walls were repaired in 2018 by master craftsmen under the supervision and guidance of conservation architect for mitigating future deterioration.
