QUTB SHAHI HERITAGE PARK

CONSERVATION & LANDSCAPE RESTORATION

ANNUAL REPORT 2021

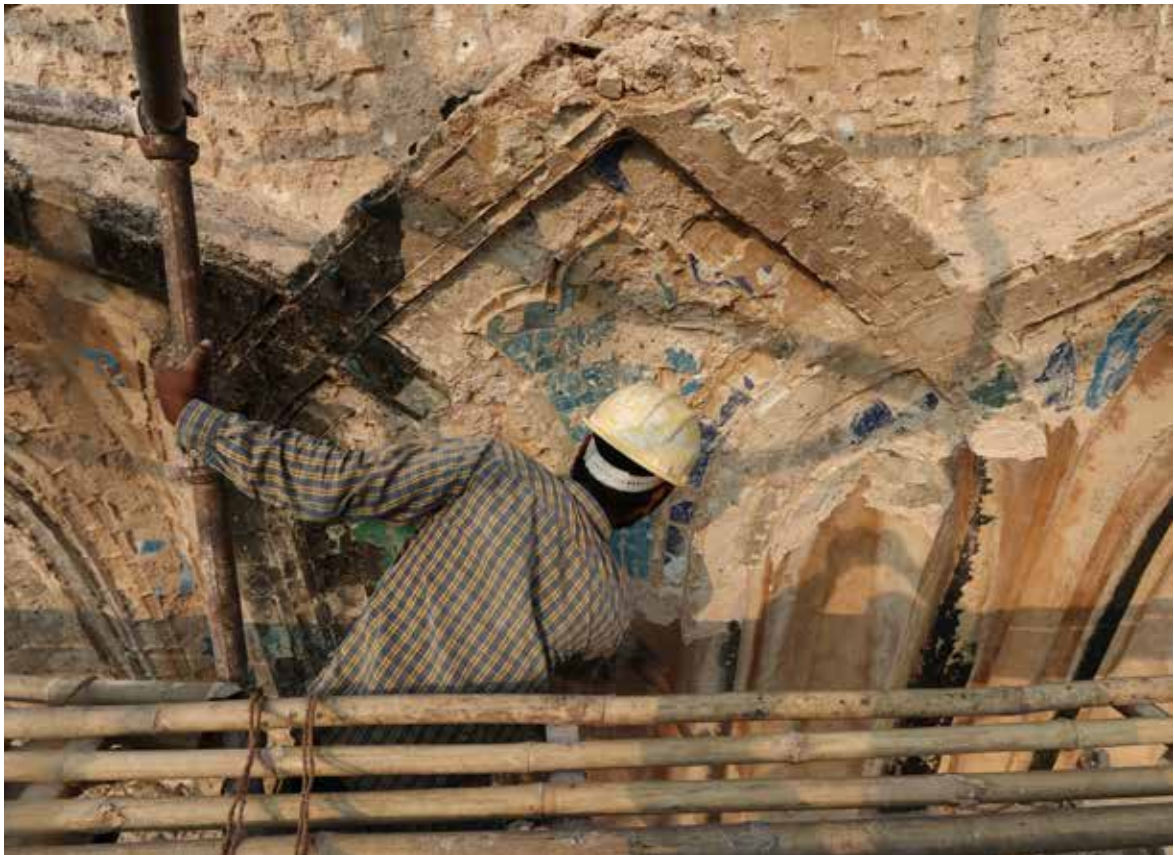
(Above) Portions of glazed tiles revealed on merlons of the dome of the mausoleum of Muhammad Qutb Shah

In removing the 20th century cement plaster from the facade of the lofty mausoleum of Muhammad Qutb Shah, intricate patterns in glazed tiles were discovered. Though tile fragments from the dome were already known, it was unexpected to recover complete patterns on the facade. This important discovery enables a better understanding of how these glorious monuments appeared prior to the 20th century when they were profusely covered with cement plaster and thus accelerated their decay.

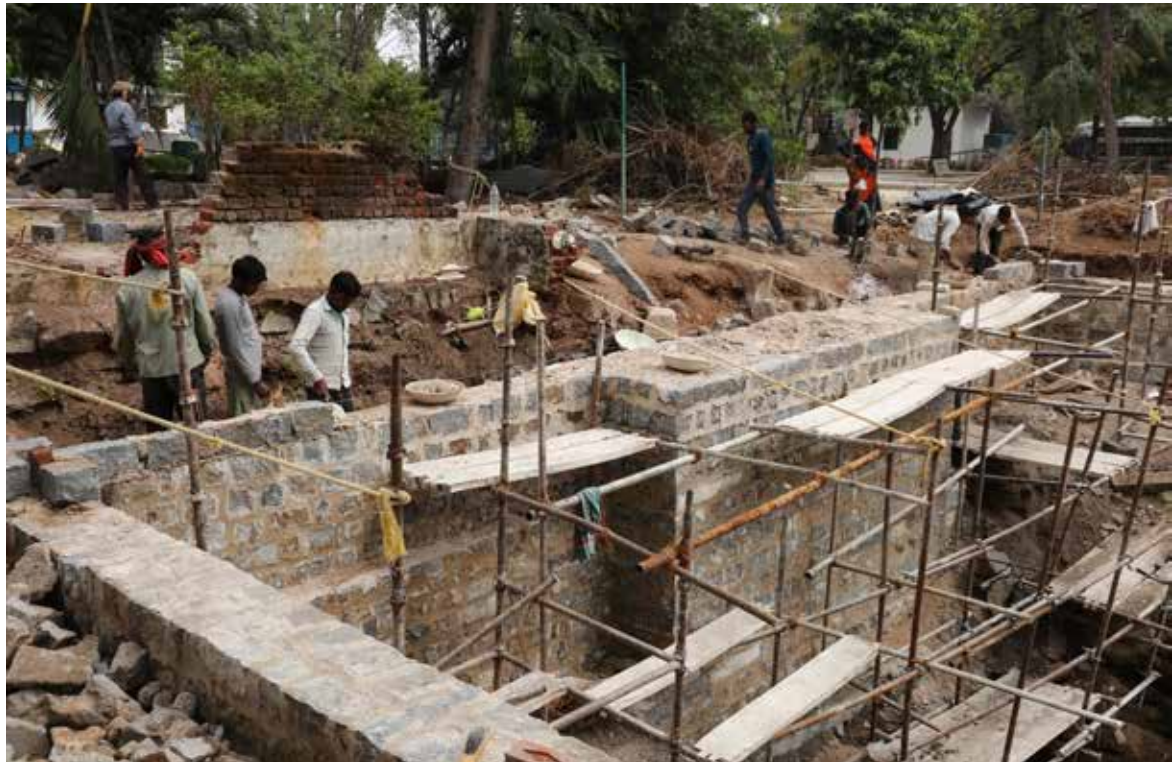
(Below) Walls of the Bagh Baoli were reinstated based on original evidence

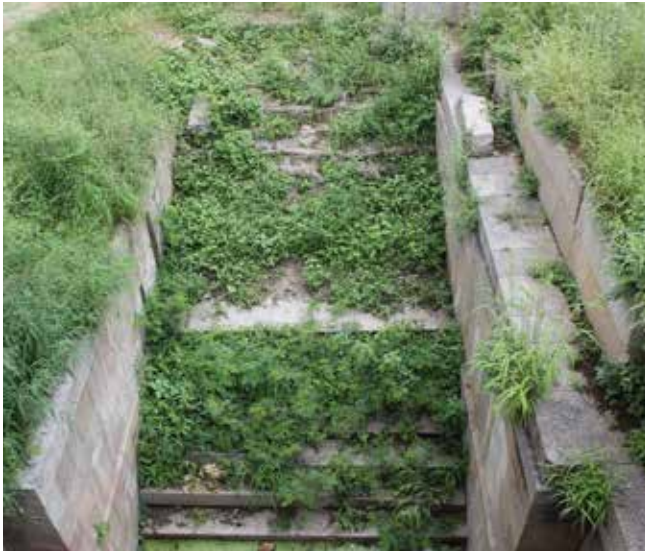
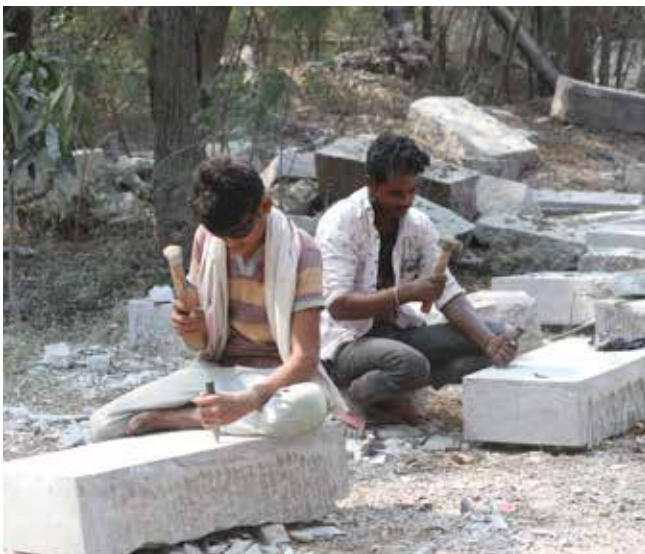
- 12 steps on the southeast corner, through which the baoli is accessed, were found severely damaged. Over 50-meter span of the existing damaged stone was replaced with hand-dressed blocks of granite matching the historic stone. Rough blocks of matching granite stone, each weighing over 400-500 kilograms were cut to size, hand dressed and manually installed by a team of traditionally skilled stonemasons.

Damaged steps leading into the baoli were replaced with hand-dressed blocks of granite matching the historic evidence

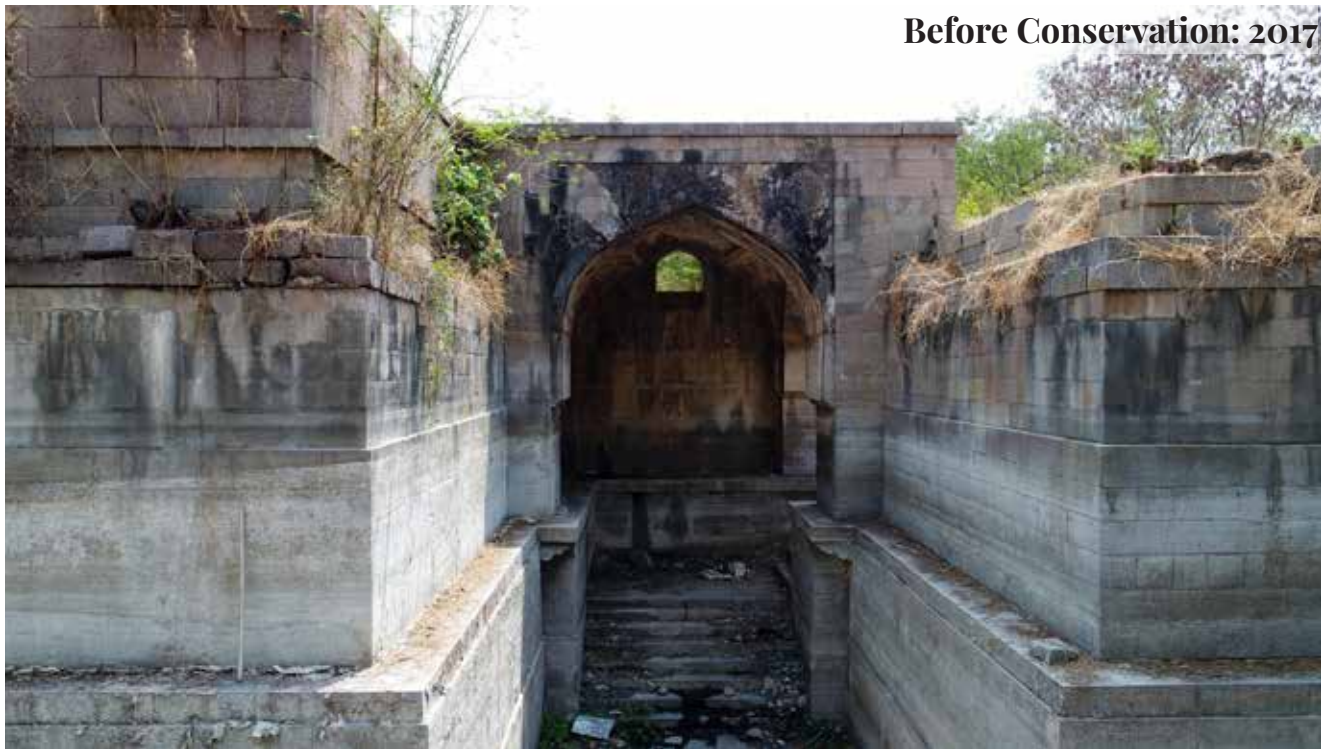
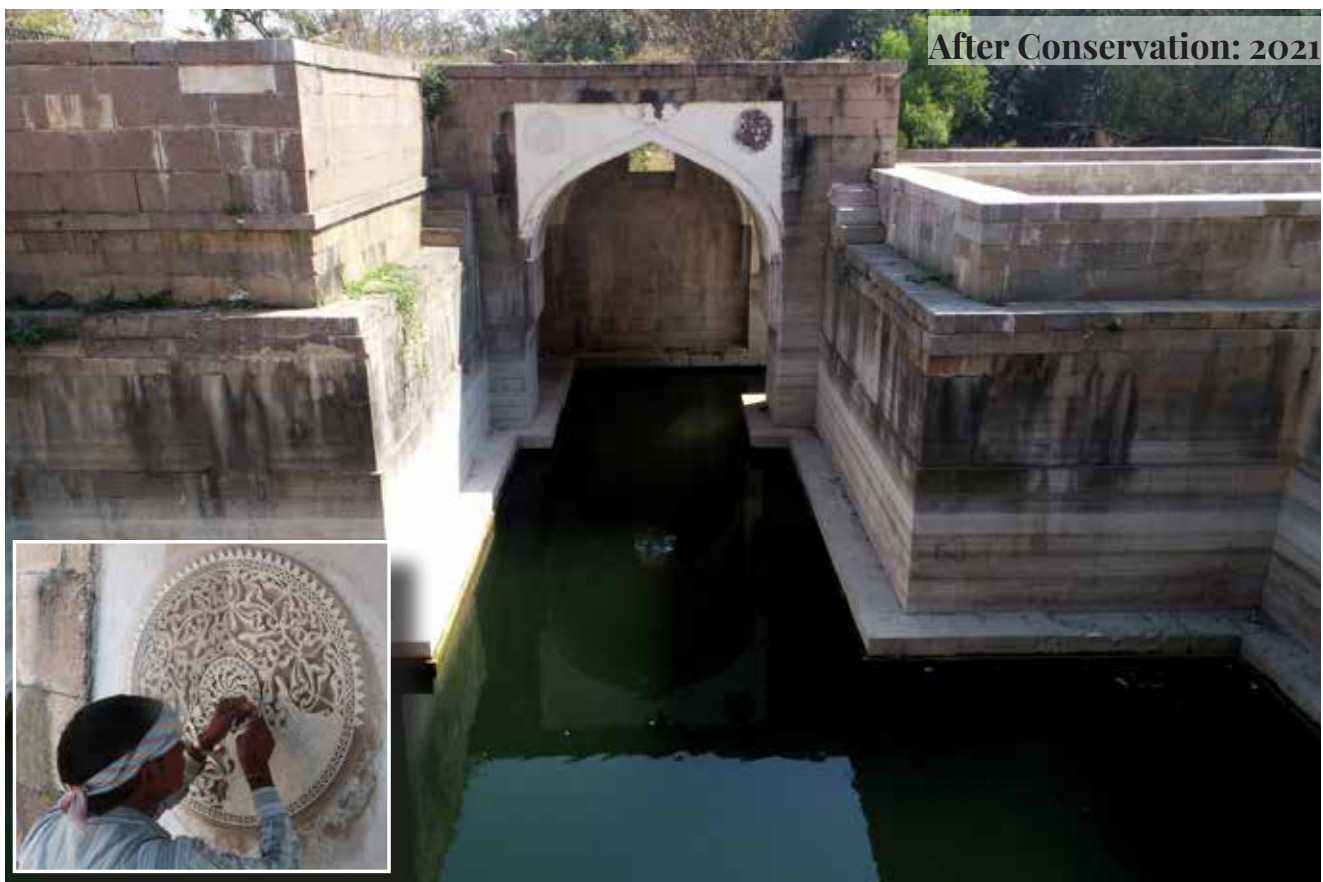
View of the eastern facade of the baoli before and after installation of missing stones, and realignment of displaced stones. The intricate floral medallion was also restored by skilled craftsmen

- Detailed architectural illustrations were made to highlight the missing stones on the steps, vertical walls, and coping ledge. The missing stones were later hand dressed and laid in masonry by stone crafts persons. All the missing stone blocks were measured and matched with the on-site evidence.

- Over 120 large-sized granite stone blocks were hand dressed by a team of 15 stone craftsmen and installed in the missing portions on the south and south-east portions of the baoli.

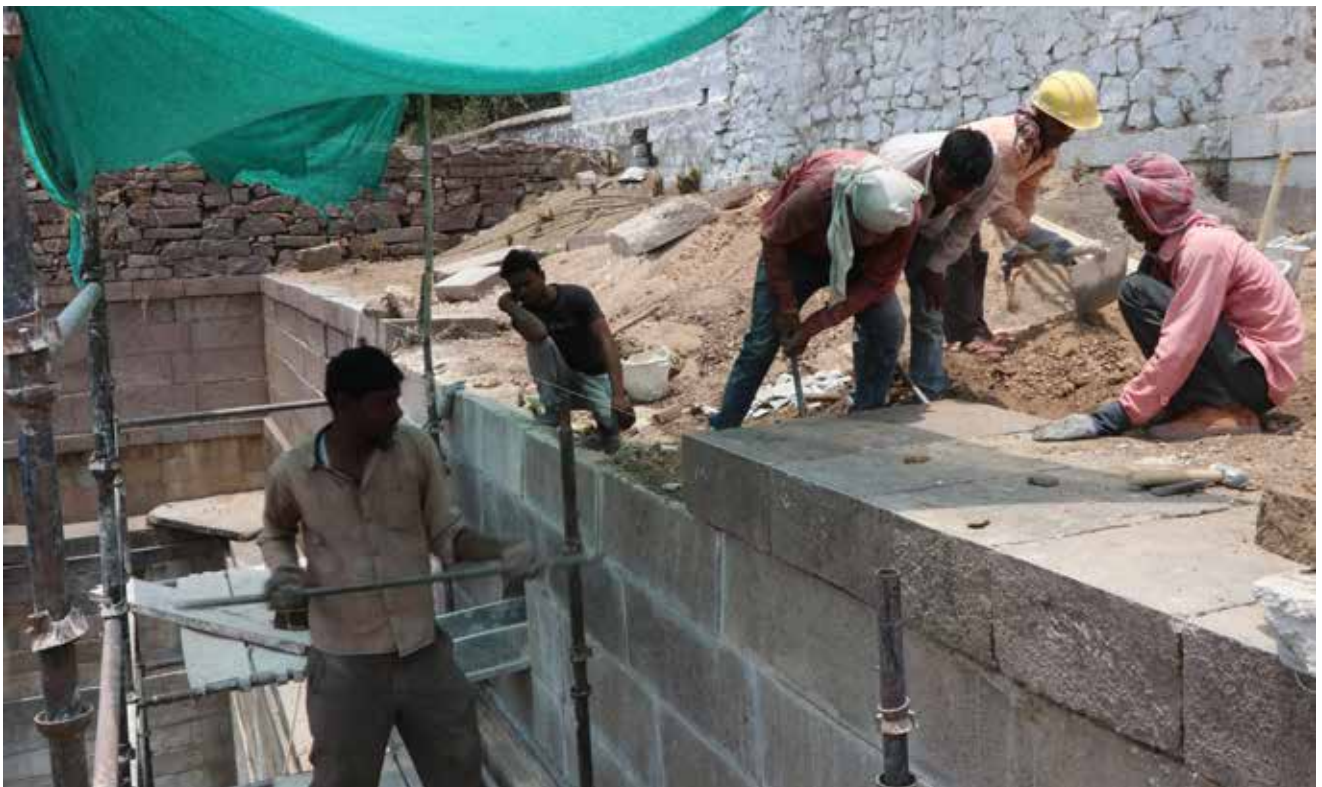
All the displaced dressed stones were reset into place using the existing stones as reference

- Rough blocks of granite were cut to size, hand-dressed, and installed in portions where the original stone was found missing. It was followed by reinstating the existing collapsed stones to their location. An 18-meter length of coping was prepared from rough granite blocks and subsequently reinstated.

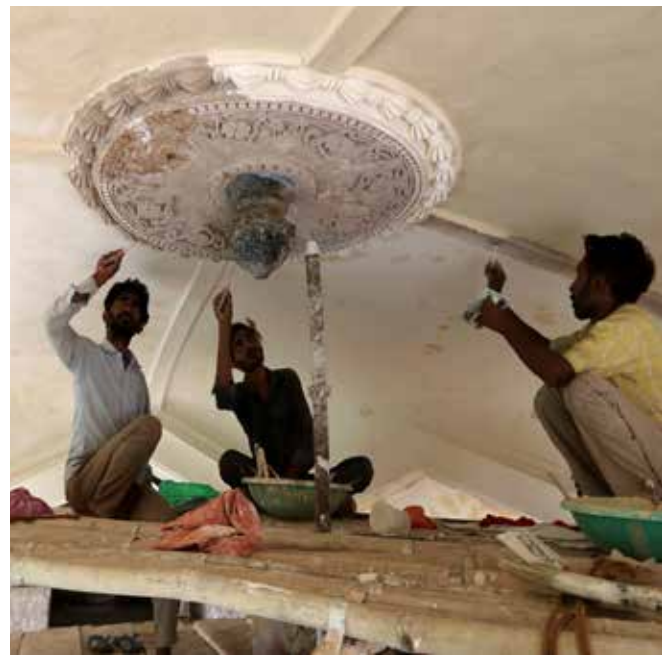
The medallion was restored based on in-situ evidence. A 1:1 scale drawing was prepared to match the existing evidence

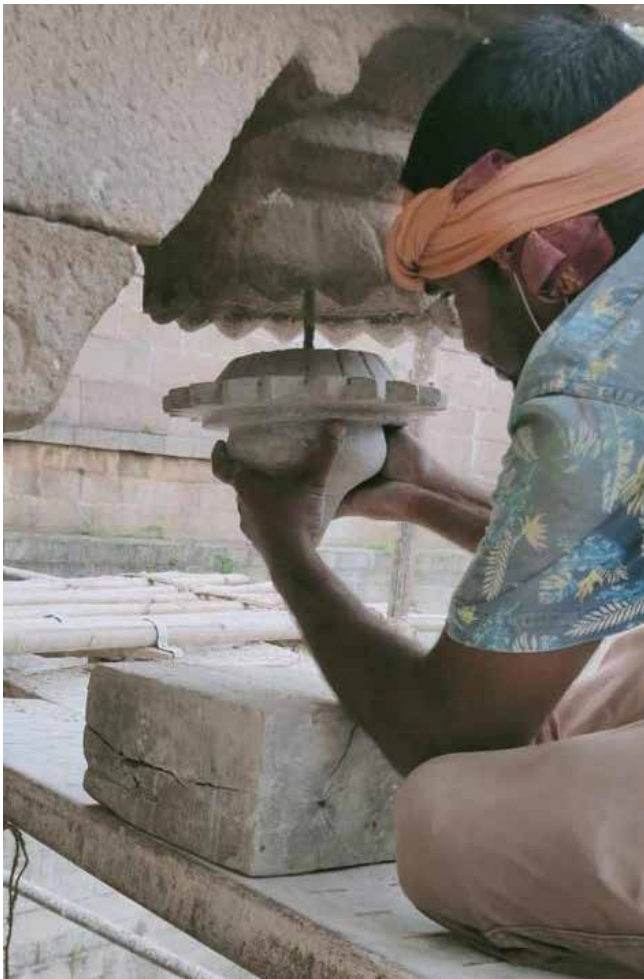
*(Left) Installation of bell-shaped motif based on in-situ evidence;
(Right) Restoration of the masonry of the ramp - missing stones
were reinstated to match the original masonry*

- The profile of the ramp wall above the dressed stone wall is dotted with dressed stones projecting from the wall surface. This is finished with ornate corbellings and bell-shaped motifs – carved out of stones - of which one was missing.
- The existing motif was documented, craved out of a single piece of stone, and reinstated by stone crafts persons.
- Missing portions of the masonry on the ramp above was reinstated with stones of similar shape and sizes.
- Necessary earth filling and removal of vegetation was carried out on the ramp to ensure long term preservation of the structure.

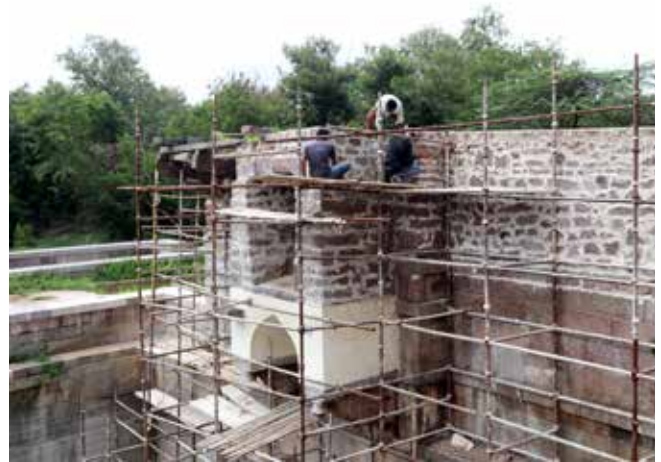
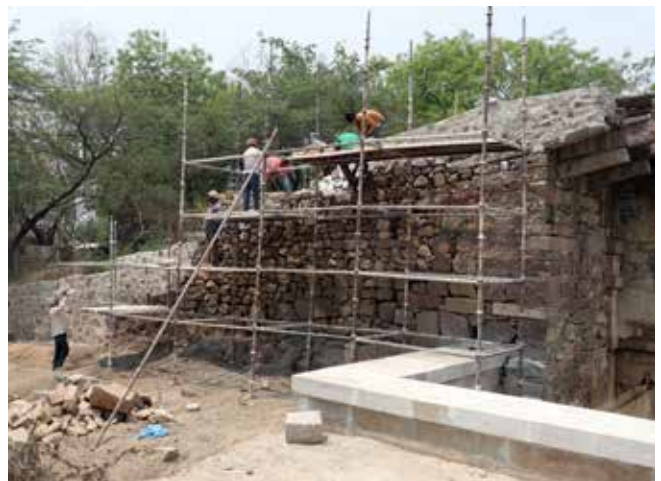
The ramp on the southern edge was severely vegetated, and had missing decorative details. The masonry also suffered from displacement and distortion from its original form.

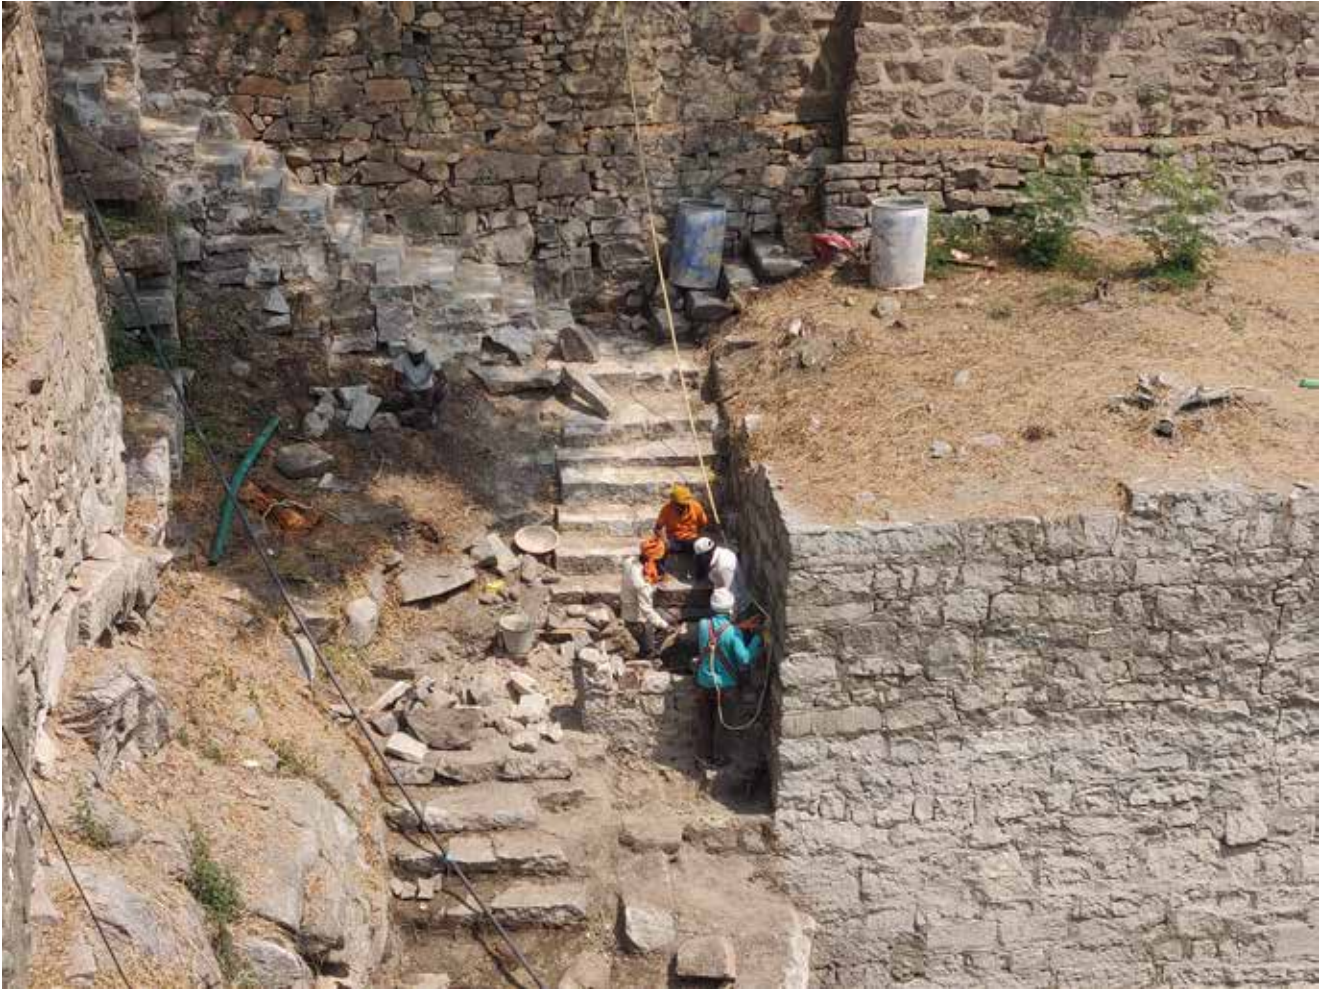
(Above) Installation of missing stone steps

- The height of the existing masonry parapet wall was raised by 2 ft to ensure visitor safety.
- The missing approach steps, to the north, leading to the bottom of step well were installed matching the in-situ evidence.

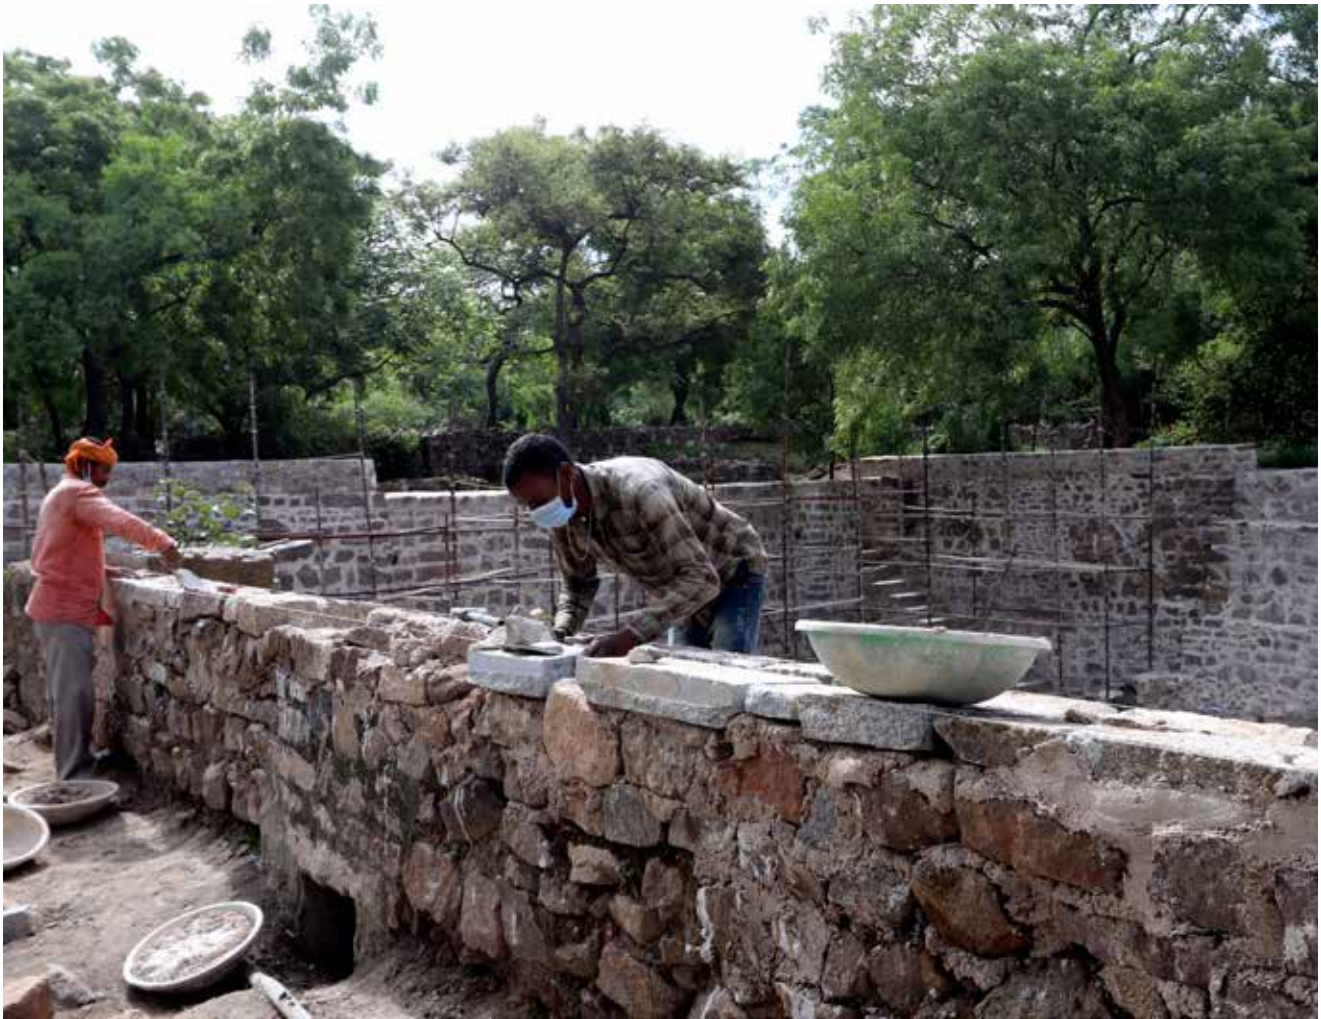
Parapet wall height was raised to ensure visitor safety

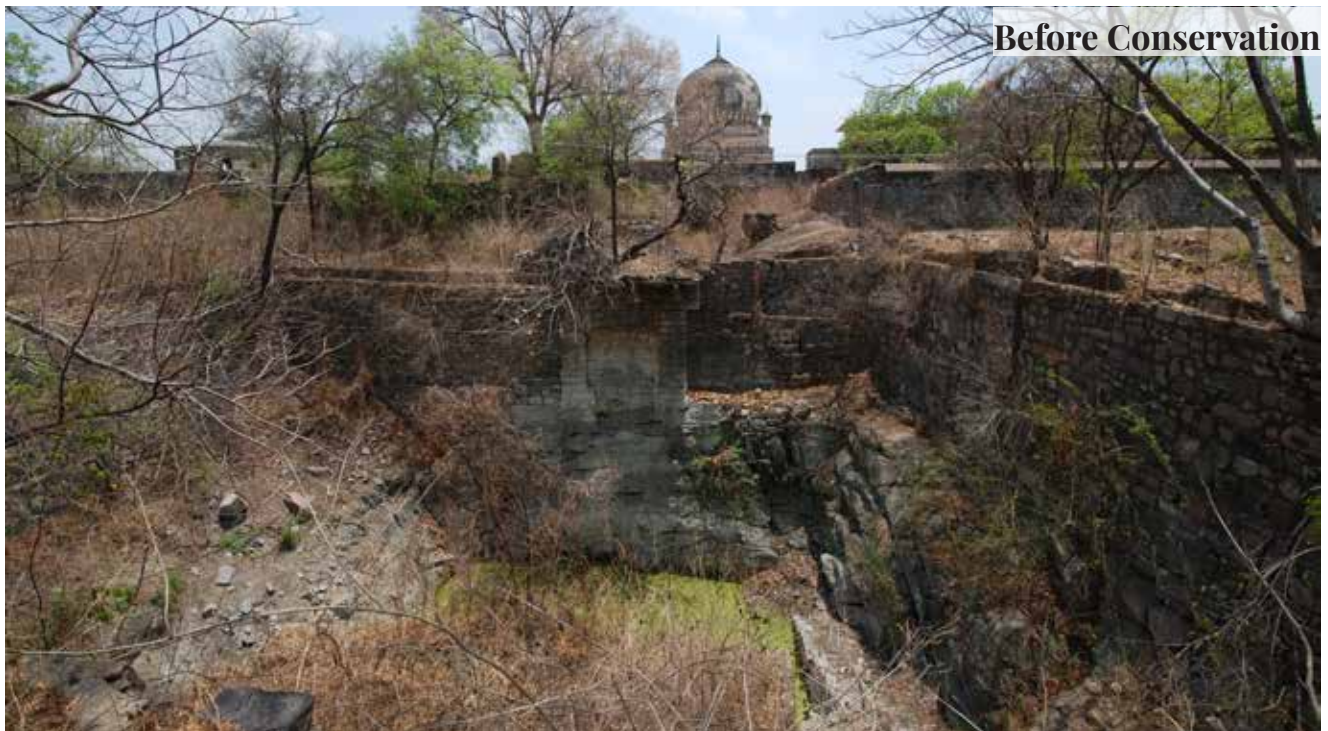
**Before Conservation**

Retaining walls of the baoli had deeply embedded plant roots and damaged masonry in the walls, which had led to structural damages to the baoli.

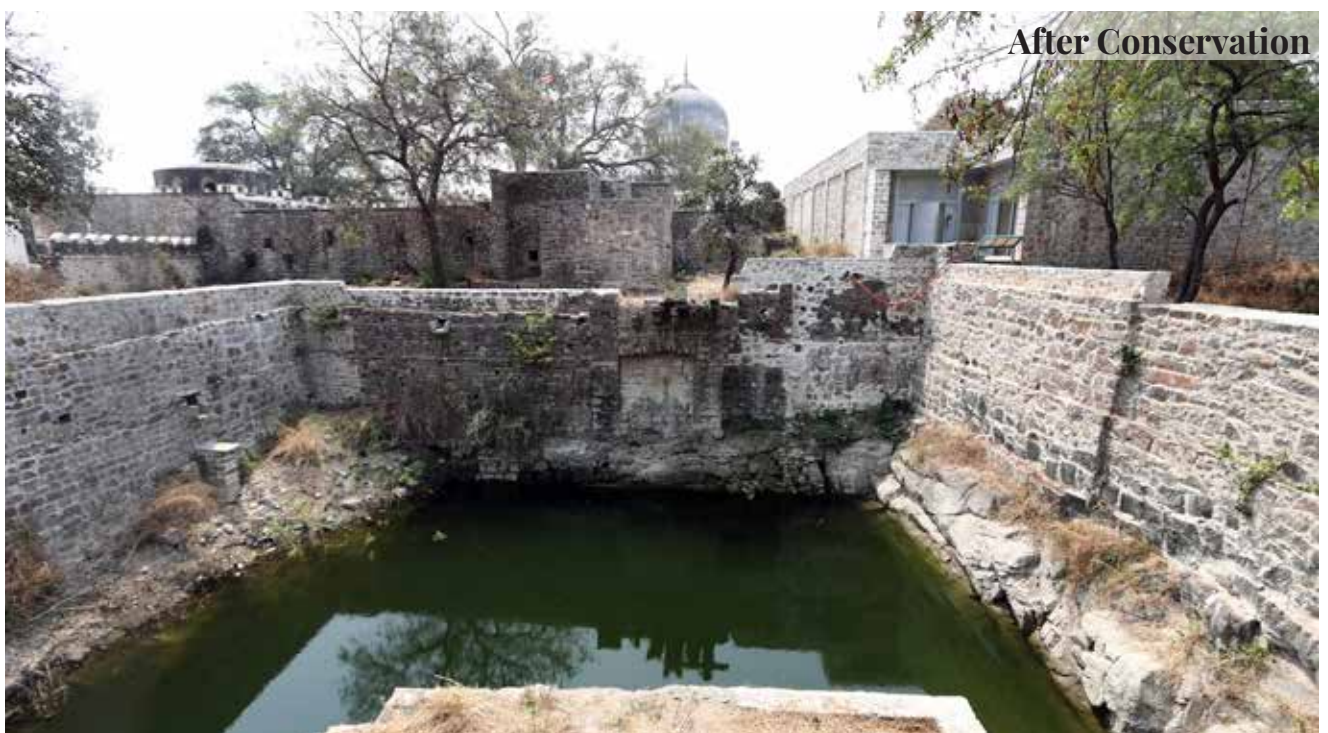
**After Conservation**

Restoration of the granite steps, underpinning and re-pointing of historic walls has reinstated the historic formal appearance of the grand step well as envisaged by the original builders. Removal of silt and debris from the well along with clearance of vegetation in its immediate setting has helped increase the carrying capacity of the well, now containing over 4.7 million litres of water.

- De-silting was carried out which resulted in removal of over 225 cubic meters of sludge and debris from the bottom of the step well.
- The existing structural and minor cracks in the masonry were stitched using traditional lime mortar.

- The retaining walls in stone masonry were re-pointed using rich traditional lime mortar for further strengthening and mitigate plant growth on the internal surfaces of the 16th-17th century stepwell.

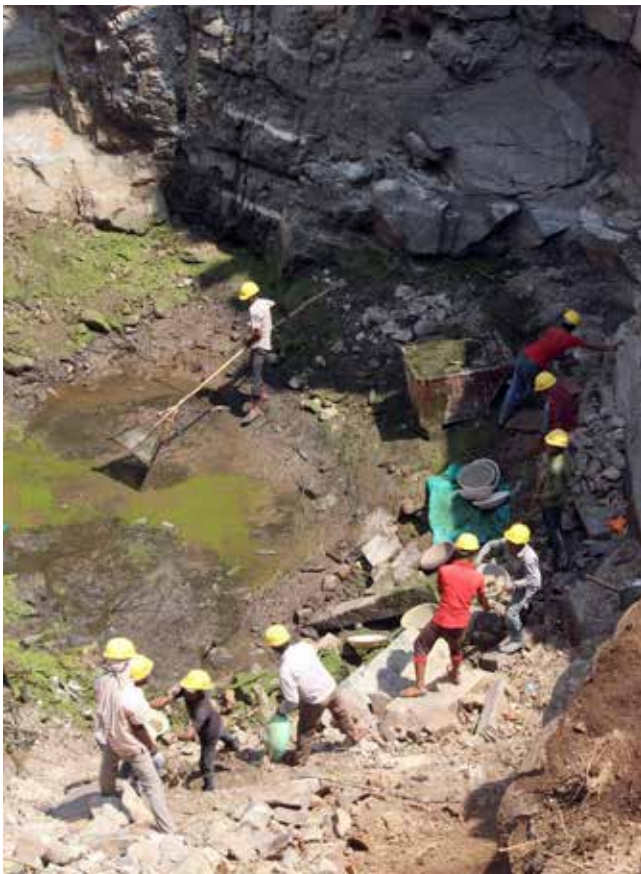
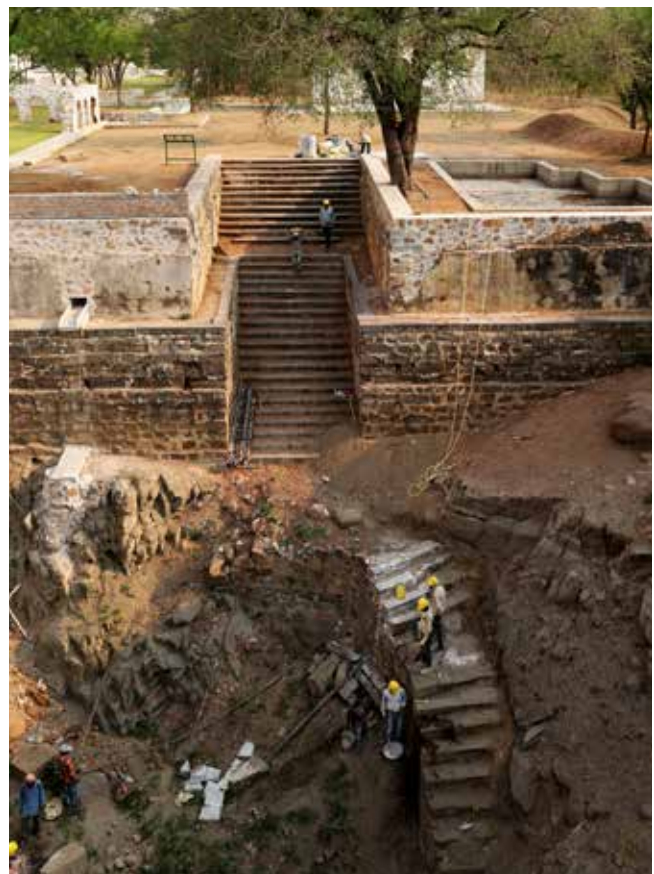
(Left) Removal of sludge and debris accumulated inside the baoli over the years; (Right) Reconstruction of missing steps based on original evidence

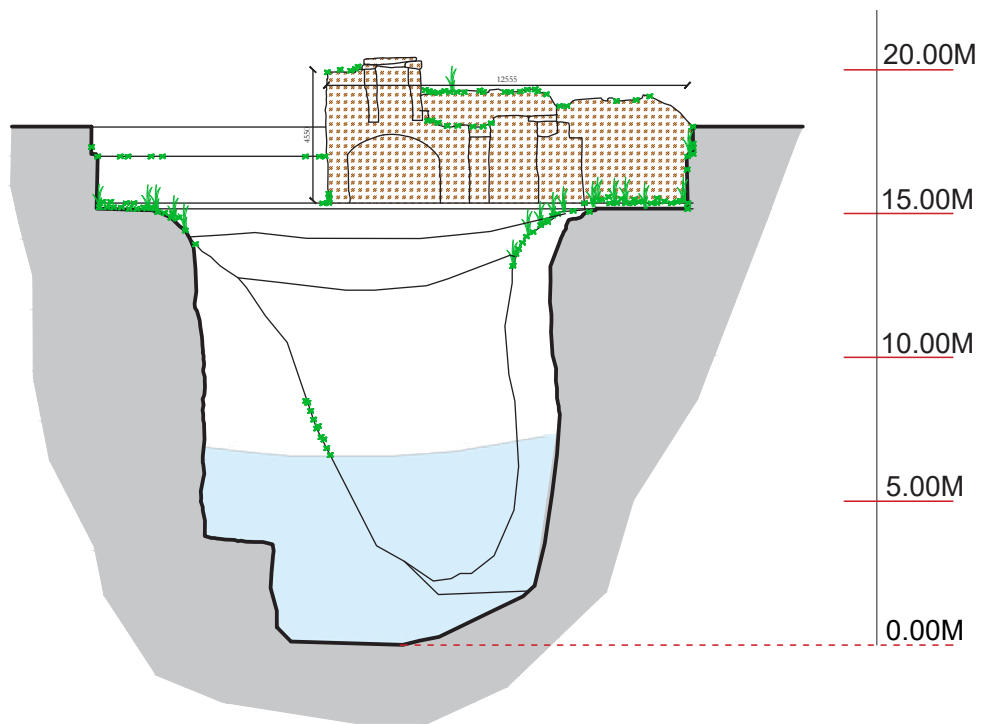
(Above) Sectional elevation, and
(Below) Plan of the Western Baoli

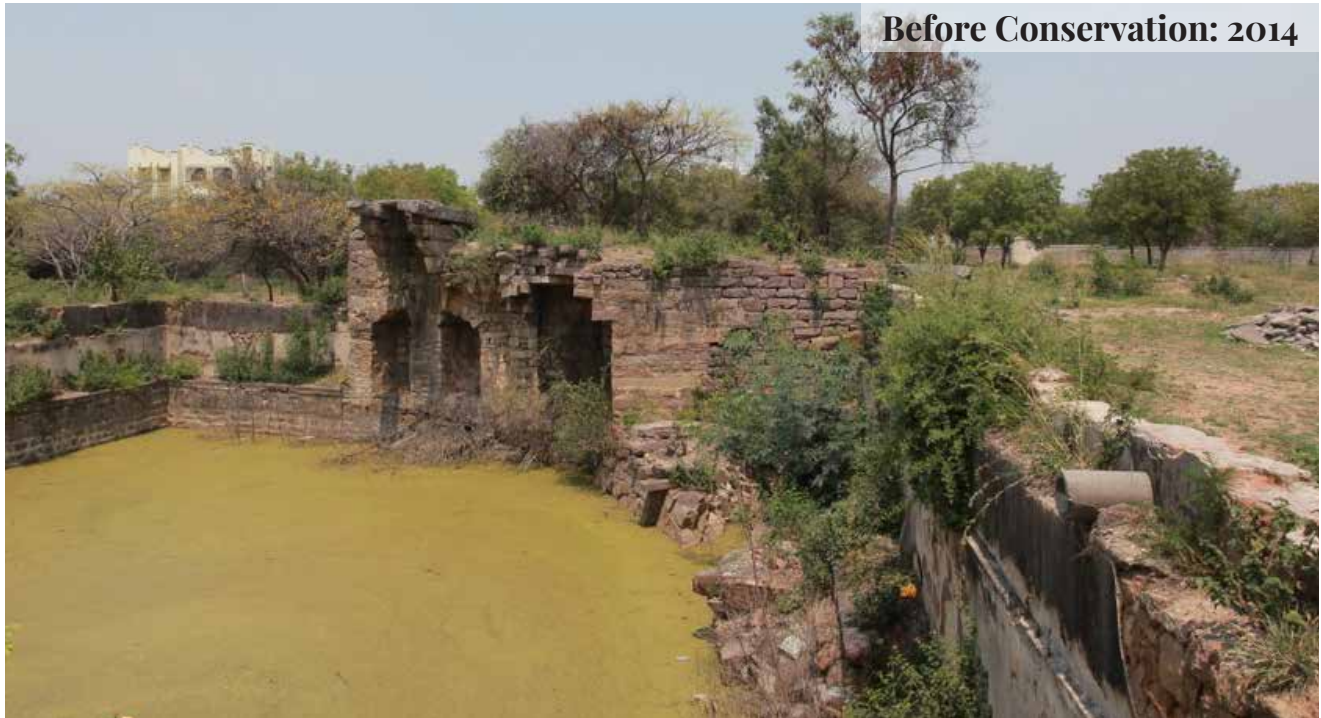
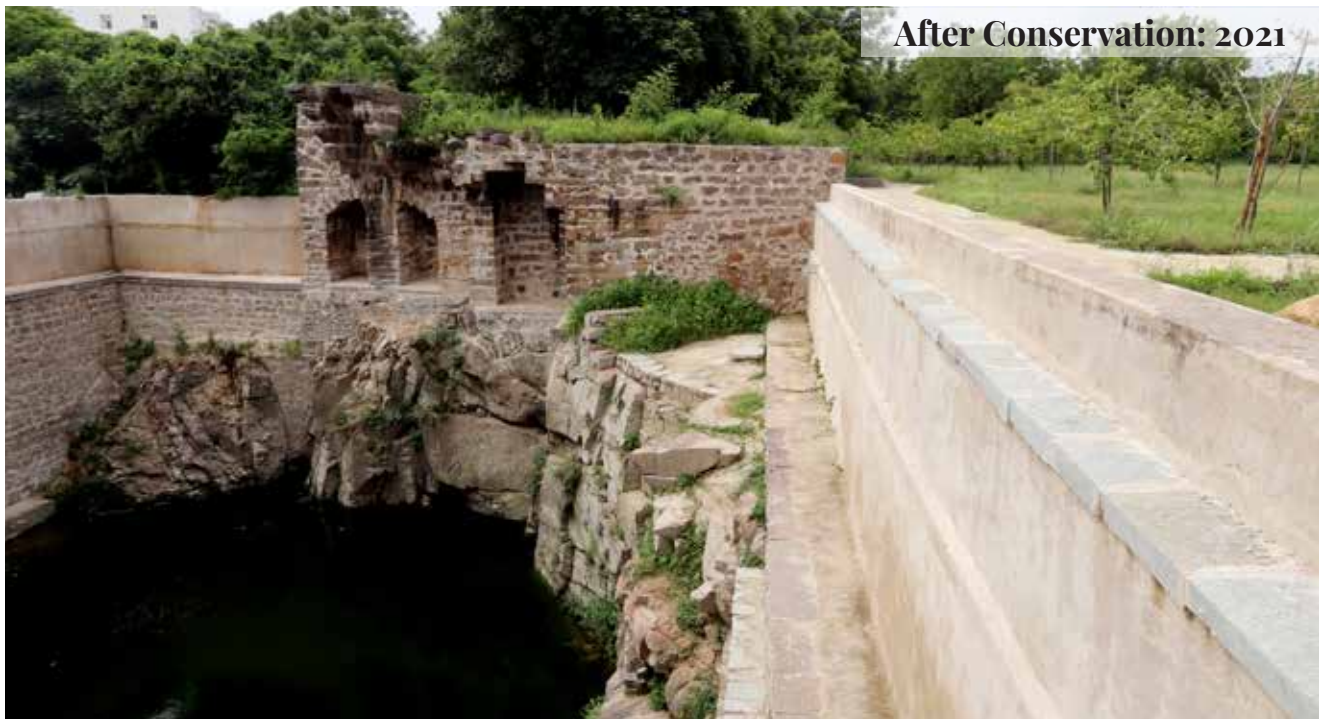
Internal walls were re-plastered with traditional lime mortar along with granite edging installed on top of parapet wall after removal of deeply embedded plant roots

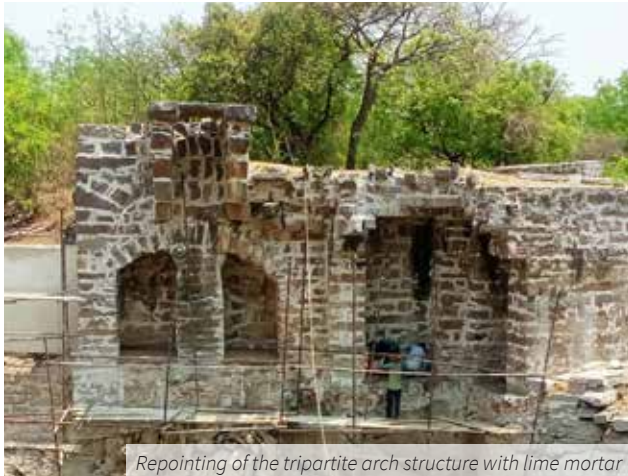
Repointing of the tripartite arch structure with lime mortar

- The rank vegetation at tripartite arch structure at the northern wall, supporting the ramp and water channels above, was removed and followed by re-pointing with lime mortar.
- Lime concreting was undertaken in the portion above to restrict vegetation growth on this part of the structure.

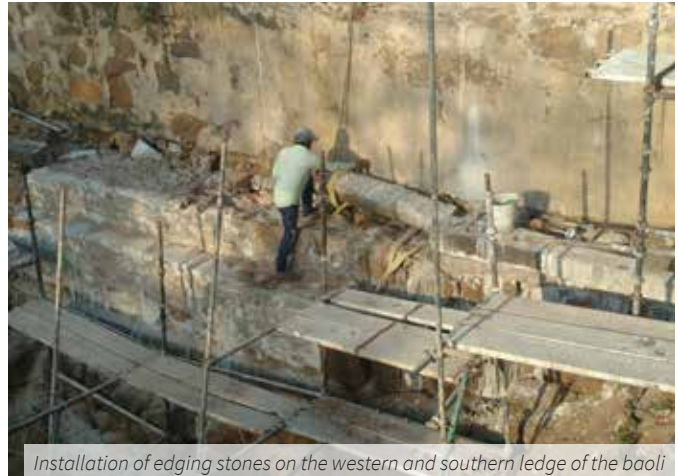
Installation of edging stones on the western and southern ledge of the baoli

- The damaged southern steps and coping stones situated on the western and northern ledge were dismantled. The same have been reinstated with dressed coping stones, matching the existing evidence, to prevent plant growth and ingress of rainwater into the structure.

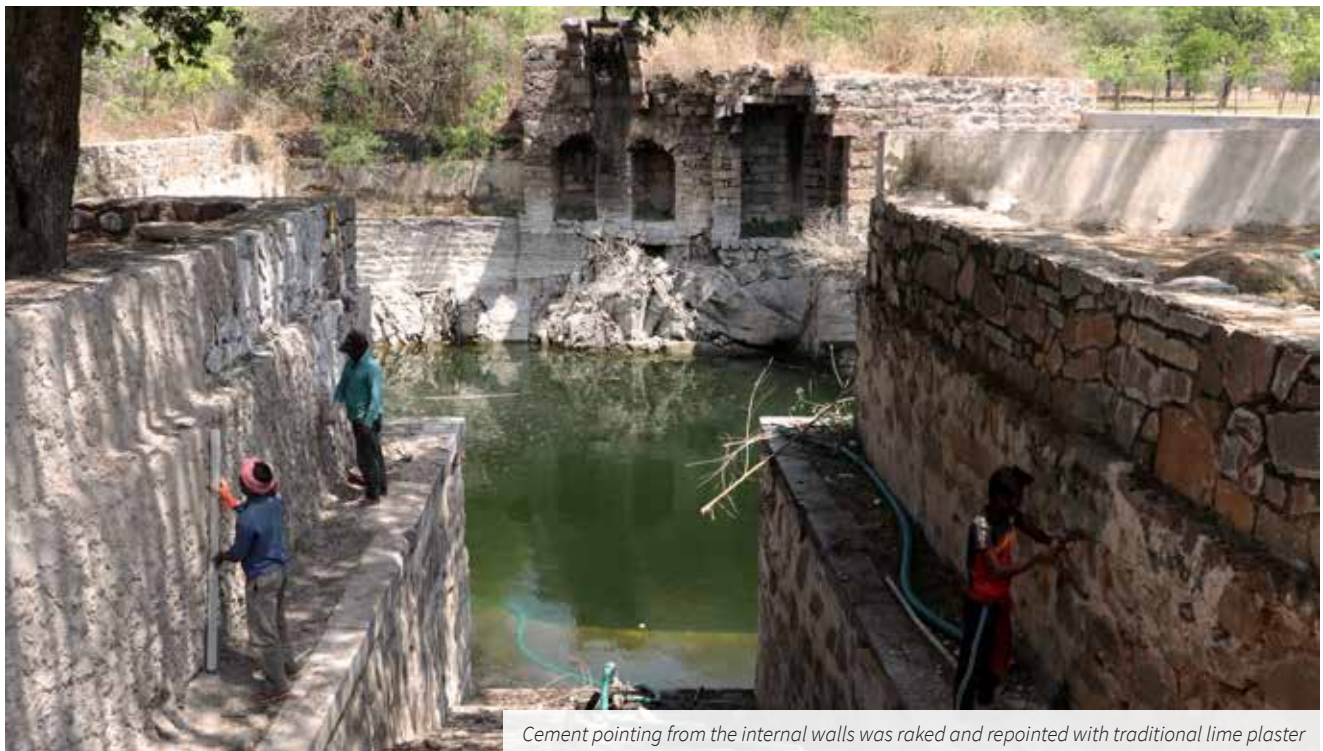
Cement pointing from the internal walls was raked and repointed with traditional lime plaster

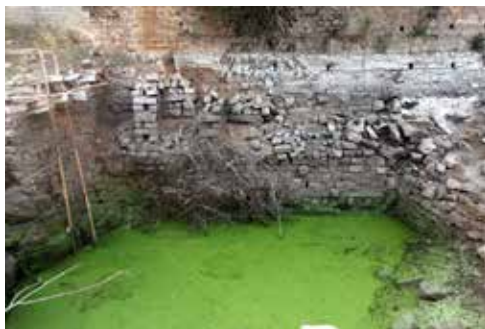
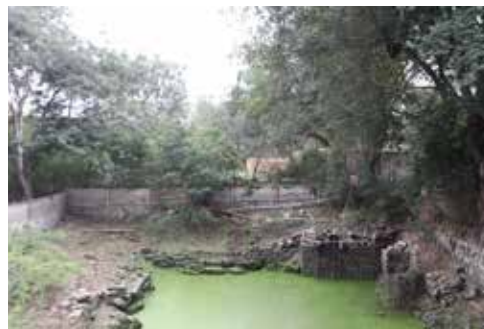
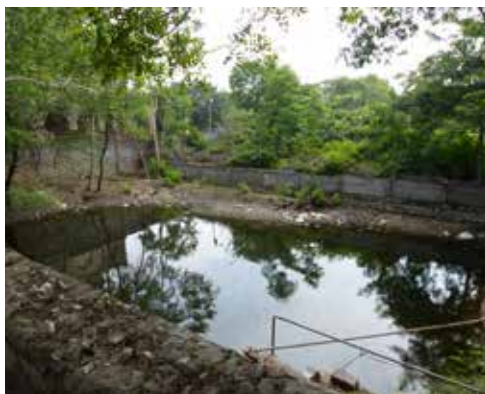
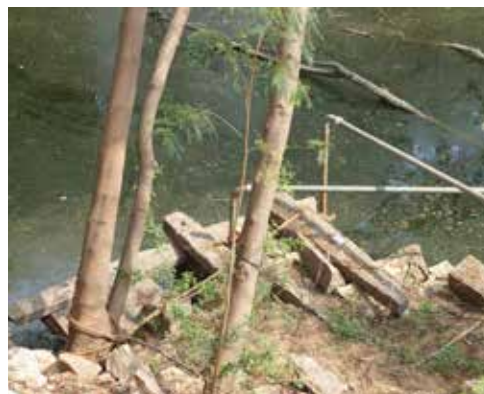
Detailed Condition Assessment of the Eastern Baoli

The baoli was in a state of despair due to silt deposition and excessive vegetational growth. The plant growth at the periphery also resulted in dilapidation of the retaining walls especially to the east and north. The condition assessment of the baoli revealed missing and damaged masonry, water seepage, and alteration of original immediate landscape settings which hindered the natural water channels of the baoli.

The western wall of the baoli which also doubles as a buttress support to the larger western retaining wall was in a dilapidated condition with missing stone blocks and buttresses in deformed profiles. The debris deposition and the vegetation growth at the periphery also aggravated the water seepage in the retaining walls.

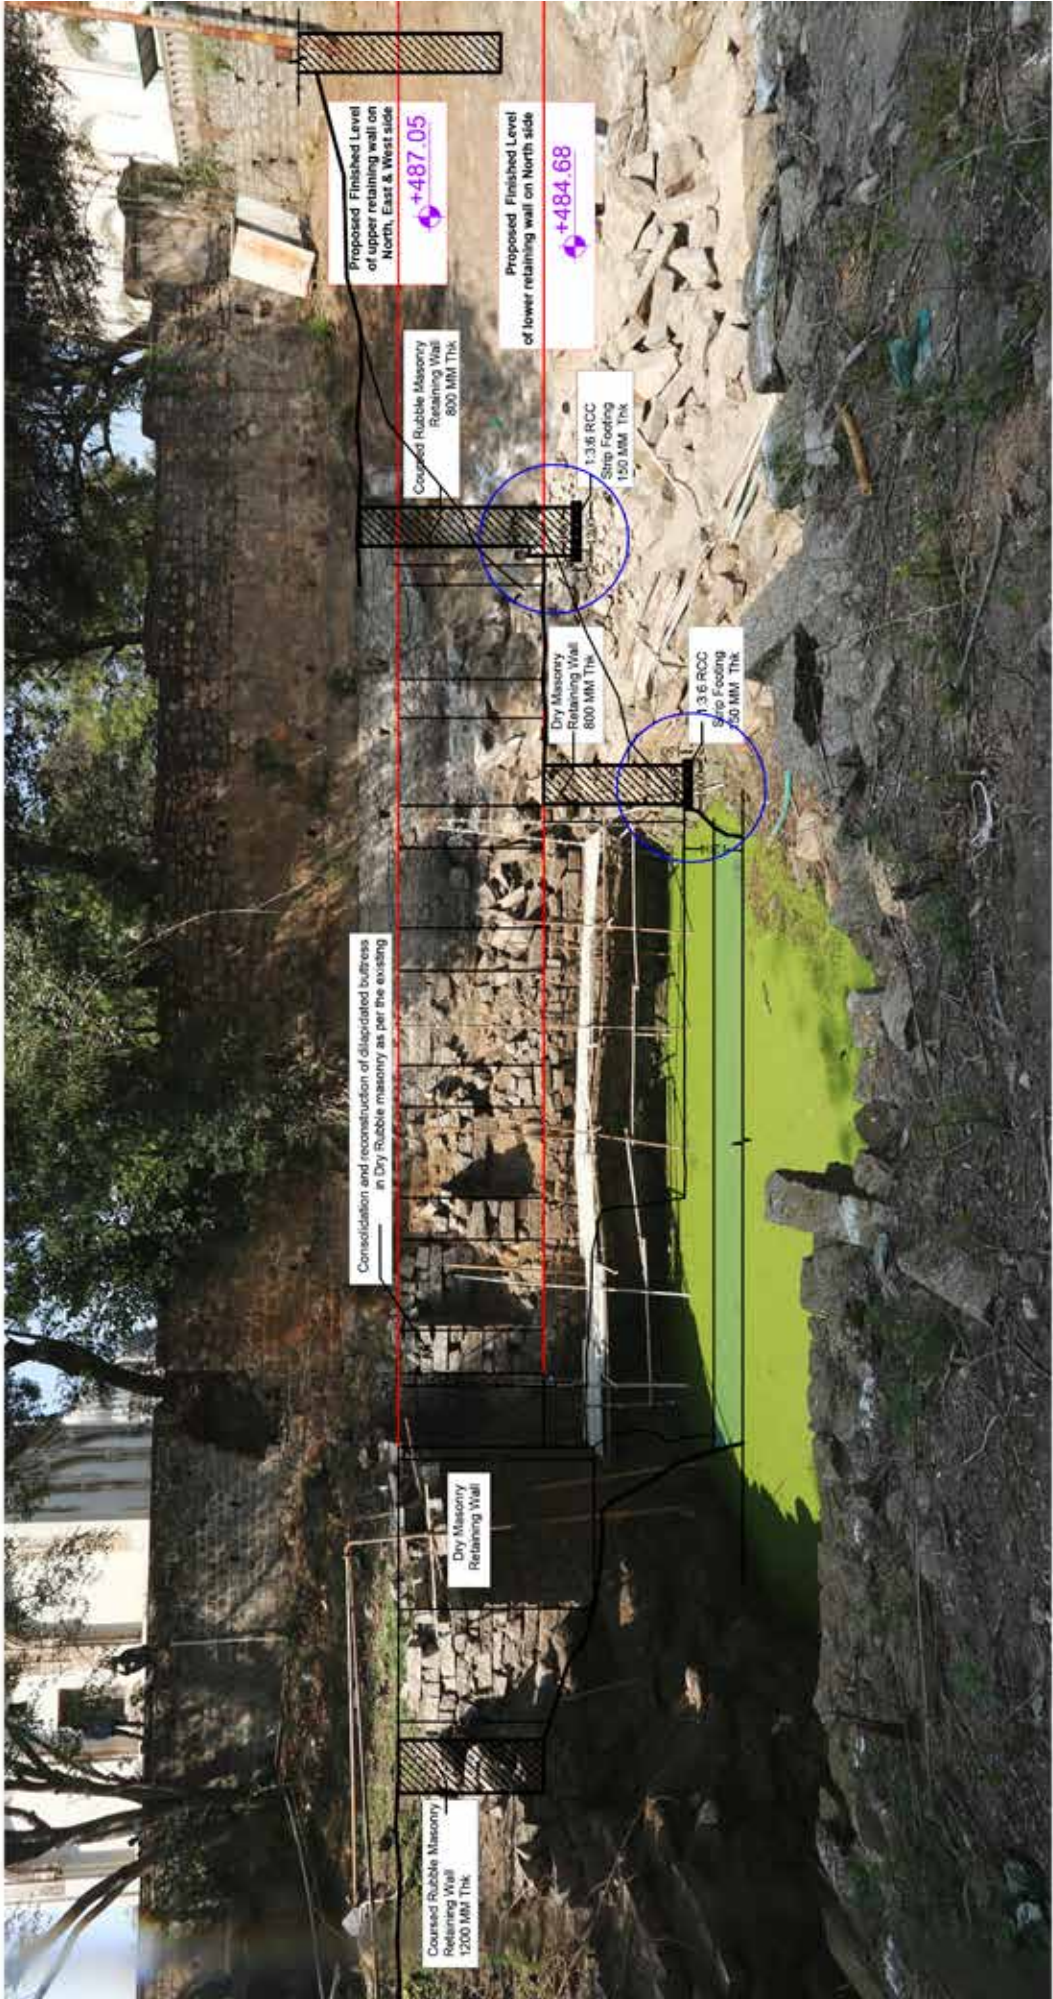
Restoration of the dilapidated buttresses on the western wall carried out after thorough documentation in compliance with the style of historic masonry

- Restoration of the dilapidated buttresses on the western wall was carried out after thorough documentation, adhering to existing heights. The buttresses were restored in compliance with the style of historic masonry found to enhance support and strengthen the abutting retaining wall to the west.
