QUTB SHAHI HERITAGE PARK

CONSERVATION & LANDSCAPE RESTORATION

ANNUAL REPORT 2021

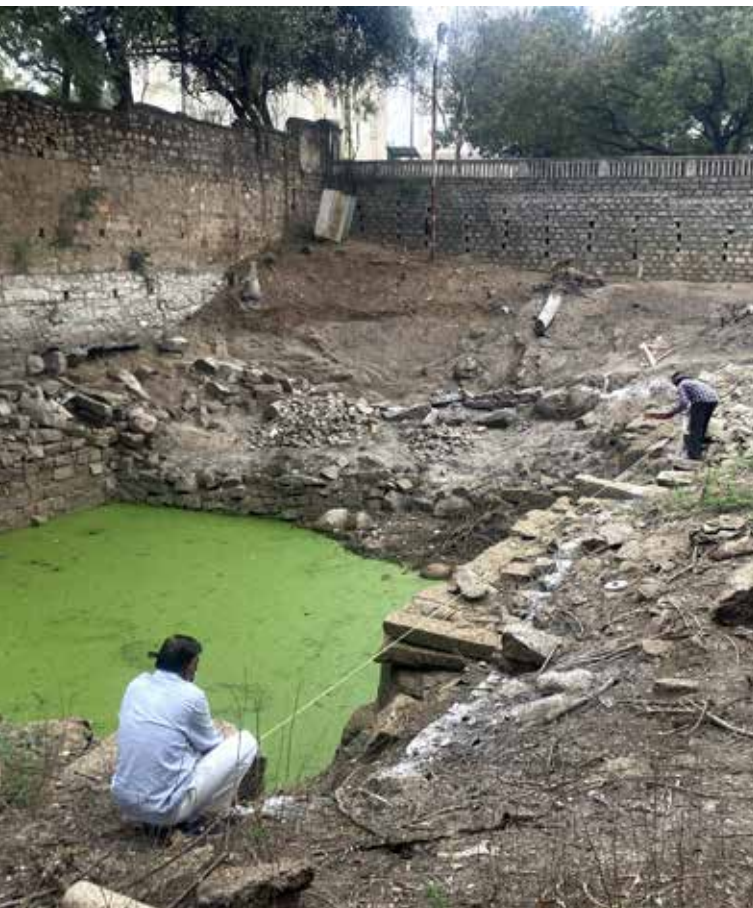
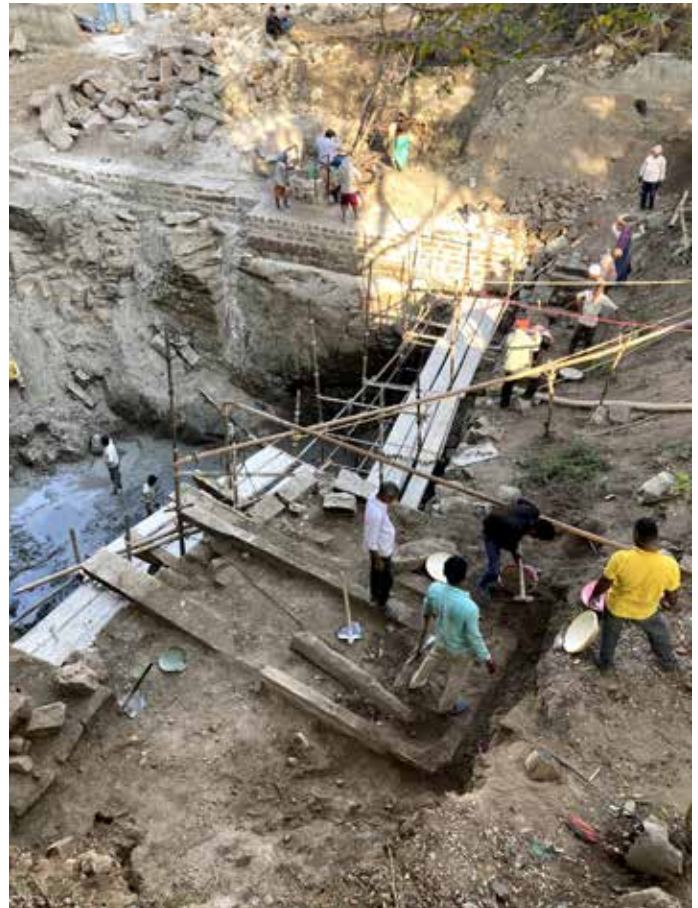
*(Left) Marking of profile of the eastern retaining wall based on historic evidence
(Right) Exposing original water channels*

The ramp at the southwest corner of the baoli is largely intact with debris deposition and vegetation growth on the top. The debris and vegetation removal also exposed the original water channels in stone.

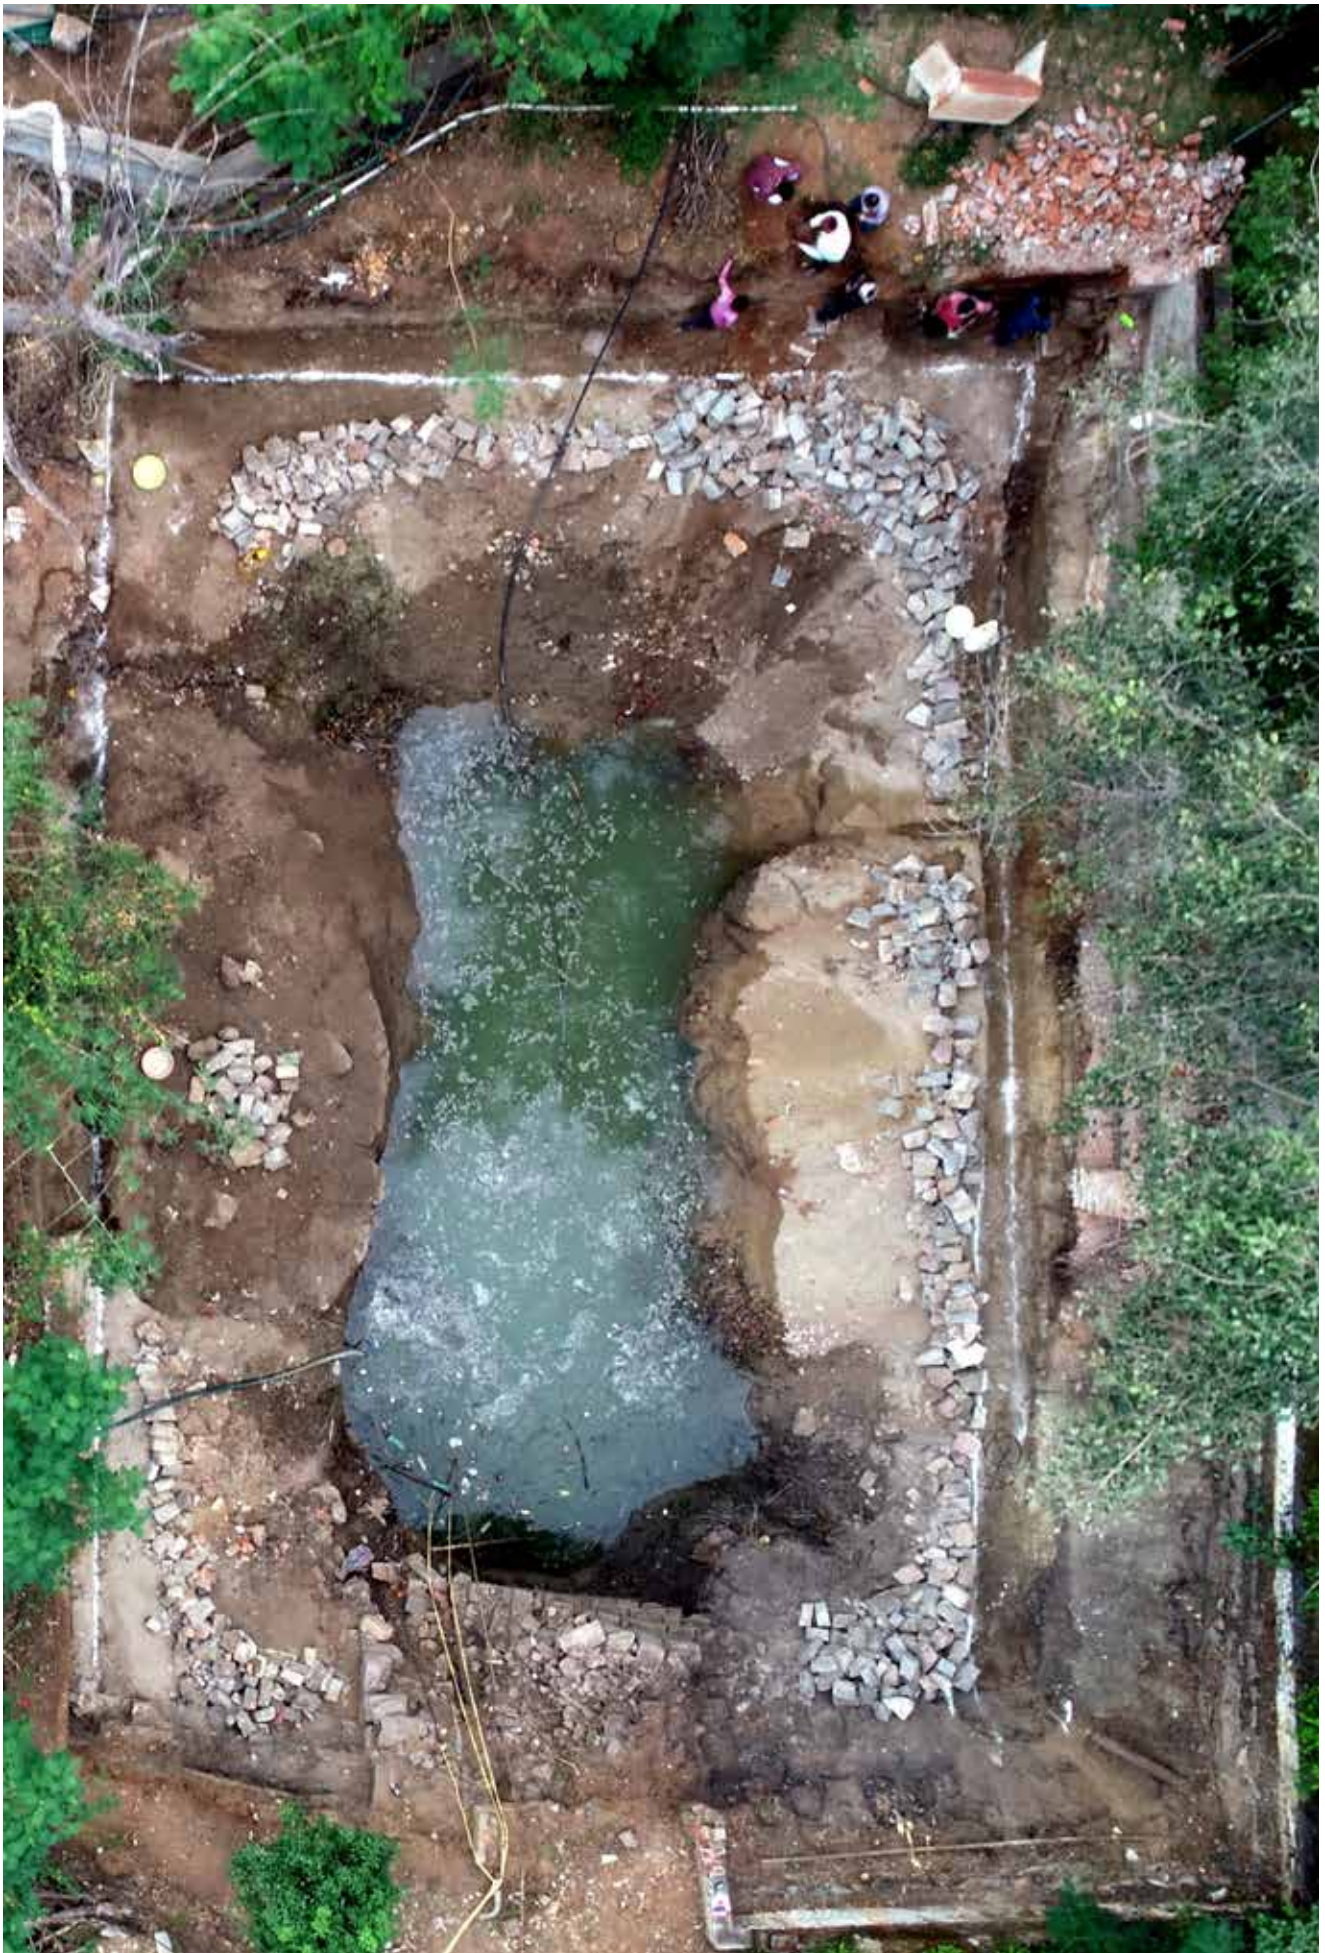
Marking original profile of the baoli based on evidences found on site

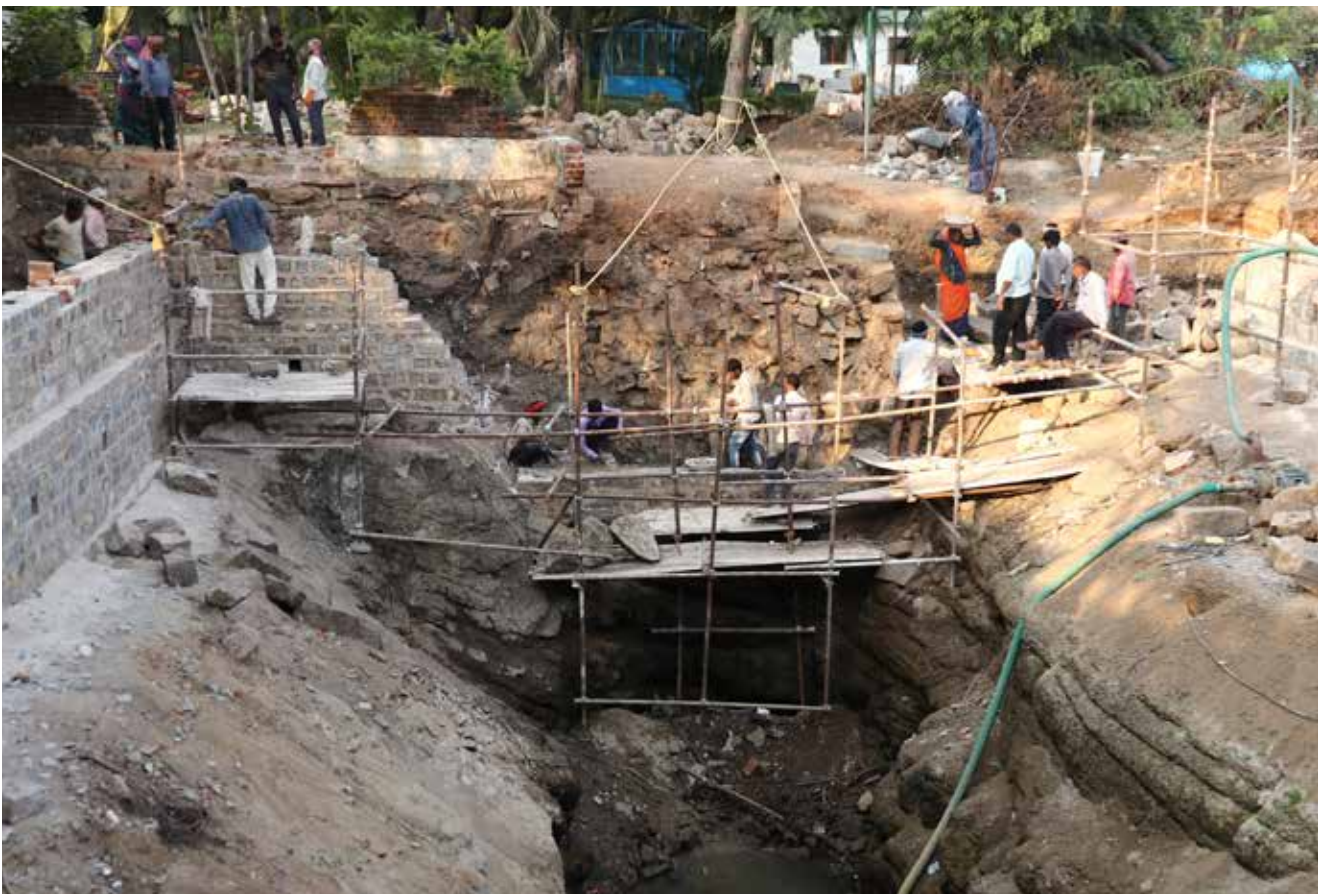
Stone masons restoring the projection in the northern wall as per site-evidence

- The projection in the north wall, of historic stone blocks weighing about 80kg each, had collapsed during the last rains and was thus consolidated by reassembling the stones manually as per the physical evidence at site.

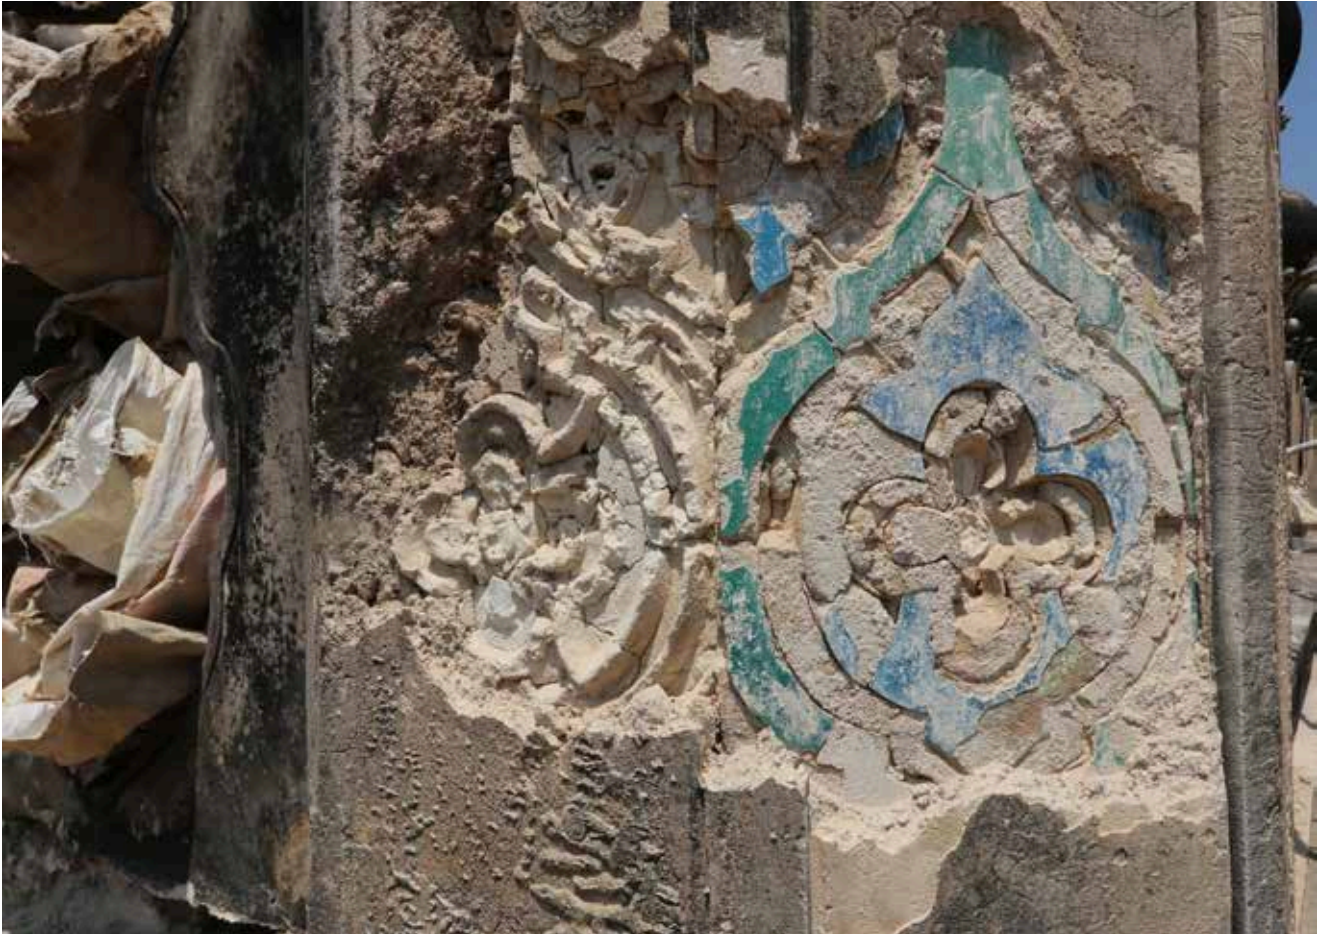
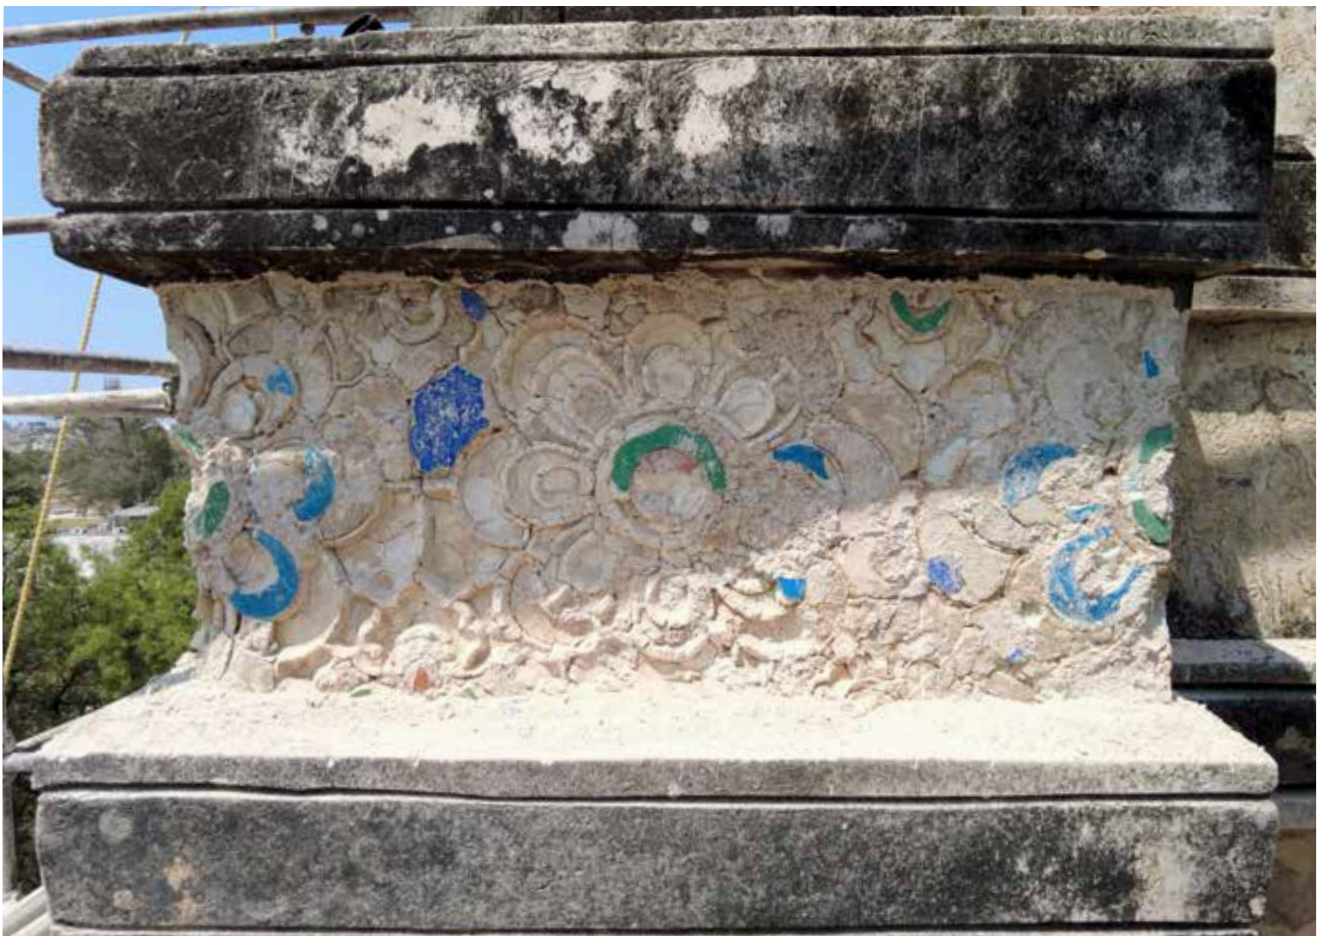
Original lime stucco details with glazed tiles found on removal of 20th century cement layers from the corner columns

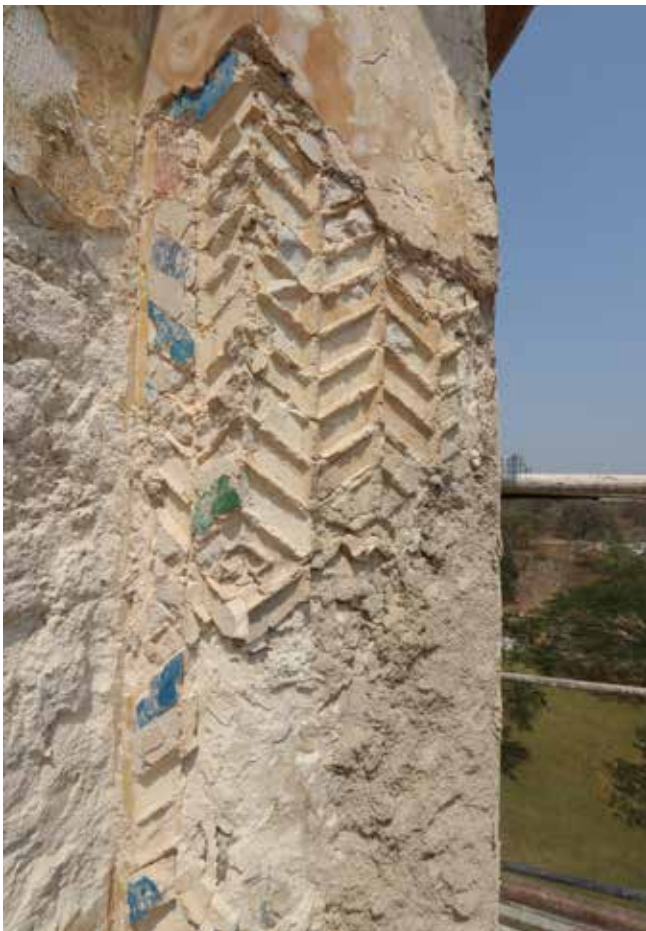
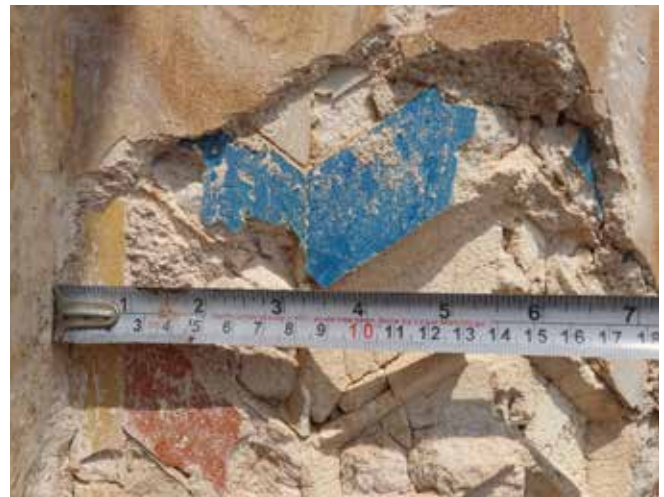
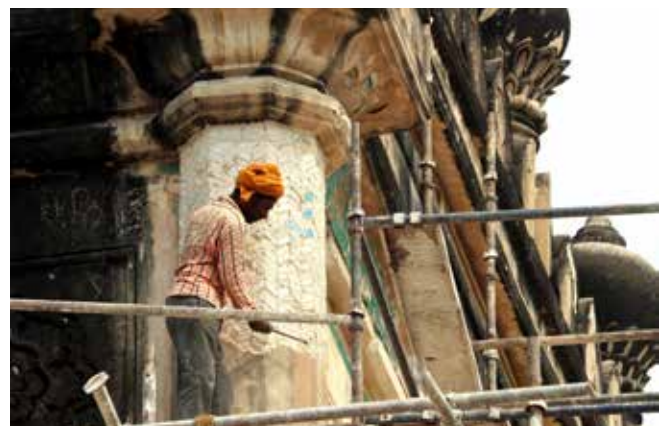
Remnants of multi-coloured inlay chevron tiled pattern was revealed on the corner columns at the upper plinth level

Corner column of the Muhammad Qutb Shah's mausoleum where remnants of glazed tiles were revealed

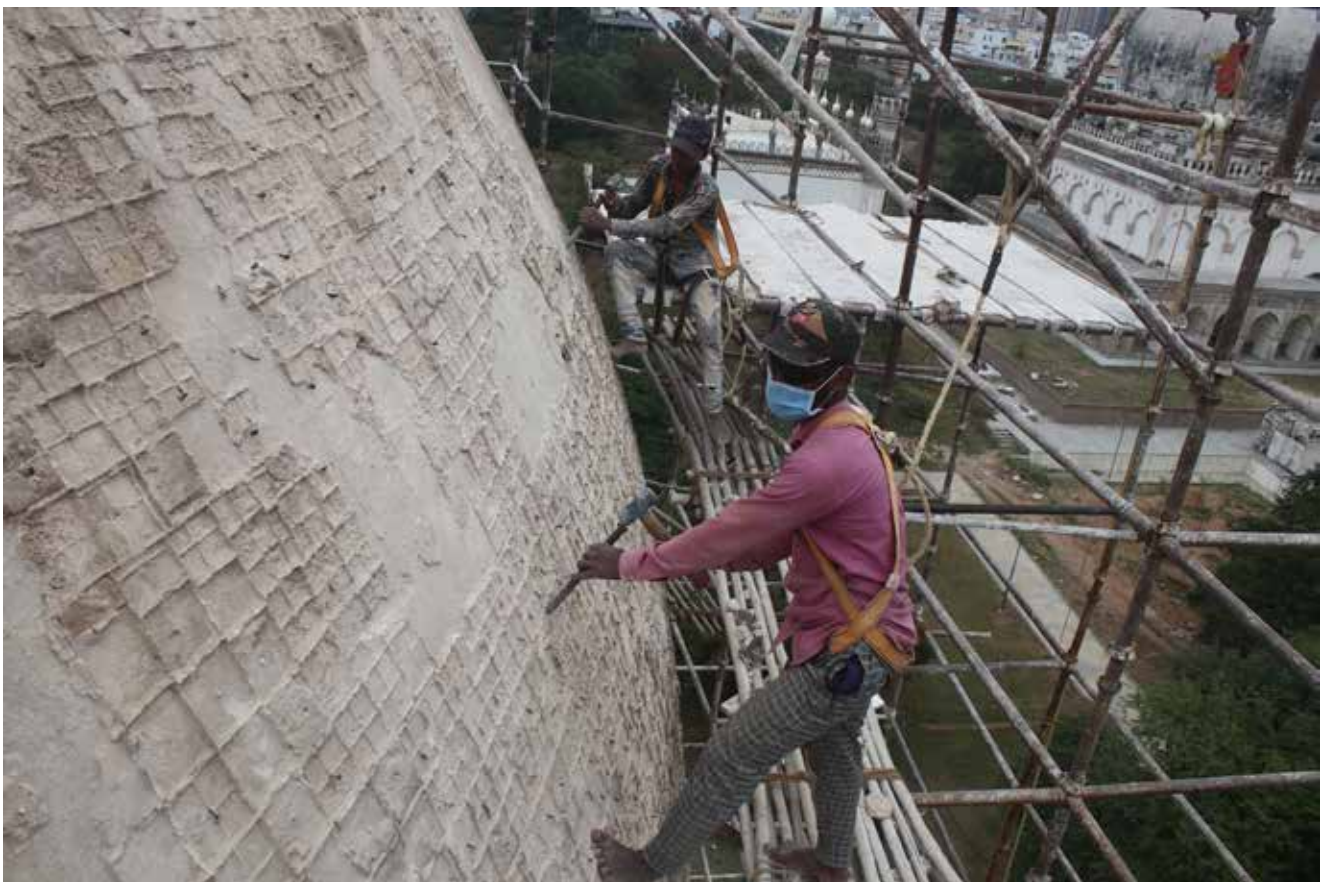
The dome suffers from many deformities, repairs and patch works at various places. A large portion in the southwest quadrant of the dome has a brick infill which is also testified by the 1860s archival image. Pinning of domes surface is also visible in the same quadrant. Other infills to the dome also include stone, lime and cement concrete. A major portion of south east quadrant was bulging out loose leaving the base of the dome.

Careful removal of 20th century cement plaster from the dome revealed historic tiles underneath

- 30m high scaffolding was erected to work on the dome of the mausoleum.
- The 20th century concrete was carefully dismantled from dome's surface by stone masons using appropriate tools thereby exposing the tile layer below.
- The existing tiles were meticulously documented using computer aided design softwares, photogrammetry and aerial imagery to determine an exact number of surviving tiles on the dome.
- The dismantling of 20th century plaster from the triple bands also revealed a tiled layer below. The middle band exhibited a chequered pattern below the tiled layer at southwest and northeast corners.
- The loose glazed tiles were carefully stored for further understanding of the method and materials used for fixing the tiles originally.

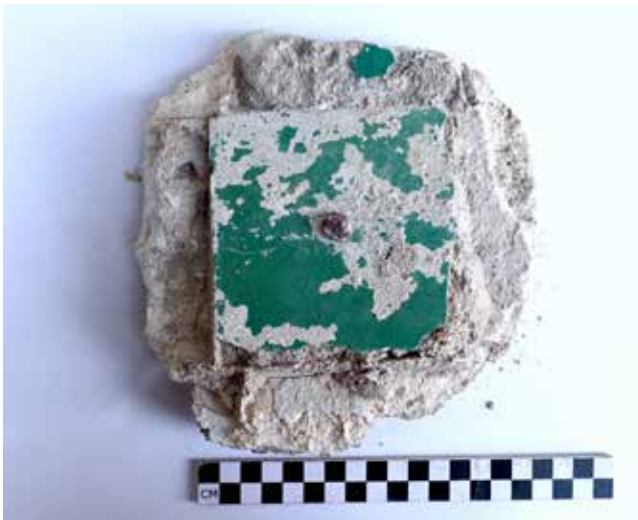
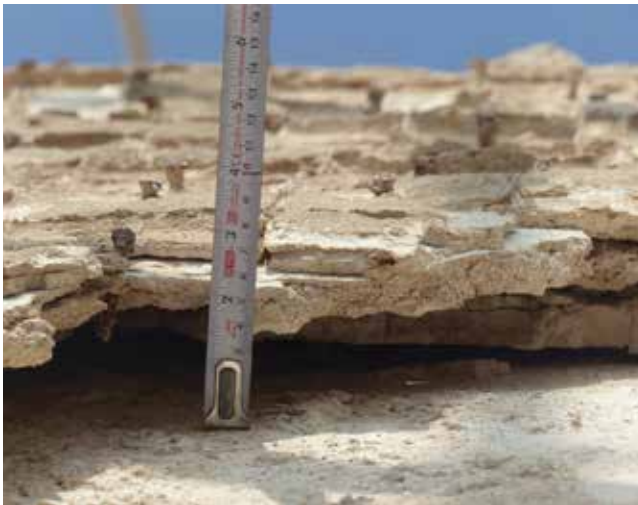
(Clockwise from left) Sample tile was carefully removed from the dome for examination; Five layers were observed on the dome surface that hold tiles along with the nails; The tile bases are interspersed with missing portions of tiles, with only evidence of the base plaster

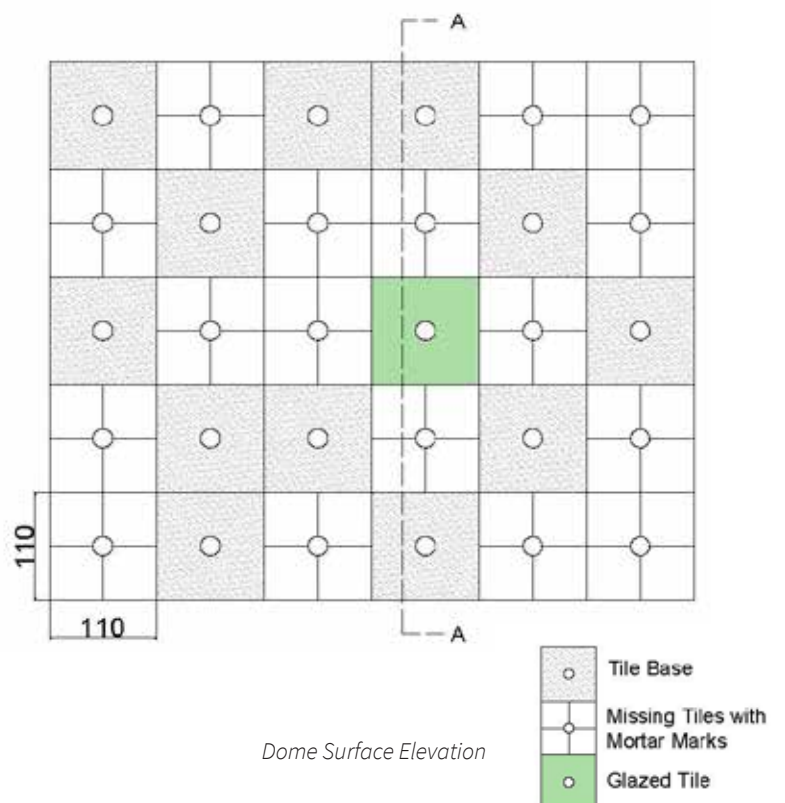
Dome Surface Elevation

Five layers were observed on the dome surface that hold tiles along with the nails

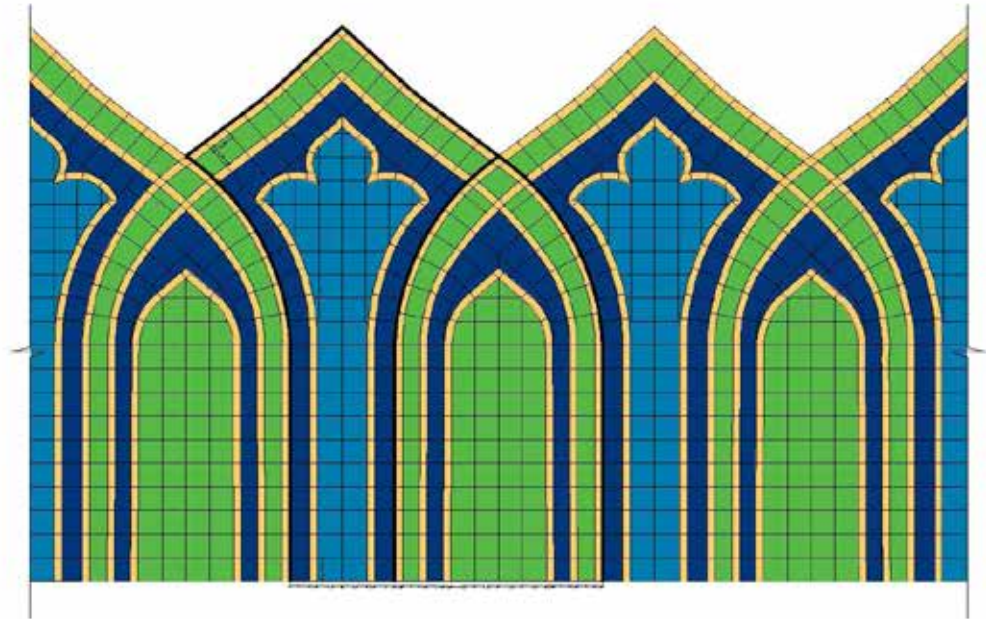
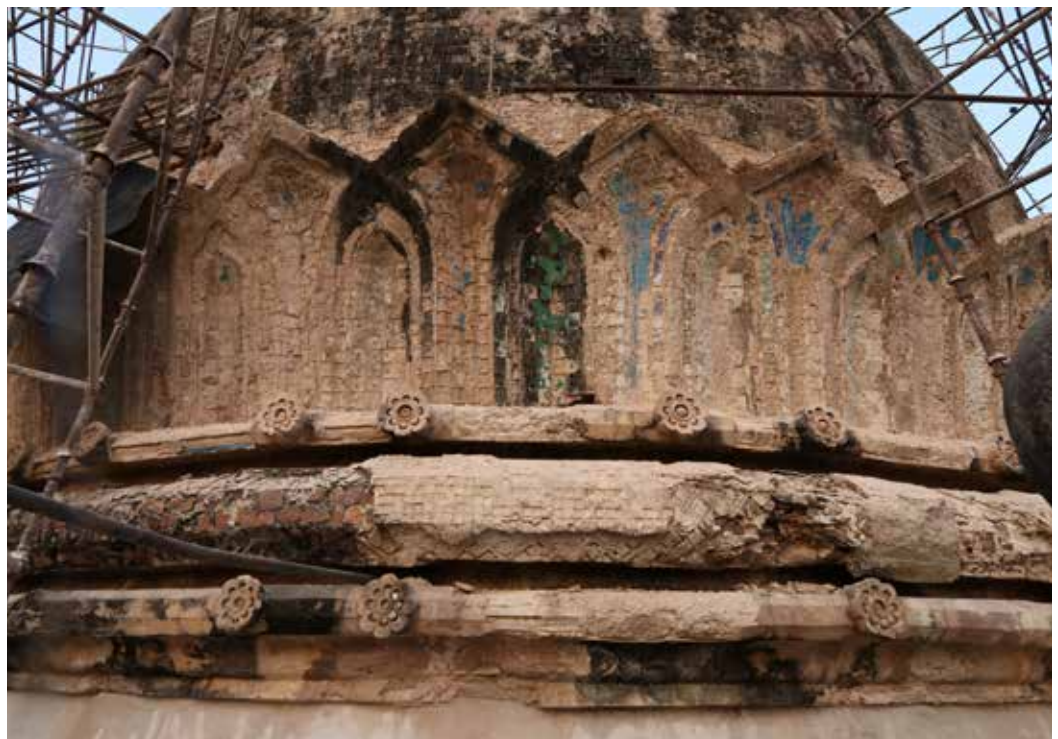
Tile evidences found on the petals and band on the dome were documented carefully

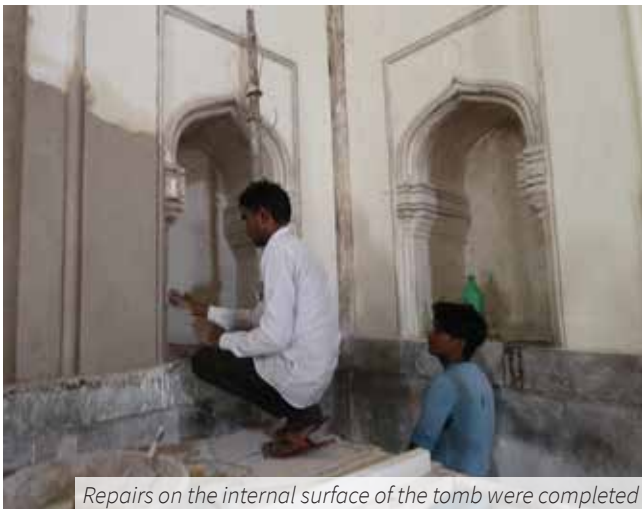
Repairs on the internal surface of the tomb were completed

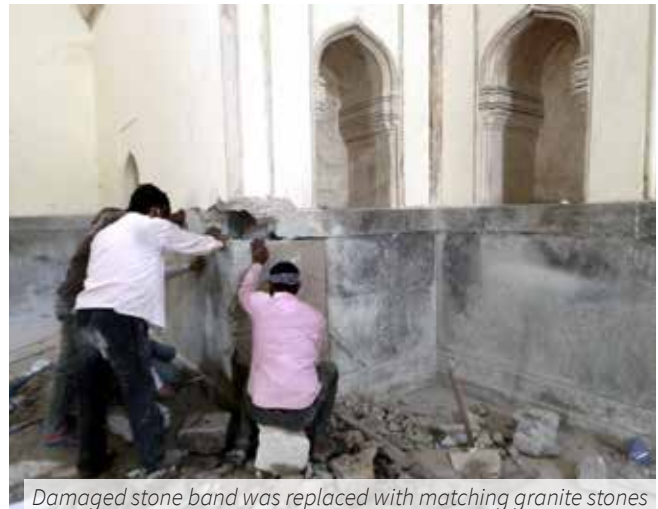
Damaged stone band was replaced with matching granite stones

- Upon removal of paint, it was observed 20th century cement plaster was covering damaged portions of the stone surface at various portions on the western and north-eastern walls. The damaged stones were carefully dismantled and reinstated with matching granite stones.

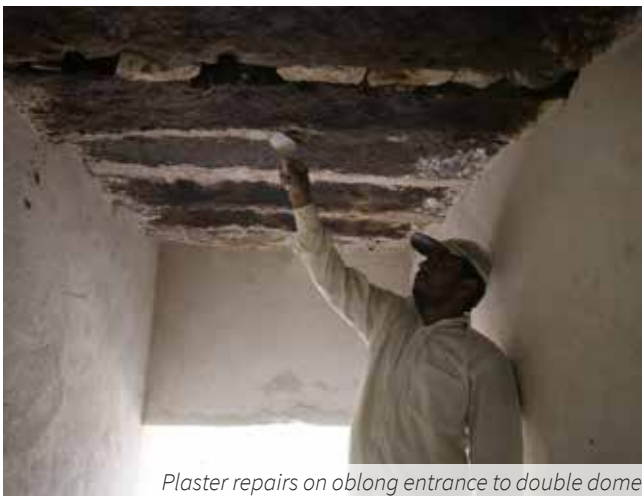
Plaster repairs on oblong entrance to double dome

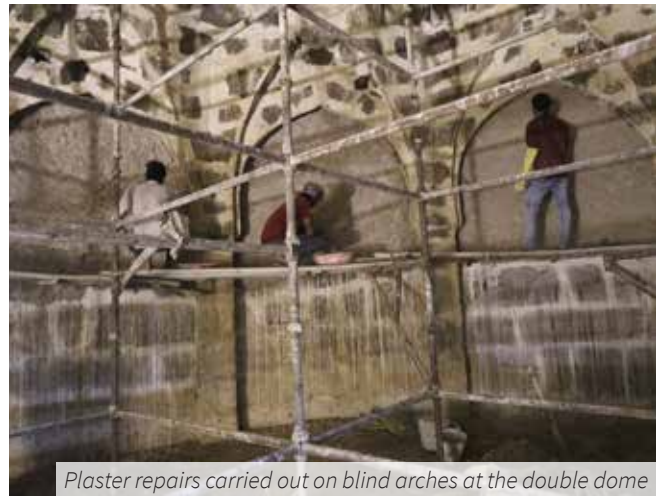
Plaster repairs carried out on blind arches at the double dome

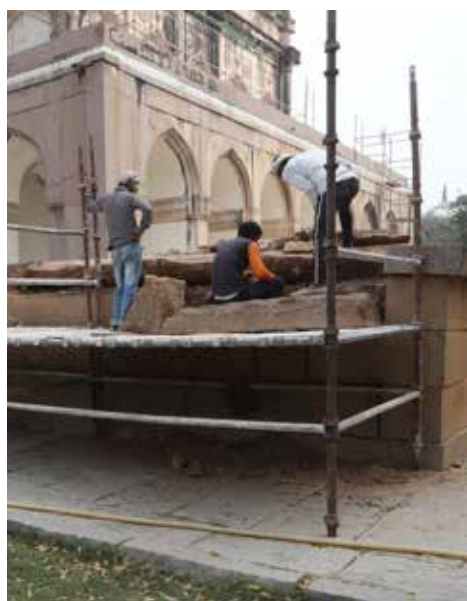
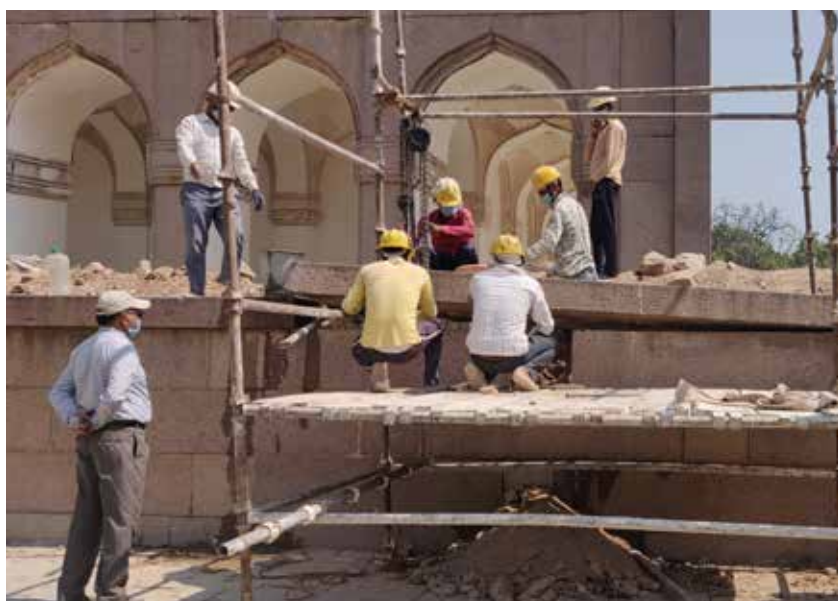
The lower plinth finished with thick granite dressed stone blocks was found to have bulged on the southwest side. The dressed stone blocks on the west and southern side were also found to have been dislocated due to thick plant roots embedded in masonry due to water seepage along with few coping stones which were also found to be missing.

Realignment of the projected plinth by skilled stone masons

- Damaged hand dressed coping stones on the western projected plinth were removed and reinstated over an 18-meter-span by the stone craftsmen.
- Dressed stone blocks matching with the original stones were placed as coping stones in the missing portions.

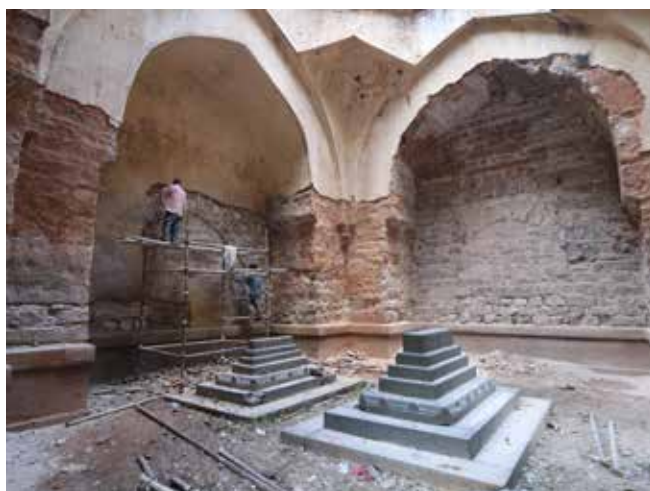
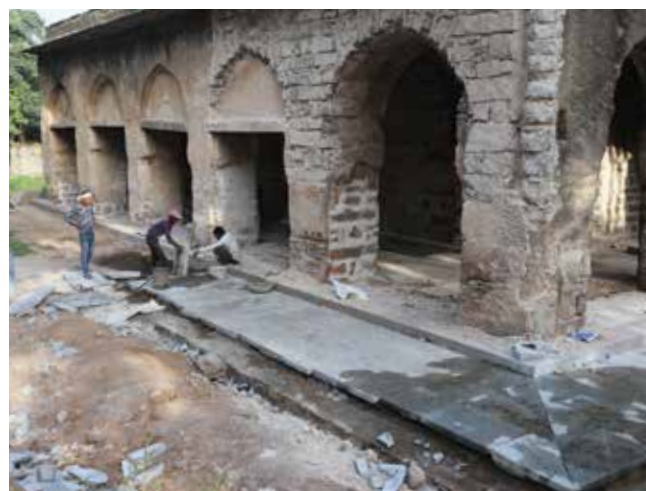
(Left) Removal of cement layer from the interior portions of the monument; (Right) Installation of plinth protection

- 20th century cement was removed from the stone masonry on the lower external facades and re-pointing was done on the same using traditional lime mortar.
- Later added plaster layer on the lower northern facade was carefully removed and masonry joints were filled using traditional lime mortar to prevent further ingress of rainwater.
- Cement mortar was removed from the joints of the stone beams spanning over the arched corridor and re-pointing was carried out using lime mortar.
- Dismantling of 3-inch-thick cement mortar from the internal wall surfaces is being carried out.

- Repair of damaged portions of the tandur stone flooring inside the arched corridor was carried out.
- 100 mm thick granite slabs were installed as plinth protection to the mausoleum.
- 44 hand-dressed blocks of granite have been installed along the perimeter of the mausoleum with the existing corridor flooring flushed with top edge of stone for efficient drainage of rainwater away from the structure.
- Double-tier steel frame for pigeon net has been fabricated and installed on upper and lower ledge of the blind arch gallery situated below the missing dome. Net will be put in place upon the completion of masonry repairs on the structure.

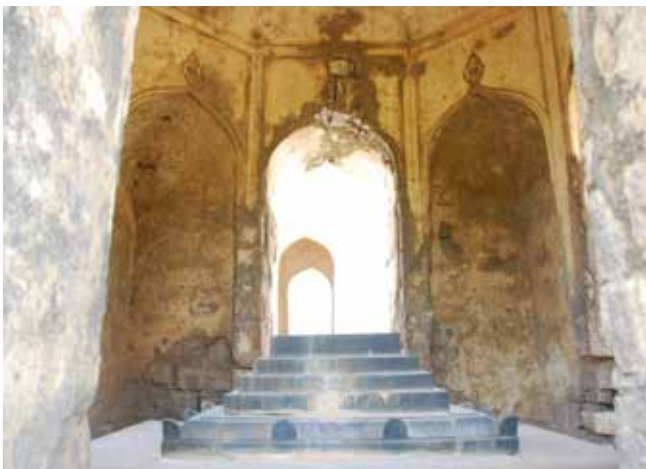
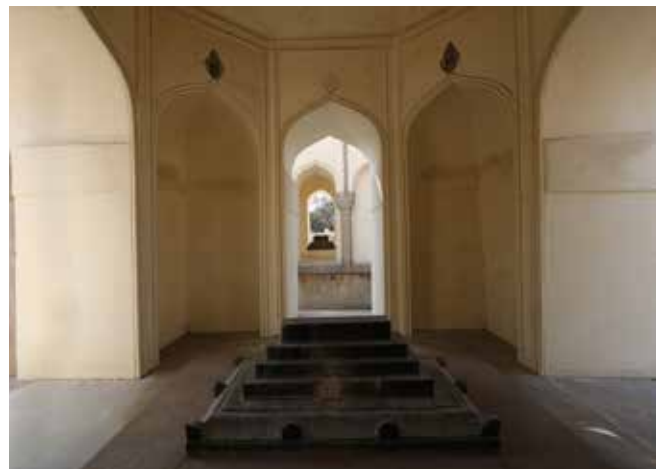
View of the interior facade of mausoleum no. 4 before and after conservation

- The damaged parapet along with vegetational growth was manually removed to ensure no further damage to the structure.
- The terraces was removed of decayed layer of 20th century concrete along with tree roots and other vegetational growths.
- The terrace was casted with rich lime mortar after consolidation with aggregates and lime concrete.
- The original alignment of the parapet was marked based on the existing evidence on the terrace.
- Waterspouts were provided at all four elevations to prevent any water ponding on the terrace.
- The parapet wall was raised to height based upon the evidence obtained on site.
- The plastered parapet wall was finished with punning layer on top in a fine lime mortar.
- The rectangular panels below the eave projections were also repaired by skilled lime masons to original details.

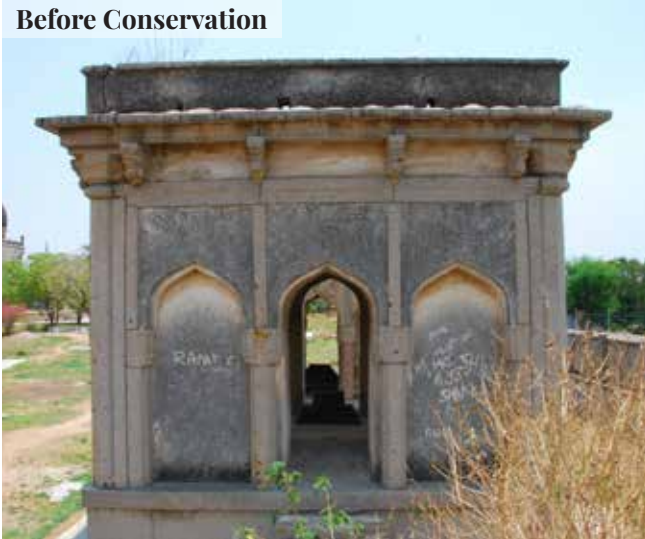
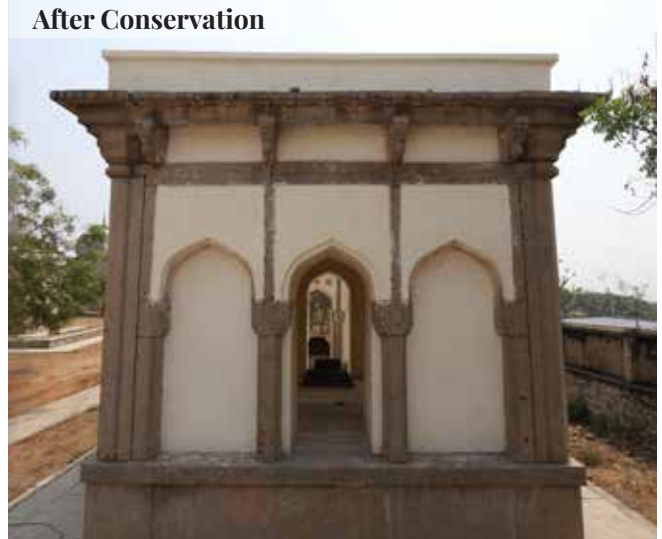
MAUSOLEUM 3

Before Conservation

After Conservation

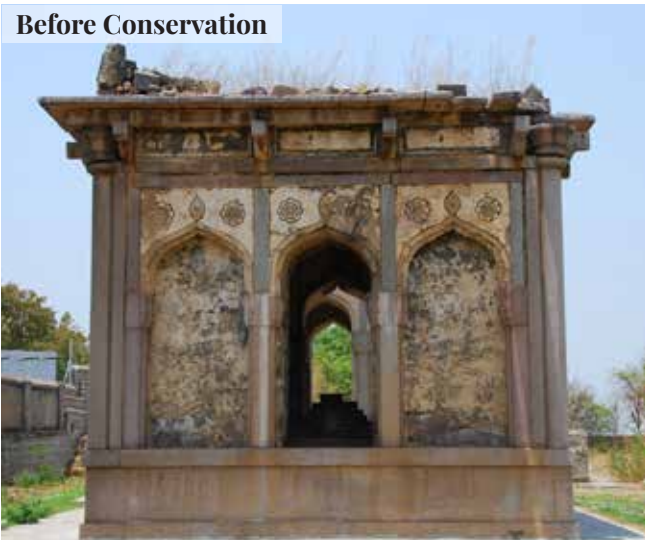
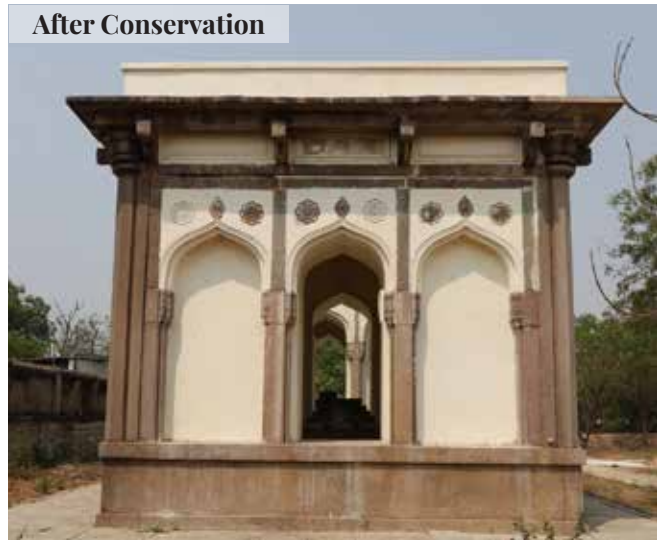
MAUSOLEUM 4

Before Conservation

After Conservation

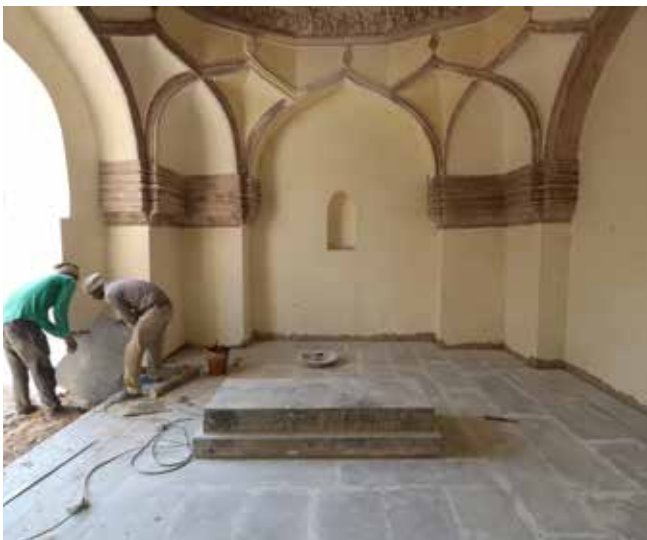
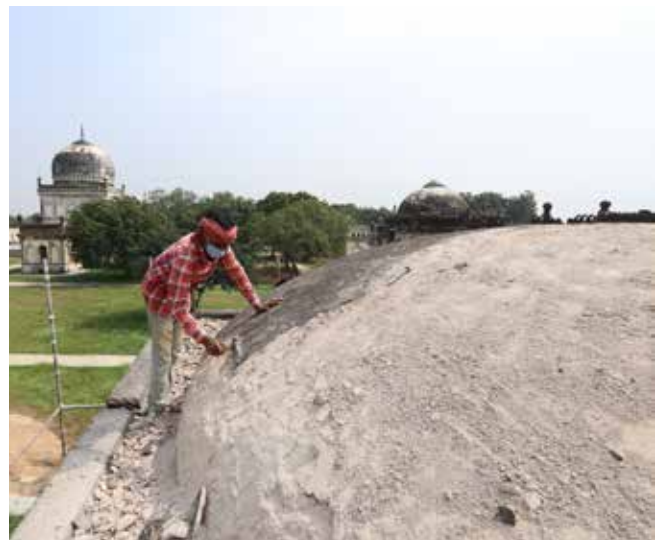
*(Left) Granite flooring laid inside the mausoleum as per approved layout
(Right) Removal of 20th century cement concrete from the terrace*

traditional lime concrete in appropriate slope to mitigate future rainwater ingress in the structure.

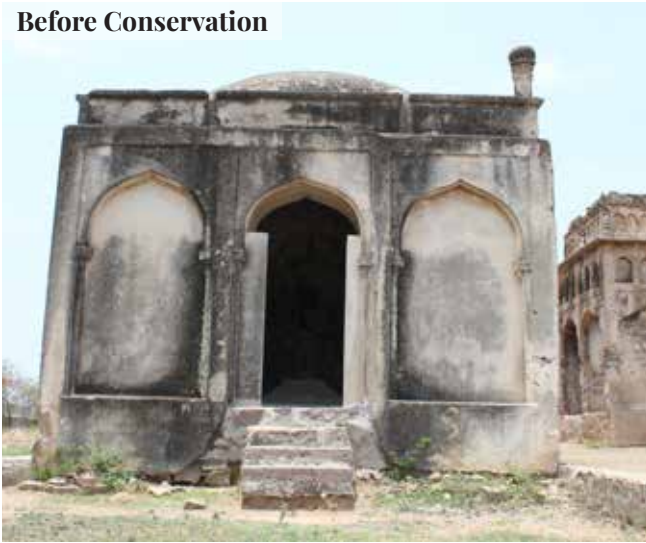
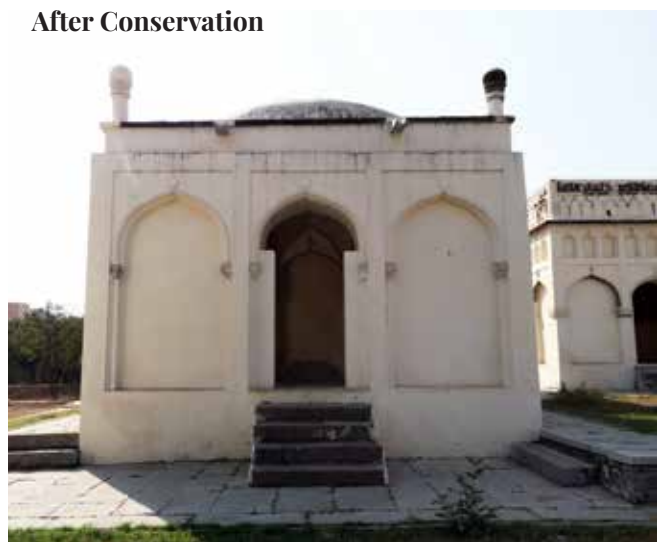
MAUSOLEUM 10

Before Conservation

After Conservation

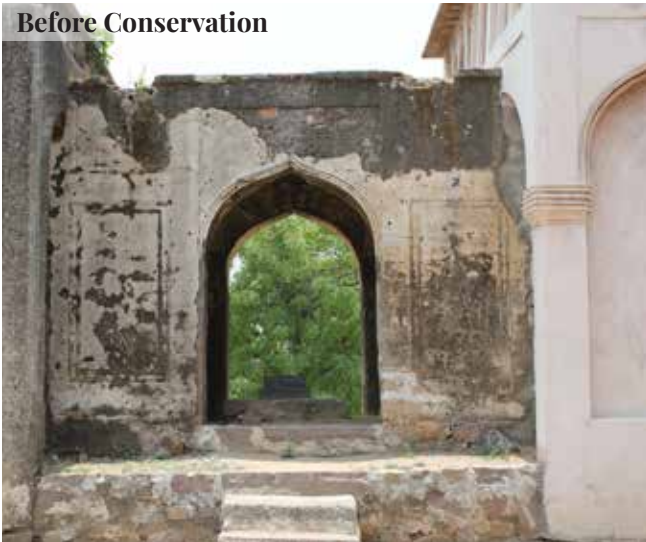
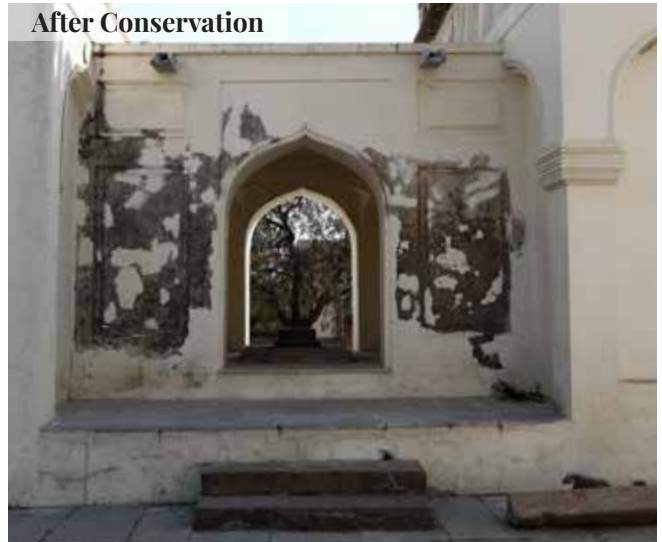
MAUSOLEUM 11

Before Conservation

After Conservation

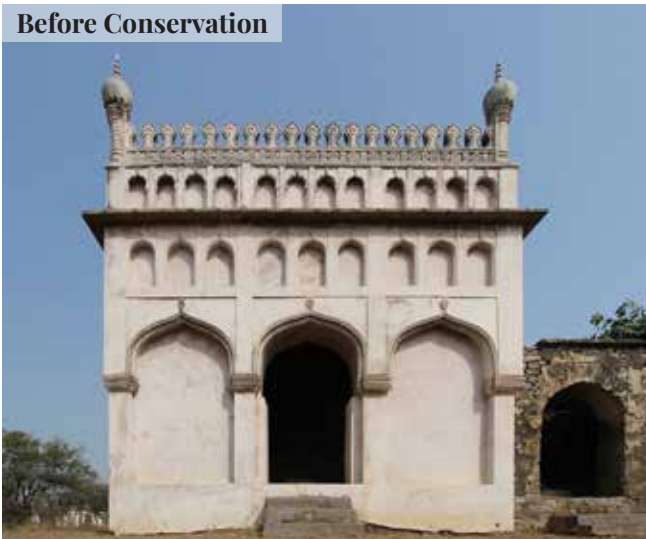
MAUSOLEUM 12

Conservation works at terrace and flooring were taken up. There were visible signs of water ingress from the terrace and deep-rooted plant growth leading to leakage of water inside the structure. Layers of cement plaster had been added to the internal and external facades during the previous repairs.

Before Conservation
