QUTB SHAHI HERITAGE PARK

CONSERVATION & LANDSCAPE RESTORATION

ANNUAL REPORT 2021

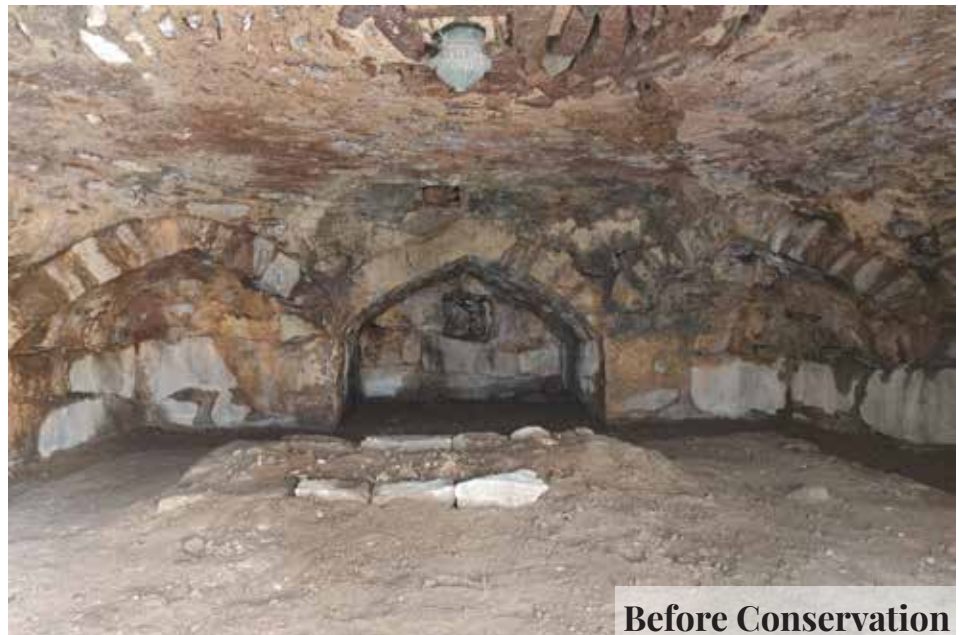
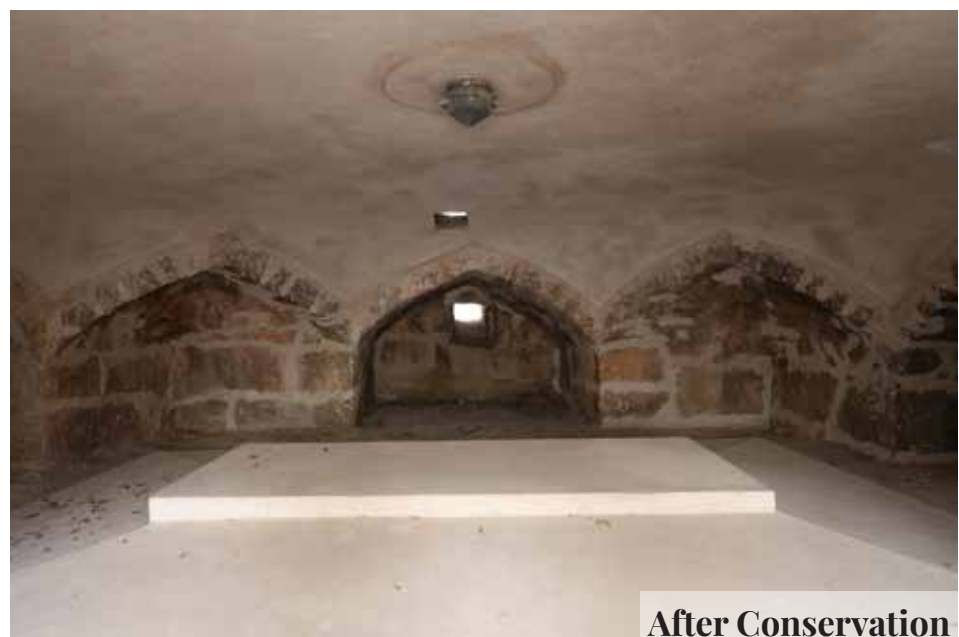
The interior of the crypt was revealed on removal of several feet of earth and with debris. The domed chamber has two vents. The arched access at the east was also blocked by debris. The ceiling was in exposed masonry with signs of moisture and dampness making it prone to collapse due to dead weight above.

Before Conservation

After Conservation

- The loose stones were removed from the arched opening to access interior of the crypt for carrying out further conservation works.
- The joints of the exposed masonry were raked to remove decayed 20th century concrete from the ceiling.
- The ceiling was then plastered till the squinch level in rich lime plaster by master craftsmen using traditional tools and techniques.
- The grave was consolidated in rich lime concrete in a rectangular plan based on the evidence found at site.

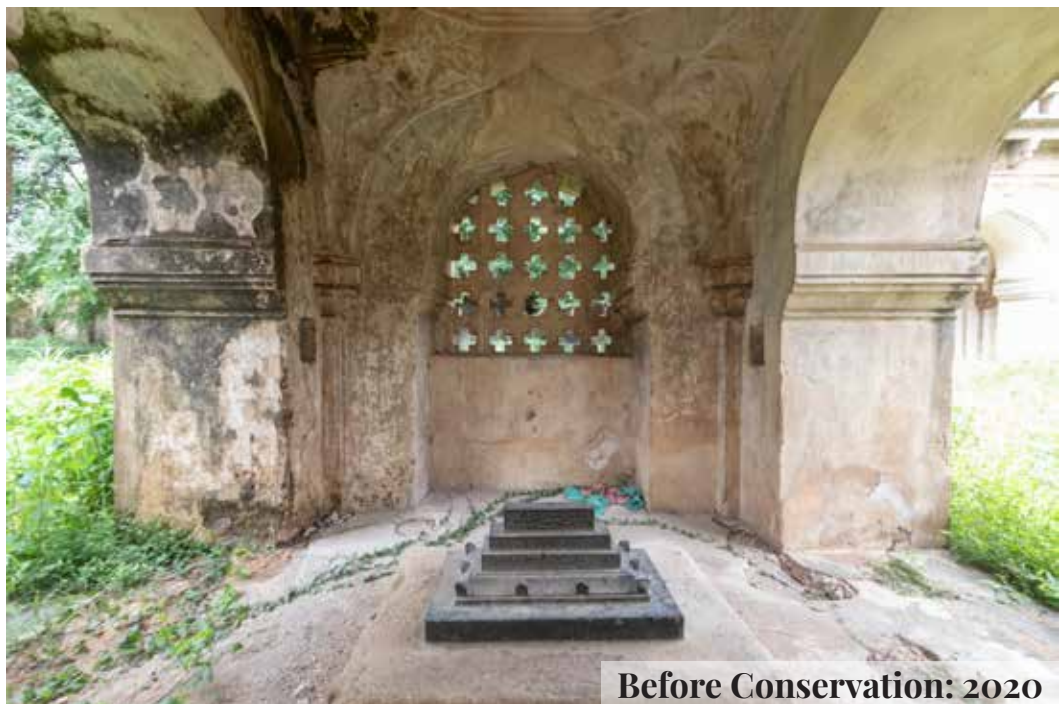
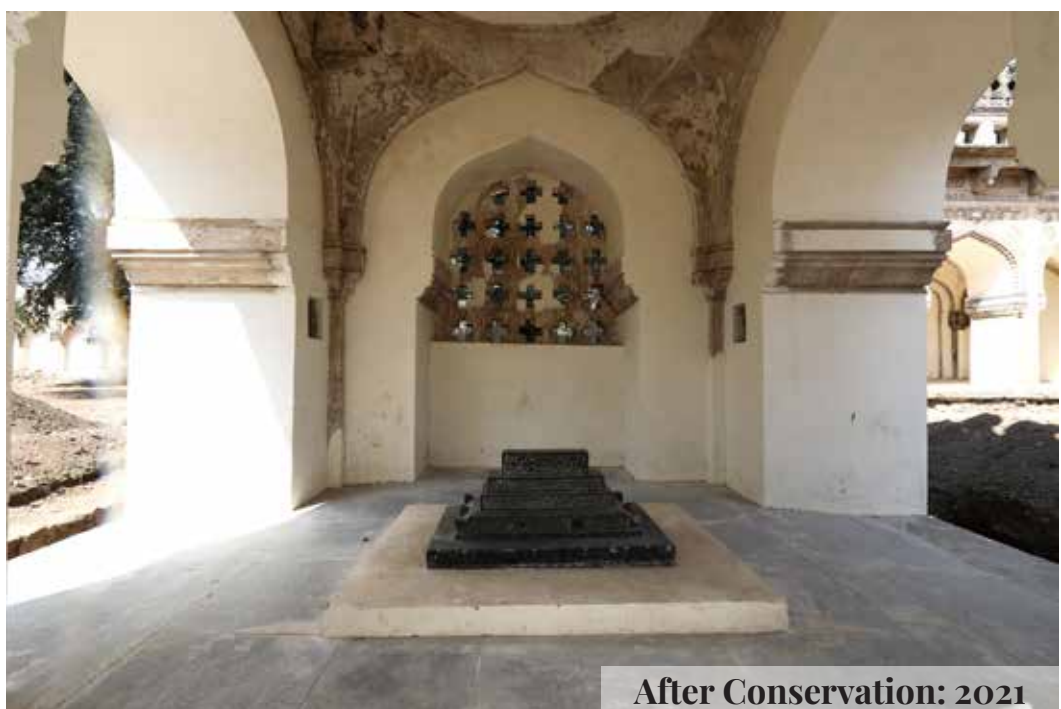
The structure suffered from material decay and missing merlons at the parapet. The walls were also delaminated of the plaster layer at the bottom due to capillary action below. Soot deposition and vegetational growth could also be seen on the structure.

Before Conservation: 2020

After Conservation: 2021

- The mausoleum was scientifically cleaned of the vegetational and algal growth on the external and internal facades.
- The 20th century cement layers have been dismantled from the mausoleum using traditional tools and techniques.
- The facades were then re-plastered in traditional lime mortar by master craftsmen.

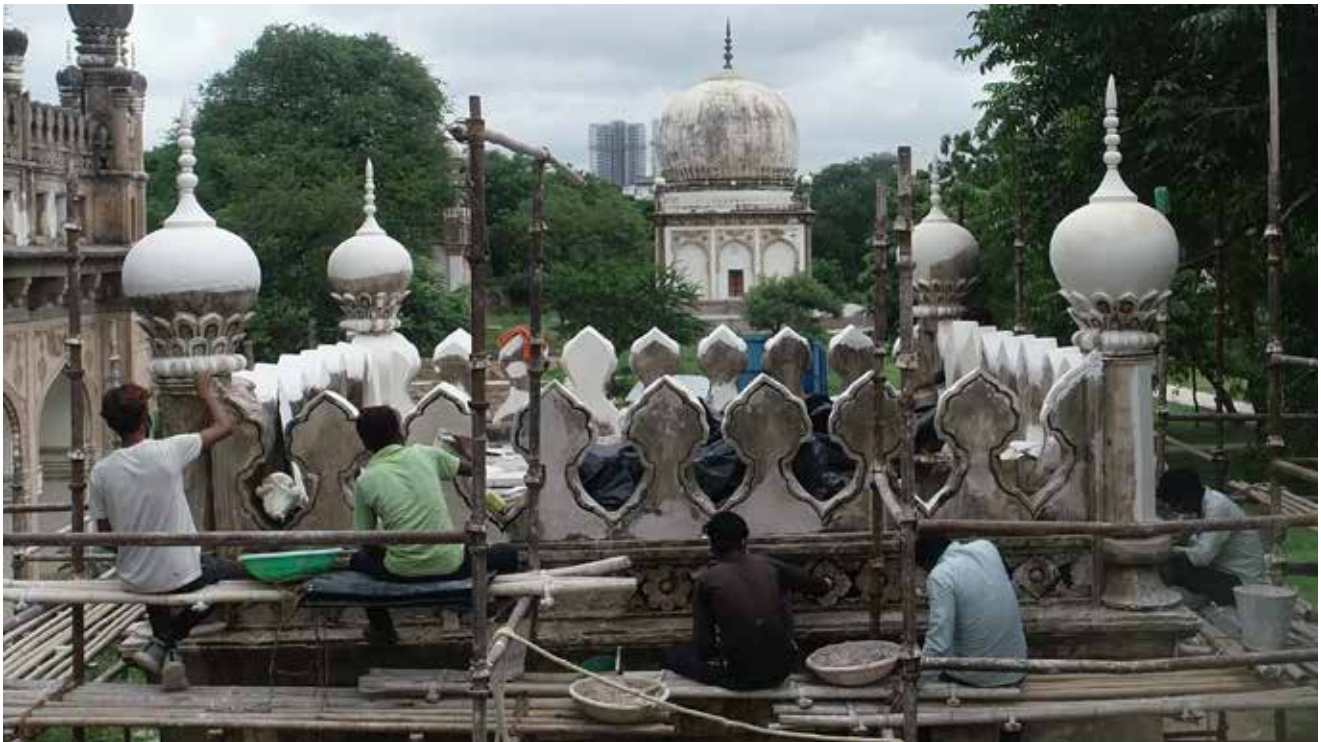
The parapet was visibly suffering from plant roots embedded in the joints of hand dressed stones. It also exhibited dilapidated merlons and decayed plaster on minarets. The terrace was suffering undulation leading to water clogging during monsoons.

Damaged minarets, missing merlons, and decorative lime stucco details on the parapet being restored carefully by skilled craftsmen

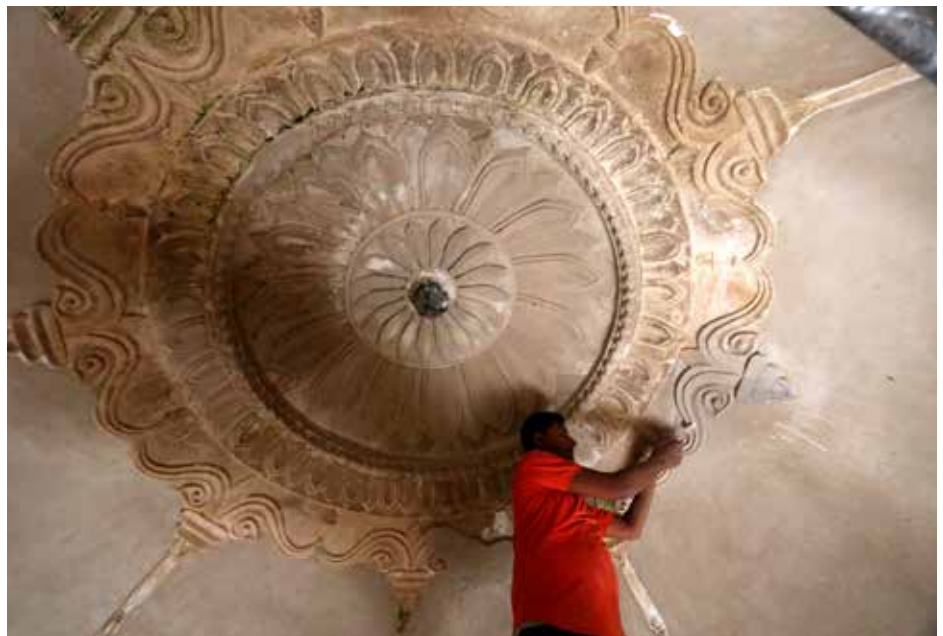
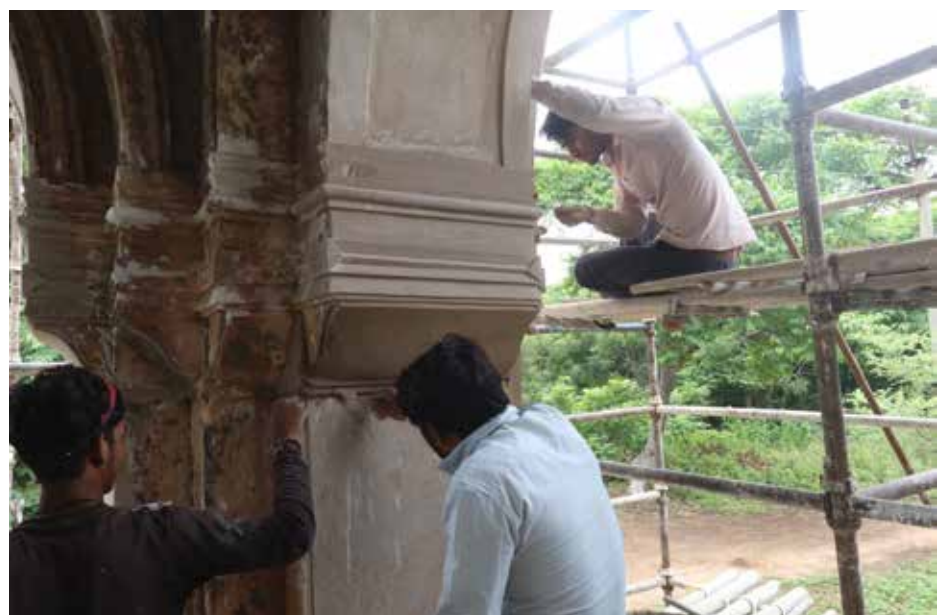
(Above) Ornamental medallion on the internal dome ceiling being restored based on original evidence; (Below) Skilled craftspeople restoring damaged capital bands

- Dismantling of dilapidated plaster layers from the wall and ceiling surfaces was carried out.
- Damaged capital bands and moulding bands on the internal and external facades were reinstated using rich lime mortar.
- Ornamental ceiling medallion on the internal dome ceiling and projected bay was carried out matching the existing detail by traditional craftsmen.

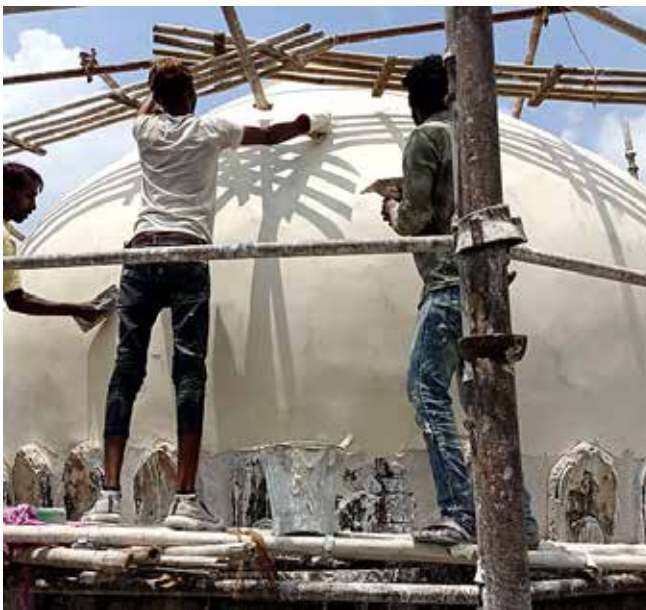
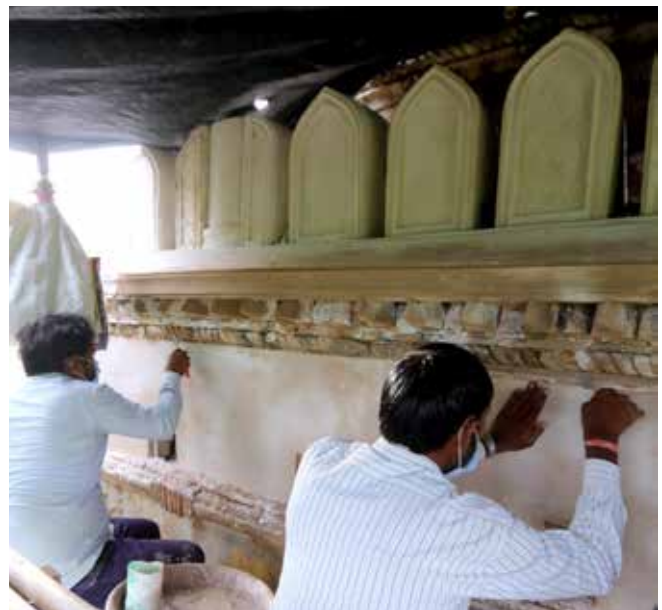
*(Left) Final lime punning of the dome after replastering;
(Right) Damaged merlons and the decorative bands below them were restored*

- Re-plastering of dome was carried out and finished with a one-millimetre thin layer of lime putty mixed with organic additives.
- Damaged merlons and moulding bands were reinstated on all sides of the monuments
- The dilapidated terrace concrete was dismantled, and deeply embedded plant growth was uprooted, and voids were filled with rich lime mortar.
- Traditional lime concrete was laid in appropriate slope to channel rainwater away from the structure

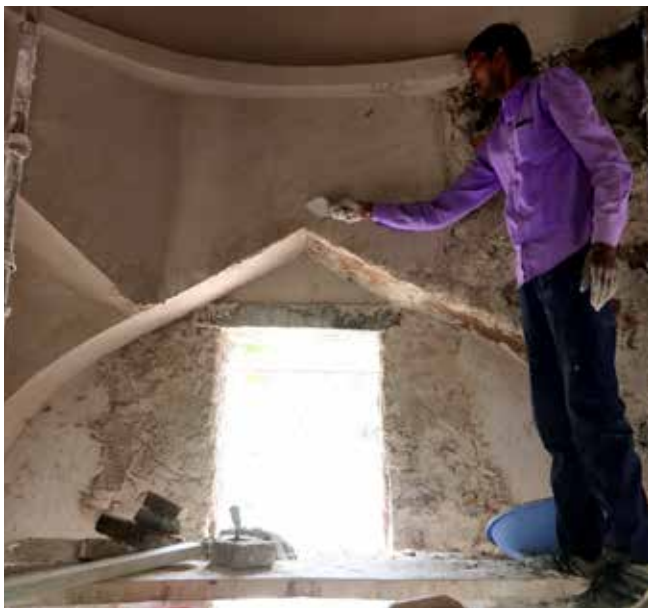
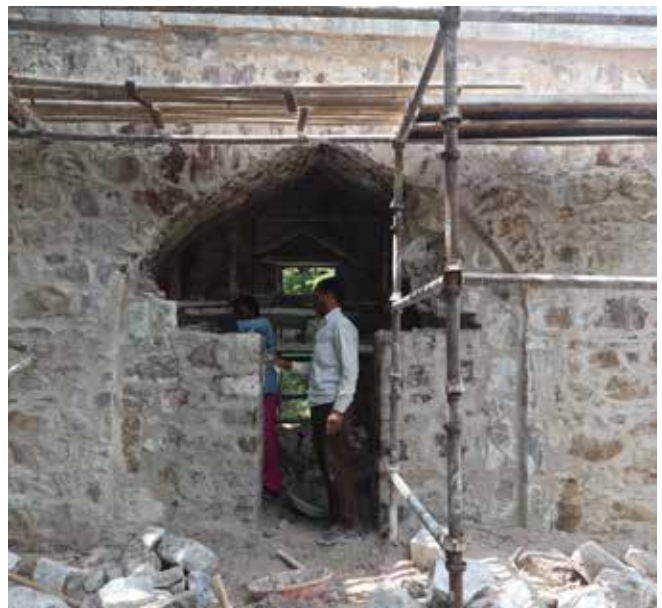
The structure had missing masonry at the arches and deep vegetational growth on the terrace. The monument also suffered from uneven settlement of the base.

- Dismantling of dilapidated plaster layers from the wall and ceiling surfaces was carried out.
- Masonry walls were constructed inside the arched openings in all four sides for structural support.
- Door openings with lintel stones at top were placed in centre of all four facades.
- Re-pointing was carried out on all four facades at lower level.
- Metal grills were installed on all the four door openings to prevent vandalism and allow for ambient air and light inside the mausoleum structure.
- Plaster repairs were carried out on the internal walls and ceiling surfaces of the mausoleum to match the existing evidence on site.

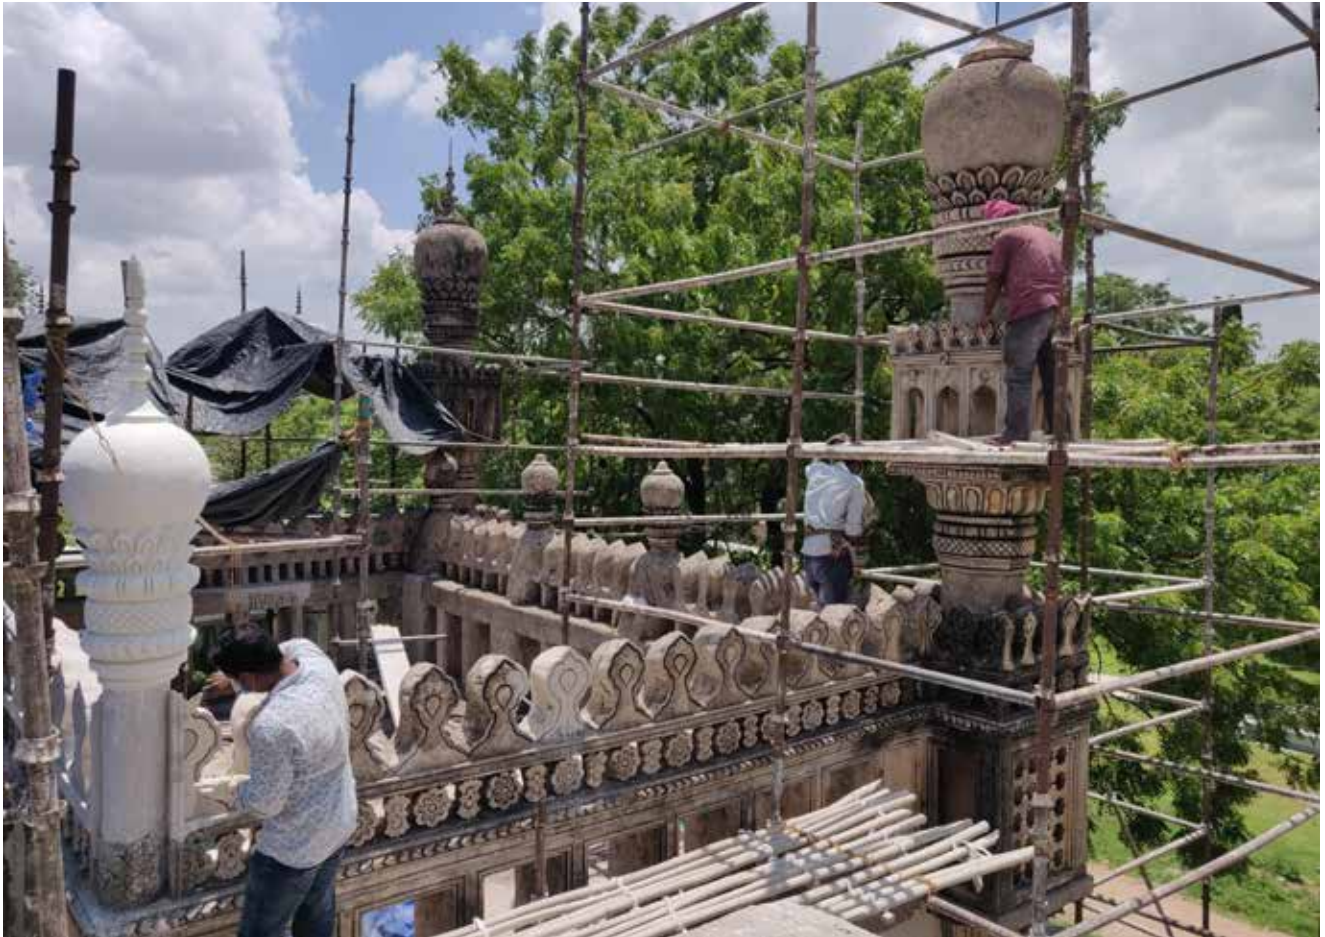
Minarets and the damaged merlons on the parapet walls were reinstated

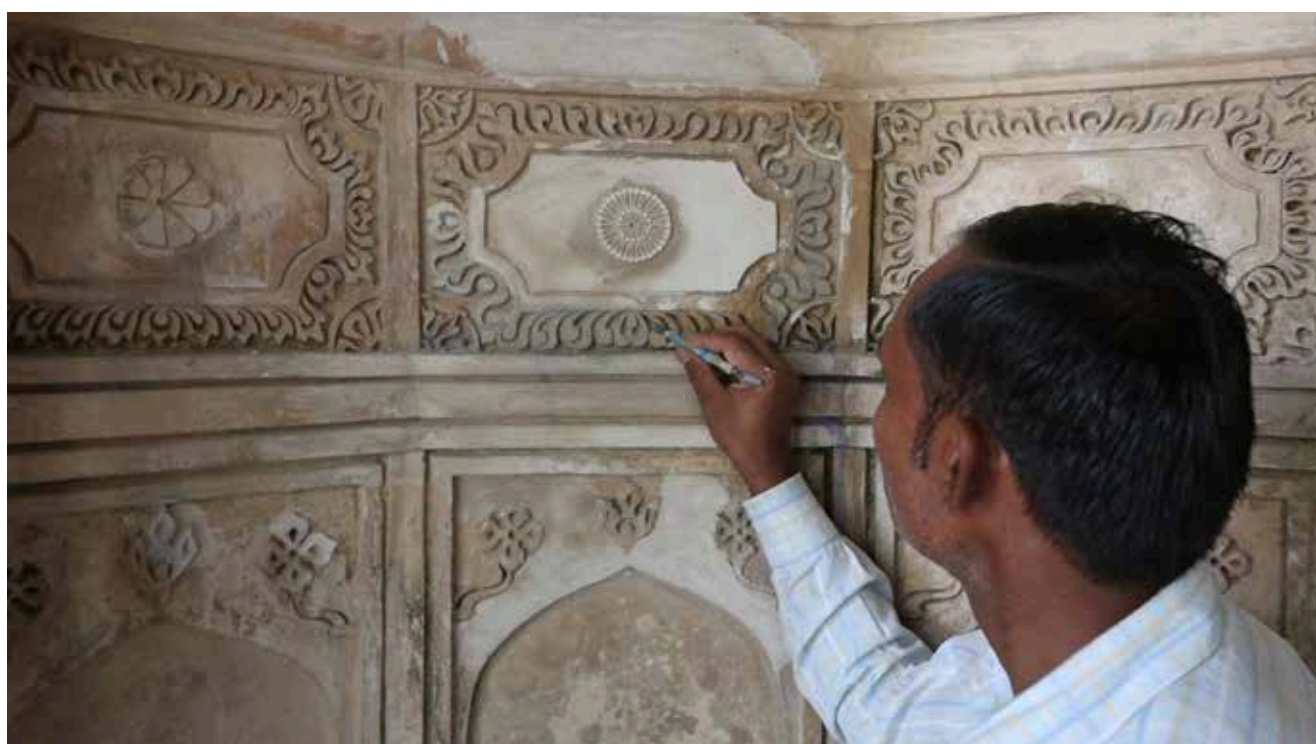
Master-craftsman restoring lime stucco ornamentation at the mihrab of the funerary mosque

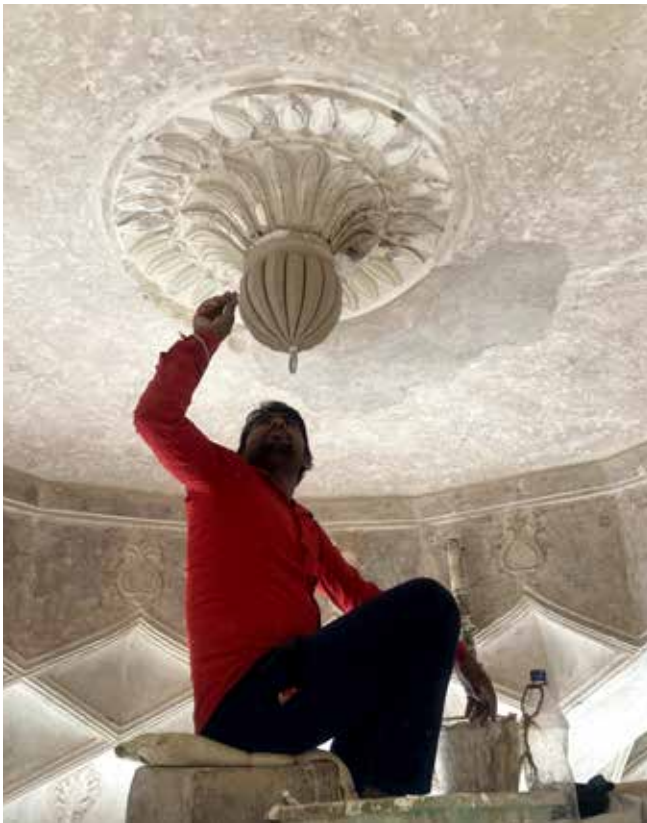
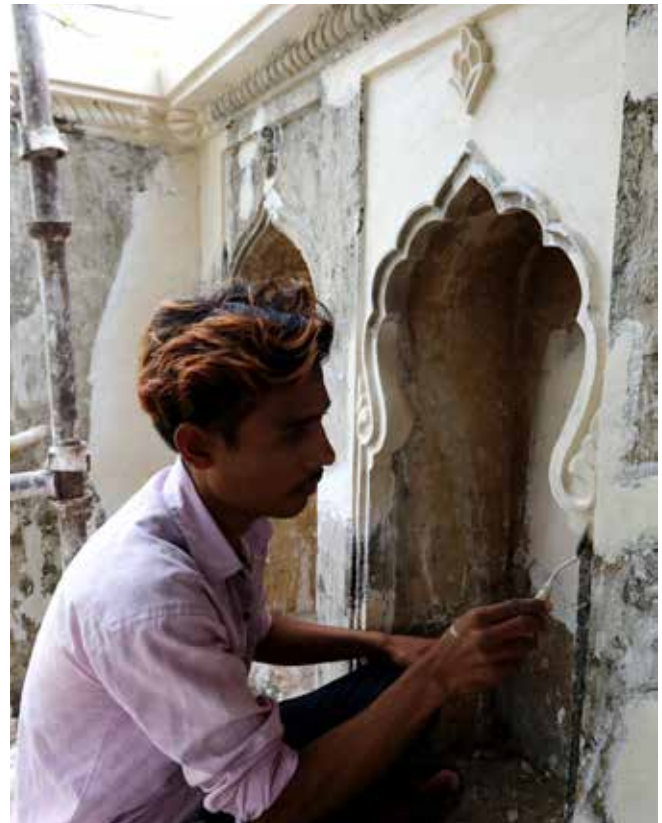
*(Left) Restoration of damaged ceiling medallion
(Right) Ornate details on the eastern parapet wall reinstated*

- Missing portions of the existing medallions and other intricate stucco details on the interior of north, west and south facades were restored using traditional lime mortar and finished with a layer of lime putty.

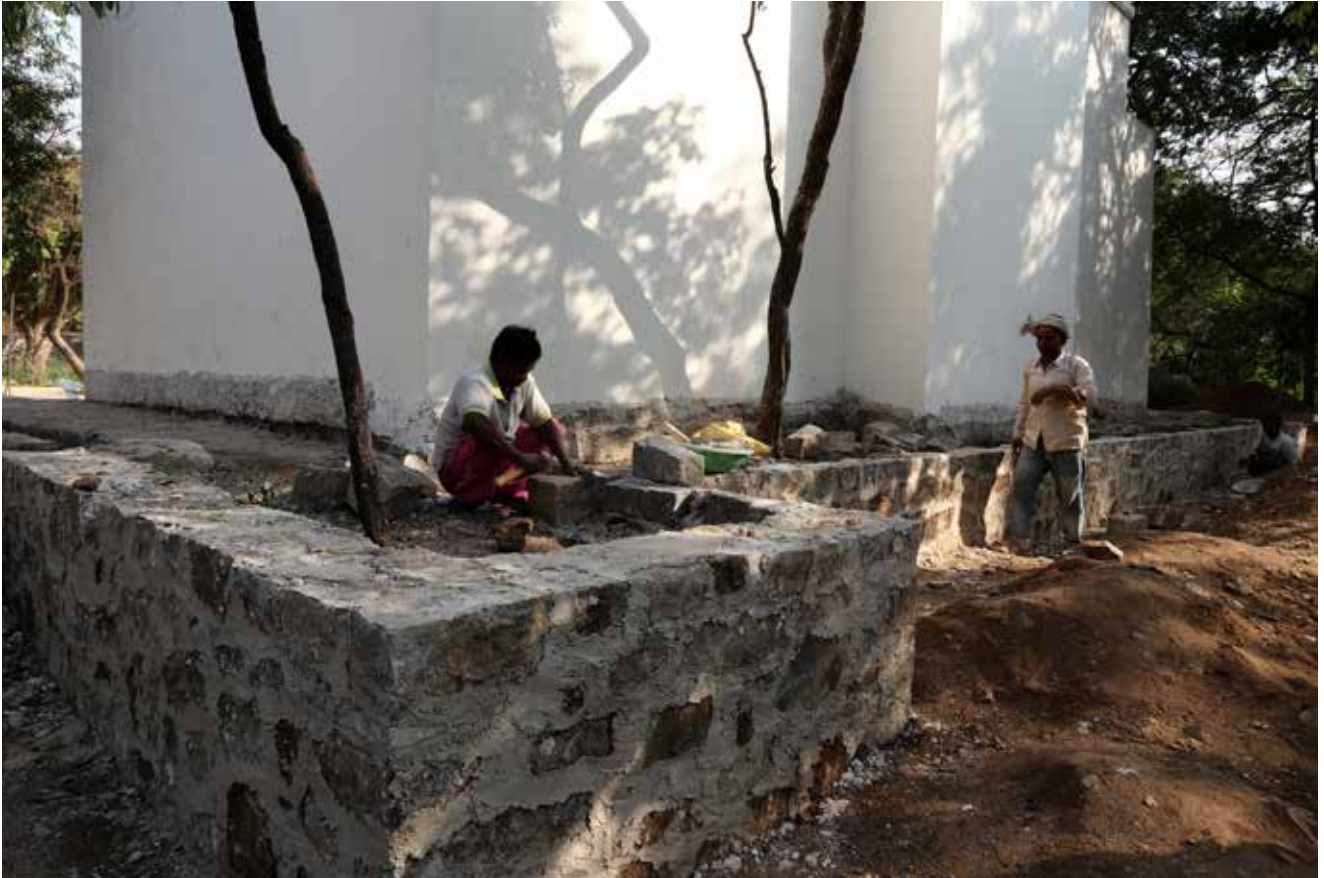
Stone craftsmen installed a plinth protection around the funerary mosque

- Scientific cleaning was carried out to define the original extent and historic levels of the monument.
- Base work for the plinth protection around the monument was completed based on the evidence found while considering the existing vegetation surrounding the monument.
- The water channel adjoining the plinth was exposed around the North-East corner. Consolidation of the same was carried out matching original levels.

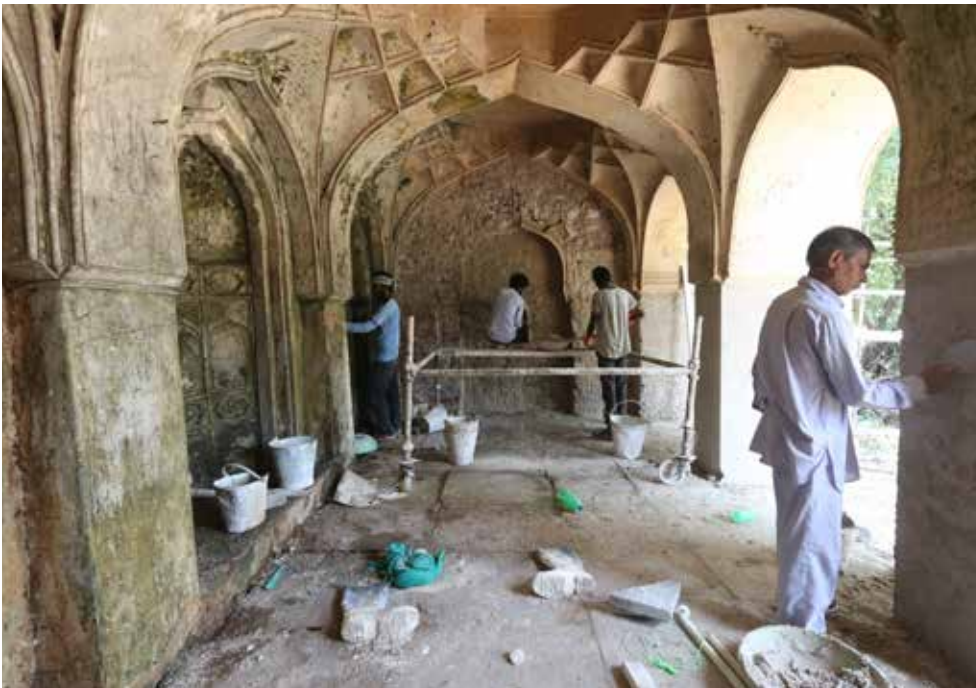
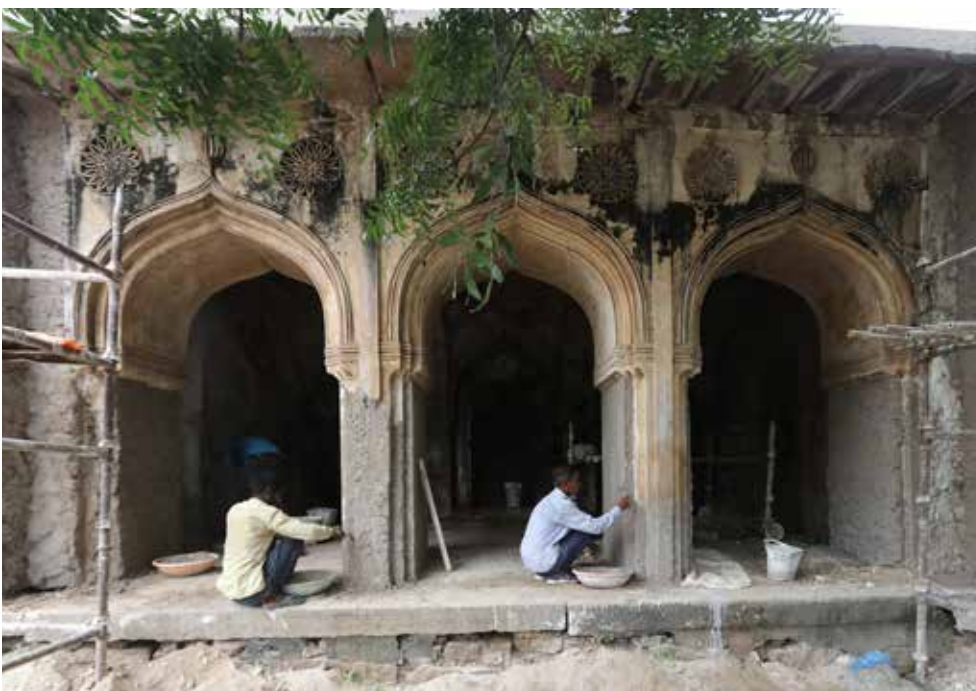
Plaster repairs were carried out on the damaged portions of the internal and external surface of the funerary mosque

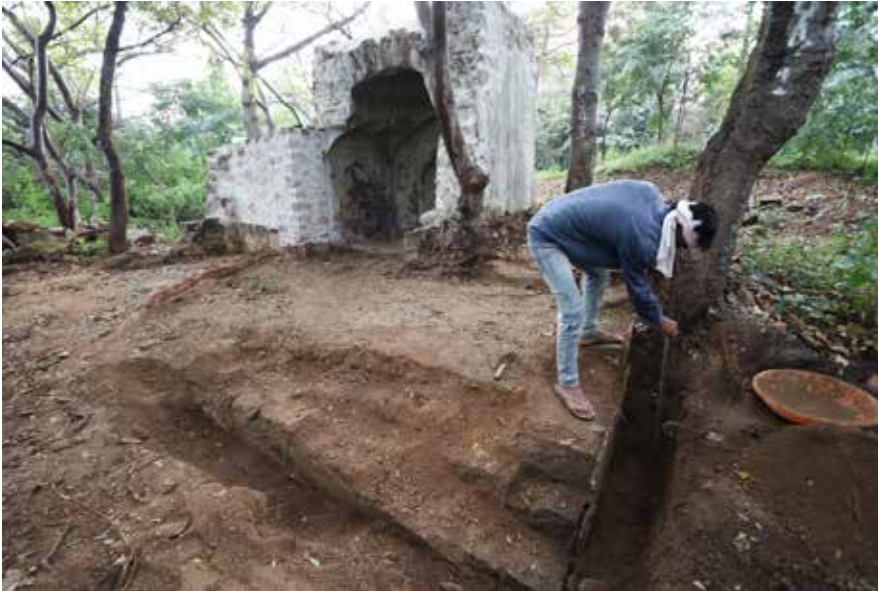
(Left) Scientific clearance around the ruin to determine the original extent
(Below) Architectural plan of the ruin

- Scientific cleaning and manual removal of the vegetation surrounding the monument was carried out to determine the original extents of the monument.
- Architectural documentation was done to define the original profile of the dilapidated portions to the east of the dome.
- Trial trench was dug at the northeast corner to mark the original plinth levels of the structure.
- Traditional lime concrete was laid on the existing terrace in an appropriate slope to channel rainwater away from the structure.
- Missing rainwater spout was installed on the western parapet.
- Re-pointing using lime mortar have been carried out on the external facades after removal of dilapidated plaster to prevent further ingress of rainwater.
- Masonry repairs on the masonry walls was carried out by stone masons using traditional lime mortar.

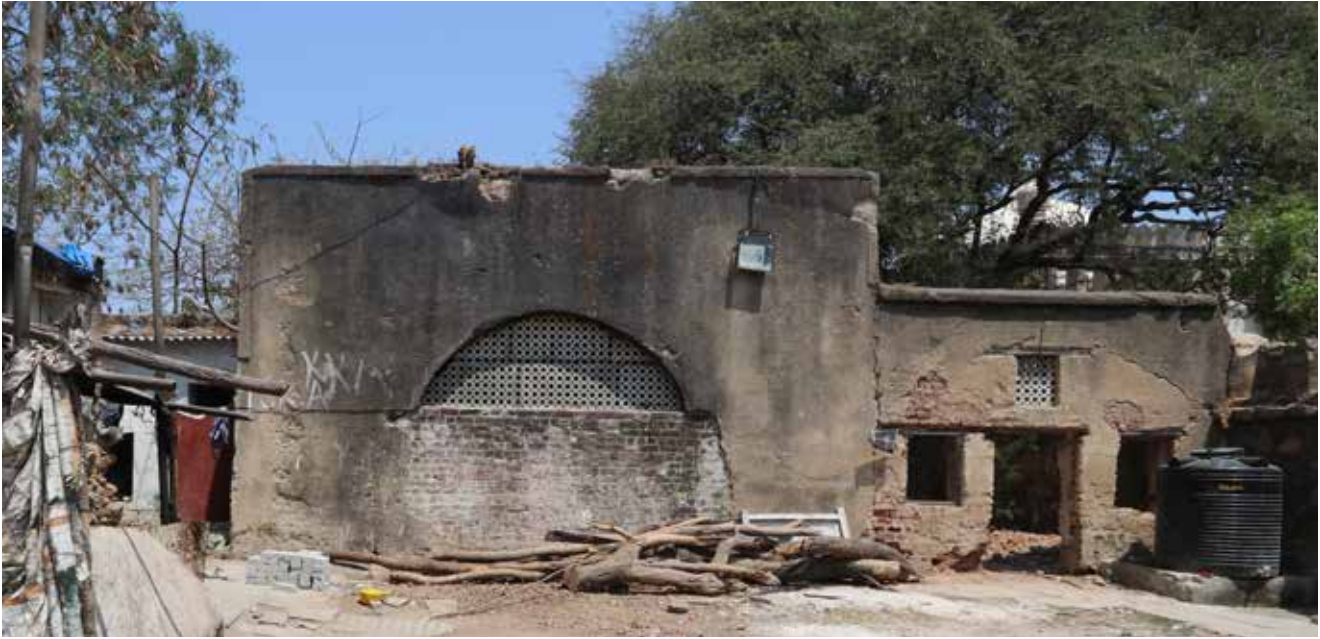
The structure suffered from vegetational growth with roots embedded deep inside the stone masonry at the terrace, and south and west facades.

- 20th century concrete was dismantled at the terrace as the monument had suffered water ingress causing sagging of the same. 6" thick traditional lime concrete was re-laid on the terrace to adequate slopes and finished with proper waterproofing after consolidation.
- The stone masonry on the external facades was derooted of the heavy vegetational growth with the help of chisels.
- 20th century cement plaster was removed from the external facade of the structure
- Raking was carried out to expose the stone masonry on the external facade.
- 20th century cement plaster was removed from the internal facade of the structure
- The walls were replastered with rich lime mortar followed by punning.

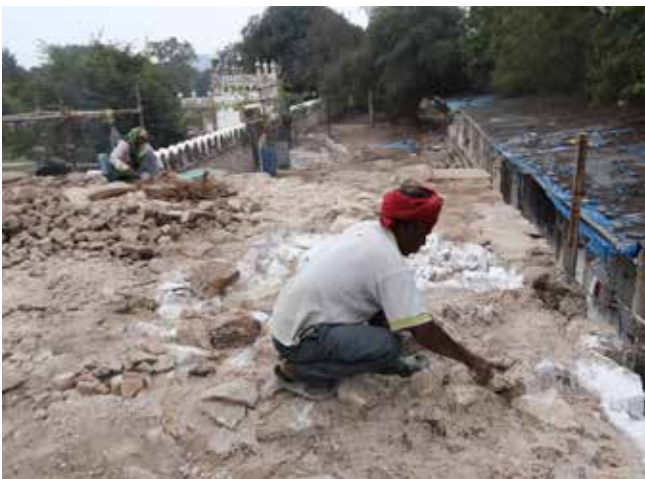
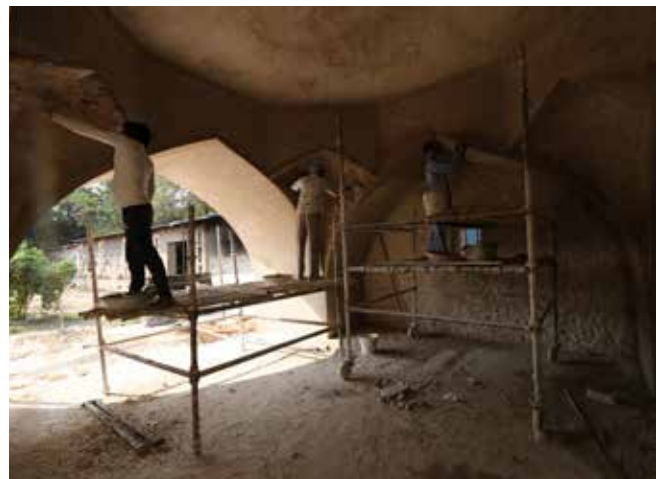
(Left) Stone mason relaying traditional lime concrete on the terrace;
(Right) Internal wall surfaces were replastered after dismantling damaged 20th century cement.

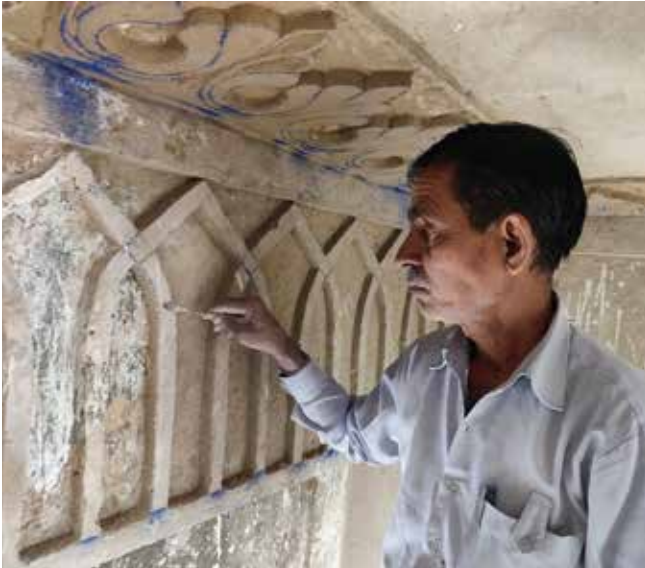
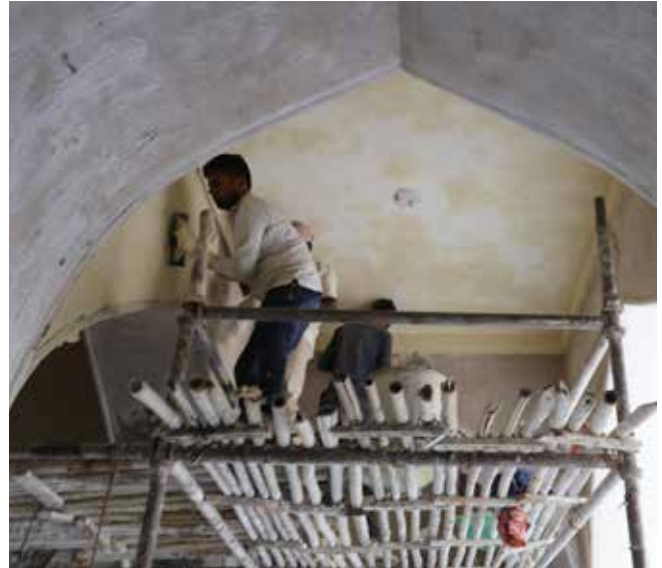
*(Clockwise from left) Ornamental stucco band on the ceiling edge restored;
Final lime punning layer on the internal walls following the plaster repairs;
Ceiling medallion was restored based on original evidence*

- Restoration of floral ceiling medallion, ornamental stucco band on the ceiling edge and the cusped arch frieze has been completed by master craftsmen corner arched bays.
- 20th century cement plaster has been dismantled from wall ceiling surfaces, followed by plaster repairs in traditional lime mortar.

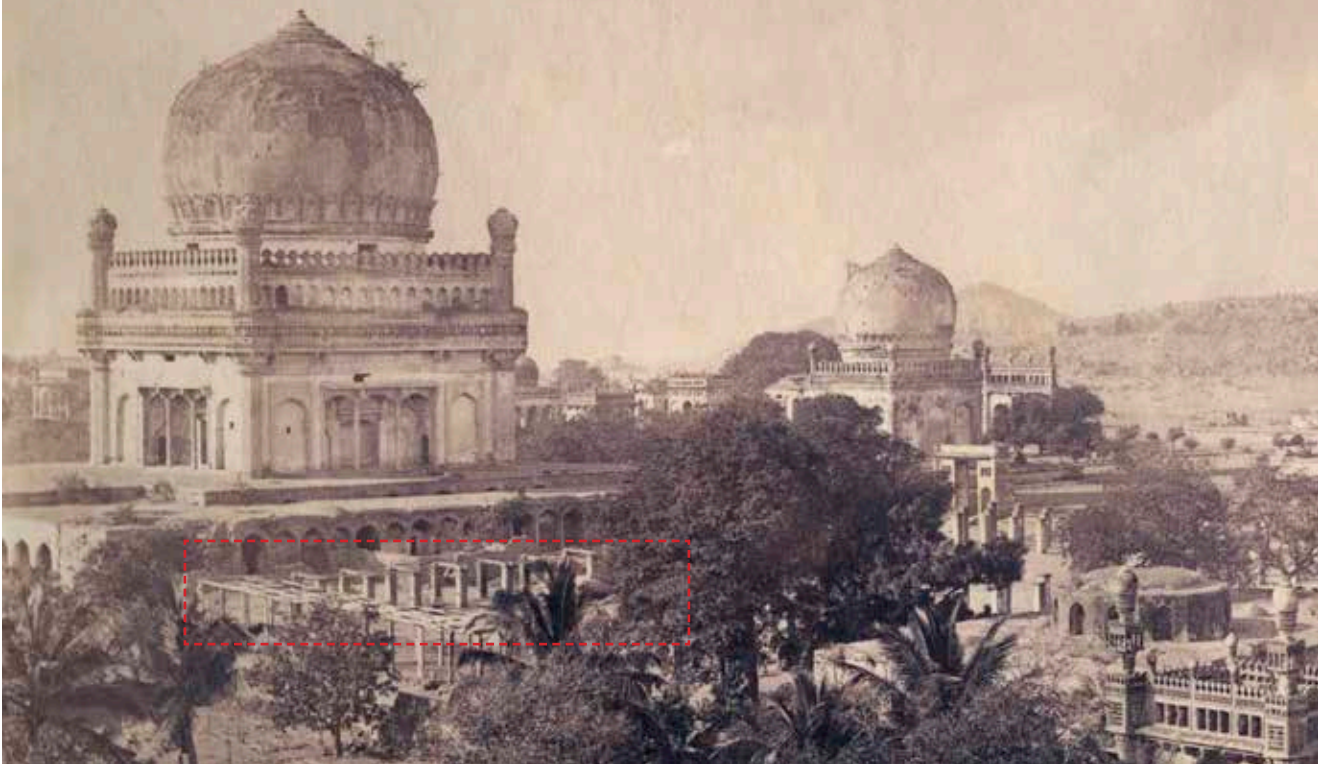
Installation of stone trellises based on vineyard seen in archival images

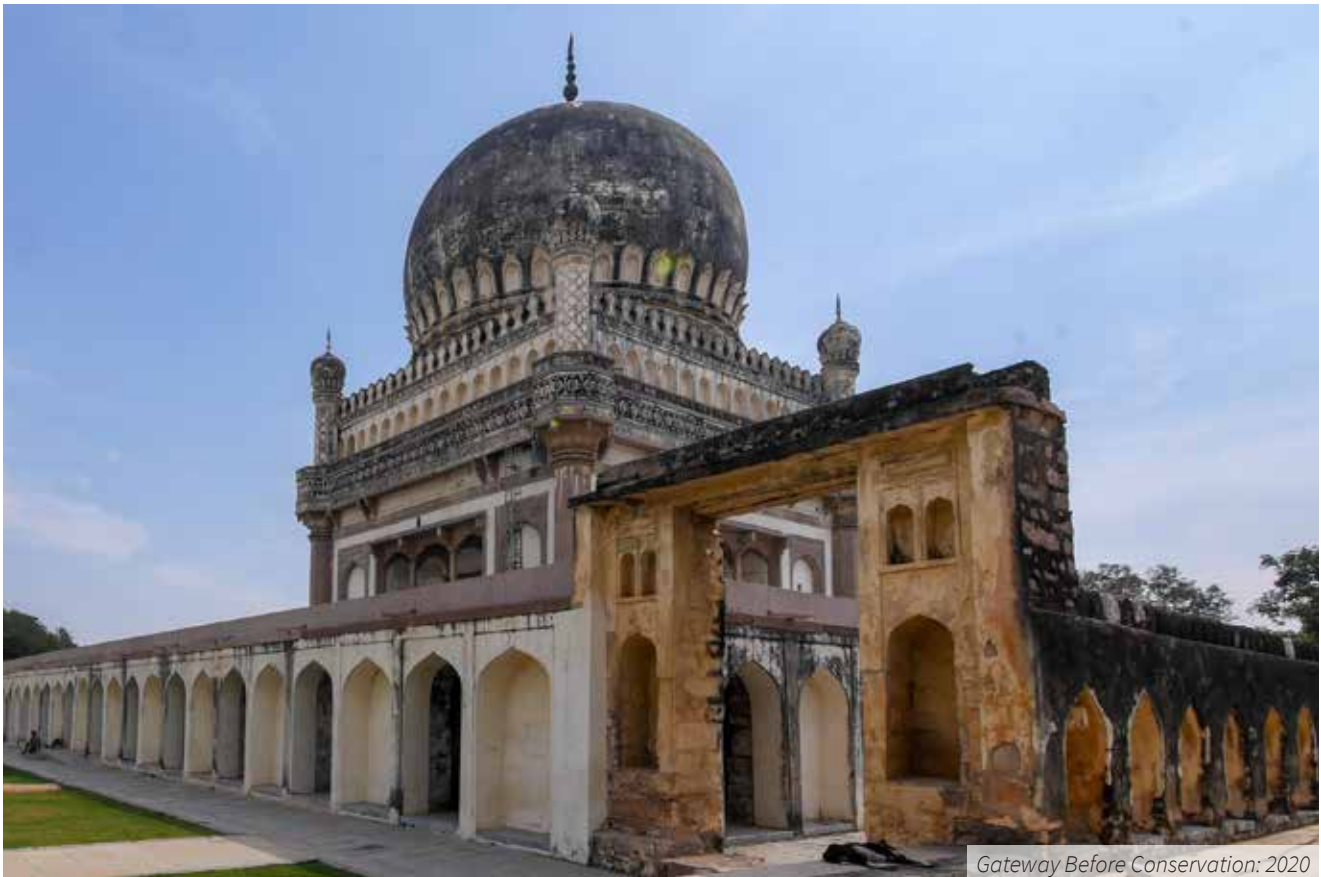
This gateway was found in a dilapidated condition with masonry exposed and details missing.

Gateway Before Conservation: 2020

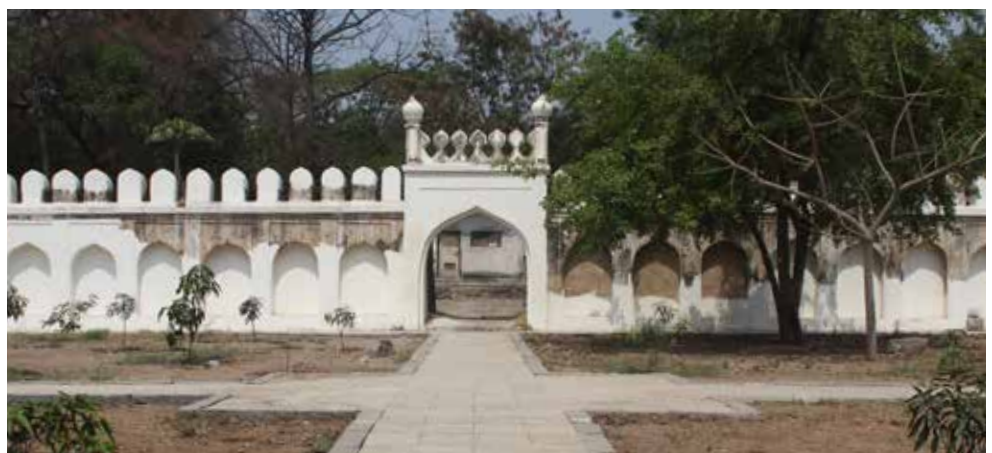
(Top) Battlements on top of the enclosure wall were revealed to the north of funerary mosque of Hayat Bakshi Begum on removal of 20th century cement plaster
(Right) Portion of the enclosure wall

- Repairs on the damaged battlements on the south-eastern end of the enclosure wall was carried out using rich lime mortar.
- Moulding bands below the battlements were reinstated on the entire length of the wall.
- Plaster repairs were carried out on the recessed arches and finished with 1-millimeter thin layer of lime putty mixed with organic additives.
- Racking of 20th century cement was followed with repointing with lime mortar on the north-western end of the enclosure wall.
- The crenelations at the top of the enclosure wall were revealed to the north of the funerary mosque of Hayat Bakshi Begum mausoleum.
- Raking and pointing of the existing historic coursed rubble masonry was carried out manually with wire brushes at the northeast and north side of the enclosure wall.

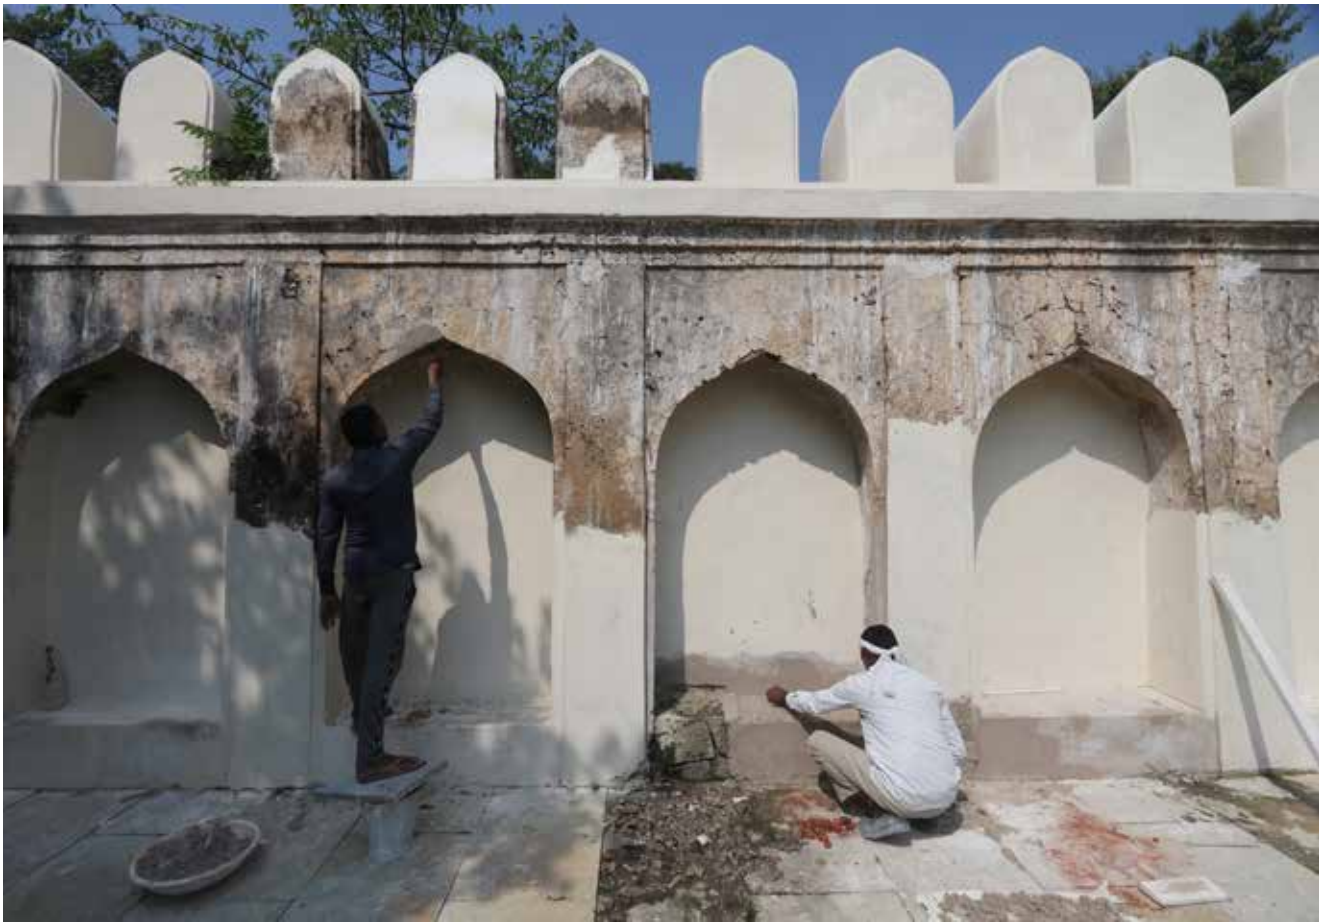
(Top) Damaged portions of the battlements and recessed arches were restored on the south-eastern end of the wall

- The missing crenelations on top of the northern and eastern side walls will be restored in random rubble stone masonry.

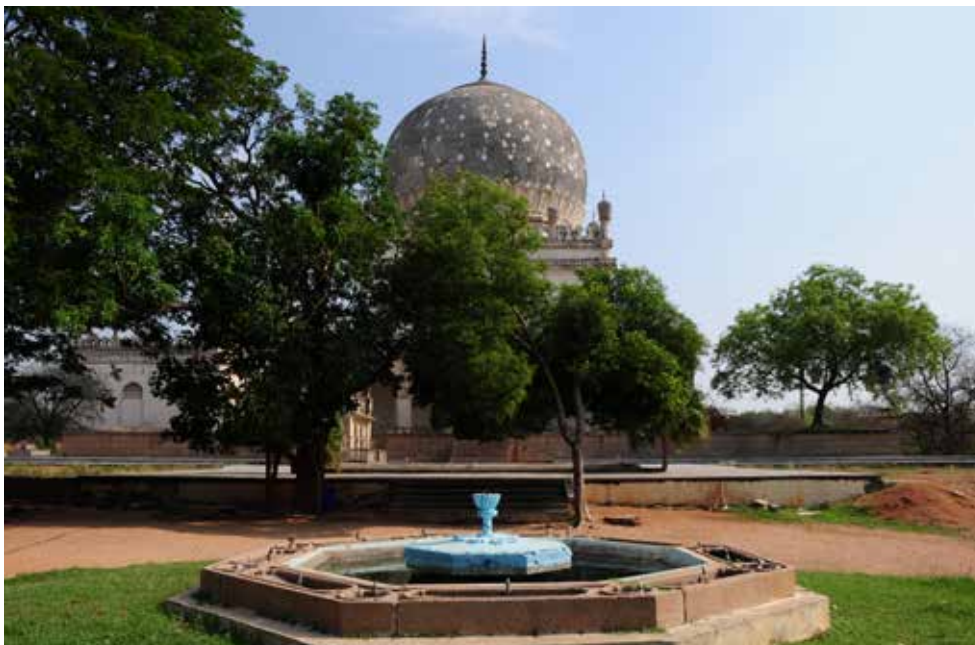
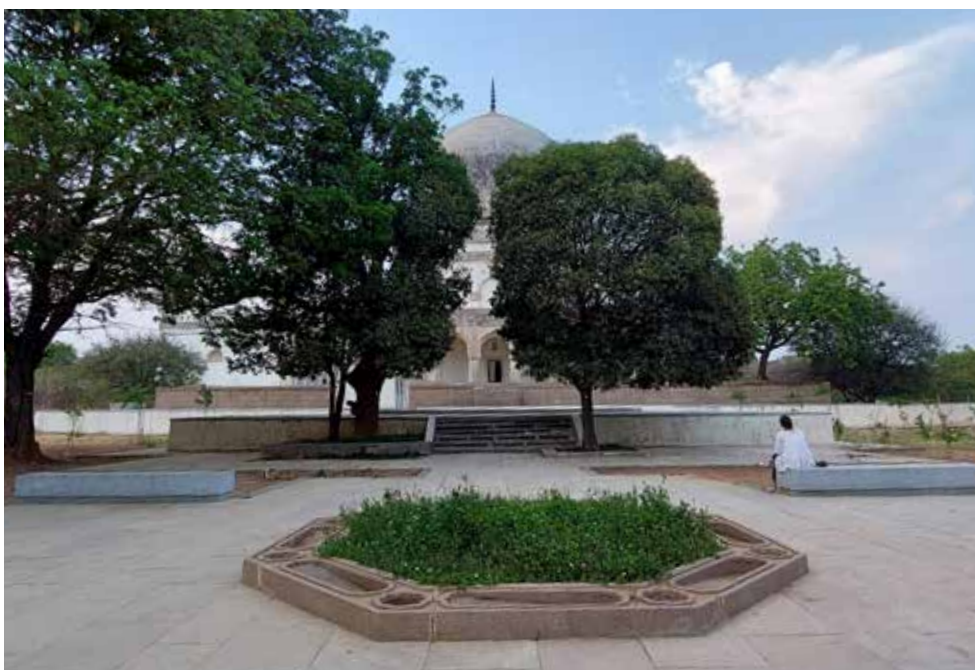
A plaza was developed south of Hayat Bakshi Begum. Brick and stone masonry were removed from the existing fountain, and the dressed stone feature was installed at the finished floor level of the plaza.
