QUTB SHAHI HERITAGE PARK

CONSERVATION & LANDSCAPE RESTORATION

ANNUAL REPORT 2021

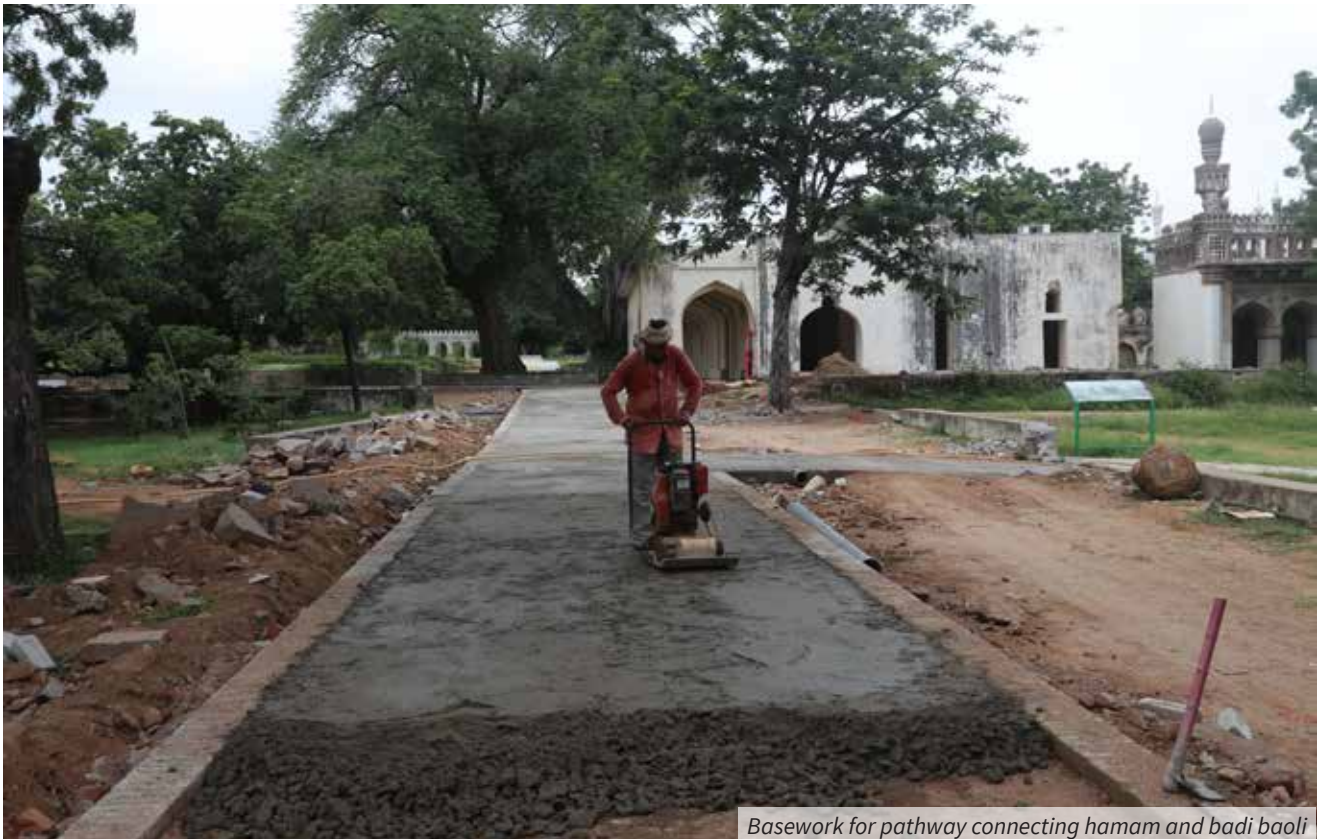
Basework for pathway connecting hamam and badi baoli

- The levels of the pathways have been finalised after careful consideration of the existing water channels which collect the rain water and direct it to the Badi Baoli.

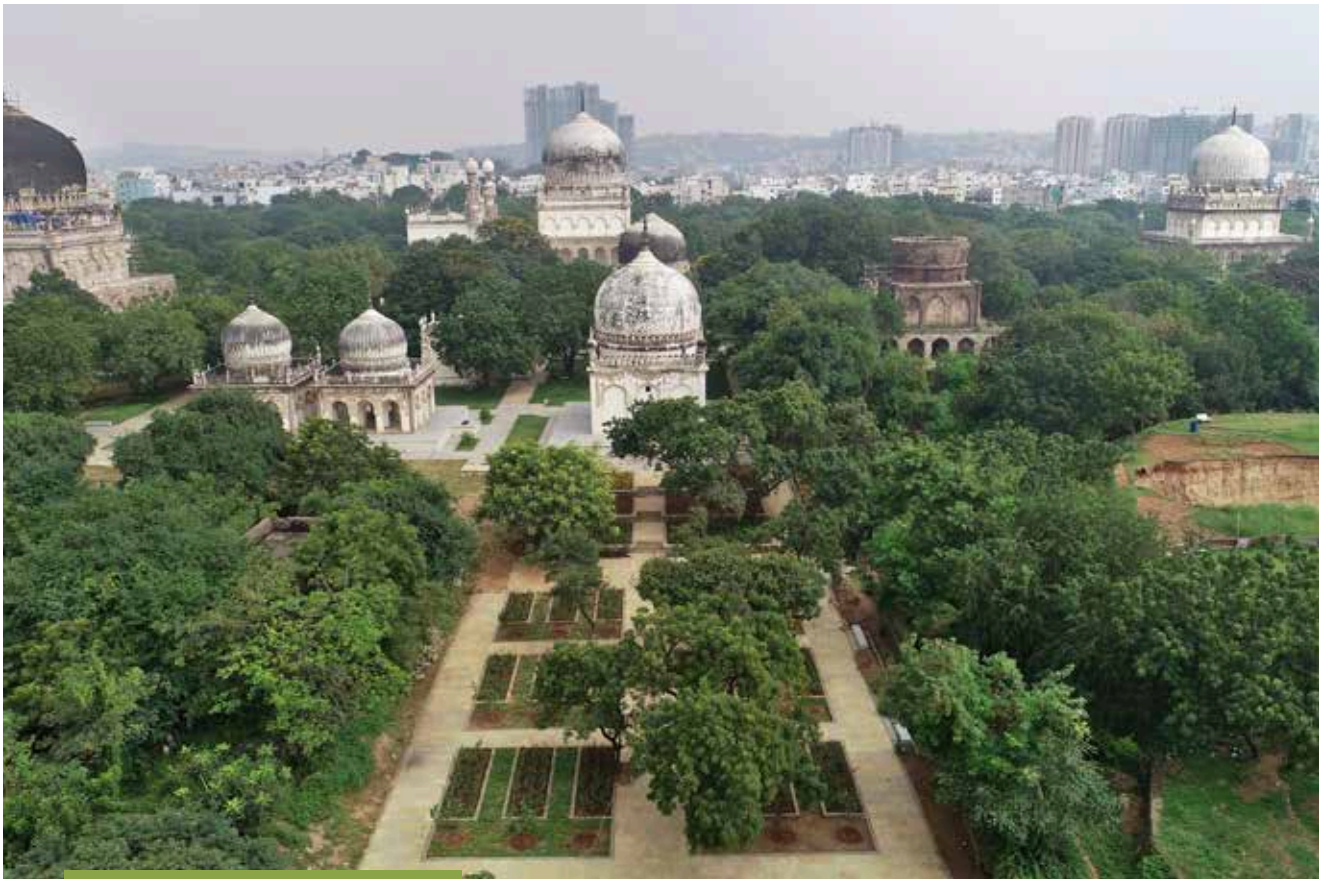
All the trees within the Qutb Shahi Heritage Park have been mapped and marked on the map. Basic information on every tree comprising of size of canopy, width of girth, height, species and nativity has been tabulated.

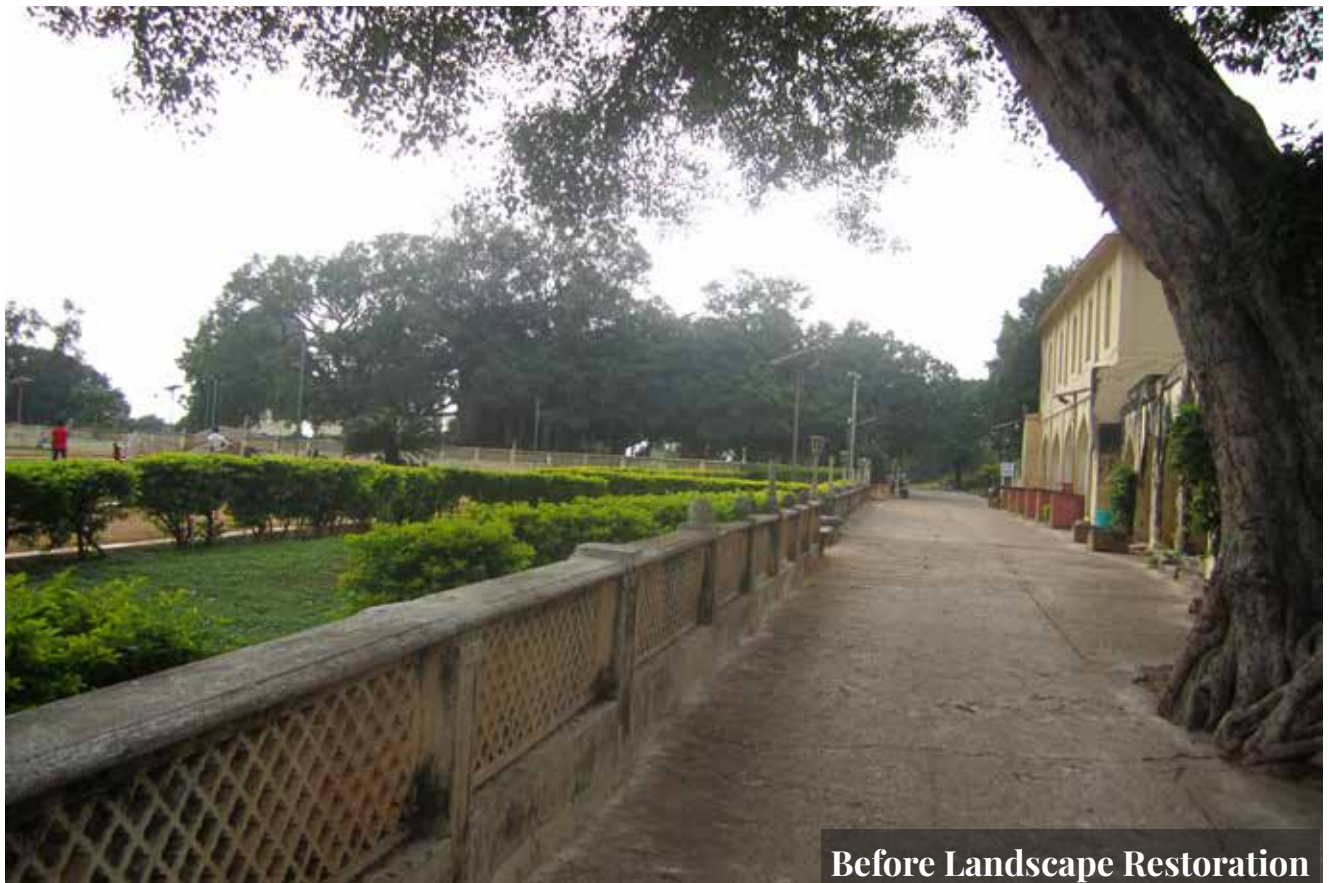
Before Landscape Restoration

(Above) While restoring the historic contours south of Hamam, it was realised that the roots of the Peepal tree abutting the structure would remain exposed. Hence, a planter in random rubble masonry was built around the tree to an adequate height.

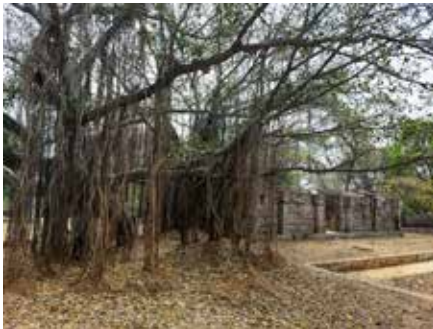
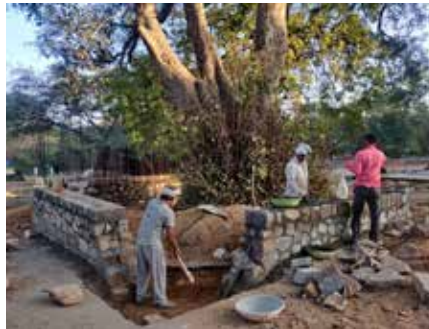
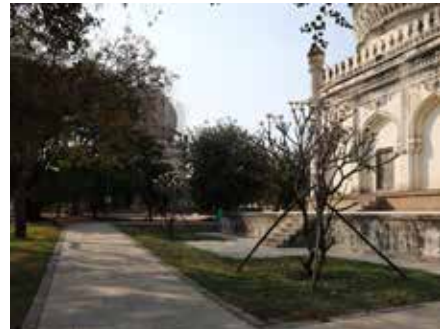
*(Left) Aerial roots of the banyan abutting Fadma Khanum's mausoleum
(Centre) Planters around the trees were built to safeguard them
(Right) Champa tree was transplanted from the Deccan park area*

- At many places, necessary changes to the profile of the pathways were made to ensure adequate area for uninterrupted tree growth. Similarly, masonry walls have been built along the pathways or around the trees ensuring that the existing earth levels are retained.
- Smaller native trees growing in sensitive areas such as on the monuments, plinths or other areas causing damage to the monument have been successfully transplanted to a open areas.
- Invasive species such as Subabool are removed from the ecological zone to allow unhindered growth of existing trees with rich medicinal and ecological value.

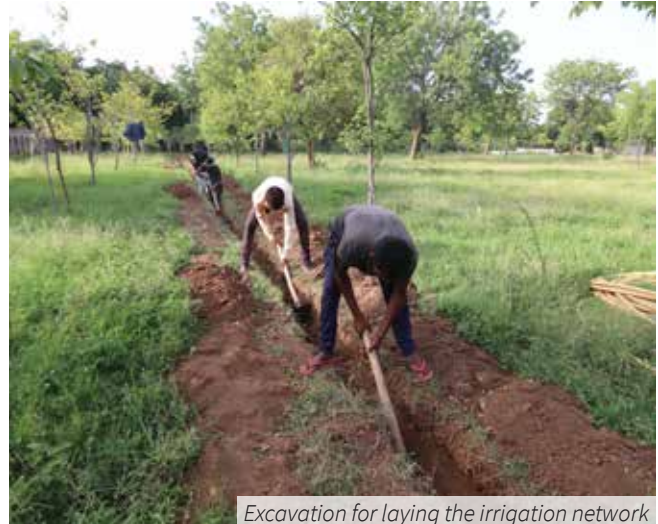
Excavation for laying the irrigation network

- Four water pumps (3- 5 Hp) has been installed in four major baolis (Badi baoli, Idgah baoli, Jamshed Baoli and Hamam Baoli) to draw water from the stepped wells.
- UPVC water line of 3300 mts (approx.) has been laid in phase-I and phase-II of the complex catering the major manicured green spaces and orchard greens.
- Outlets are provided at various points to ensure easy accessibility of water to the farthest area of the site where regular watering is required.
- This has not only increased the efficiency of the horticulture staff but also improved the water utilization and management capacity.

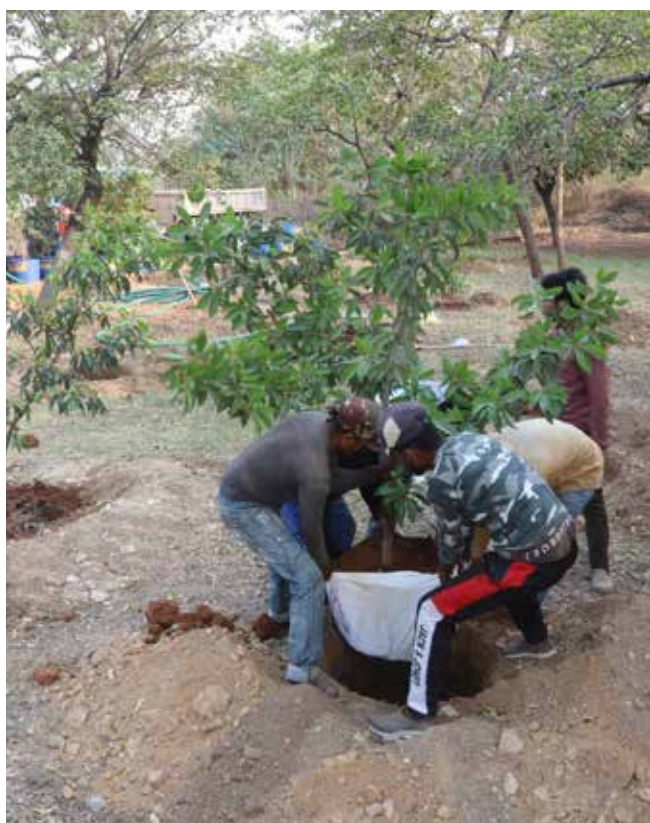
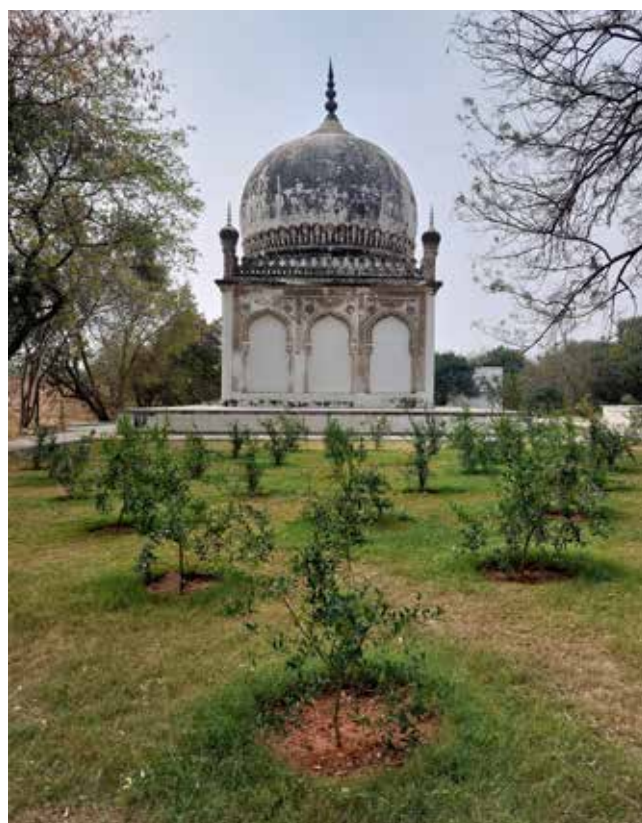
(Left) Chikoo plantation south of Muhammad Qutb Shah's mausoleum
(Right) Pomegranate trees planted north of Commander's mausoleum

- Ground cover such as wadelia, Verbena and Hemelia was planted at various locations such as north of Taramati Tomb, south of Hamam and south of Hayat Bakshi Begum.

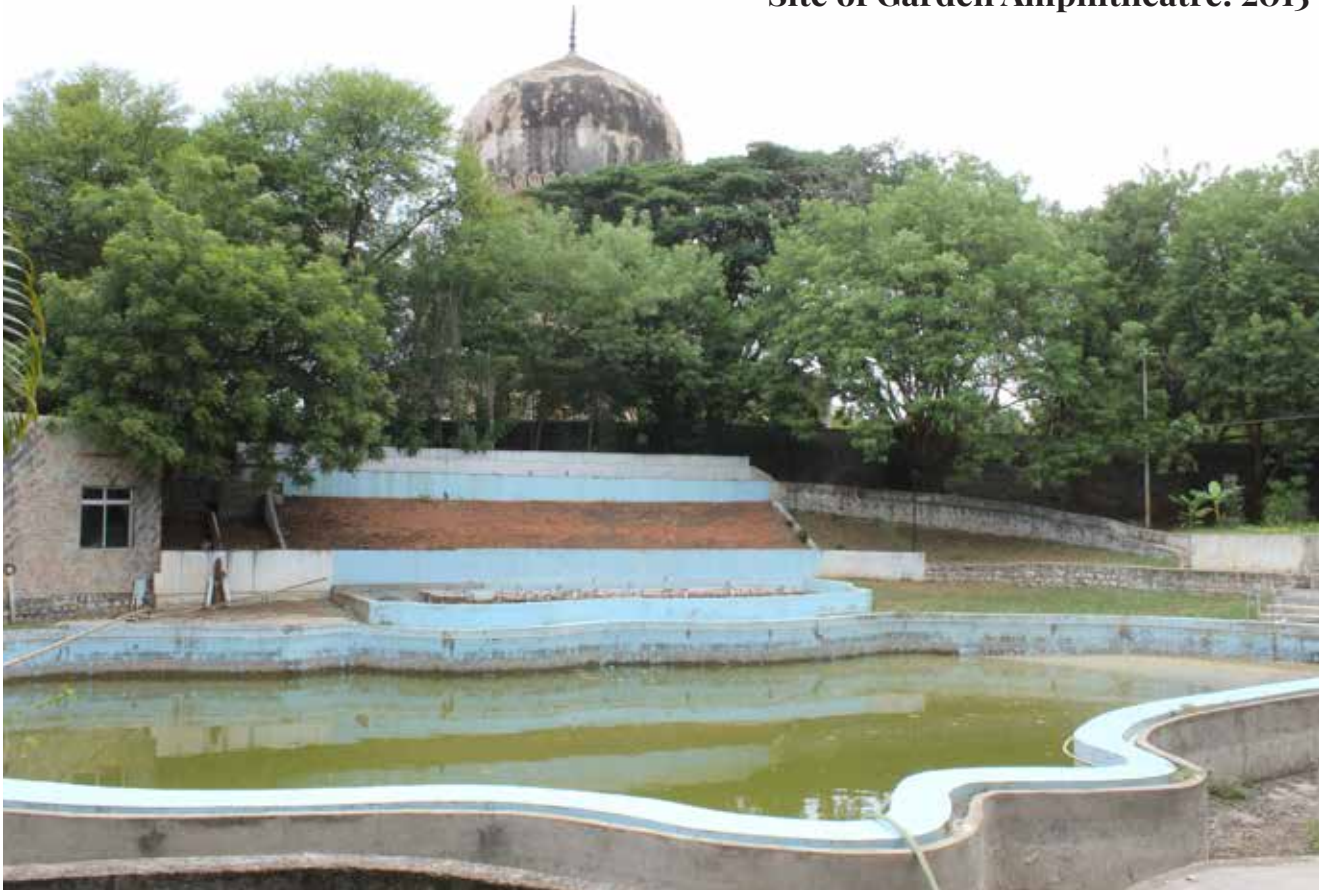
Site of Garden Amphitheatre: 2015

*(Above) The 'defunct' swimming pool replacing which the Garden Amphitheatre was developed
(Below) A Jazz Concert was held in December, 2021 at the newly developed Garden Amphitheatre*

- All the civil work for the garden amphitheatre has been completed including laying of pathways around the Amphitheatre with 50 mm thick Tandur in appropriate slopes and pattern as per design.
- Construction of rear wall has been completed with provisions for light fixtures in niches as per the proposed design.
- Provision for storm water disposal has been made in the south west corner of the amphitheatre.
- Plantation along with laying of local grass has been completed in the immediate surroundings of the amphitheatre.

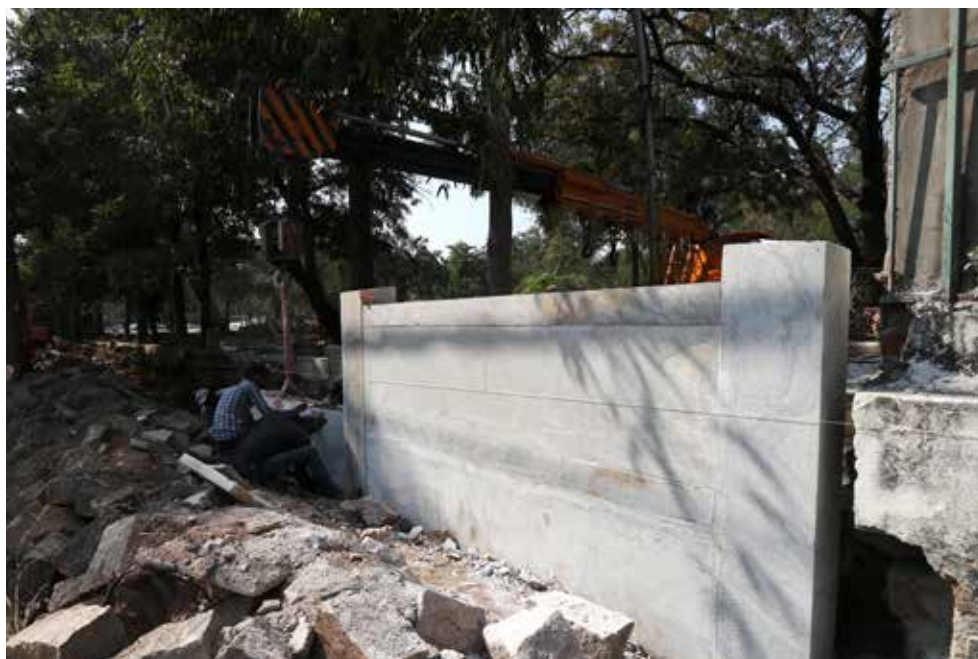
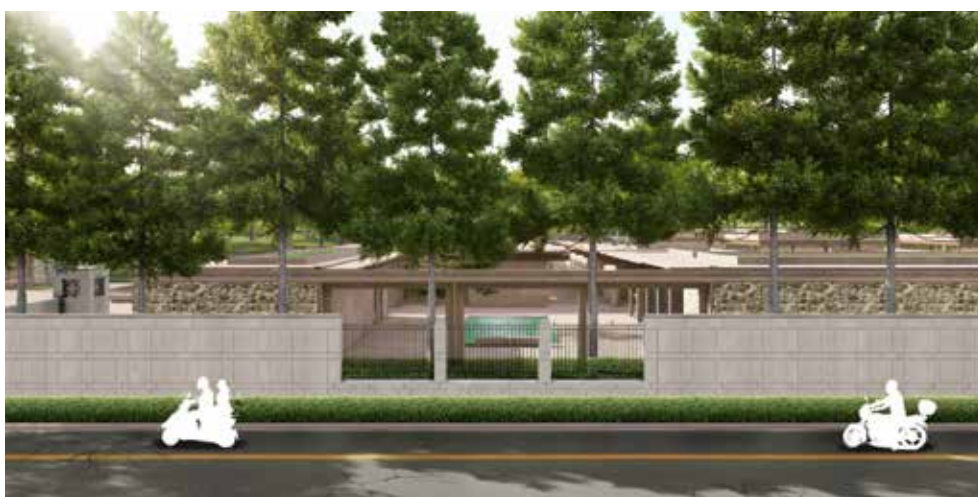
(Above) Installation of stone blocks for the boundary wall
(Below) Proposed view of the boundary wall

- Stone blocks of required size and pattern has been installed on 120 metres of the wall separating the Parking from the rest of the Park.
- Similar stone blocks have been placed on the boundary wall along the main road leading from Shaikpet to Golconda fort as per the pattern size and existing levels, following the removal of the existing metal grills demarcating the boundary of Deccan Park on the east side. 100 metres of the 250 metres have been completed.
- 2.4 metres high 300 mm thick stone columns have been placed every 2.7 metres as per the proposed design of the front boundary wall.
- Sample of metal grill design has been fixed and final colour of the grills have been finalised.
- Metal grills are being installed on the both the walls as per the proposal.

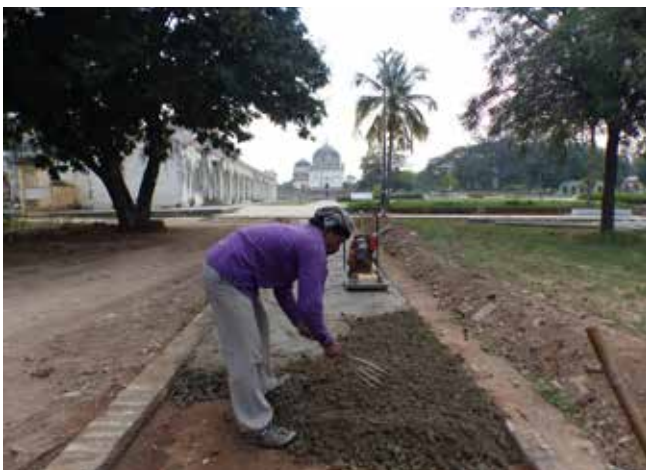
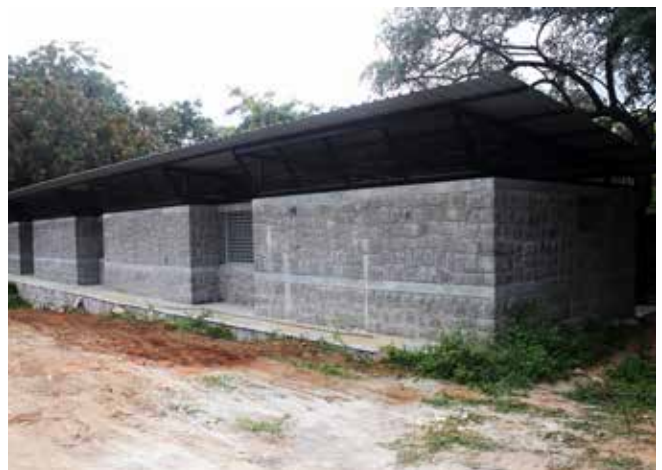
(Left) Basework of pathway north of toilet block

(Right) Construction of toilet block nearing completion

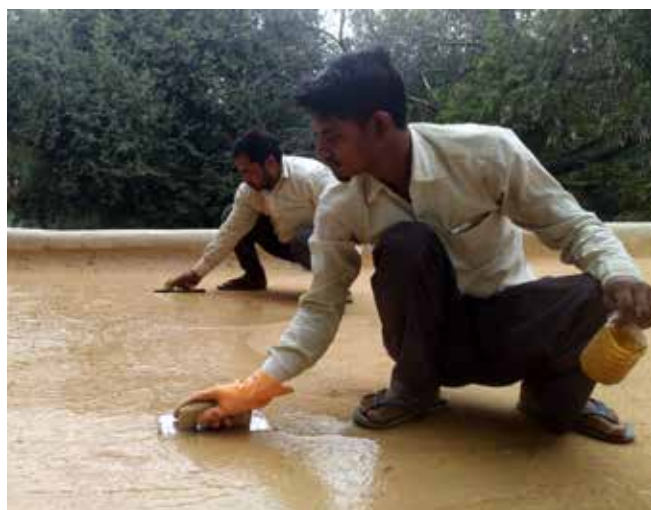
(Left) Spreading and Levelling waterproofing layer on the terrace of Samakhana using traditional aggregates

- The existing terrace concrete on Samakhana was found to be dilapidated and hence was dismantled.
- Traditional lime concrete was laid on the roof of Samakhana and adequate compaction has been undertaken along with organic additives.

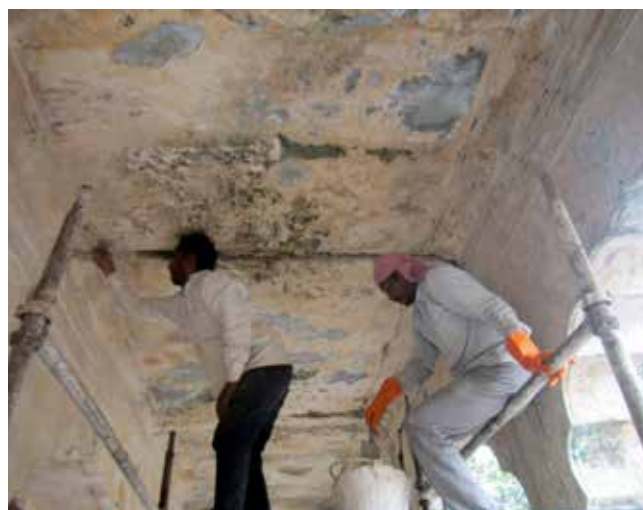
(Right) Repairs of the cracks on the roof of Ghansimiyan's tomb

- Structural cracks along the roof were adequately repaired and grouted with traditional lime mortar with organic additives.
- Layers of paint from the surfaces of the internal facade was removed manually to reveal the lime punning below.

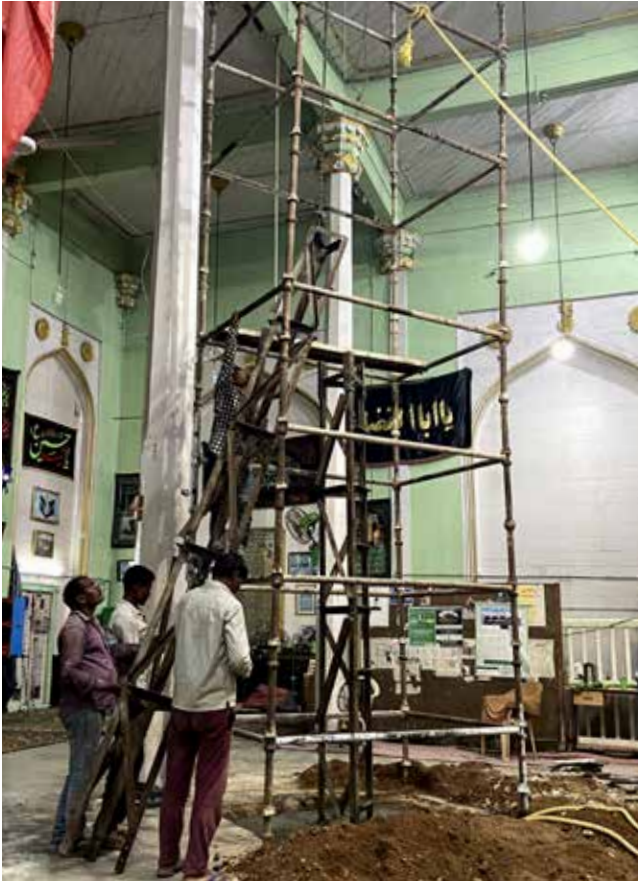
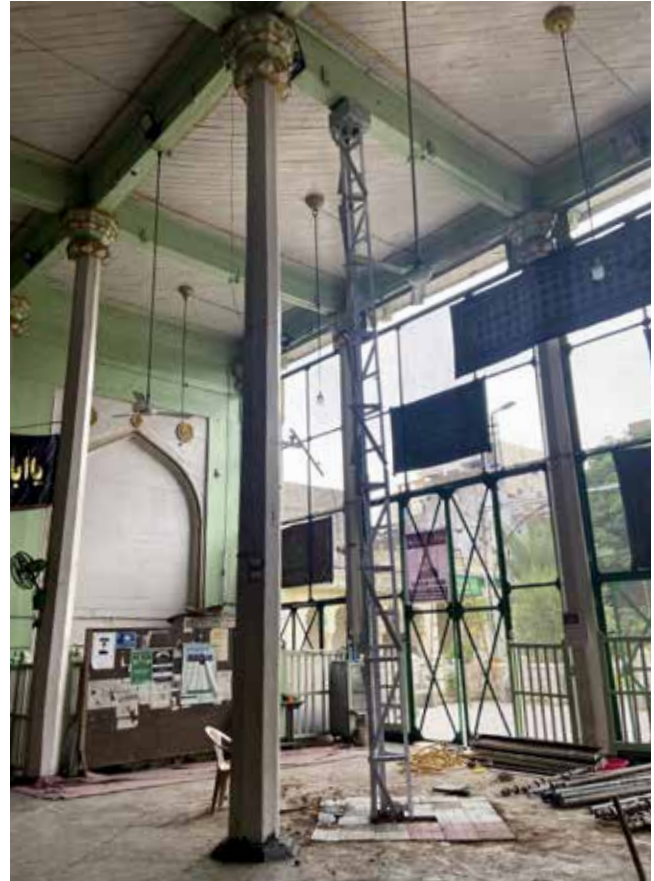
Temporary steel supports installed to support the sagging wooden beam and prevent further displacement on the damaged wooden bracket

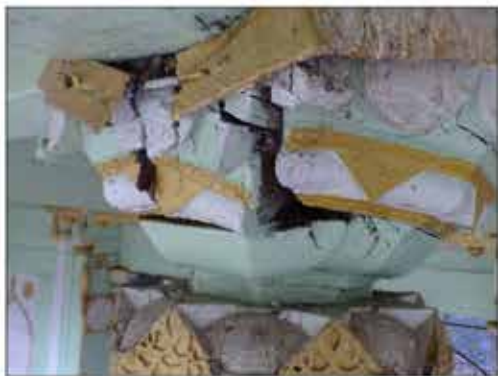
Deteriorating Timber Capital

- Documentation of tiles in the main building has been completed along with condition assessment.
- It was observed that one of the wooden column capital in the foyer of the main building had developed cracks due to water seepage while being displaced from its original location due to deviation in one of the wooden beams. After thorough investigation, with the Department of Heritage Telangana, temporary steel supports were installed as shoring for additional strength till appropriate measures are taken to secure the structure.
- Temporary grouting work was undertaken and sizes of water spouts on the terrace were increased for effective drainage of storm water.

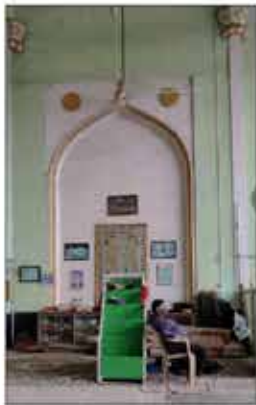
Enamel Painted Timber Planks

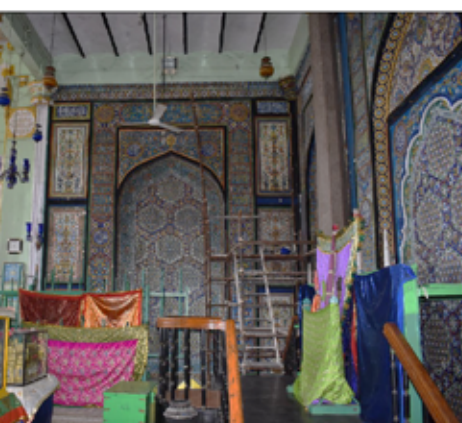
Glazed Mosaic Tile Panel - 5

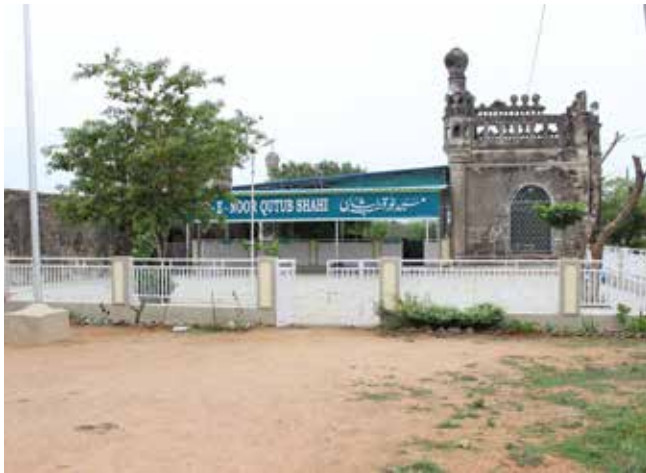
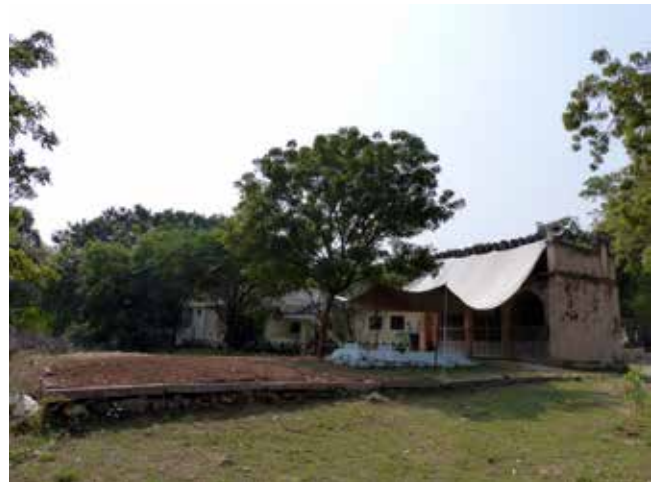
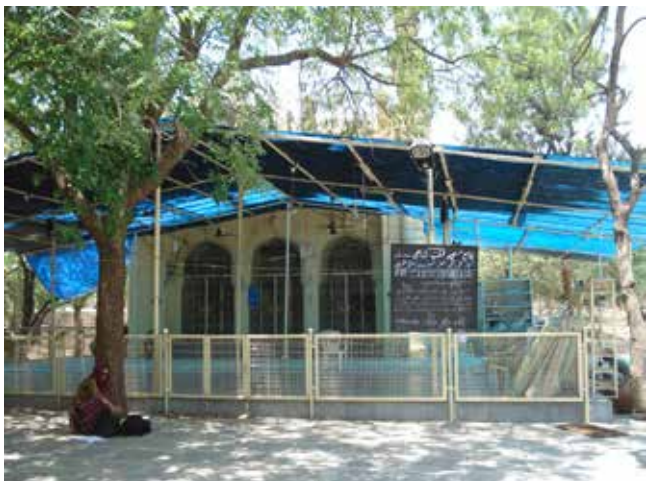
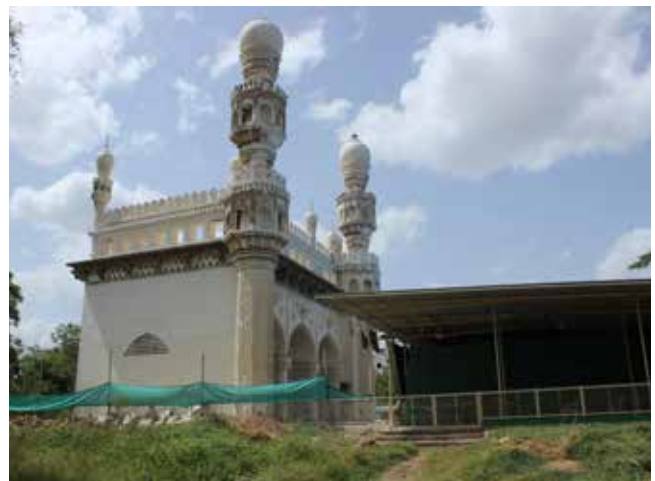
Four encroached funerary mosques within the Qutb Shahi Heritage Park

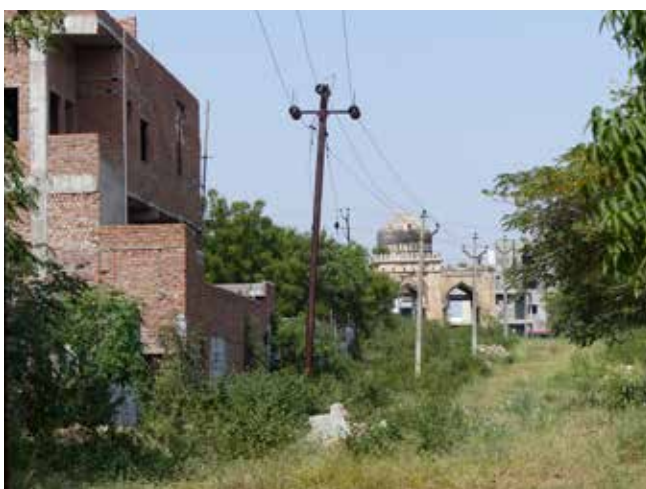
Modern constructions on the west and north sides of the site disturb the long view of the monuments.

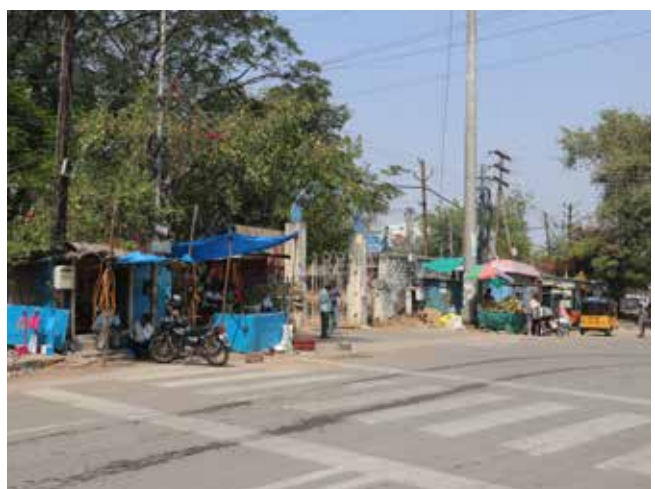
Illegal shops encroachment outside eastern periphery

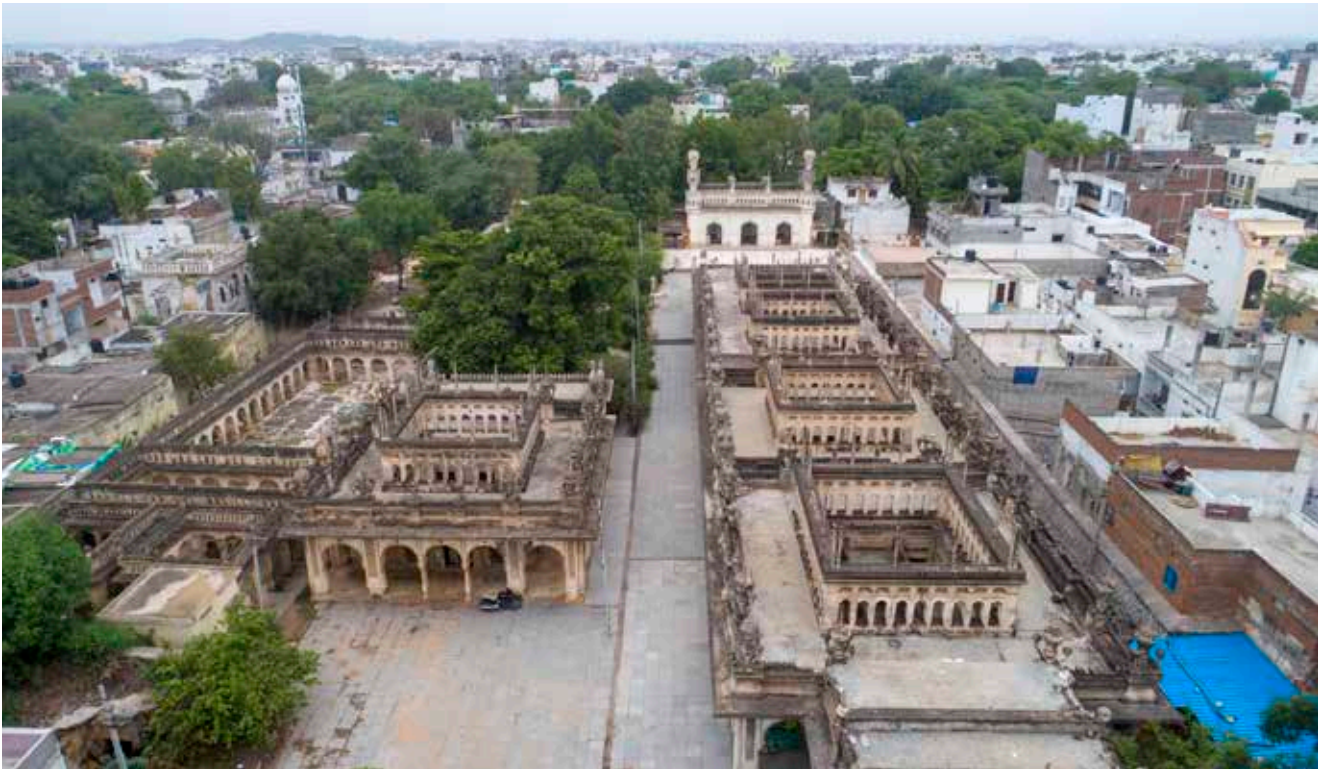
Paigah Tomb complex hemmed in by modern construction on periphery

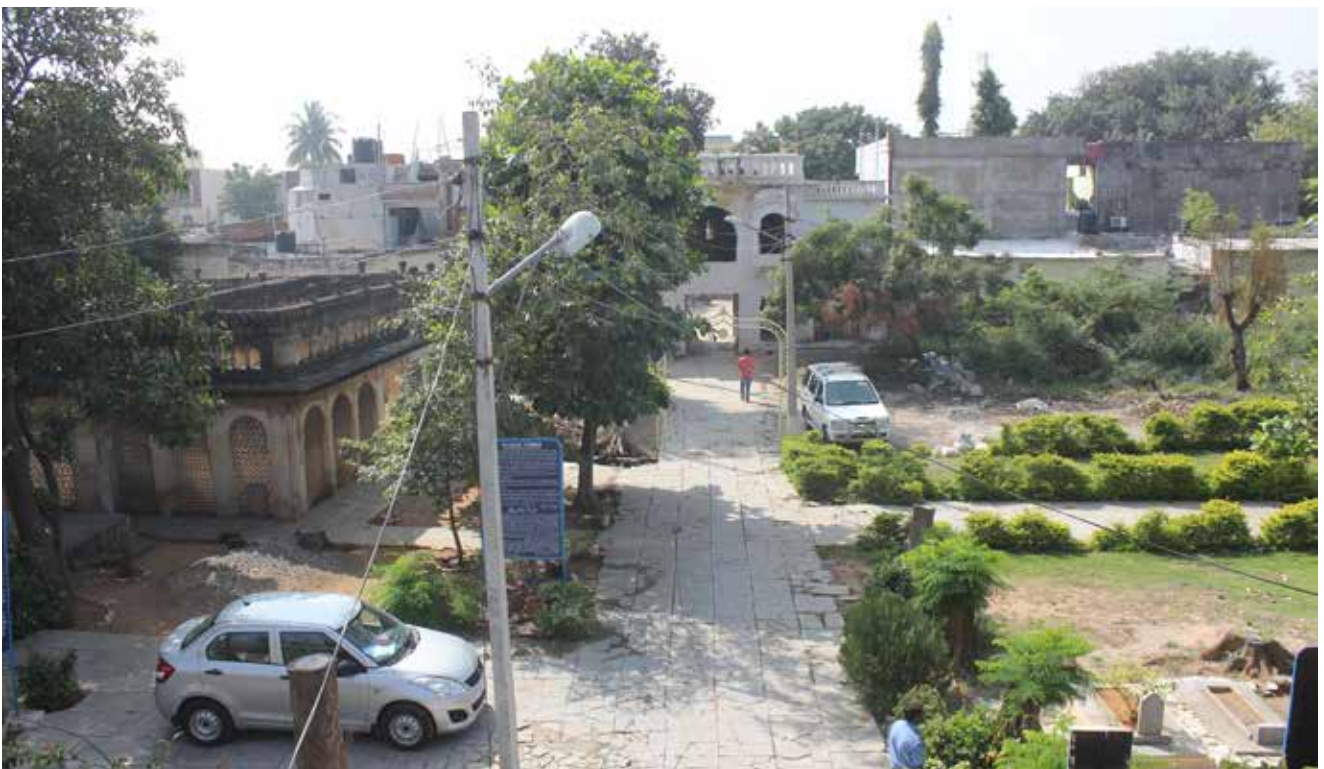
Inappropriate parking inside the tombs complex

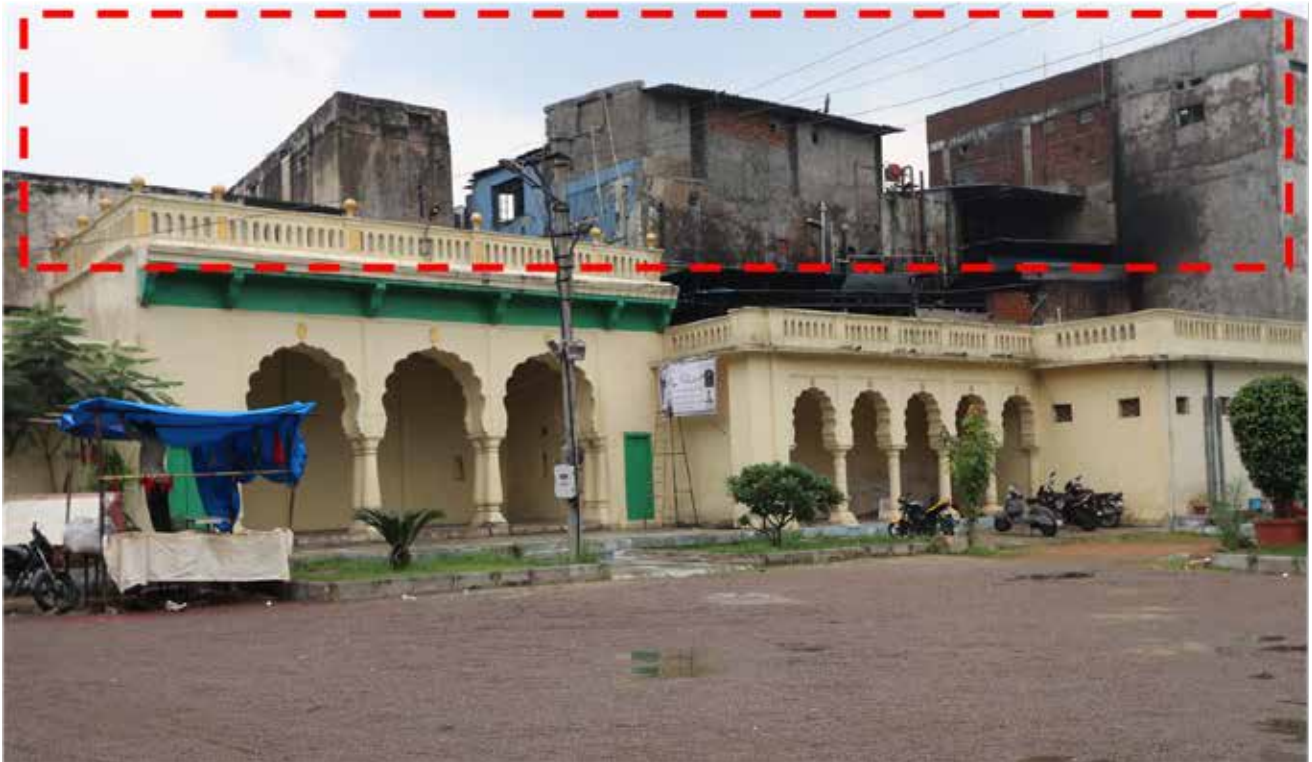
Encroachments along the periphery

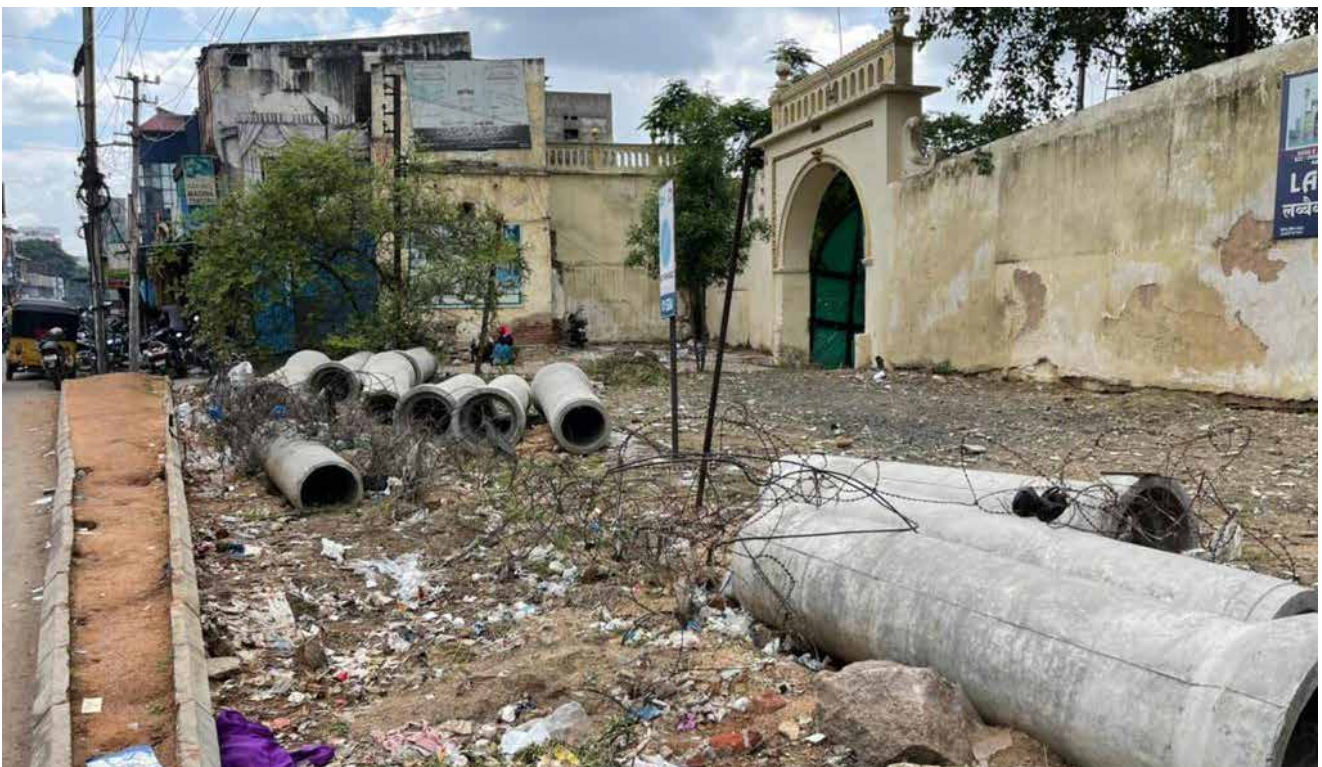
An urban forest is proposed to be planted in vacant area abutting the entrance archway

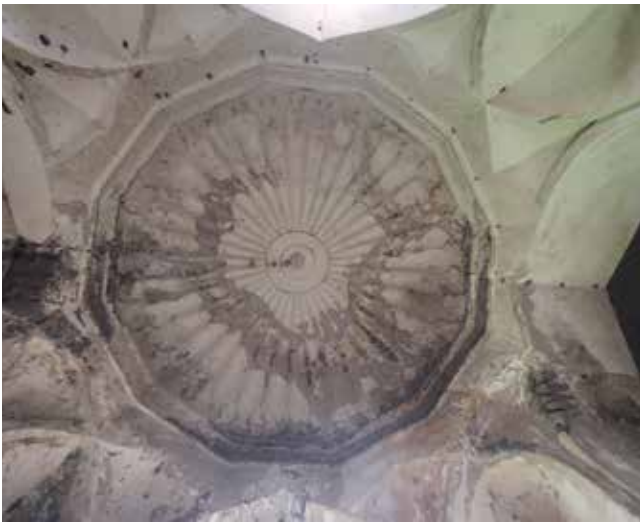
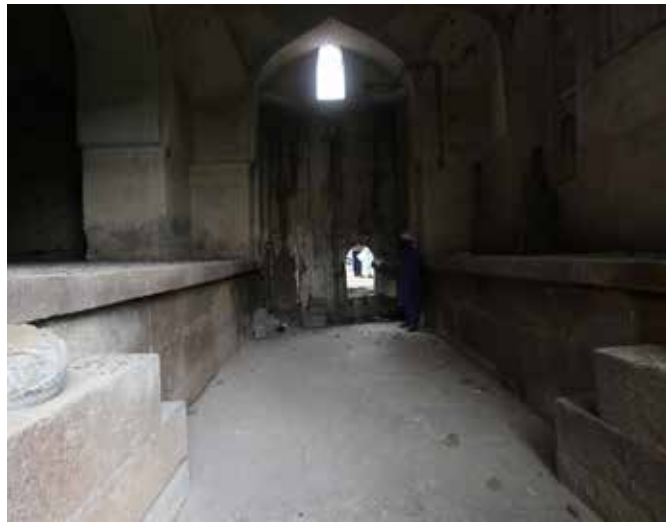
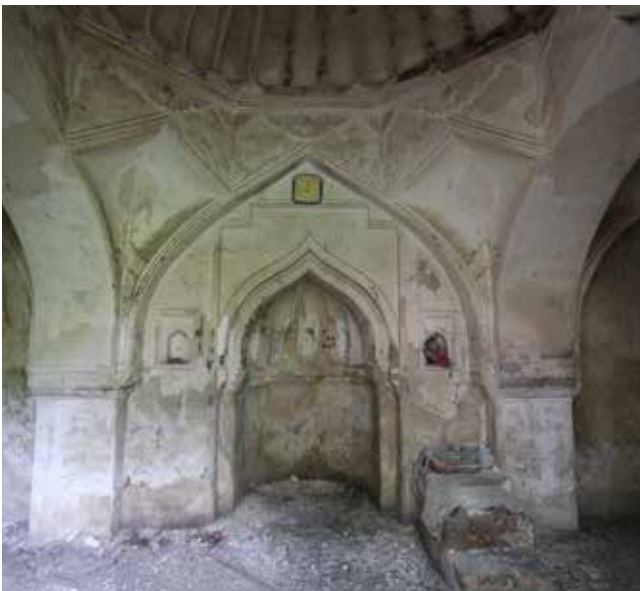
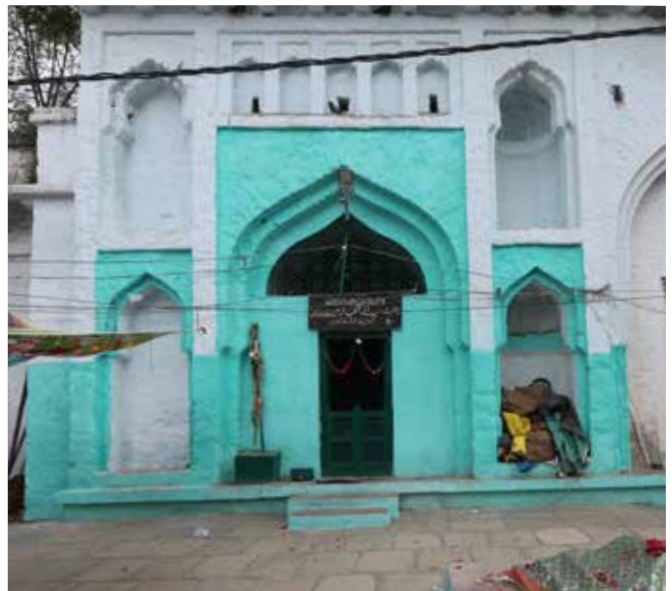
An old mosque with remnants with intricate stucco embellishment and remnants of tile ornamentation on the principal façade is situated inside the second courtyard. Due to extensive vegetation, a major portion of the courtyard is not accessible. Both the gateway and Sarai are in a state of decay. A portion of the boundary wall on the east has collapsed and led to encroachment inside the site near the gateway.

(Clockwise from left) Damaged ornate ceiling of the gateway; Entrance gateway; Dargah adjacent to the entrance; Interior of the mosque located on the site

There are evident signs of massive water seepage from the terrace which has aggravated due to use of inappropriate modern materials like cement for 20th century repairs and has led to pulverization of the original plaster. Deeply embedded plant roots need to be carefully removed and the voids in masonry to be filled with rubble stone and rich lime mortar to prevent further ingress of rainwater. Relaying of traditional lime concrete on terrace in appropriate slope and adequate curing to water tighten the terrace of both the gateway and the series of arched vaults and mosque will be followed with installation of projected stone waterspouts to effectively channel the rainwater away. Restoration of damaged plasterwork on the external facades, internal walls and ceiling will be carried out last. Stone flooring needs to be installed inside the gateway, arched vaults, and the mosque.

- Emergency conservation effort needs to be carried out on the monument including removal of deeply embedded tree roots on terrace followed by lime concreting on terrace to prevent ingress of rainwater into the structure and restoration of plasterwork. It needs to be followed by periodic preventive maintenance for prolonging life of the monument.
- Repair of damaged and missing of boundary wall around the complex to prevent encroachment.
- Adequate signage for the Shamsheerkota would augment the visitor inflow. Currently there is no visible signage or board to mark the existence of such a site along the road.

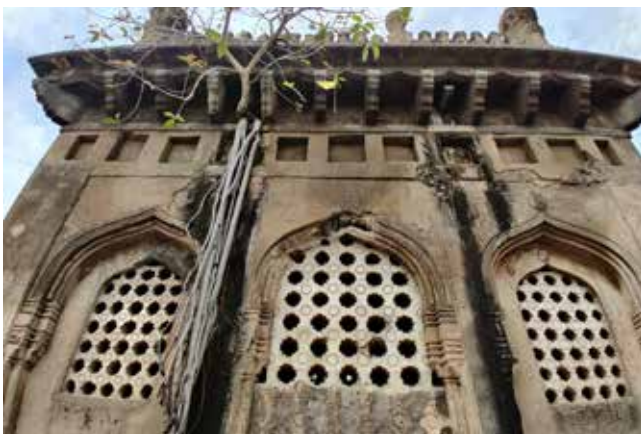
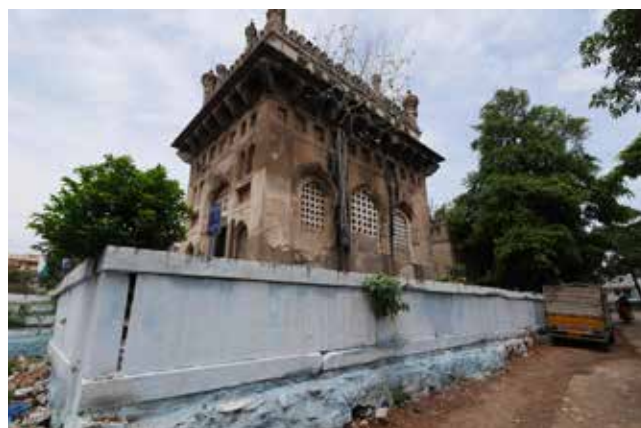
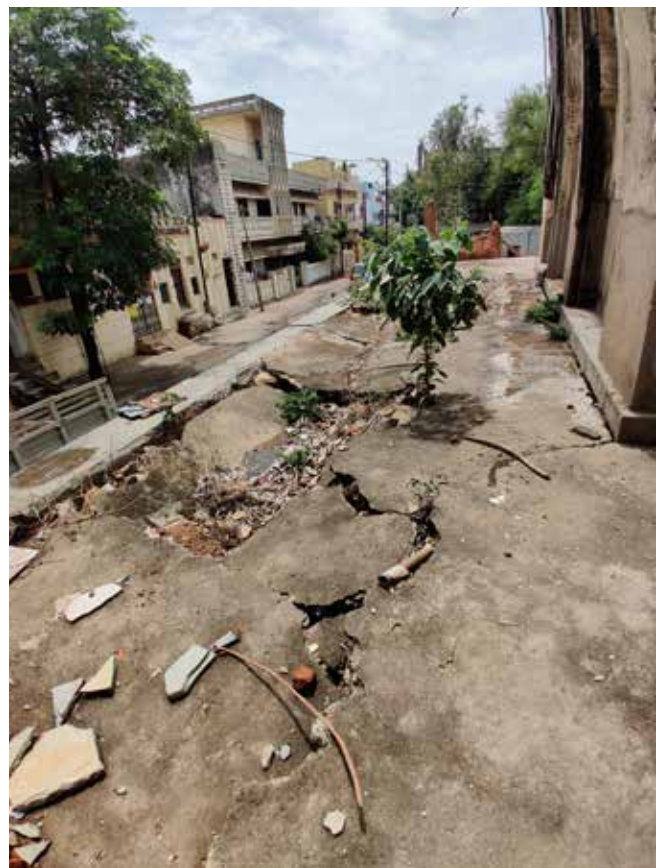
The structure is in an advanced state of decay and needs immediate conservation works. The grave of his son is situated in the centre with of Khairat Khan's grave on its side. The adjoining tomb is said to be of his wife, but there is no inscription on the grave. The mausoleum of his wife, smaller in size, is situated on the south-west corner of Khairat Khan's tomb.

(Clockwise from left) Deeply embedded tree roots on the facade; Dilapidated projected plinth; Bulging of vertical dressed stone

Major conservation works need to be carried starting with emergency stabilization and repair of the collapsed projected plinth lined with dressed granite stones as it poses a structural risk to the monument. There are evident signs of massive water seepage from the terrace which has led to tall peepal trees growing on the terrace surface with their deeply embedded roots in the masonry of the structure. Use of inappropriate modern materials like cement for 20th century repairs has further aggravated the water seepage problem and has led to pulverization of the original plaster. These roots need to be carefully removed and the voids in masonry to be filled with rubble stone and rich lime mortar to prevent further ingress of rainwater. Relaying of traditional lime concrete on terrace in appropriate slope and adequate curing to water tighten the terrace will be followed with installation of projected stone waterspouts to effectively channel the rainwater away from the structure. Restoration of damaged ornamental stucco and plasterwork on the external facades, internal walls and ceiling will be carried out last. Battlements and finials on the parapet are partially damaged and will need restoration using rich lime mortar and finishing with a thin layer of lime putty mixed with organic additives. Stone flooring needs to be installed on the projected plinth to channel rainwater away from the structure. Bulging and displaced granite stones on the collapsed plinth need to be realigned in their original position.
