QUTB SHAHI HERITAGE PARK

CONSERVATION & LANDSCAPE RESTORATION

ANNUAL REPORT 2021

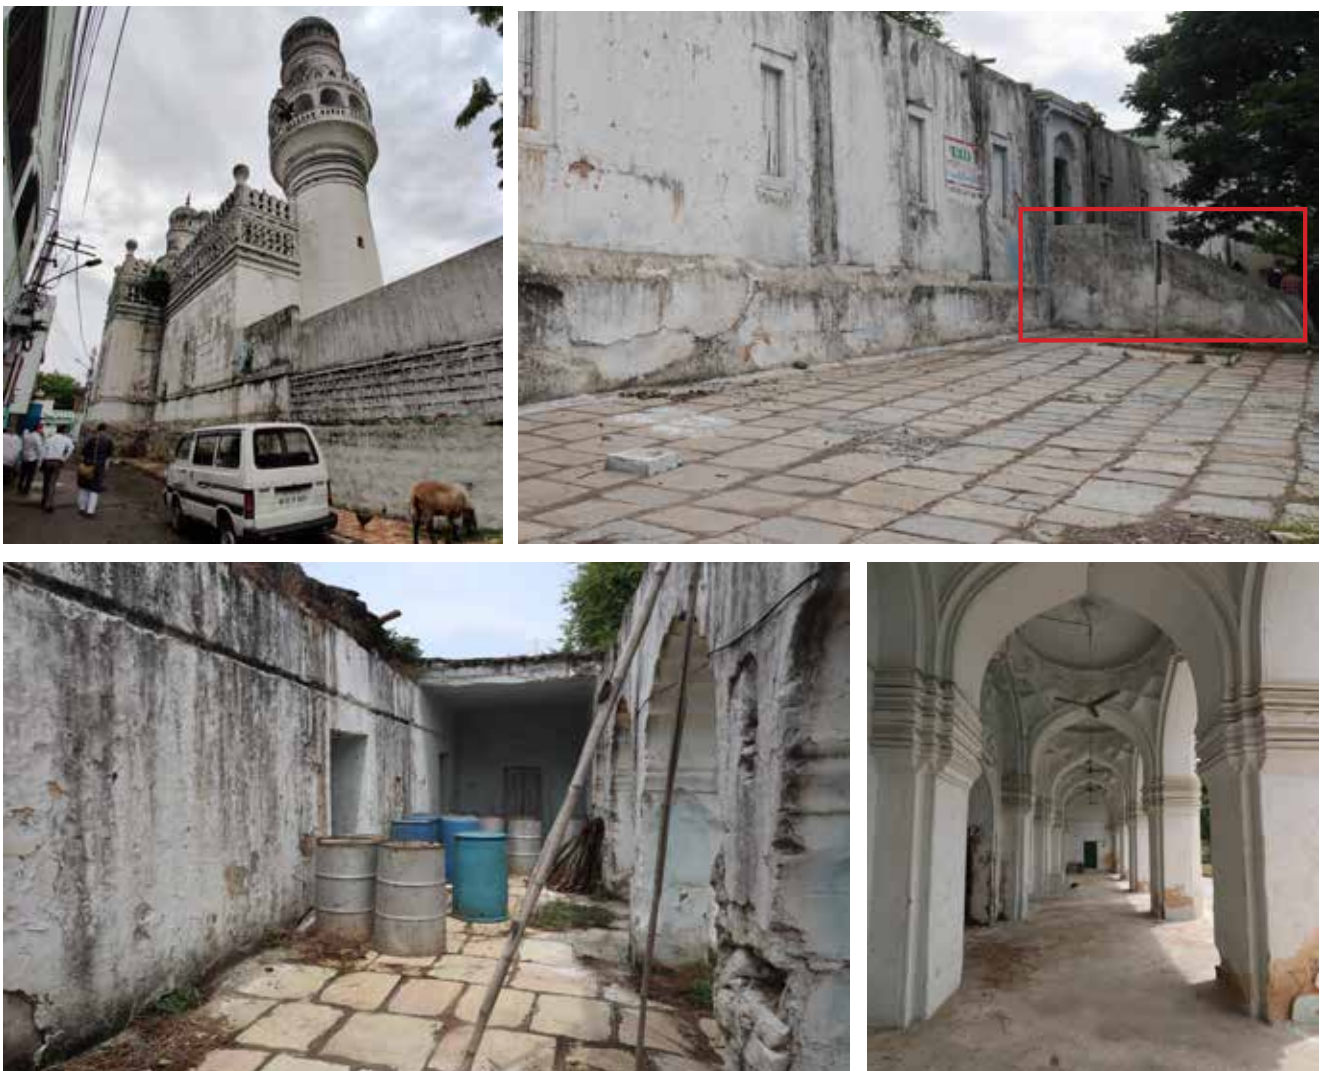
(Clockwise from left) Current principal entrance through a narrow lane; Steps at the original entrance might be demolished due to road widening; Partially collapsed roof of the sarai; Evident signs of water seepage inside the Idgah

The mosque requires constant monitoring on account of its significance. Minor repairs on the parapet and the lofty minarets need to be carried out and finial on one of the minars is severely tilted and needs urgent attention. Water tightening works need to be carried out on the terrace. No alteration of the structure should be permitted on account of the high archaeological value. Additions to the later added structures and construction of new buildings should not be permitted within the enclosure. Redesigning of southern steps in the available space after road widening needs to be carried out.

- Greater Hyderabad Municipal Corporation
- Minor repairs, water tightening on terrace and rebuilding of collapsed portions of serai.

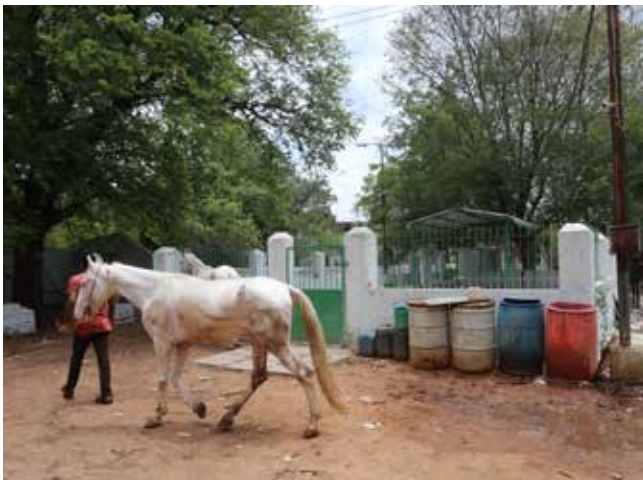
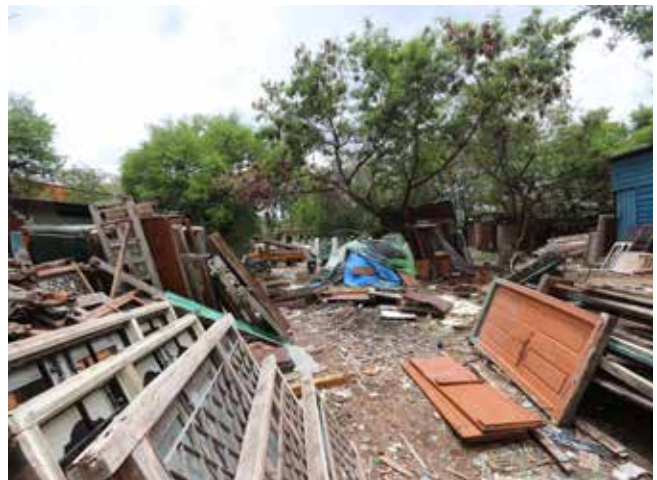
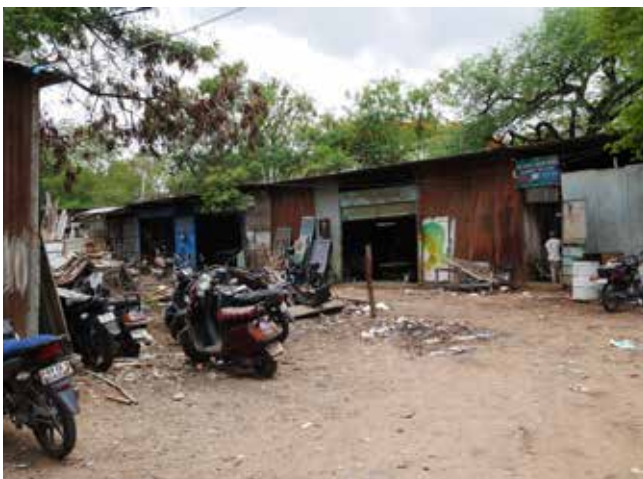
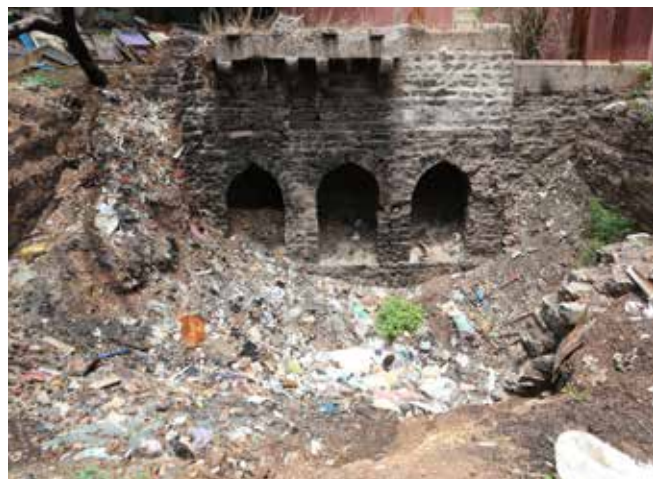
The baoli located on the adjacent land is in a ruinous condition and is full of debris and garbage. Steps in the available space after road widening needs to be carried out.

Land adjacent to the tomb with historic baoli in dilapidated condition

- Monument precincts needs minor conservation works for reinstating the damaged stucco and plasterwork on external and internal facades of the tomb. Periodic preventive maintenance coupled with removal of vegetation and algae removal on the external facades to be carried out.
- If the property is under the ownership of DHT then conservation works at the baoli including urgent desilting and major conservation works to reveal its historic character.
- In case the property of adjacent land is found under the ownership of the Department of Heritage, removal of encroachment should be initiated immediately.
- Adequate signage for the Tomb of Saidanima Ma Saheb would augment the visitor inflow. Currently there is no visible signage or board to mark the existence of such a site along the road abutting the tomb complex.

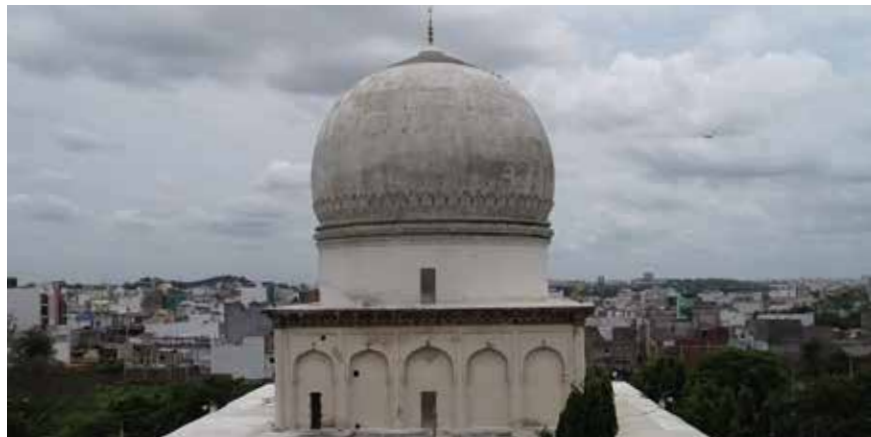
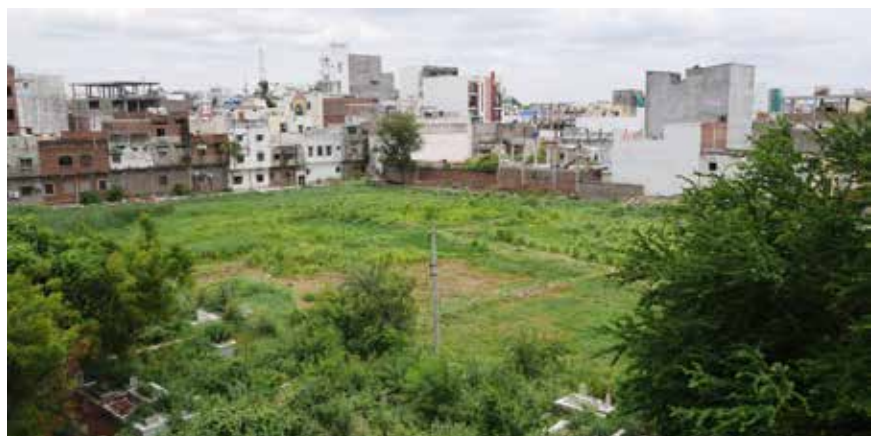
(Top) Staircase required to reach from terrace below to base of dome - for maintenance

(Bottom) Two rows of tall trees to be planted along the periphery - will help screen the views of modern building

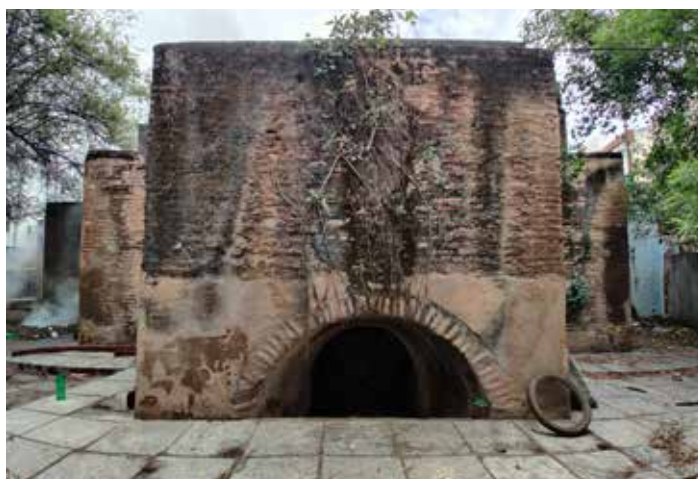
The Gunfoundry was built in the year 1795 during the Asaf Jahi period. At present, massive brick walls and cubicles supported by brick masonry arches at ground level and subterranean brick kilns are visible. There are series of arched openings which are interconnected to each other. The site situated in Abids area of Hyderabad can be accessed through a narrow lane and is surrounded by three-storey residences.

Minor conservation works need to be carried out on the brick masonry coupled with the removal of plant roots causing seepage of rainwater into the brick masonry. Some of the original bricks are found missing in minor portions of the structure and need to be reinstated. Removal of vegetation on upper facades of the structure to be carried out and voids to be blocked with lime mortar. Pointing with lime mortar to be carried out on external brick masonry to prevent ingress of rainwater. Adequate provisions to be made to prevent surface runoff water draining into the arched openings situated at ground level in case of heavy downpour. Solid iron bars interlocked on the upper portions of external brick masonry façade needs to be consolidated at the junction where the metal bars penetrate the brick masonry to prevent ingress of rainwater.

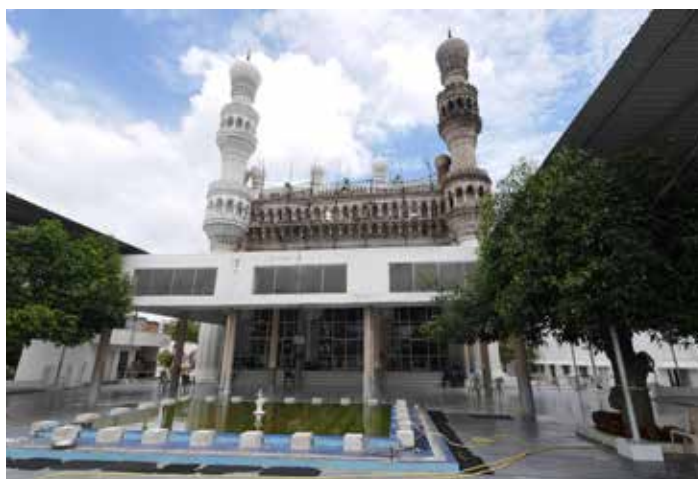
Situated in the Lakdikapul locality of Hyderabad, Khairati Begum's tomb and mosque are situated in proximity. Historically, the Khairati Begum's Mosque and tomb were part of the same complex but with modern buildings now built in between, the tomb is segregated. The mosque is situated inside a large open tract of land mostly paved with stone significantly reducing the ground water recharge. The mosque with the tripartite arch principal façade is embellished with highly ornamental multi-tier parapet supported by decorative stone brackets and boasts of tall corner minarets.

Modern concrete structure built abutting the principal façade and corner beams resting on the corner minarets of the mosque has obfuscated the original appearance and compromised the archaeological value. Later added concrete steps built over the historic stone steps in an abrupt manner. Two inappropriate modern concrete structures adjoining the historic steps have been constructed for provision of Wuzu. Internal wall and ceiling surfaces of the mosque have been covered with multiple layers of 20th century paint obfuscating the formal historic appearance of the mosque interiors. The tomb stands on a raised plinth and has a square plan.

A major conservation effort on the mosque structure is being carried out by Department of Heritage Telangana. Periodic preventive maintenance is required for the mosque structure. There are tall plants with deeply embedded roots growing on the dome of the tomb and seepage of water has led to pulverization of ornamental stucco plaster on the external facades and internal walls. Uprooting or plant roots and masonry repairs will be followed with installation of waterspouts for drainage of rainwater. Restoration of parapet battlements, corner minarets and stucco ornamentation on the lower facades to be carried out. Seepage of water has led to the displacement of dressed granite stones lining the plinth walls and need to be reinstated. Projected plinth needs to be paved with stone in appropriate slope to channel rainwater away from the structure.

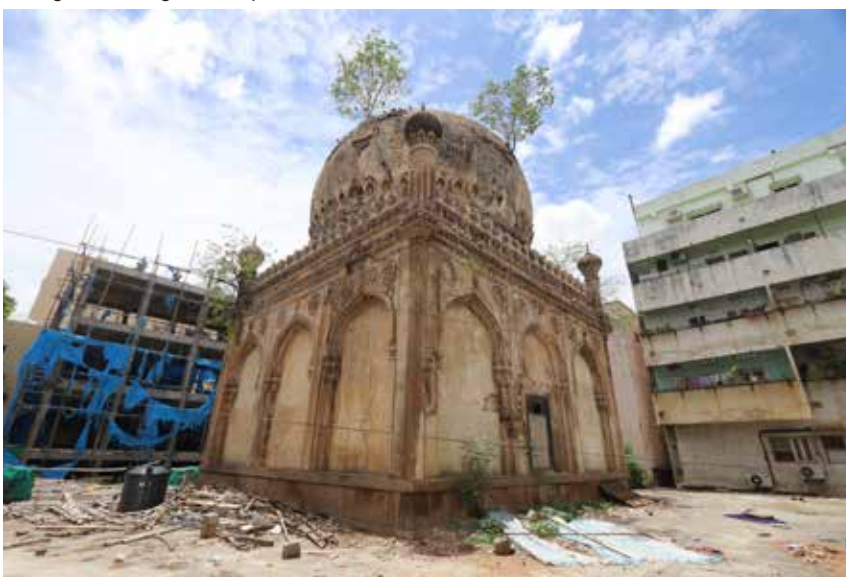
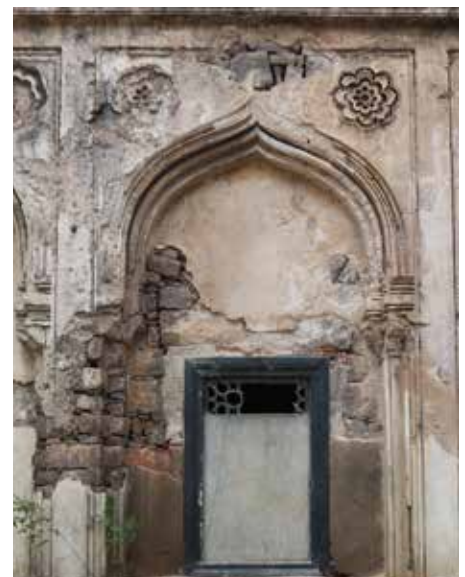
The tripartite façade arches of Tomb are decorated with ornamental stucco bands and floral medallions. Partial remnant of an exquisitely carved lattice screen on one of the openings is visible. The structure has a huge dome surrounded by a parapet with battlements and four smaller minarets. On three sides, multi-storey residential buildings are hemmed in till the edge of the projected plinth. Major water seepage leading to deeply embedded plant roots have caused damage to the masonry structure. The archaeological value of Khairati Begum's tomb is intact.

Images showing the dilapidated tomb

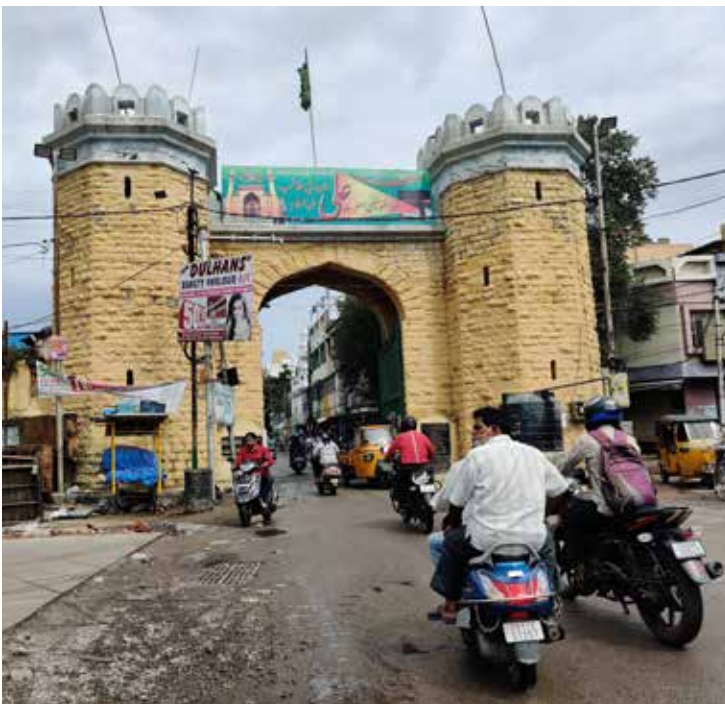
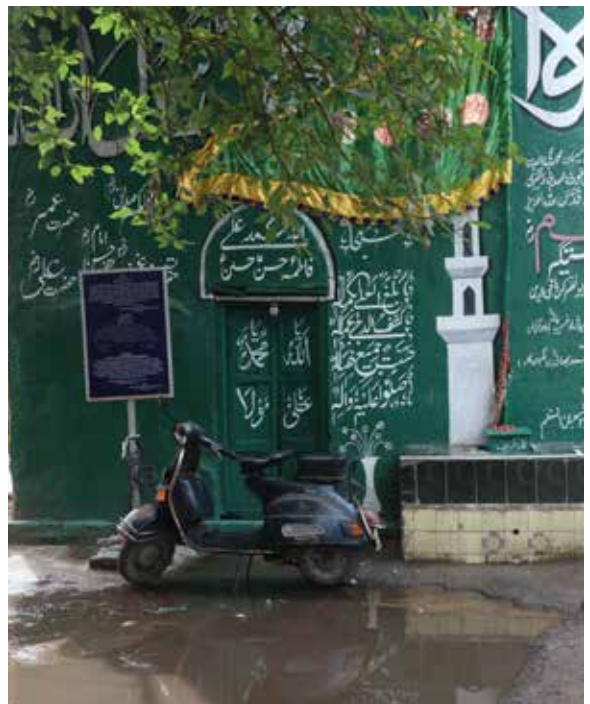
The pointed arch gate, built in the early 18th century, is flanked on either side by octagonal tower bastions. The arched gateway stands prominently at a thorough fare. Its original extent now limited on account of new structures and portions of the gateway are used as a shrine. The structure is covered with multiple layers of 20th century enamel paint. Historic wall adjoining the bastions has been demolished compromising the archaeological value of the structure. Shops encroaching the side walls and obfuscating the façade of the monument have defaced the monument. The original extent of the land is unknown.

(Left) Thoroughfare through the historic gateway
(Right) Shrine established abutting the gateway

Minor conservation works need to be carried out on the terrace for removal of deeply embedded plant roots aggravating the water seepage inside the structure. Relaying of traditional lime concrete to arrest further seepage of rainwater needs to be done. Meticulous removal of multiple layers of 20th century enamel paint needs to be carried out to reveal the formal historic appearance of the monument. Repairs on the partially decayed wooden doors need to be carried out.

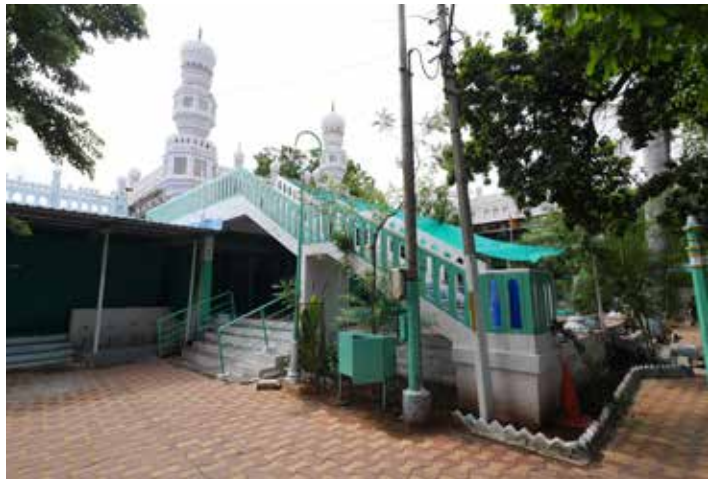
Situated near the Puranapul bridge, Mian Mishk Mosque stands within an arcaded enclosure and its principal entrance is accessed by a narrow road. The mosque, domed mausoleum, ancillary structure abutting the mosque and enclosure wall remain intact with minor damage visible in certain portions on the serai. A massive concrete structure with an elaborate staircase has been built abutting the mosque overwhelmingly compromising the archaeological value of the complex. The mosque and arcade have been covered with multiple layers of 20th century enamel paint obfuscating the historic formal appearance of the Qutb Shahi era structure.

Damaged and missing battlements and finials are visible at the parapet level of the ancillary structure attached with the mosque. It is currently being used as a gymnasium. There are evident signs of water seepage coupled with capillary rise leading to pulverization of the internal plaster in the arcaded enclosure. Access to the mosque complex from the northerner and southern entrances is hindered due to water logging during rains as the level of the adjacent roads has been raised above the adjoining mosque floor.

Minor repairs using lime mortar on the damaged portions of the parapet of the pavilion attached to mosque and arcaded enclosure needs to be carried out. Water tightening works need to be carried out to prevent pulverization of internal plaster. Conservation works on the mosque should be planned after the careful demolition of modern RCC structure abutting the monument.

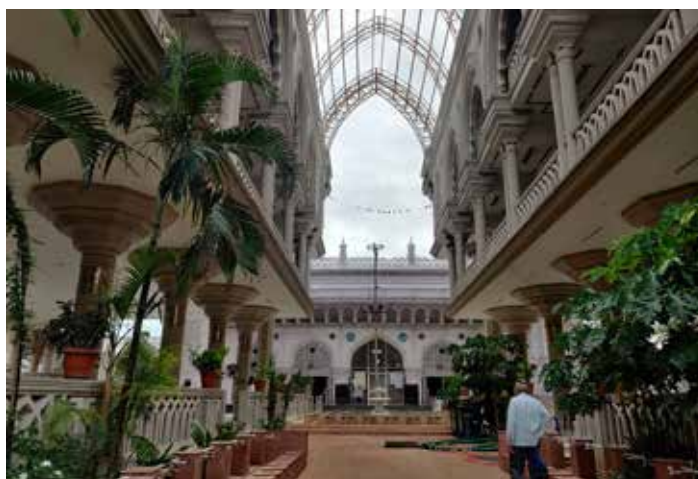
The mosque is in Musheerabad, one of Hyderabad's oldest localities. The mosque is an impressive structure built in the Qutb Shahi era with profuse ornamentation – that remain largely intact. The principal façade of the mosque with a flat roof is divided into five arched bays, with central wider arch and flanked on both sides by lofty minarets and an impressive parapet embellished with intersecting arches coupled with intricate stucco ornamentation. The mosque is enclosed by an elaborate arcade. The interior wall surfaces have been painted over with modern paint.

The open space within the enclosure has been completely built upon with four-storey double height colonnaded structure used for Friday prayers that has obliterated the historic character blocking the viewshed of the mosque. This inappropriate modern structure with a tall metal canopy has overwhelmingly compromised the architectural authenticity of the historic complex. Historically, a large courtyard with a large wuzu tank lined with hand dressed granite stone existed which has been built over with the colonnaded structure. There are visible signs of dampness. Water seepage, vegetation, and pulverization of the stucco on corner minarets.

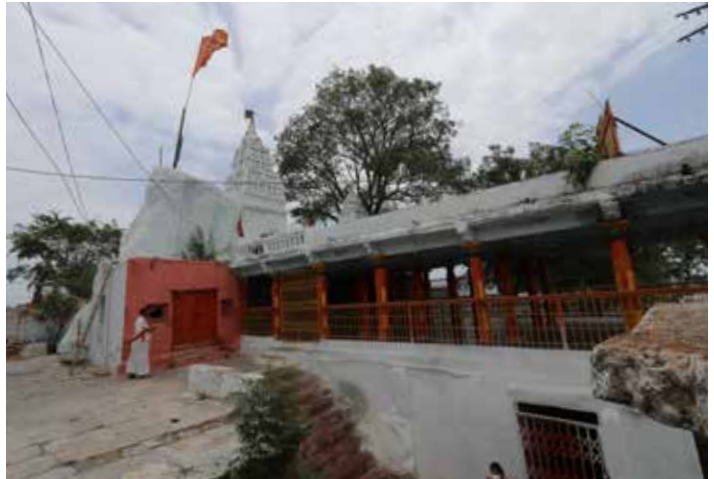
The Swayambhu Chennakesava Swamy temple dedicated to Lord Shiva is situated approximately 9 kms from Mahatma Gandhi Bus Station on the road leading to Srisailem in Chandrayangutta (V), Hyderabad. The temple is perched on a 60-feet high hillock accessed by a flight of over 100 steps from one side and a steep ramp from other. The hillock is also referred as Kesavagirigutta by the local population. The temple is defined by a masonry Shikhara embellished with beautifully carved figurines built over natural stone boulders that define the shrine. Chennakesava Swamy figurine is carved on a boulder with ornaments. The temple consists of garbhagriha and antarala connected with 28 pillared mandapa having access from both the south and north sides.

Of the several structures in the complex, only two stone pillared halls are historic, having been built between late 19th and early 20th century. Several ancillary structures constructed in mud mortar, situated besides the temple have partially collapsed. The shikhara above the garbhagriha is found to be of major archaeological value, whereas the mandapas are a later addition. Coupled with collapsed ancillary structures, difficulty in access, the overall archaeological value of the temple complex is severely compromised.

- Lack of easy access to be addressed by repair and cleanliness of the pathway coupled with the use of electric vehicles ferrying devotees till the entrance steps.
- Limiting of building activity around the temple complex and construction of missing boundary wall around the temple land to be constructed for preventing further encroachment.
- Designing development guidelines for new buildings coming up in the vicinity of the temple complex
